Interim report on the investigation of the collision between the high speed passenger craft *Seadogz* and a navigation buoy resulting in one fatality in Southampton Water on 22 August 2020

The aim of this interim report is to inform operators of small high speed passenger craft and UK port authorities of the circumstances of the accident and MAIB’s initial findings so that appropriate actions can be taken ahead of the boating season. A full report will be published when the investigation is complete.

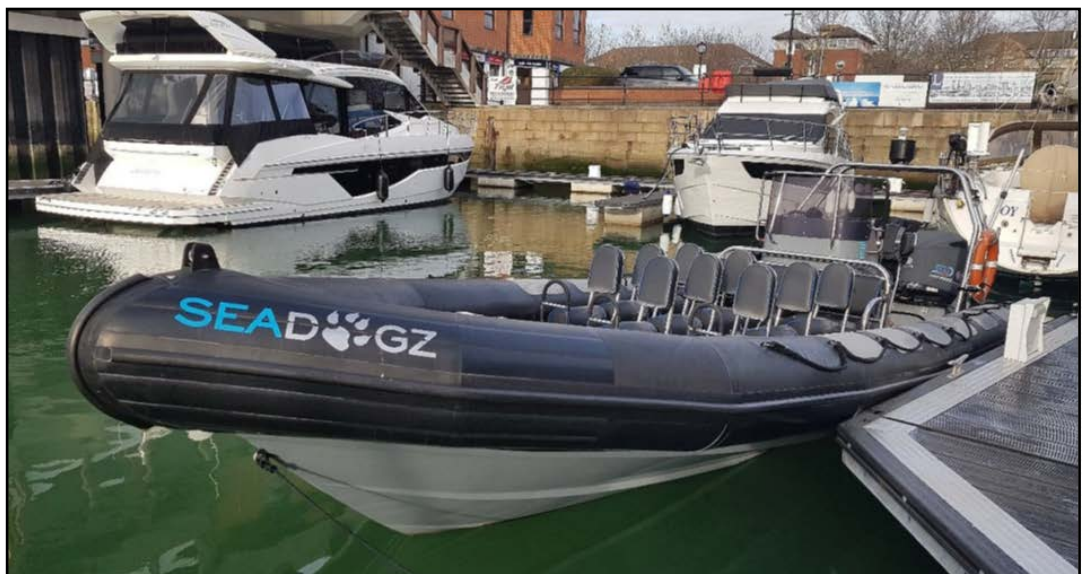
Figure 1: *Seadogz*

Seadogz was designed and manufactured by Red Bay Ribs Ltd in 2012 with a high sheer bow, deep 'v'-shaped hull, and inflatable tubes with seven buoyancy chambers. *Seadogz* was equipped with twin 300hp Yamaha outboard engines that, when first fitted, could drive the RIB at speeds of up to 55kts. The passenger seating on *Seadogz* comprised of nine cushioned jockey style seats and one cushioned bench seat that could accommodate three passengers. A semi-circular stainless-steel handrail was provided for each passenger at the front of their seat. Except for the front row seats, the passenger handrails were built into the jockey seat back rests. Due to the staggered configuration of the jockey seats, the handrail for the central position on the bench seat was extended and stiffened by a stainless-steel tie rod. There were two further jockey seats behind the helm console for crew.

The forward three sections of the buoyancy tubes on *Seadogz's* port side were punctured and the bow of the GRP hull was severely damaged. Several of the steel framed jockey seat backs were bent forward by the force of passengers hitting them.

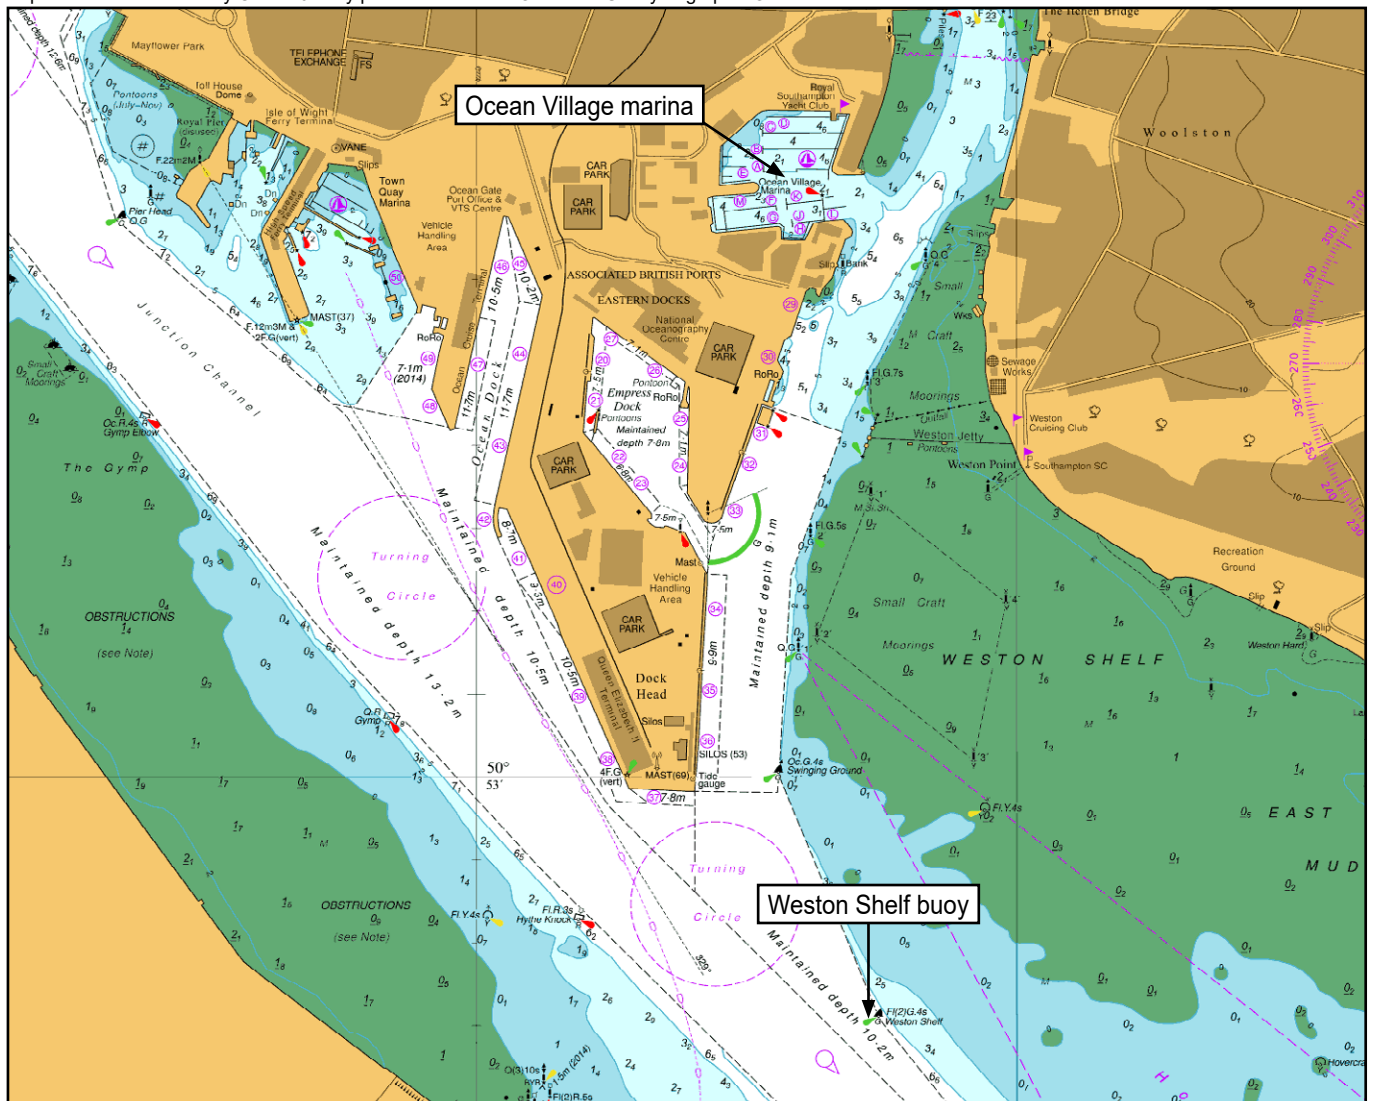
Figure 2: Extract of BA Chart 2041, showing Ocean Village and the Weston Shelf buoy

At 0946, *Seadogz* departed the marina (**Figure 2**) and moved toward Southampton Water. The weather was overcast with bright spells, the winds were 17kts from the west-south-west with gusts of 25kts, and the sea state was slight.

At 0959, *Seadogz* passed the Weston Shelf buoy (**Figure 2**) at a speed of about 33.1kts. Once clear of the buoy, the skipper put on some loud music and increased to speeds between 30kts and 40kts. During the next 12 minutes *Seadogz* carried out high speed manoeuvres up and down Southampton Water, zig-zagging across the main channel, passing close to navigation buoys and conducting figure-of-eight turns in order to cross its own wake (**Figure 3**).
