Annual Digest
Reports and Insight Articles

2020

Annual Digest of Reports and Insight Articles 2020

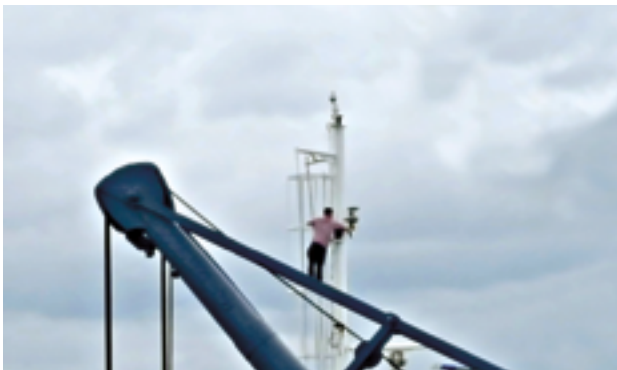
Working aloft with no safety harness or PPE

After identifying the ISM managers, CHIRP emailed the DPA who engaged immediately, allowing CHIRP to pass over details of the report. The following day the DPA contacted CHIRP with the information that the photographs in the report did indeed show a member of the ship's crew. The DPA said this was very disappointing as the actions shown were completely contrary to the vessel's SMS. Furthermore, earlier in the month the DPA had sent out a fleet-wide safety bulletin emphasising the need to complete risk assessments and permits to work for all hazardous activities.

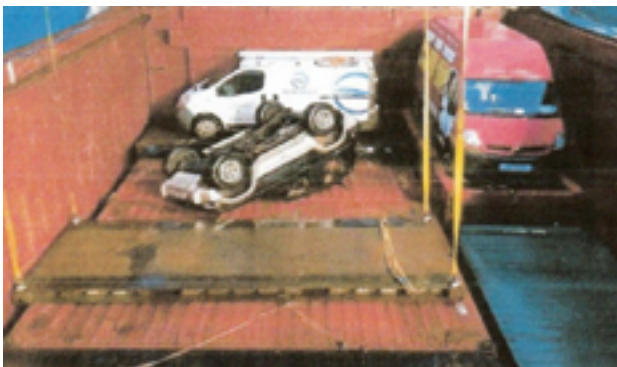
Cargo operations were being carried out by a shore crane operator and contract stevedores; no ship's crew were involved. All personnel engaged in the loading were suitably experienced and were in date for training with regards to their respective roles, there were current certificates where applicable and all lifting equipment used was in date within a six-monthly inspection routine. A six-monthly inspection routine was carried out by a third party contractor instead of a more normal annual inspection.

The 4x4 after the incident

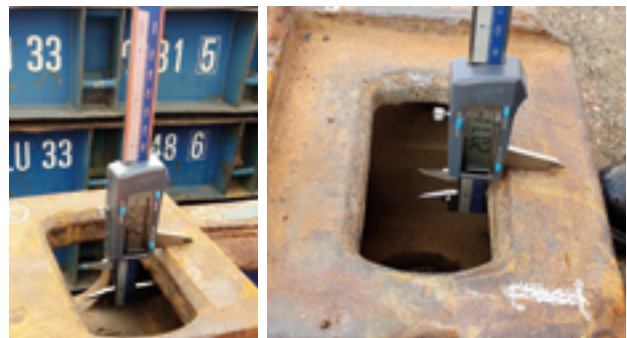
Inspection of the flat involved showed that the top plate thickness of the lifting socket of this type of unit is (at approximately 20mm) some 8mm thinner than the standard fittings on other more modern flats and the industry standard (approx. 28mm). Given that the top of the plate is chamfered, only a parallel plate thickness of 8-10mm is available for the tab to connect with. This increases the risk of the tab on the lug moving enough to enable the lug to twist and disconnect especially if there was a twist in the strop. The light rain at the time may also have lubricated the surfaces.

At ≈20mm the top plate thickness was 8mm thinner than more modern "flats" and the current industry standard, ≈28mm

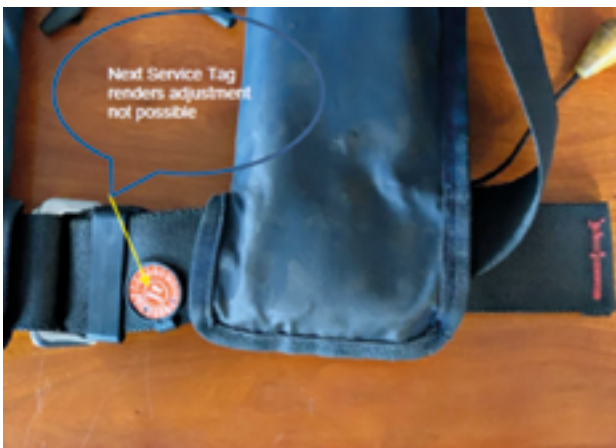
Highlighting that the positioning of the service tag renders waist strap adjustment impossible

CHIRP engaged with the reporter to confirm that the 'next service' tags in question had been fitted by a third-party service centre – they had been. After checking other vessels in the company, the reporter advised CHIRP that four other ships had equipment serviced by the same service provider. However, it appeared that this was an isolated incident which had not been replicated elsewhere. The DPA forwarded full details to the servicing company who gave assurances that it would not happen again.

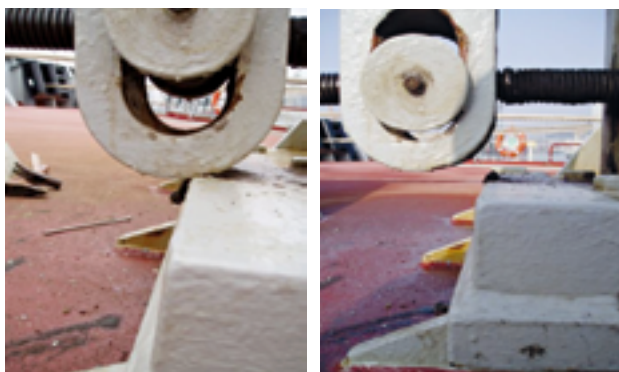
The reason for the freedom of movement was that the crosshead, located between the brake application shaft and the brake tensioning plates, was in contact with the windlass foundation, as shown in the photograph below:

Incorrect Brake Adjustment Correct Brake Adjustment

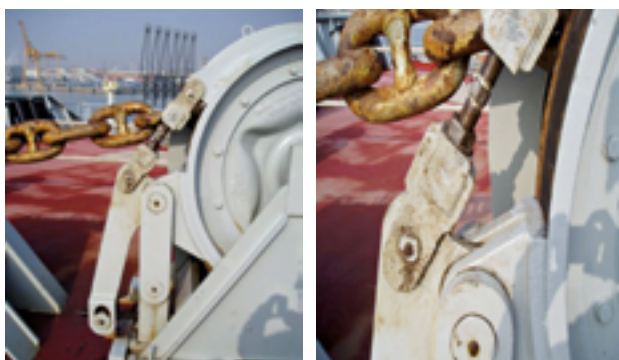
Brake 'Fully On' Bottle Screw Adjustment

The bottle screw was then tightened to the correct setting, i.e. allowing the gypsy to rotate freely in the brake 'off' position, but in the brake 'fully on' position the hydraulic motor could not rotate the gypsy. The clearance between the crosshead plates and the foundation with the brake fully applied was in the region of some 30 – 35mm.

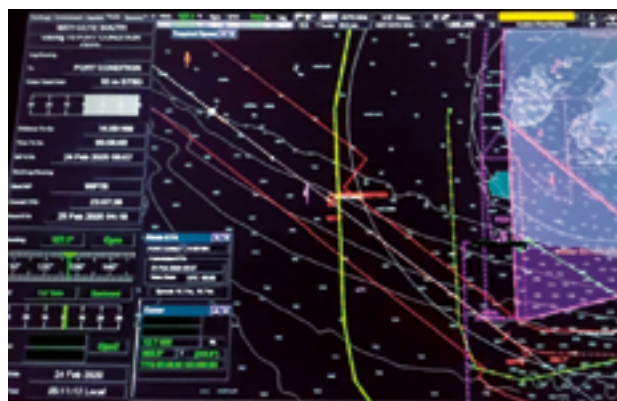
The reporter included a screen shot of the Radar/AIS clearly showing the reported ship transiting within the adjacent PSSA.

Screen shot of the Radar/AIS showing the reported ship transiting within the adjacent PSSA.

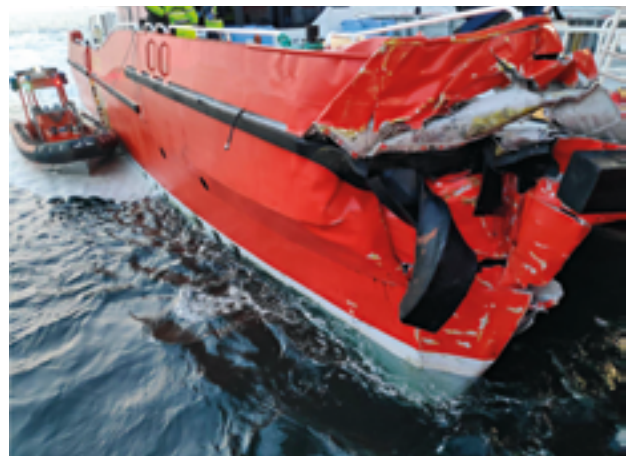
The vessel involved was a service vessel engaged in transferring personnel between a shore base and wind turbines in offshore locations. The only other details initially available were that the hull had been breached at the bow and suffered water ingress, and that three persons on board sustained injury during the allision. The damaged vessel had then been escorted to port by an offshore lifeboat.

The Consequence of distraction.

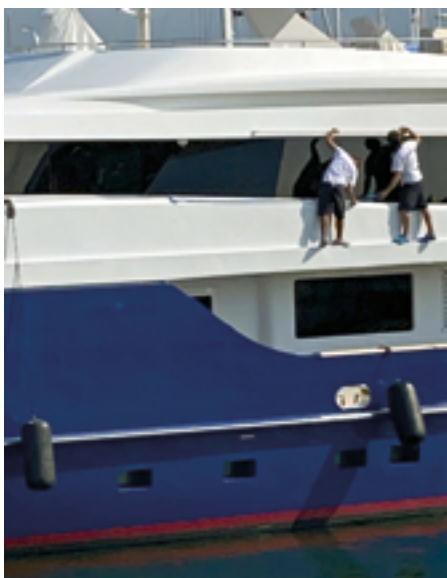
Figure 3 – Another example of poor safety culture in the superyacht sector.

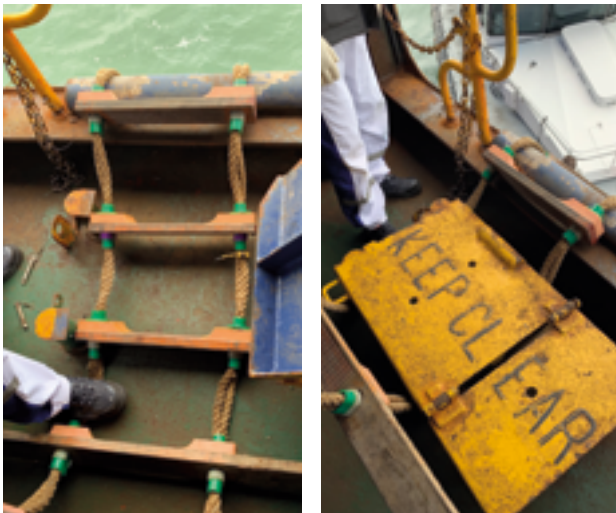
They say a picture paints a thousand words – this clearly demonstrates the appalling lengths that some mariners will go to with respect to endangering life.

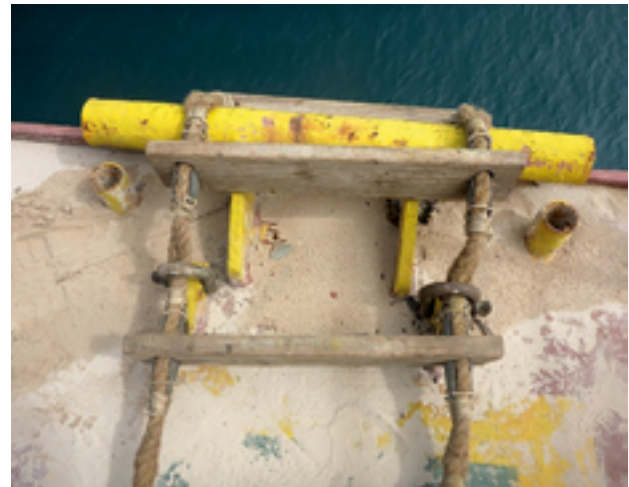
Pilot ladder incorrectly secured to the deck using D-shackles to choke the side ropes.

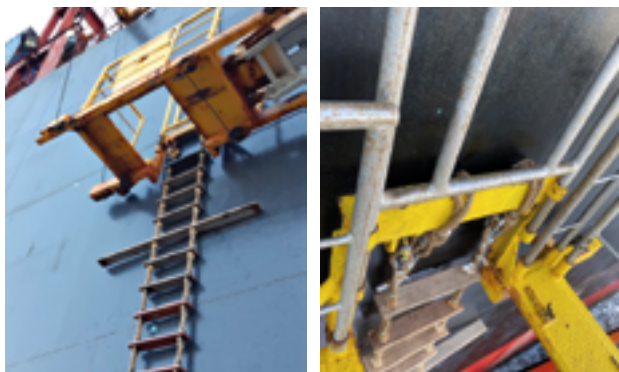
2 examples of non-compliant 'trapdoor' pilot boarding arrangements

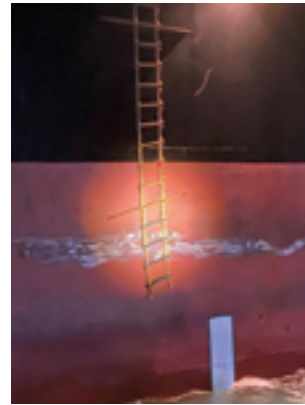
▲ Second ladder rejected due to very loose whippings

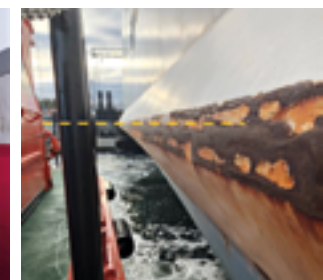
Examples of ship side features that render the vessels non-compliant by design

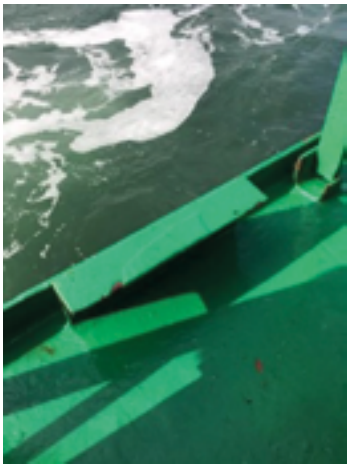
Notorious offender...

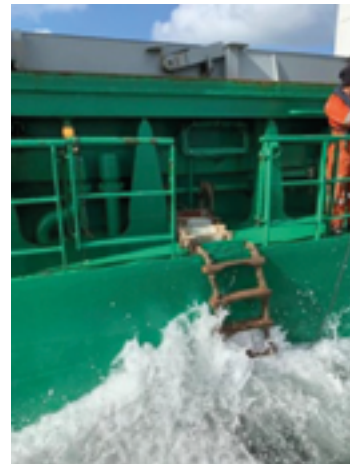
Notorious offender, and it's not even a pilot ladder. As we say: non-compliant as hell.

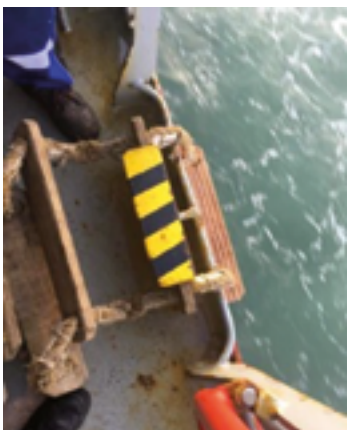
Deck tongue supporting the ladder.

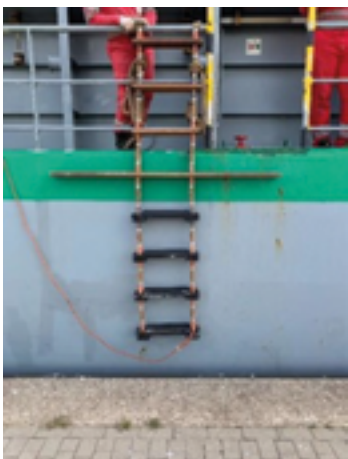
This setup means you have to stumble sideways to reach the entrance.

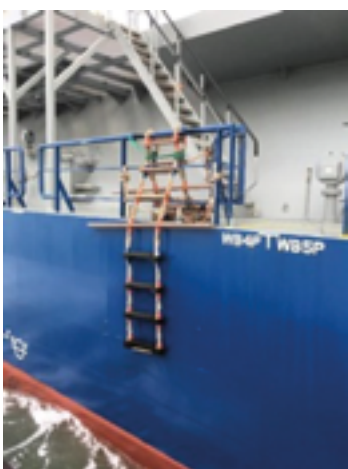
Sideway shuffle again – how strong is the railing?

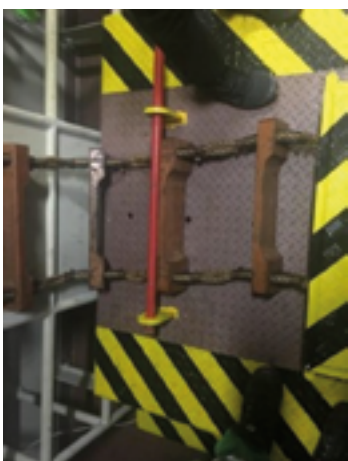
Always a surprise when you lift the lid.

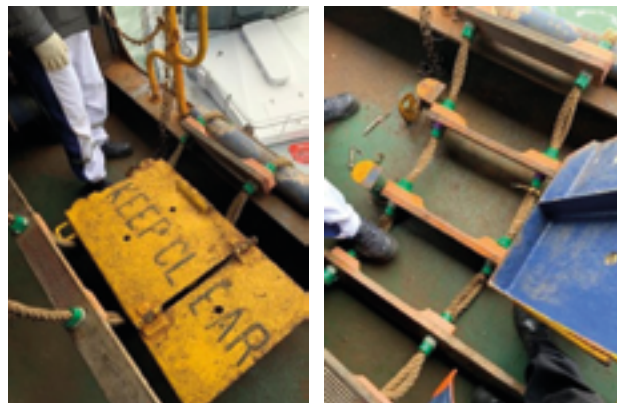
Looks like a safe access but the 3cm piece of steel is the only thing between life or death.

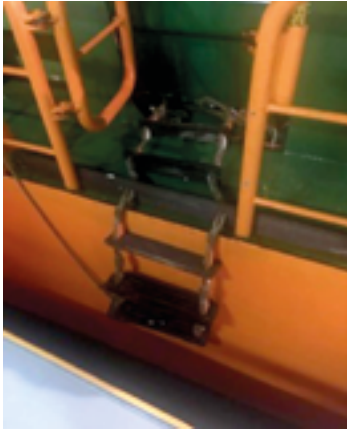
Another spreader used as a securing method.

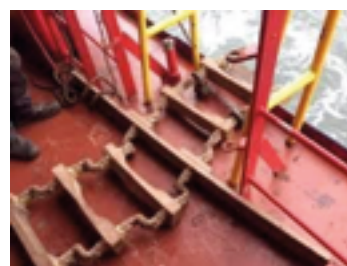
Check the condition of the sideropes.
