**MAIB**

# **SAFETY DIGEST**

**Lessons from Marine  
Accident Reports  
2/2021**

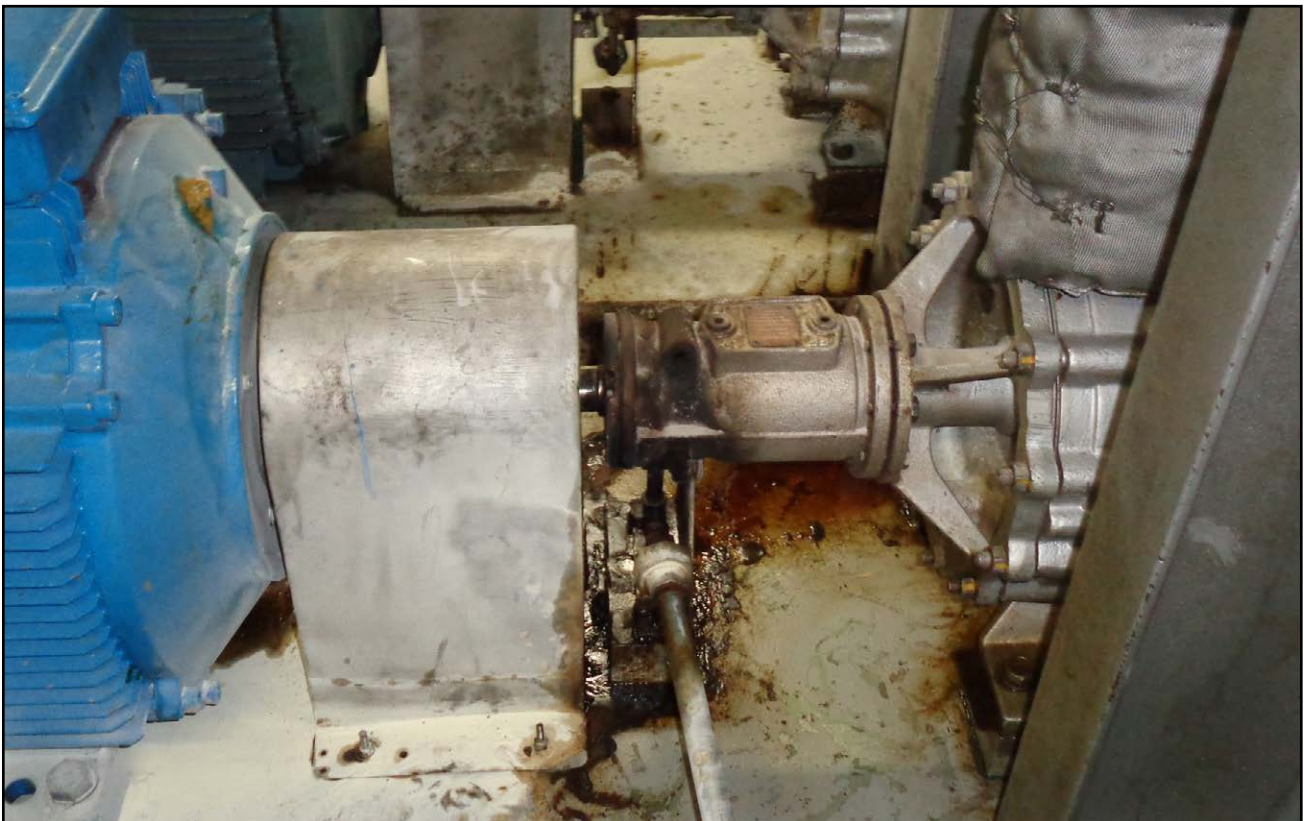
(see figure). Leaking oil from the pump then reignited and, again, the 3/E extinguished the fire with a portable extinguisher.

The cause of the fire was later found to be a failed pump bearing that had overheated, damaging the adjacent mechanical seal. The failure of the seal resulted in oil spraying out and igniting on the bearing's hot surfaces.

Figure: The scene of the fire, showing the fire damage around the coupling and leaked oil

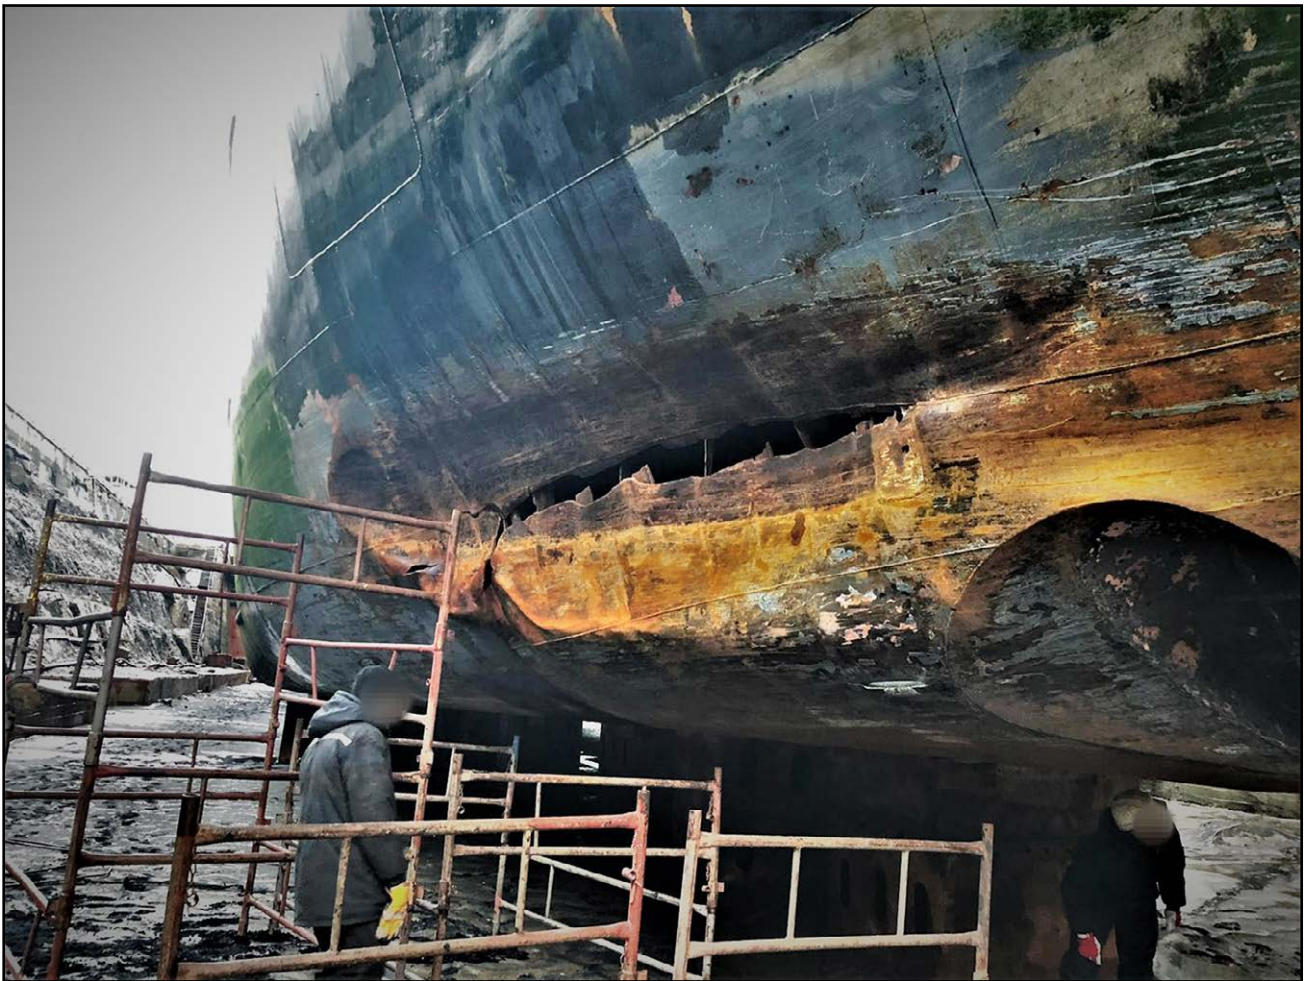
During an outbound river passage under pilotage, a general cargo vessel grounded and suffered damage to its hull plating (see figure). Despite both the bridge team and pilot feeling the contact, no report of the grounding was made to the local Vessel Traffic Service (VTS) and the vessel proceeded to sea as usual after disembarking the pilot. Hull damage was not confirmed until the day after the incident and the full extent not realised until the vessel had completed its sea passage and entered a dry dock.

Even though the initial damage assessment did not identify a breach of the hull, the next day an area of deformation in a cargo hold led to the discovery of a significant breach. The vessel was sent to a repair yard immediately on its next arrival and dry docked.

Figure: Damage to the general cargo vessel's hull plating

- 2. Even if there has only been a suspicion of a vessel grounding, it is imperative that the local VTS is informed and a comprehensive check of the vessel made before proceeding to sea. Neither were done in this case, which not only contravened the local regulations and obligations of both the pilot and the vessel's master but also placed the safety of all the crew and vessel in jeopardy.**

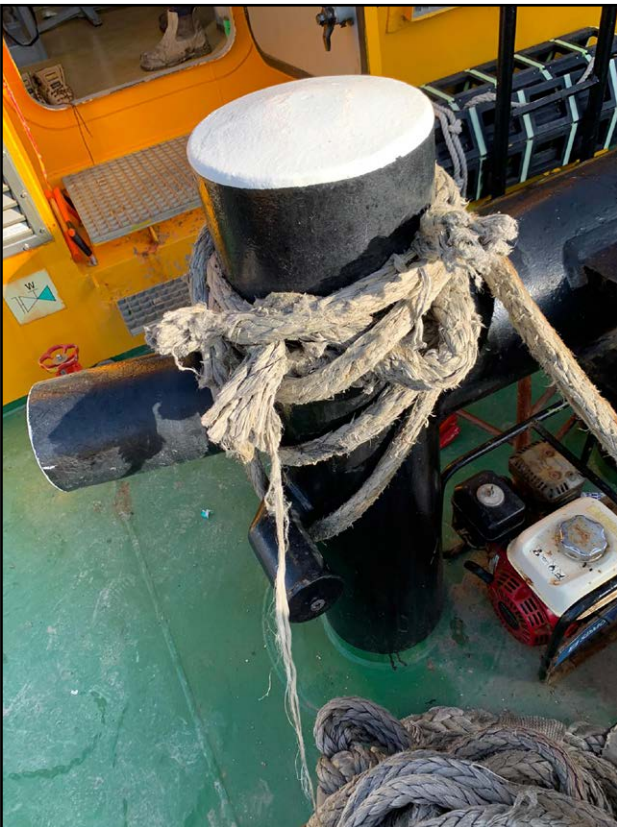
Figure 2: H post, showing cut line

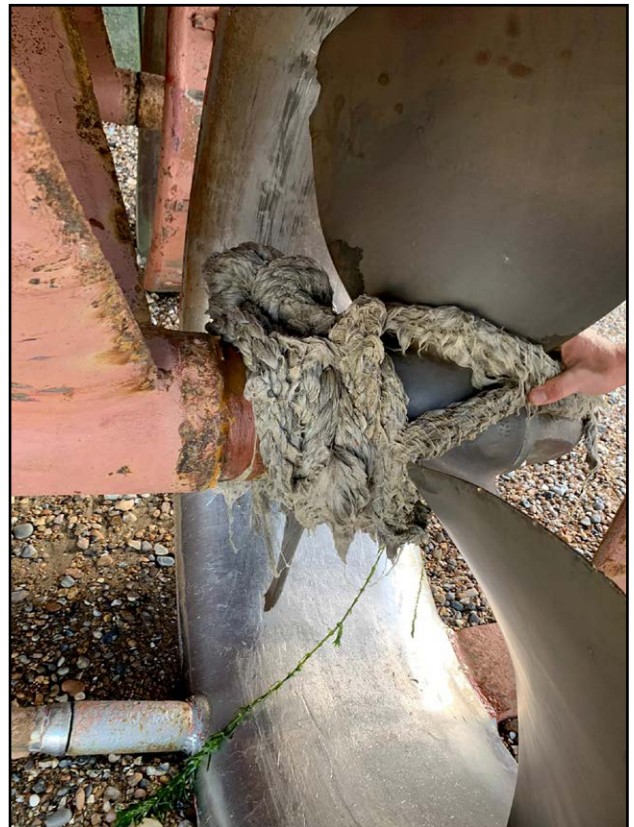
With the engines stopped, the deckhand cut the tow rope to release the engineer's hand, and first aid was administered. The engineer's hand was clearly badly injured, so a "Pan-Pan" call was made, and the tug and barge were secured to a mooring buoy to await help. An RNLI vessel attended and took the engineer ashore to an ambulance, which then took him to hospital. Two of the engineer's fingers were badly damaged, with open wounds and lacerations. Although he made a good recovery, he was off work for several weeks. The tug was towed back to base and allowed to dry out alongside to enable the rope to be cleared from the port propeller.

Figure 3: Fouled propeller

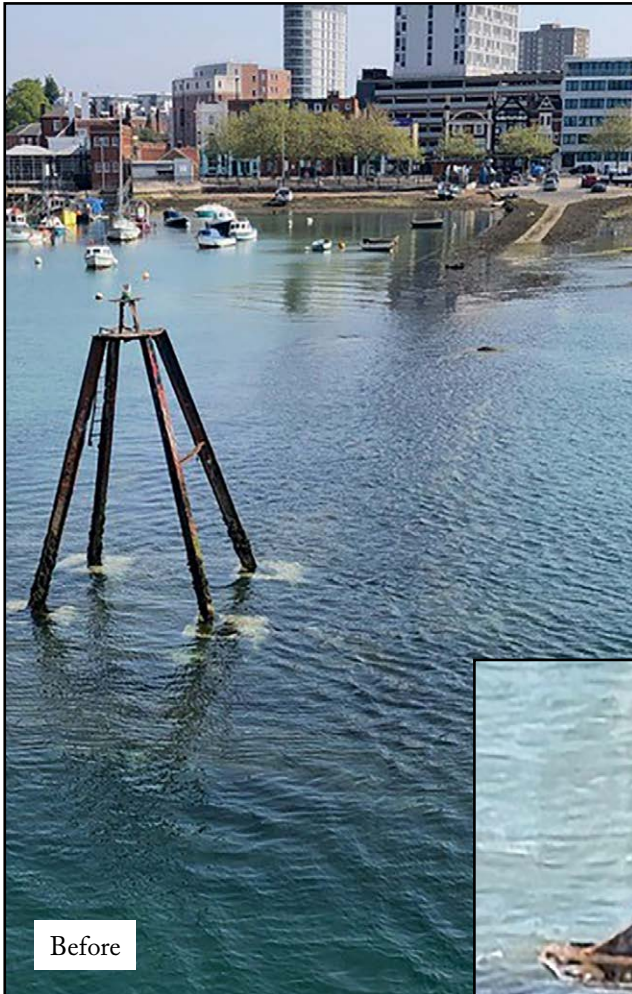
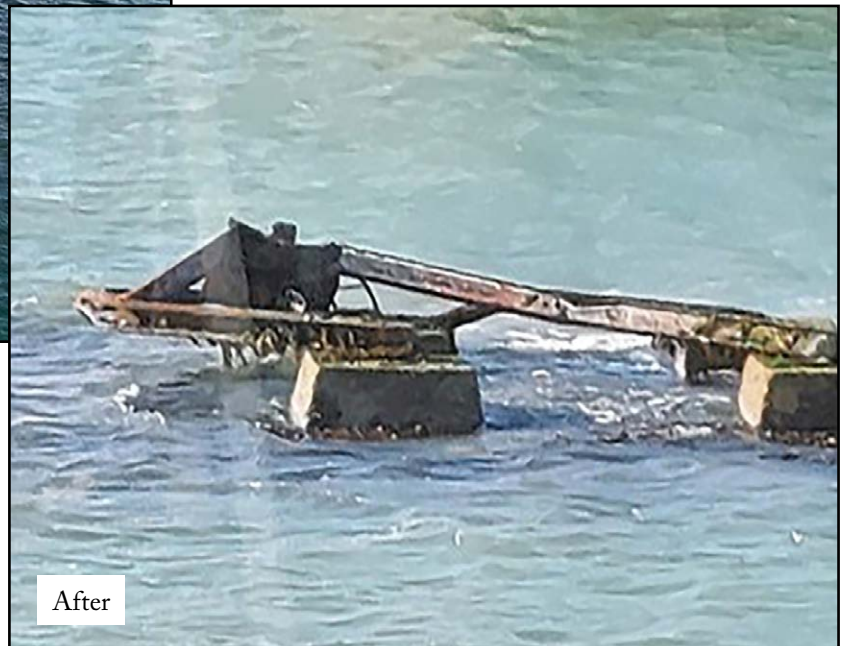
Acting quickly, the deckhand told the master and the thruster was stopped; however, this action came too late to prevent the ferry's stern making heavy contact with a navigation mark at the end of a nearby submerged slipway. The navigation mark was demolished (Figure 1); however, there was only cosmetic damage to the ferry's paintwork.

Figure 1: The navigation mark before and after the incident

1. Always check the effect of control system inputs. The ferry operated across a harbour, berthing and unberthing from the same two pontoons many, many times a day, and the master was extremely experienced at handling the vessel. Nevertheless, it's important to check the response to control system inputs, also taking into account the prevailing conditions. The reflecting sunlight was a distraction for the bridge team and vital seconds were lost trying to figure out what was wrong. Simple visual checks on the intended movement and immediate correction of unexpected movement, is necessary in the close confines of a harbour. After the incident, no fault could be found with the control system and the error could not be replicated, so it is probable that the master inadvertently selected astern and not ahead on the aft thruster.

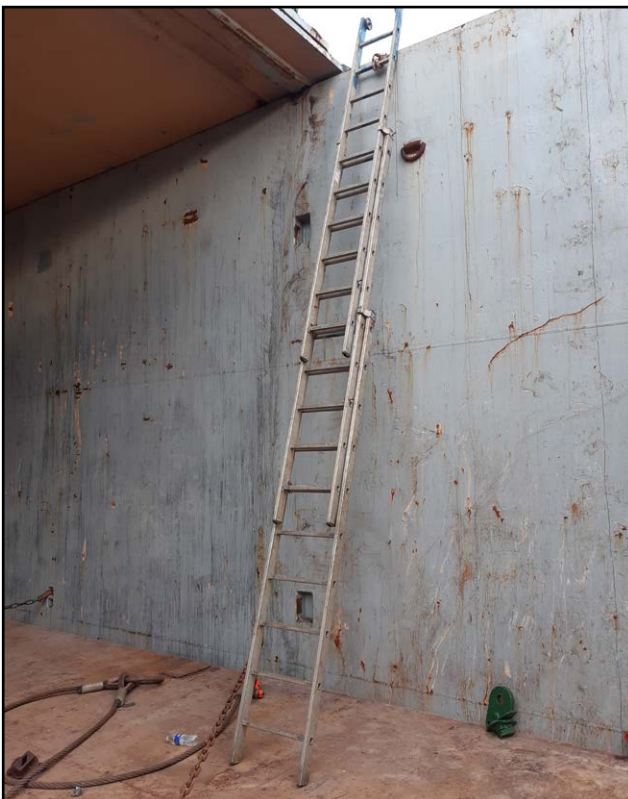
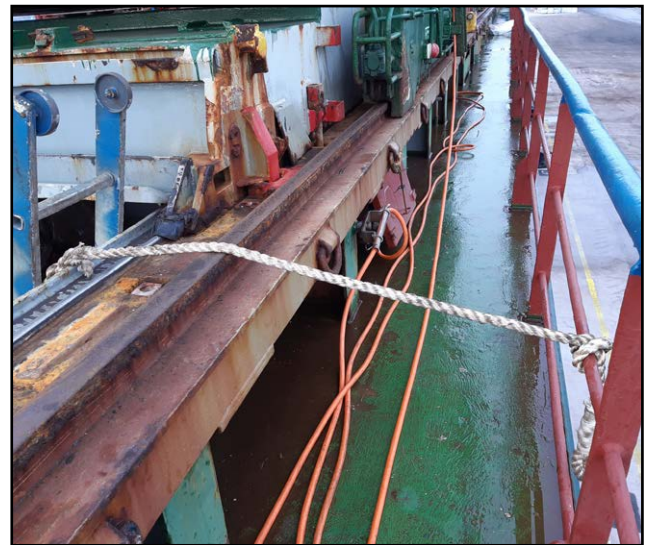
Figure 1 is a post-accident reconstruction of the ladder arrangements, noting that the securing rope shown was not present when the accident happened.

Figure 1: Post-accident images of the ladder arrangements (securing rope not present when the fall occurred)

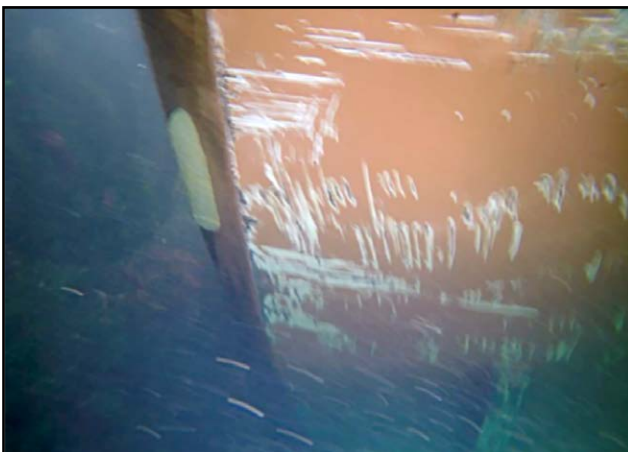
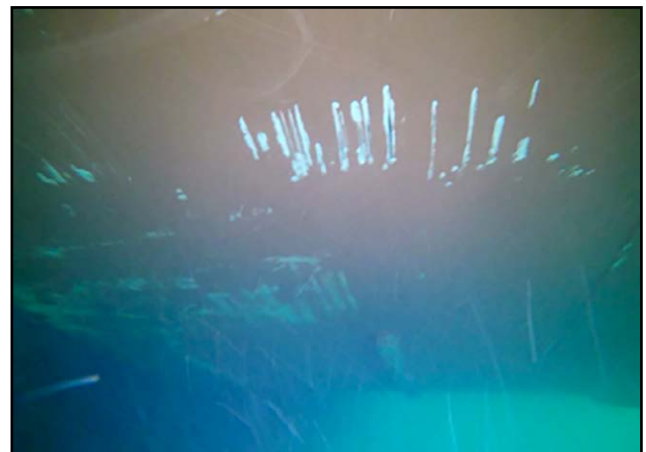
On its return to base, it was decided to slip the vessel. Once dry, this revealed a badly damaged area of hull requiring replacement together with some framing that required repair. There was also some minor damage to the port rudder linkage.

Figure 1: Dive survey photos, showing hull scrape damage

After any major incident or accident where the extent of damage is not fully known, it is essential to inform the certifying authority as soon as possible, and their advice on formal surveys and repair action must be followed. As well as affecting insurance validity, failure to do this may place the vessel and crew in danger.

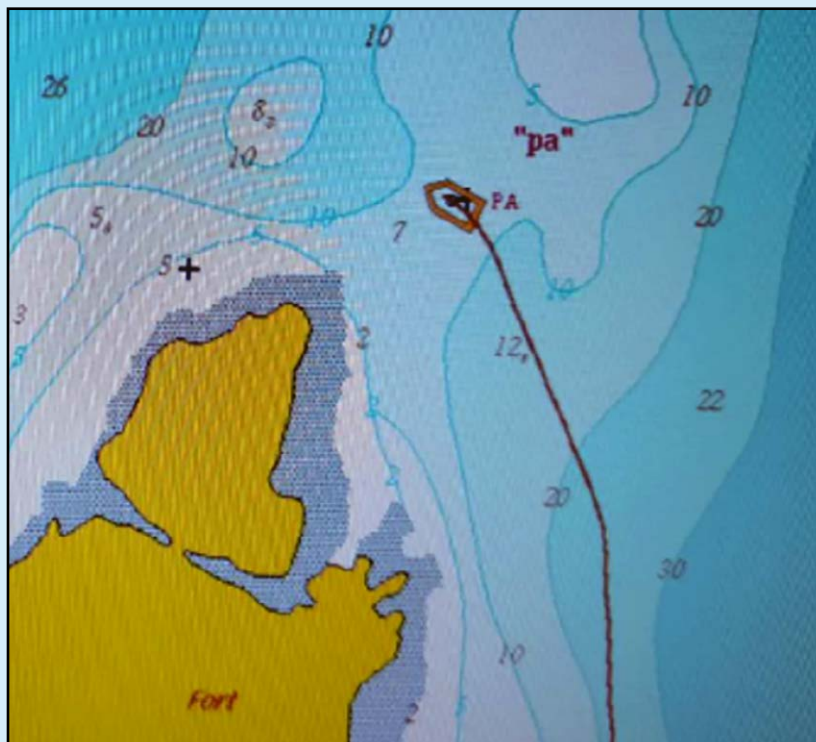
Figure 2: Chart plotter view with rock symbol covered by vessel shape

2. Safe navigation requires full understanding of equipment limitations and close attention to the position of the vessel. The electronic chart plotter displayed the rock clearly, but at smaller scales; this may have been obscured by the waypoint mark or the vessel's own symbol (Figures 2, 3 and 4). A key technique in using electronic charts is to make frequent changes of range scale to get an overview of hazards ahead as well as checking for dangers closer to the vessel. This is particularly important in confined coastal waters and when using systems that do not alarm on dangers.

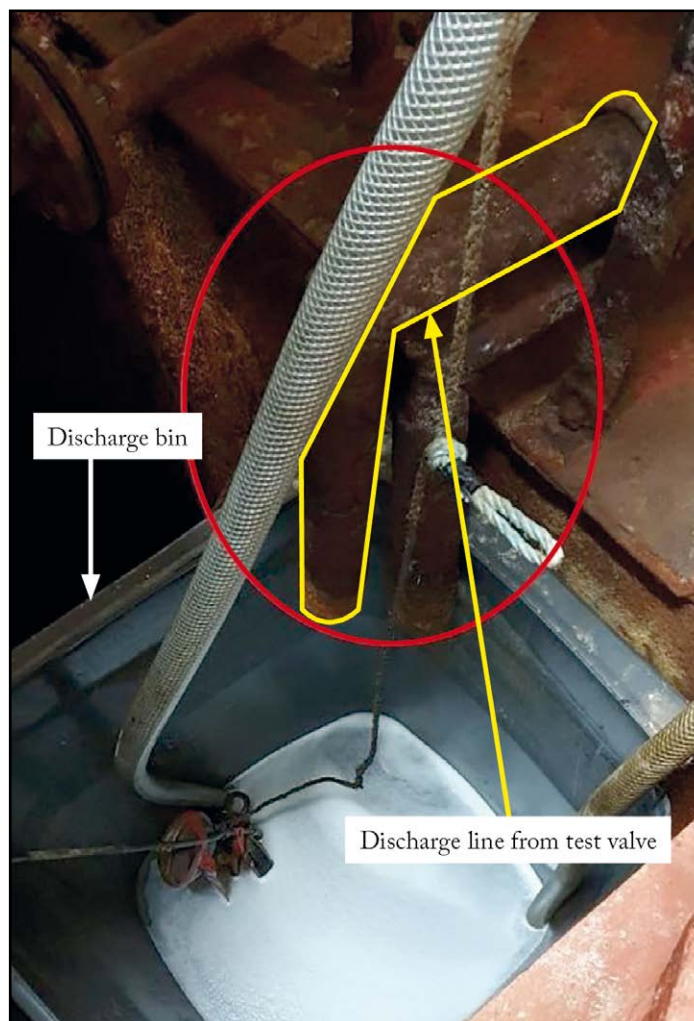
On investigation it was established that, the previous day, the duty engineer had been carrying out routine maintenance on the sprinkler system but had become distracted and forgotten to close the test valve. The test valve discharged under the closed deck plating into a bin sat in the bilge (Figure 1), which would then be pumped out once testing was complete.

Figure 1: The discharge line from the test valve into the bin

1. Just because a work around has always been in place, does not always mean it is right. The other vessels in the fleet had the corresponding test valve connected to an overboard discharge, therefore removing the hazard of unintentional flooding. Ship's crew and company superintendents need to be aware of the dangers of becoming blind to some hazards and continue to ask the question, "Is this as safe as it reasonably can be?".

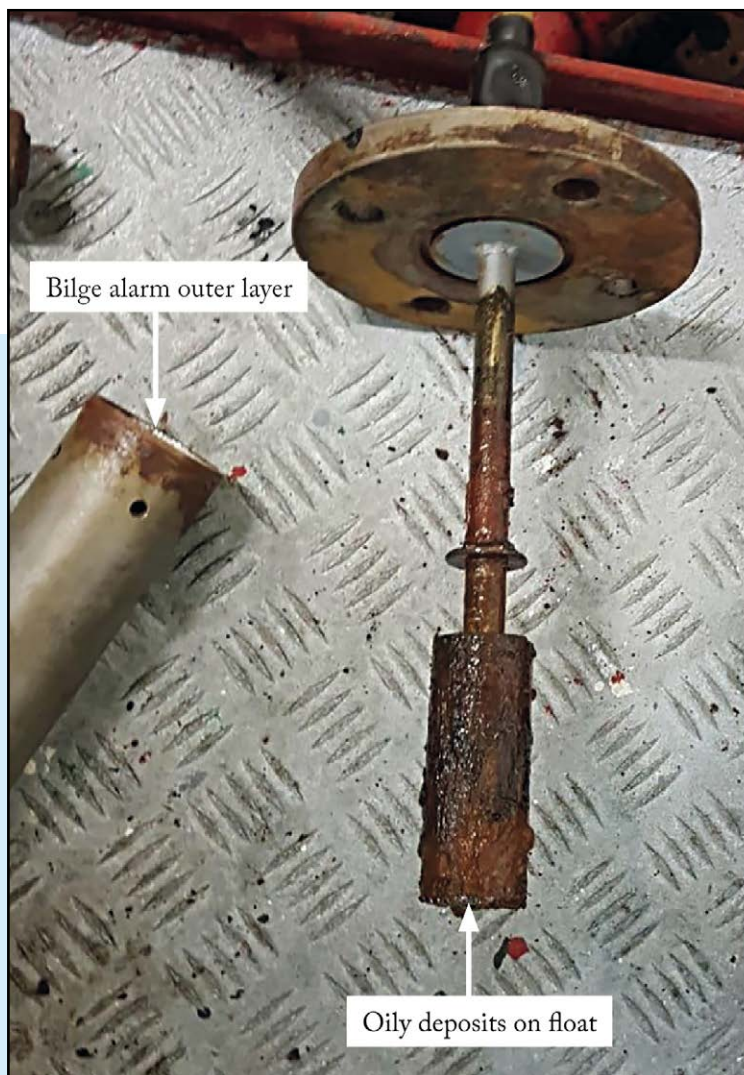
On further inspection, the bilge alarms in the space were found to be clogged with oily deposits (Figure 2). As a result, seawater had been allowed to flow unchecked and unnoticed into the vessel for approximately 18 hours.

Figure 2: The disassembled bilge alarm, showing the build up of oily deposits on the float

2. The bilge alarms were tested every 4 months, the last test being 3 months prior to this incident. On that occasion and at times previously, notes had been left in the planned maintenance system that oily deposits had been found and cleaned off before the alarm could be successfully tested. The task was signed off as successful and the unsafe condition was not raised with the chief engineer and so no solution was sought. Planned maintenance systems will only work effectively if defects are proactively reported to the appropriate level of vessel or shore management, so that persistent problems can be resolved.

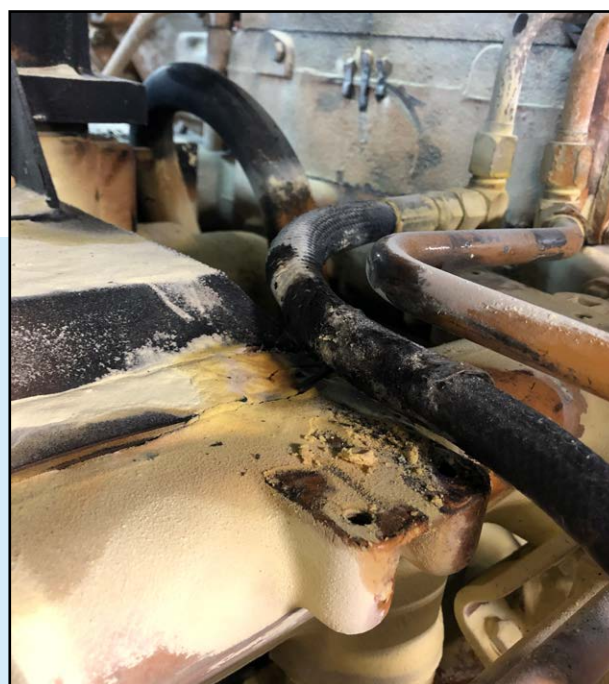
A post-accident investigation found that the fire was caused by fuel igniting when it sprayed onto the engine's exhaust after a flexible hose had failed. The failed fuel hose had been chafing on the engine, resulting in its eventual failure. Moreover, the investigation found that the hose was suitable for use with fuel systems; however, due to some previous maintenance, the hose's run had been moved from its original position, resulting in it making contact with the engine's manifold block (see figure).

Figure: Fire damage to the flexible fuel hose

1. The use of flexible hoses for fuel lines is entirely acceptable and they can provide a good technical solution for connecting systems in difficult situations. The post-accident report found that this hose was suitable for the task. However, to prevent contact damage, flexible hoses need to be supported by clips and kept separated from other lines and hot machinery. If flexible hoses are disturbed due to maintenance, it is important that they are restored to their original position and all clips and supports replaced. Flexible hoses should also be inspected periodically to ensure that they remain in the correct position and are not degrading.

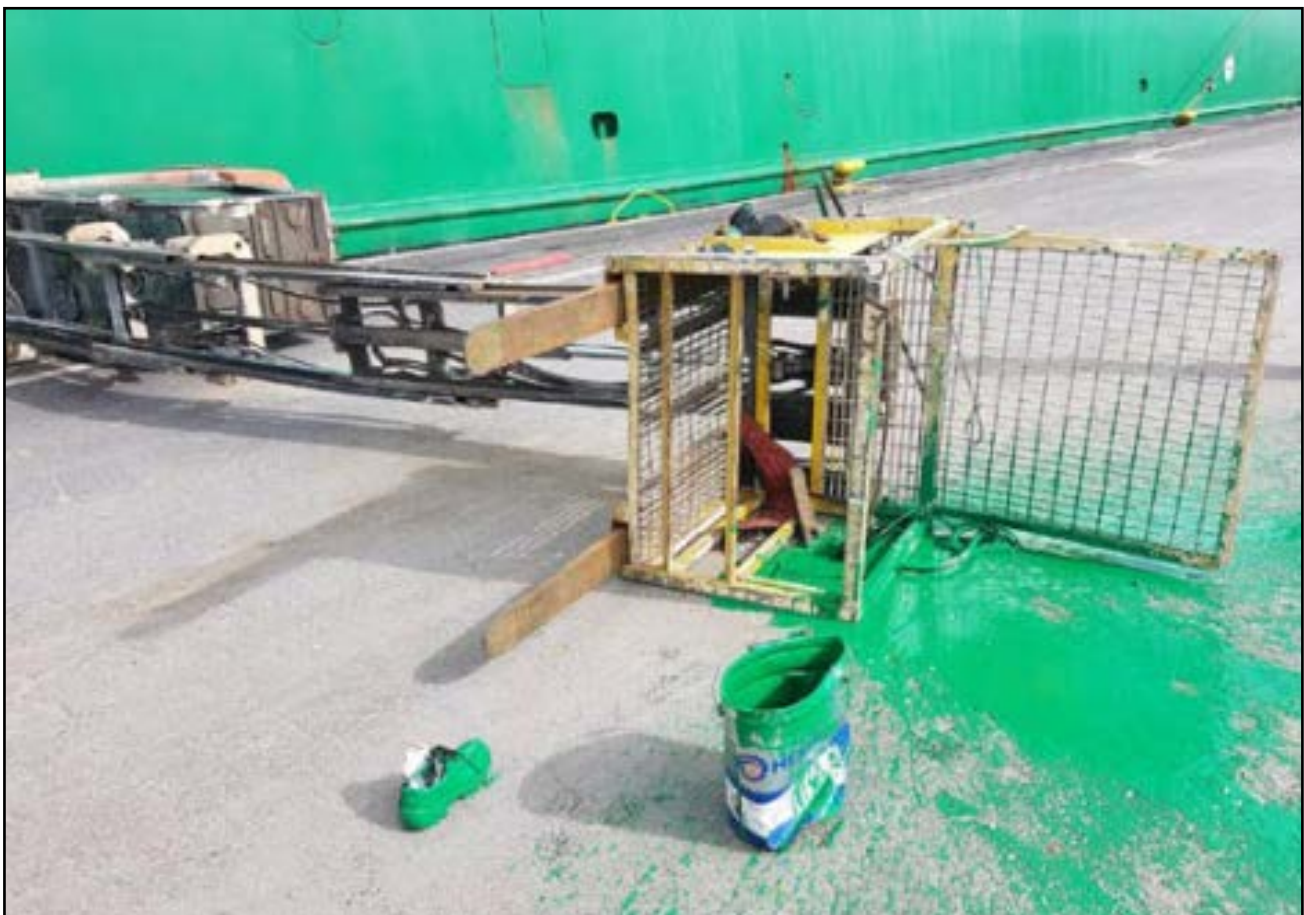
Figure: Toppled forklift truck

3. Although the man basket was well constructed and the forklift truck maintained, with neither being certified at the time of the accident there was a lack of assurance provided by the ship's management to their workforce. In accordance with workplace regulations and the company's SMS, ship's crew should check that equipment is properly certified and inspect it before use.

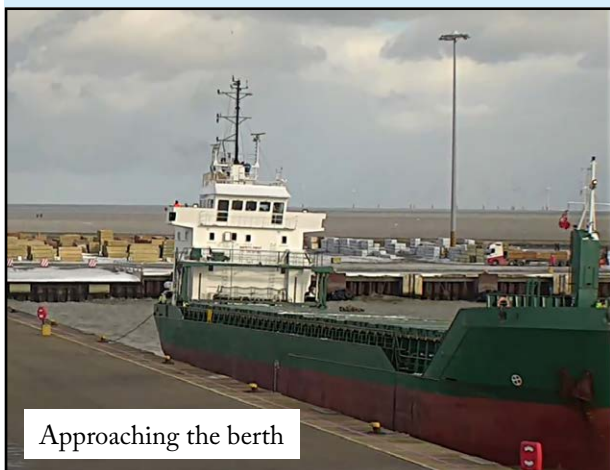
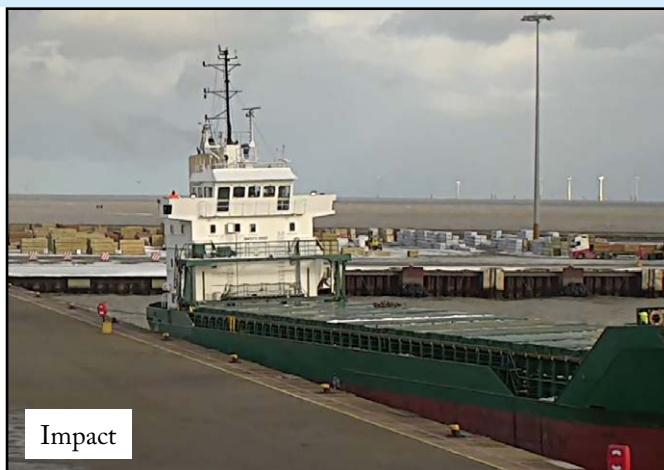
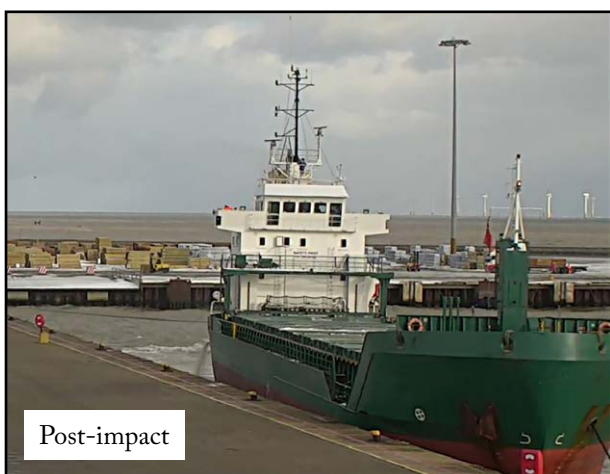
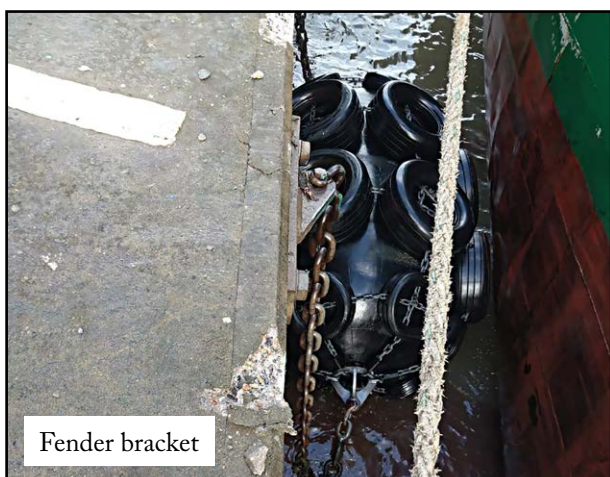
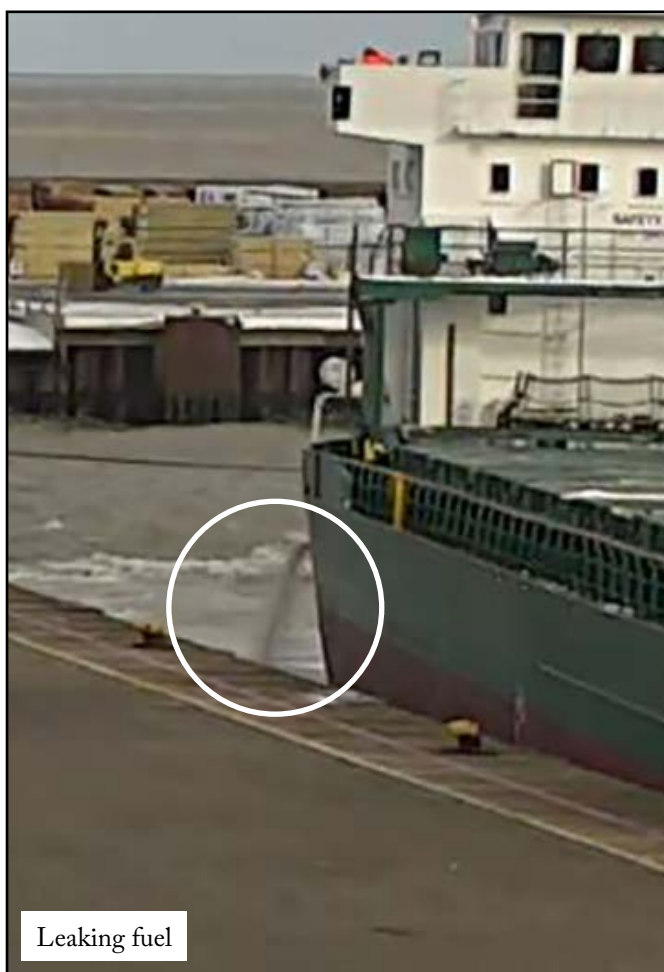
Figure 2: CCTV of accident sequence with fender bracket and leaking fuel

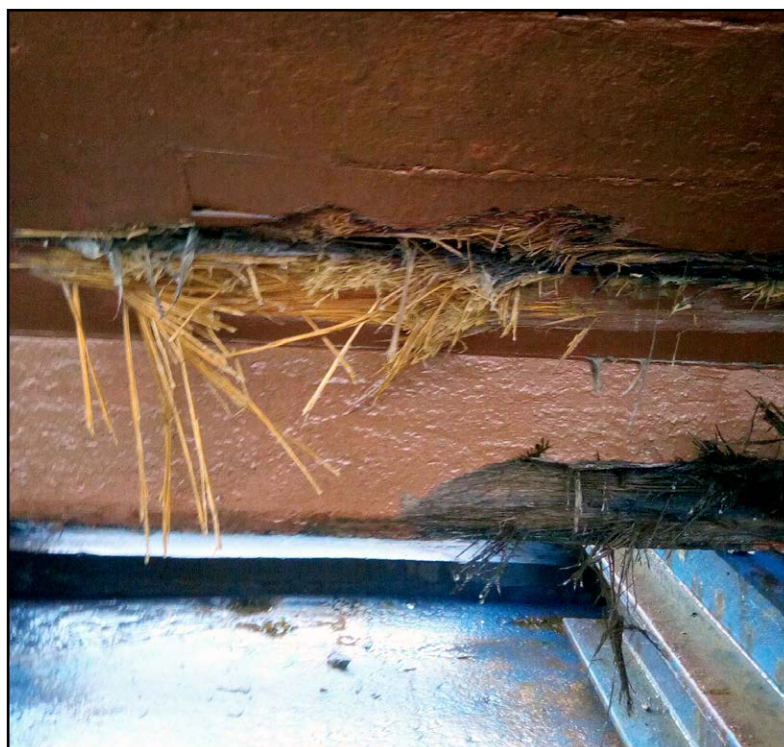
vessel came clear. No major water ingress was discovered, so the ALB returned to base and the fishing vessel followed, mooring overnight off a small coastal town. The next day, the vessel proceeded to a nearby boatyard, where it was slipped. This revealed damage to the keel and one hull plank (Figure 2). The vessel was out of service for several weeks for repairs.

Figure 2: Damage to keel and hull planking

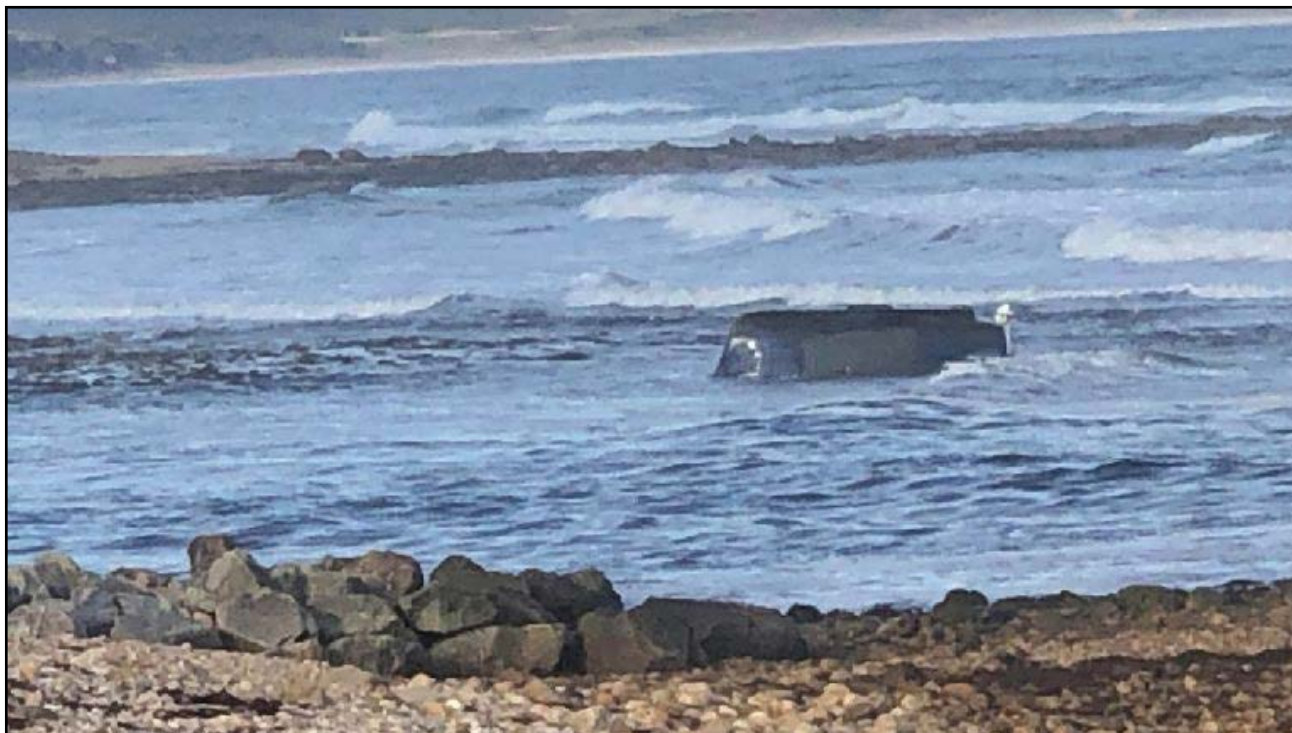
Figure: Vessel capsized and inverted

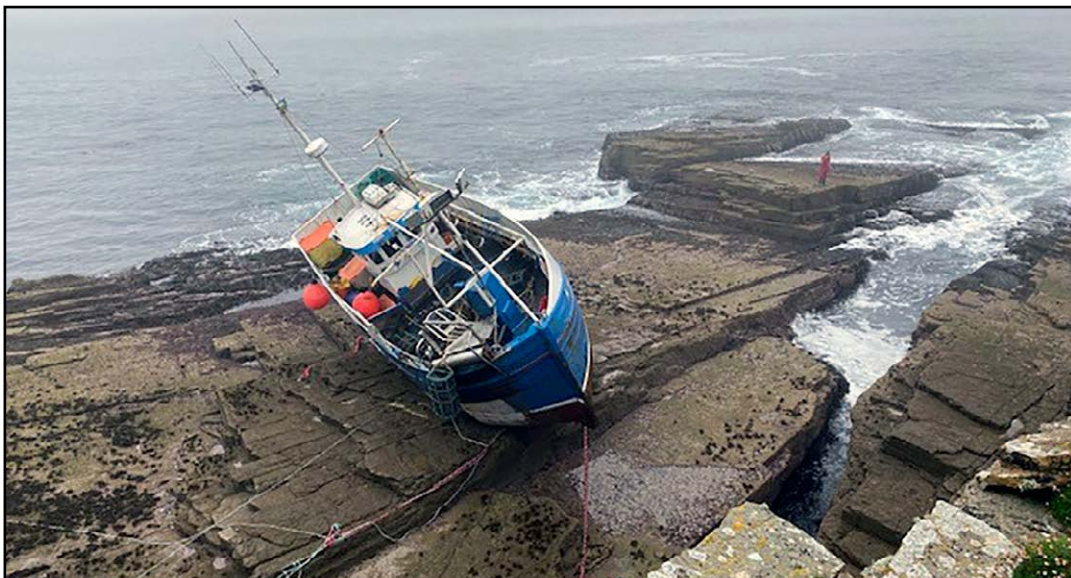
As the tide fell, the sea receded from the rocks and the fishing boat was left high and dry (see figure), so the crew walked ashore to safety. The boat's hull was damaged by the grounding and it could not be repaired.

Figure: Grounded fishing boat

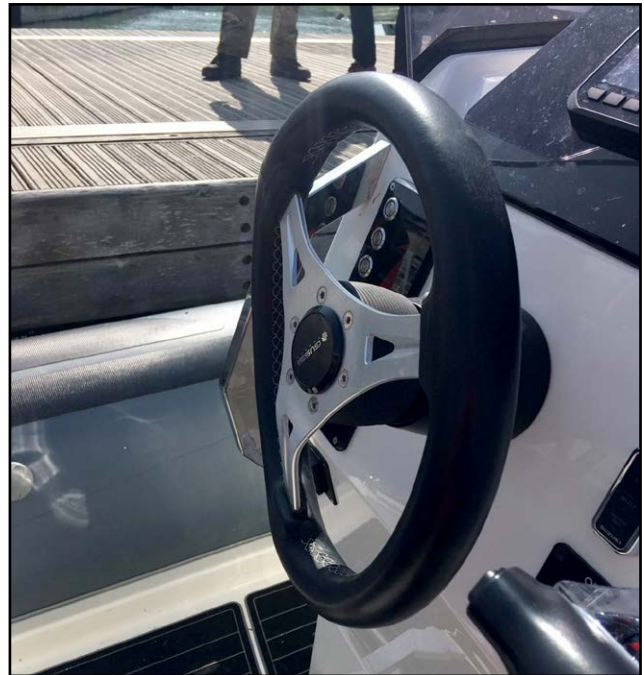
Figure 1: Buckled steering wheel

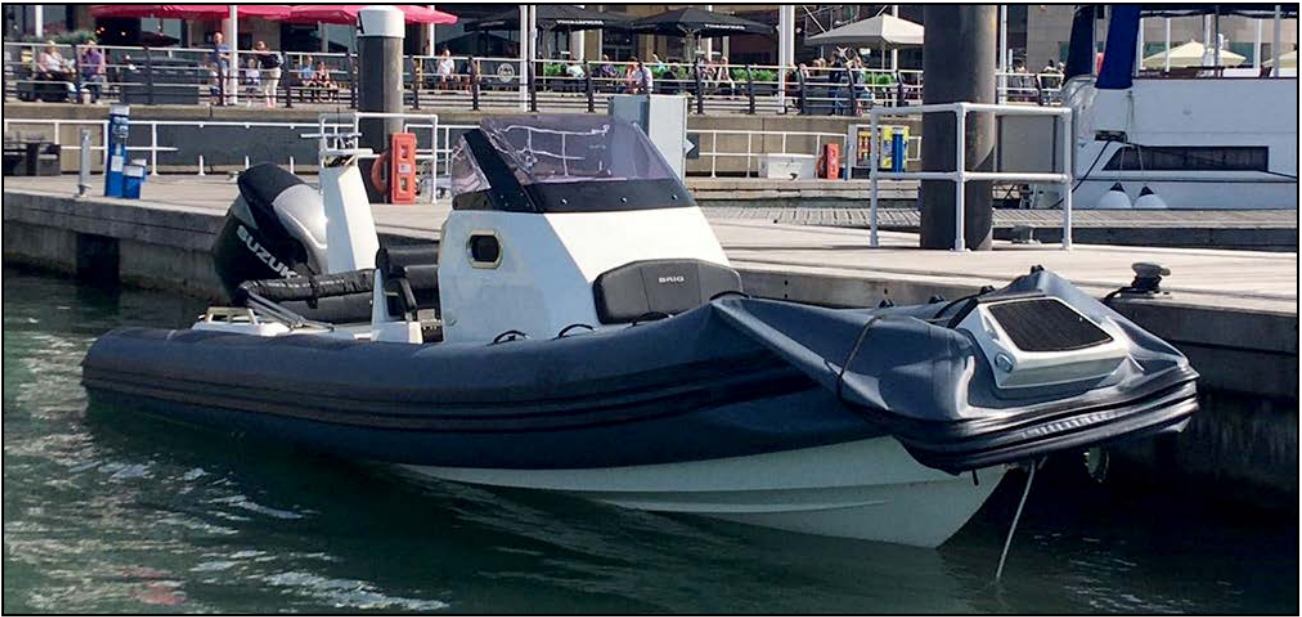
Figure 2: The RIB, showing damaged tubes

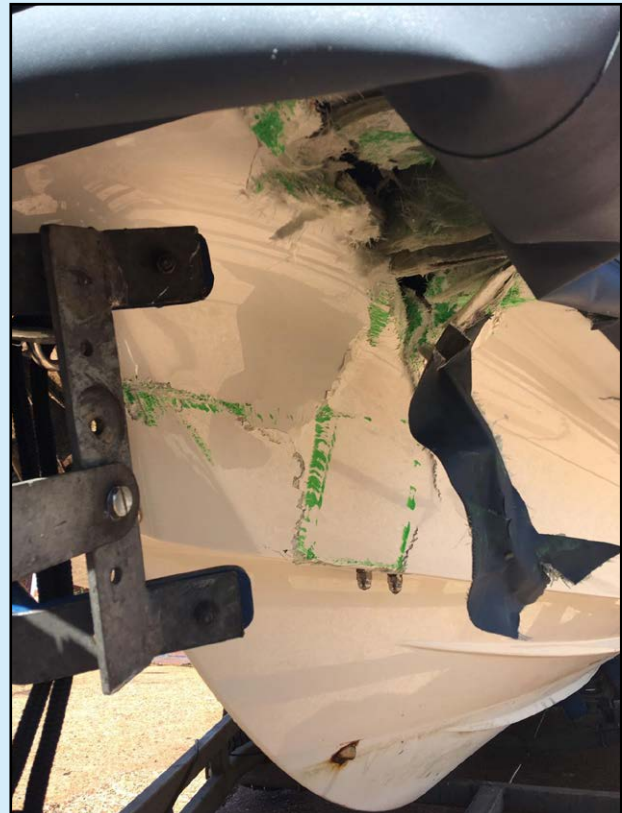
The RIB was badly damaged, and when taken out of the water it was clear that it had struck a green object (Figure 3), probably a starboard hand marker buoy. Investigations by the local port authority indicated a possible candidate, but all lights were fully operational when checked the next day.

Figure 3: Damage to bow section, showing green paint

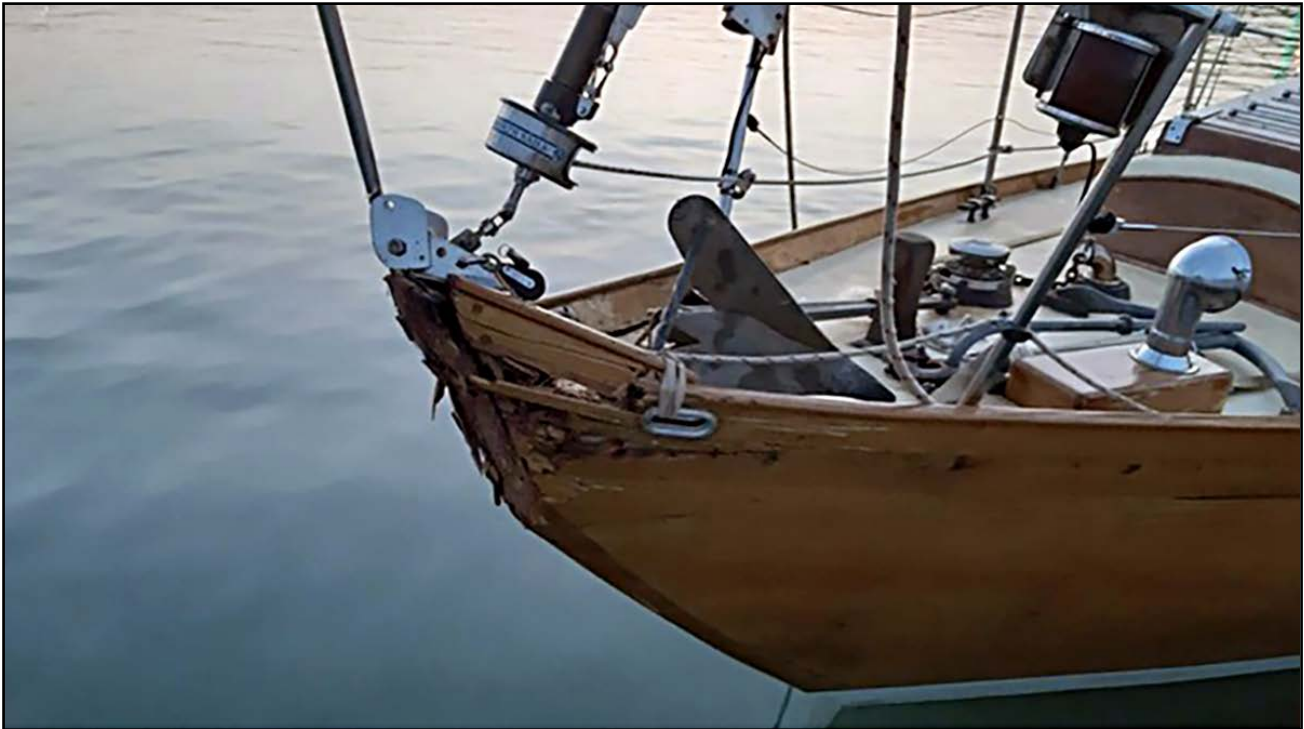
Figure 2: Damage to the classic yacht's bow
