**REPORT OF AN INVESTIGATION INTO  
AN INCIDENT INVOLVING  
A PLEASURE CRAFT  
WHILE ON OPERATIONS ON THE  
RIVER SHANNON CLOSE TO  
JAMESTOWN, CO. ROSCOMMON  
6 SEPTEMBER 2020**

**REPORT NO. MCIB/303  
(No.1 OF 2022)**

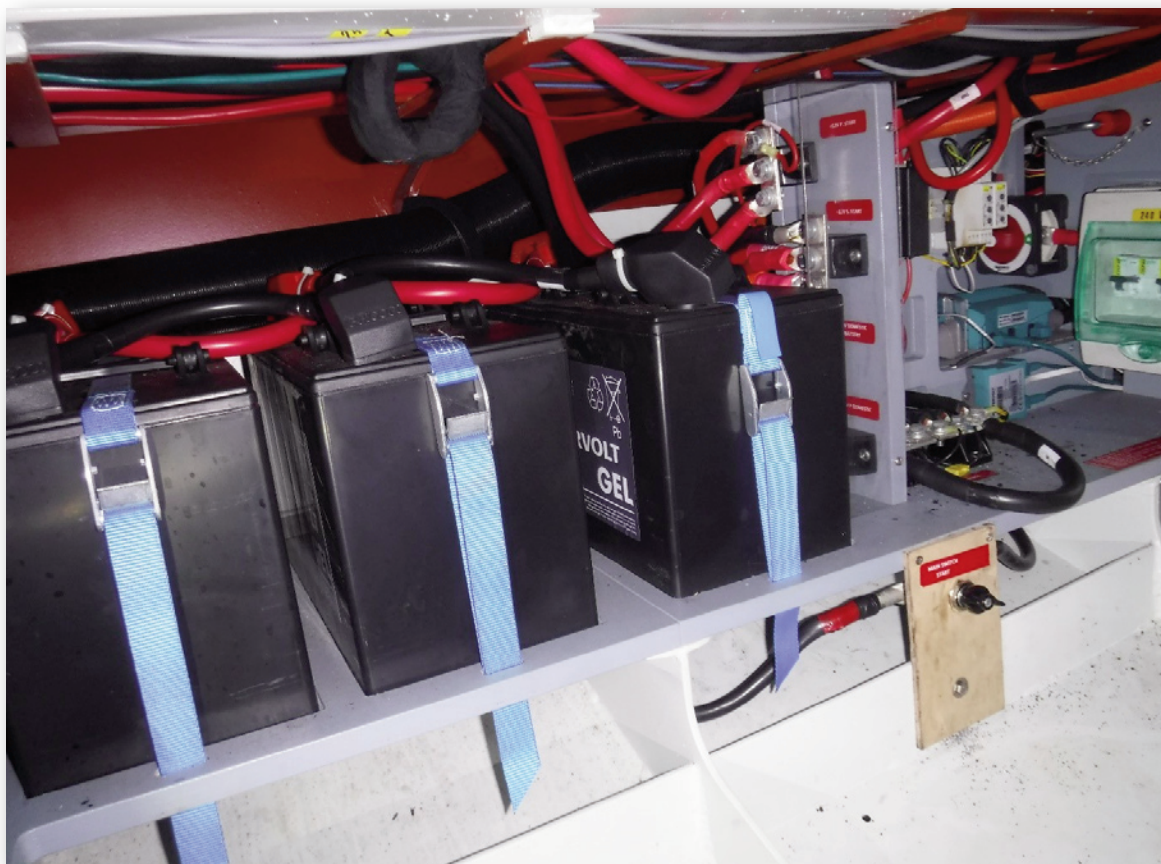
Appendix 7.4 After Starboard Corner of Engine Compartment  
(Image Taken of Sister Vessel)

- 2.16 An electrical timer relay identified as being for the forward shower drain pump on a sister ship, "X1", was found with burn marks and not as it should be when compared to "X4". This is located adjacent to the batteries and battery charger in the after starboard corner of the engine compartment.

- 4.3.4 The electrical timer relay mentioned in paragraph 2.16 and identified as being for the forward shower drain pump was found with evidence of burning. This is located adjacent to the batteries and battery charger in the after starboard corner of the engine compartment, where it has been determined the fire started. Any burning on an electrical component indicates an overload condition and hence a possible source of heat and fire. This may have been the cause of the fire but due to the extent of the subsequent damage that cannot be verified.

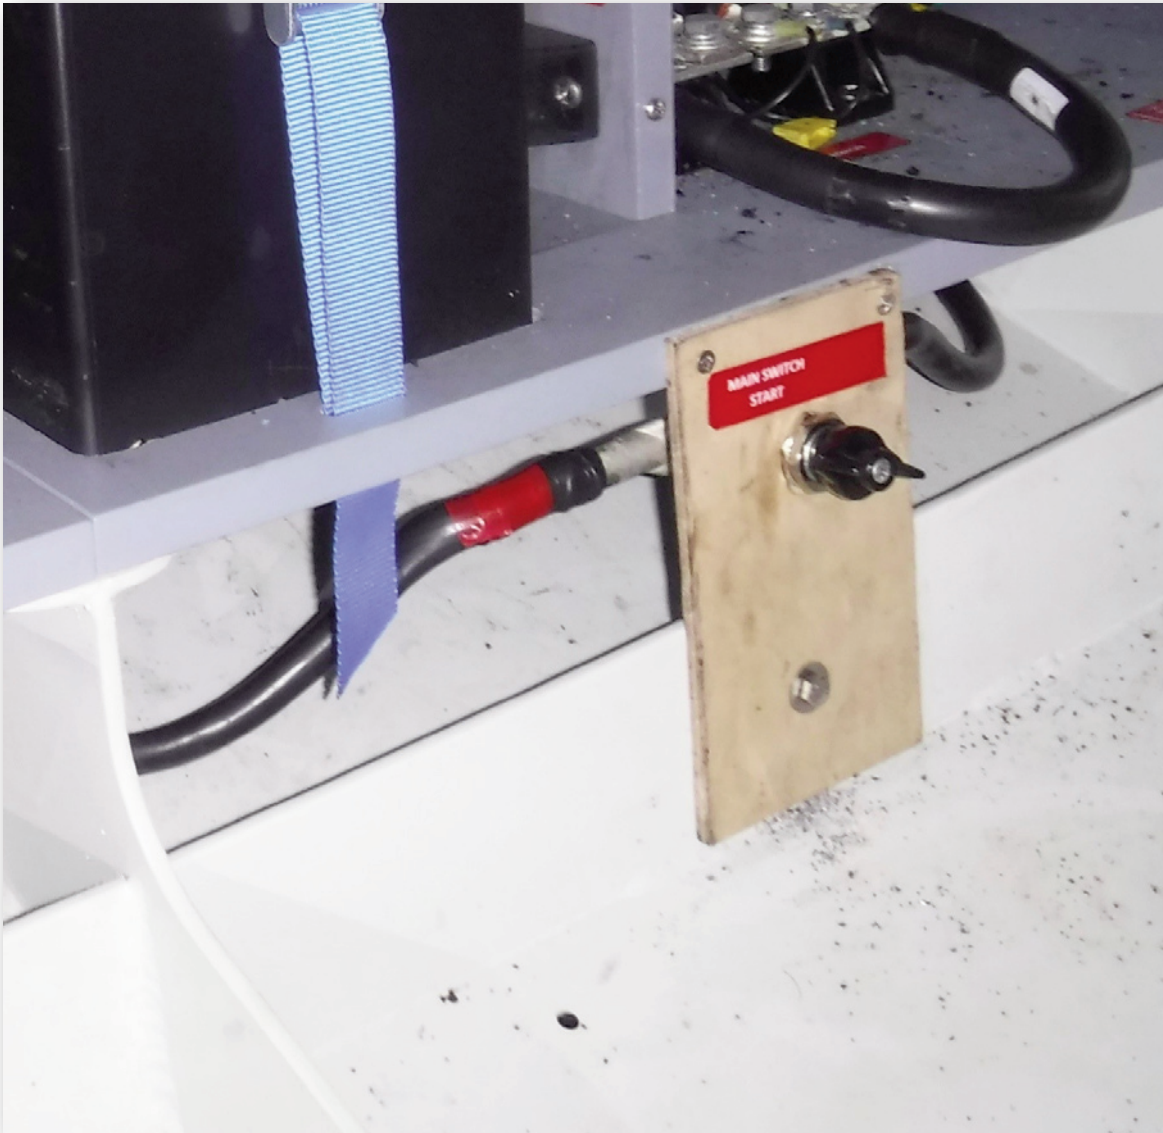
### Appendix 7.6 Start Isolator Switch

**27 November 2019** - New start isolator switch fitted. This was a replacement switch for the starting system for the engine and when fitted was located in a more accessible position.

- 4.3.3 The replacement and relocation of a battery isolating switch mentioned in paragraph 2.6 was also observed on the other Linssen 35s in the Carrickcraft

fleet. These modifications were completed by the resident electrician. This was fitted as the factory installed switch was difficult to access. The wiring for this modification observed on the sister vessels appeared to be of the approved size and type however the wires to and from the switch were unsupported and in contact with the steel hull. Any movement of these cables would cause chafe and an eventual breakdown of the insulation leading to a short circuit condition and a potential fire hazard. Due to the extent of the damage, it will never be determined if this is what happened.

- 4.4 The modifications carried out by the replacement and relocation of the start isolator switches on several Linssen 35s in the Carrickcraft fleet, raises the question of the validity of the declaration of conformity required by the Marine Recreational Craft Directive 2103/53/EU, as stated in paragraph 2.10.4, stating that *Conductors that are not sheathed shall be supported throughout their length in conduits, cable trunking, or trays, or by individual supports at maximum intervals of 300 mm.* The insulated wires (conductors) used on the switches was unsupported and in contact with the steel hull.

- 6.1 Carrickcraft should employ the services of an independent qualified marine electrician to inspect the remaining Linssen 35 vessels in their fleet to ascertain the quality of the modifications carried out and to secure the conductors to the supports and to inspect the damaged timer relay where there is evidence of burning.
- 6.2 The Minister for Transport should consider making regulations to govern the safe use of recreational craft being used for commercial purposes, which should include mandatory fire detection on vessels used for charter purposes.
- 6.3 The Minister for Transport should consider issuing a Marine Notice about the potential risks of electrical issues with similar craft.
- 6.4 The Minister for Transport should send a copy of this report to the manufacturer, Linssen Yachts BV.

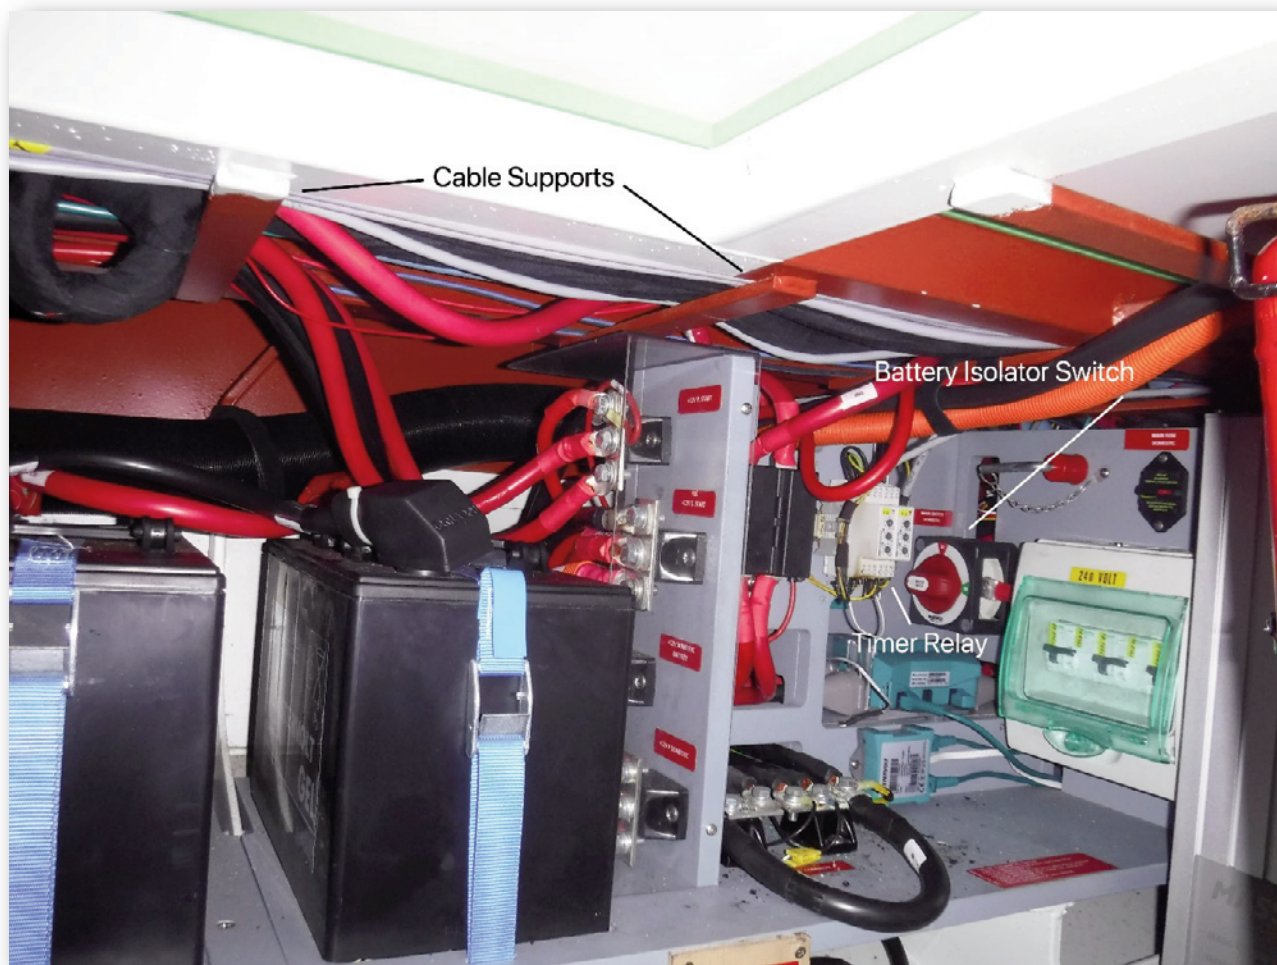
Appendix 7.10 Starboard Side Inside Engine Compartment of Sister Vessel

- 4.3.1 An inspection of one of the sister vessels of “X4” owned by Carrickcraft showed that the conductor cables for both the DC and AC electrics are supported by flat steel bars spaced 300 millimetres (mm) apart as per the international standard detailed in paragraph 2.10.3, however none of the cables are secured by ties. In a vessel which is liable to vibrate and move, any cables not secured will over time chafe and expose the copper conductors presenting a potential fire hazard. It is unlikely, given the age of “X4” that that is what happened in this case.

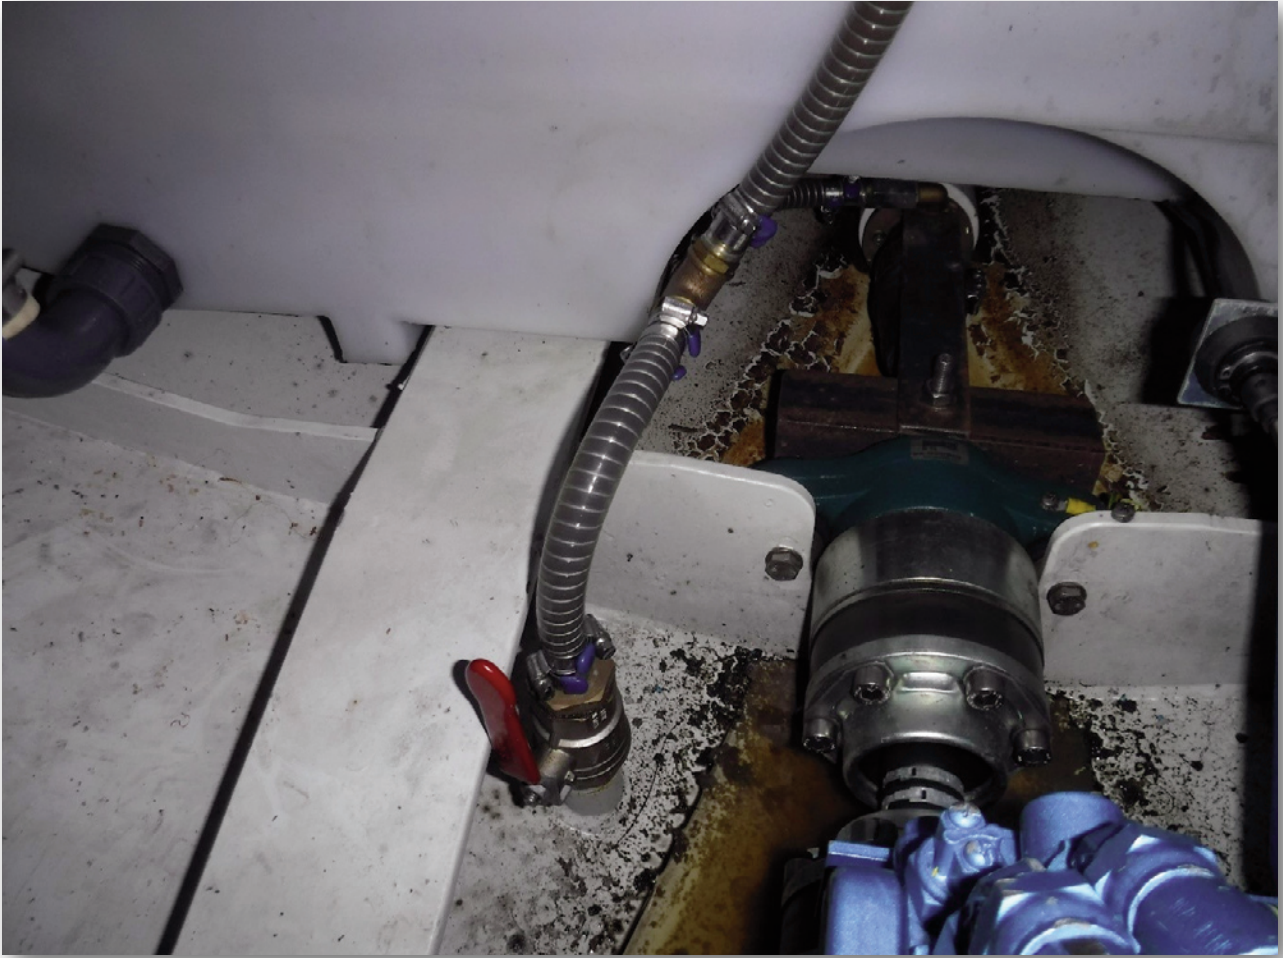
Appendix 7.11 Propeller Shaft Bearing Cooling Hose on Sister Vessel

- 2.14 Each through-hull inlet and outlet below the waterline is fitted with a stopcock. Stopcocks are used onboard a vessel to open and close joints through which liquids flow. These are found in many systems, including the cooling water inlet to the engine, the water inlet to the two toilets, cooling water inlet to the propeller shaft and the drain pump for the black water tank. Typically, water intake hoses are made from Polyvinyl Chloride (PVC) with stainless steel spiral reinforcement. In the event of a major fire onboard it is not possible to close these stopcocks and should the fire burn through a hose located below the waterline, then water will flow into the vessel. An example of the cooling hose to the propeller shaft is shown in the below appendix.

- 4.5 The fire eventually burned through at least one of several PVC inlets or overboard pipes discussed in paragraph 2.14, allowing water to flow into the hull and the vessel sank. This is by no means a fault on the vessel, as the use of flexible pipes for the stated purpose is normal practice. This is stated here to indicate to the reader the reason the vessel sank following such an extensive fire.

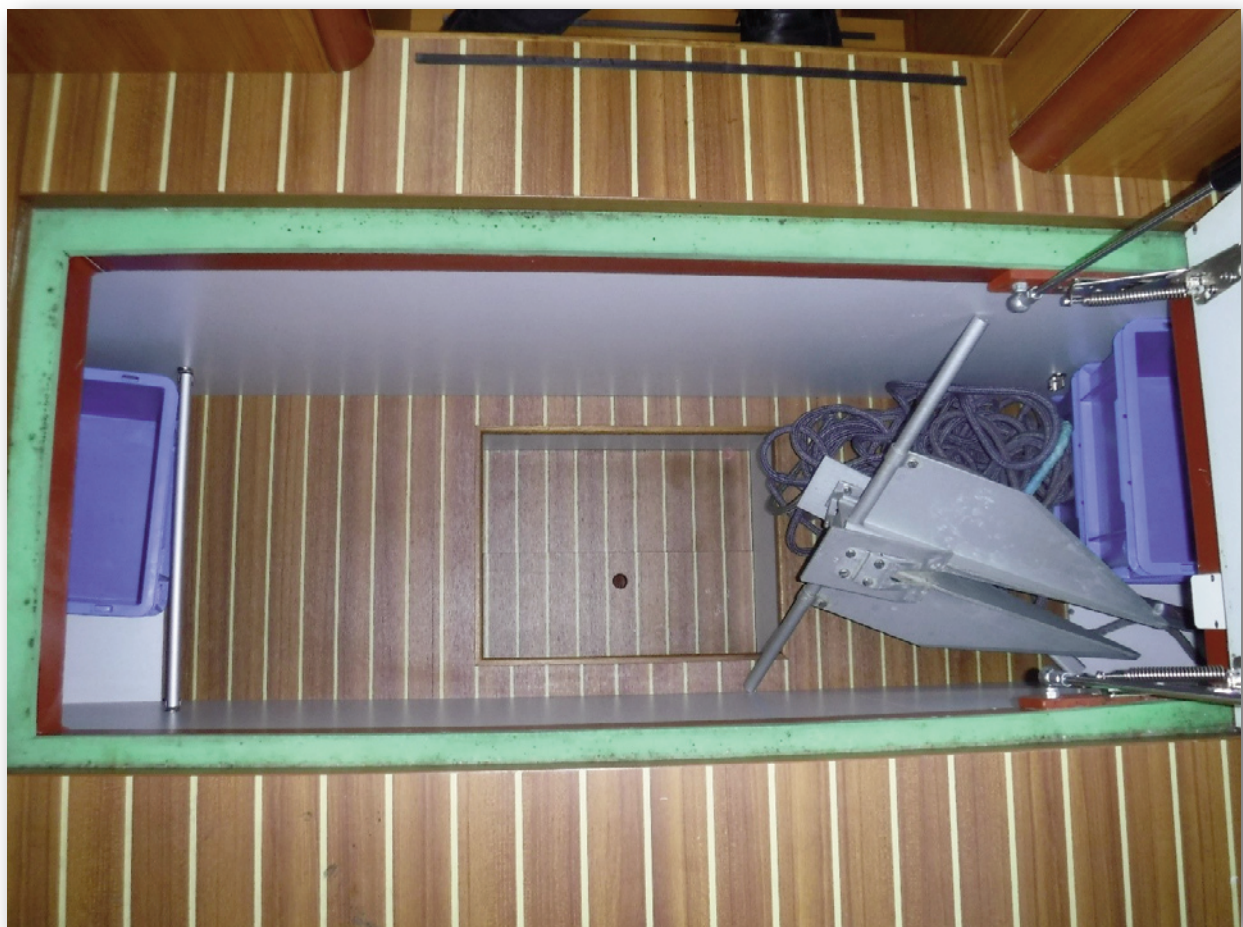
Appendix 7.14 Storage Compartment

- See Appendix 7.13 Chart Carrick-on-Shannon to Jamestown.
- 3.3 They cruised for approximately 45 minutes when they noticed smoke coming from the navigation control panel and coming up through the floor of the saloon. They stopped the boat and turned off the engine. As the vessel drifted to the side of the river, they re-started the engine and manoeuvred to the centre of the river again. One of the party went to get the anchor which was stored in a locker under the saloon floor. At this point they found the compartment was full of smoke, so much so that it prevented them from getting the anchor out.

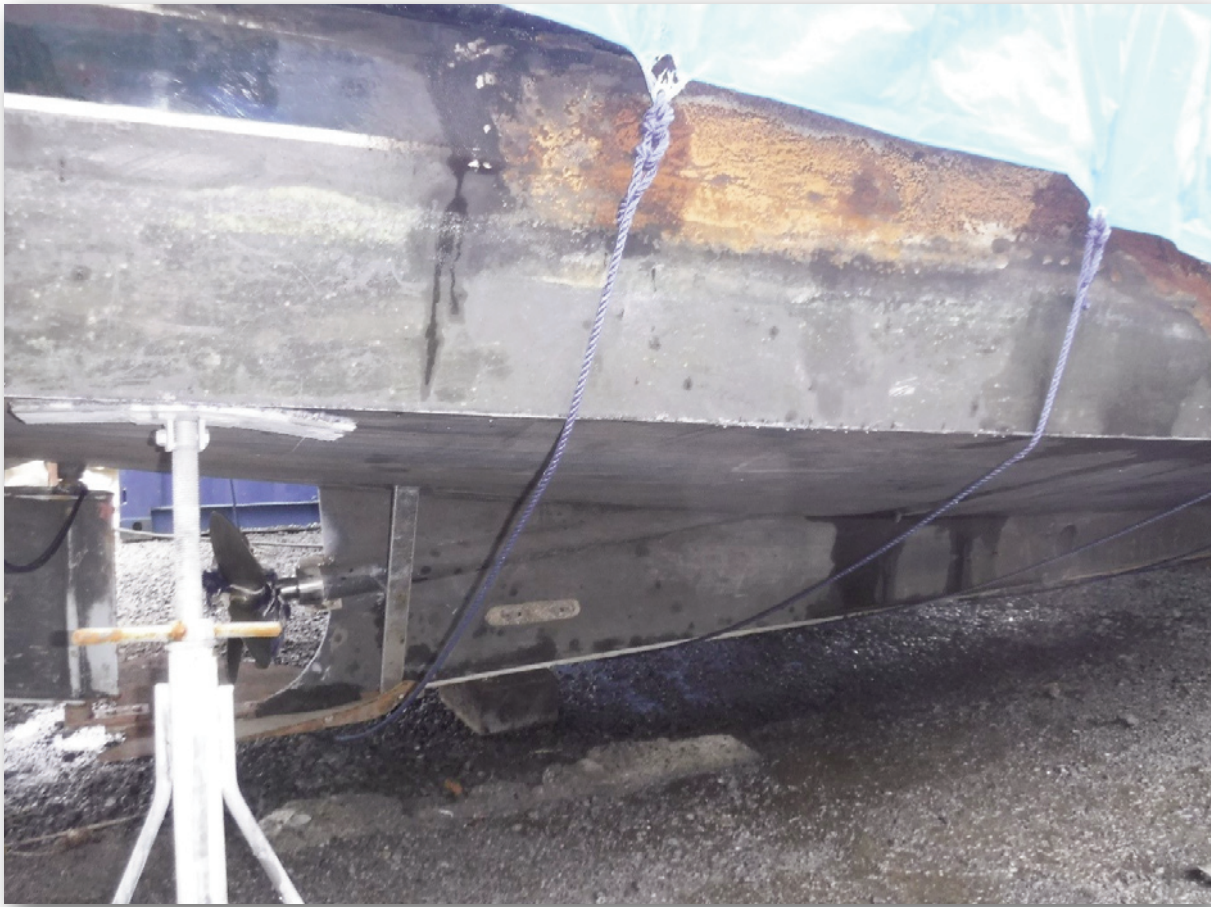
Appendix 7.18 Starboard Side “X4”

- 2.17.1 *Damage - Severe fire damage had been sustained by the vessel. All combustible material above the waterline on the starboard side has essentially been consumed by fire including all plastic coatings. Damage is less severe to the port side. There is evidence of distortion to the steel structure of the vessel including the hull. Distortion is evident to the superstructure at both port and starboard sides and on the fly bridge and to the deck. All combustible material within the saloon and forward and aft cabins has been severely damaged by fire with charring evident to timber partitions and finishes. The electrical system sustained severe fire damage. The engine has also sustained significant fire damage.*

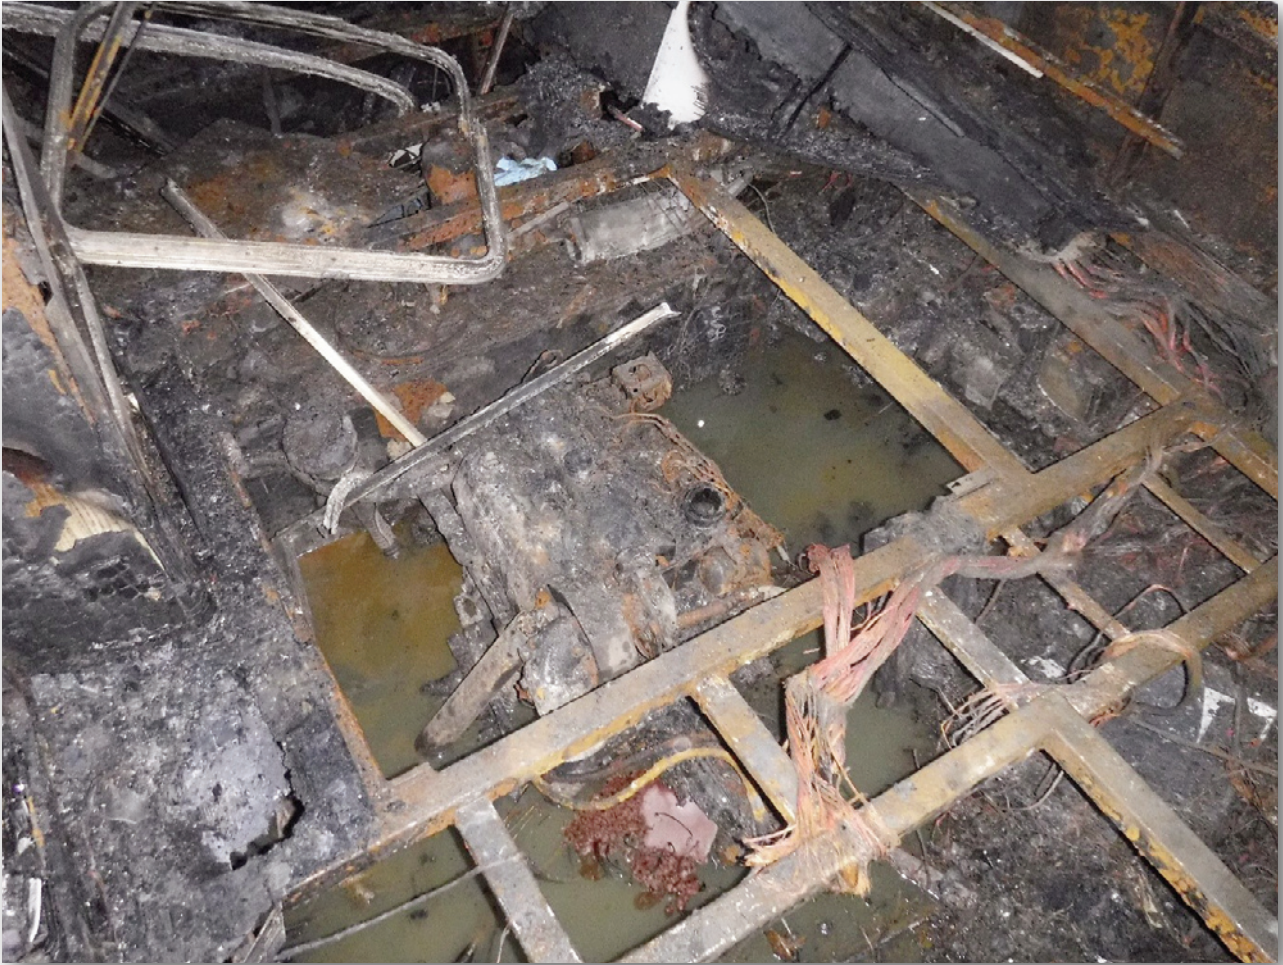
Appendix 7.19 Engine "X4"

2.17.3.3 *Defect in Engine/Fuel System or Lubricating Systems - I considered the possibility that fire occurred as a result of a defect in the engine or associated fuel oil or lubricating system. The engine appears to have suffered damage consistent with external heat and fire attack. I undertook a detailed examination of the electrical system specifically that which is unfused and permanently live providing power to the engine. I observed no evidence of unintended electrical activity which would be consistent with a fire originating in the area of the engine and spreading to involve the remainder of the engine compartment. All fuel lines and connections were observed to be tight and I observed no evidence of breakage of fuel or lubricating oil lines such that could give rise to an escape of fuel or lubrication oil. I do not consider that fire occurred as a result of a defect in the engine or associated fuel or lubricating oil systems.*

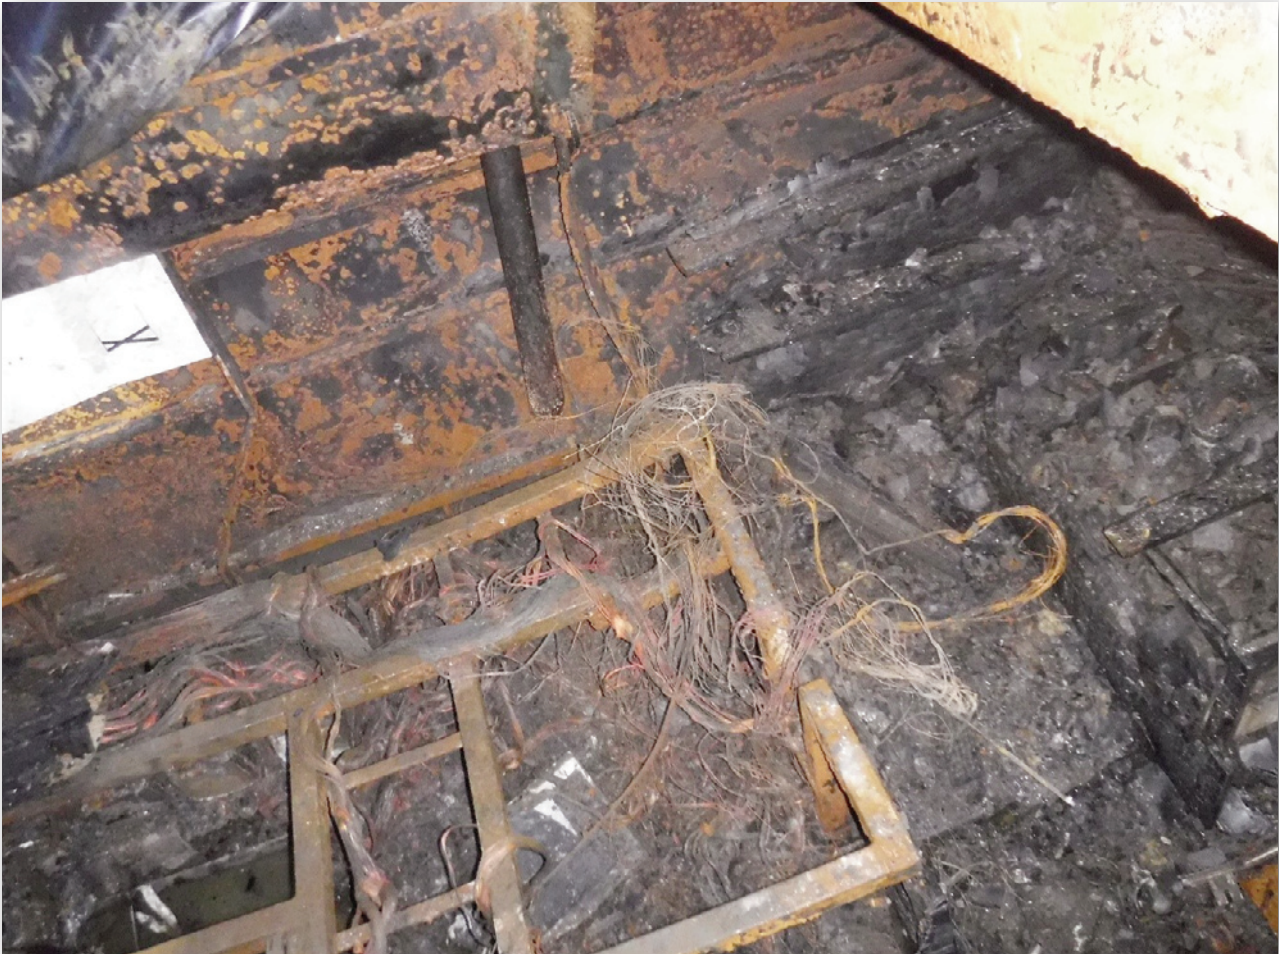
Appendix 7.20 Starboard Side Inside “X4”

- 2.17.4 *Conclusions and Recommendations - Fire has originated in the aft starboard section of the engine compartment of the incident Linssen Grand Sturdy 35 AC yacht. Fire has developed within this area of the engine compartment to*
