# Final Report

***Marine inquiry MO-2020-202***

***Bulk log carrier Funing***

***Loss of manoeuvrability while leaving port***

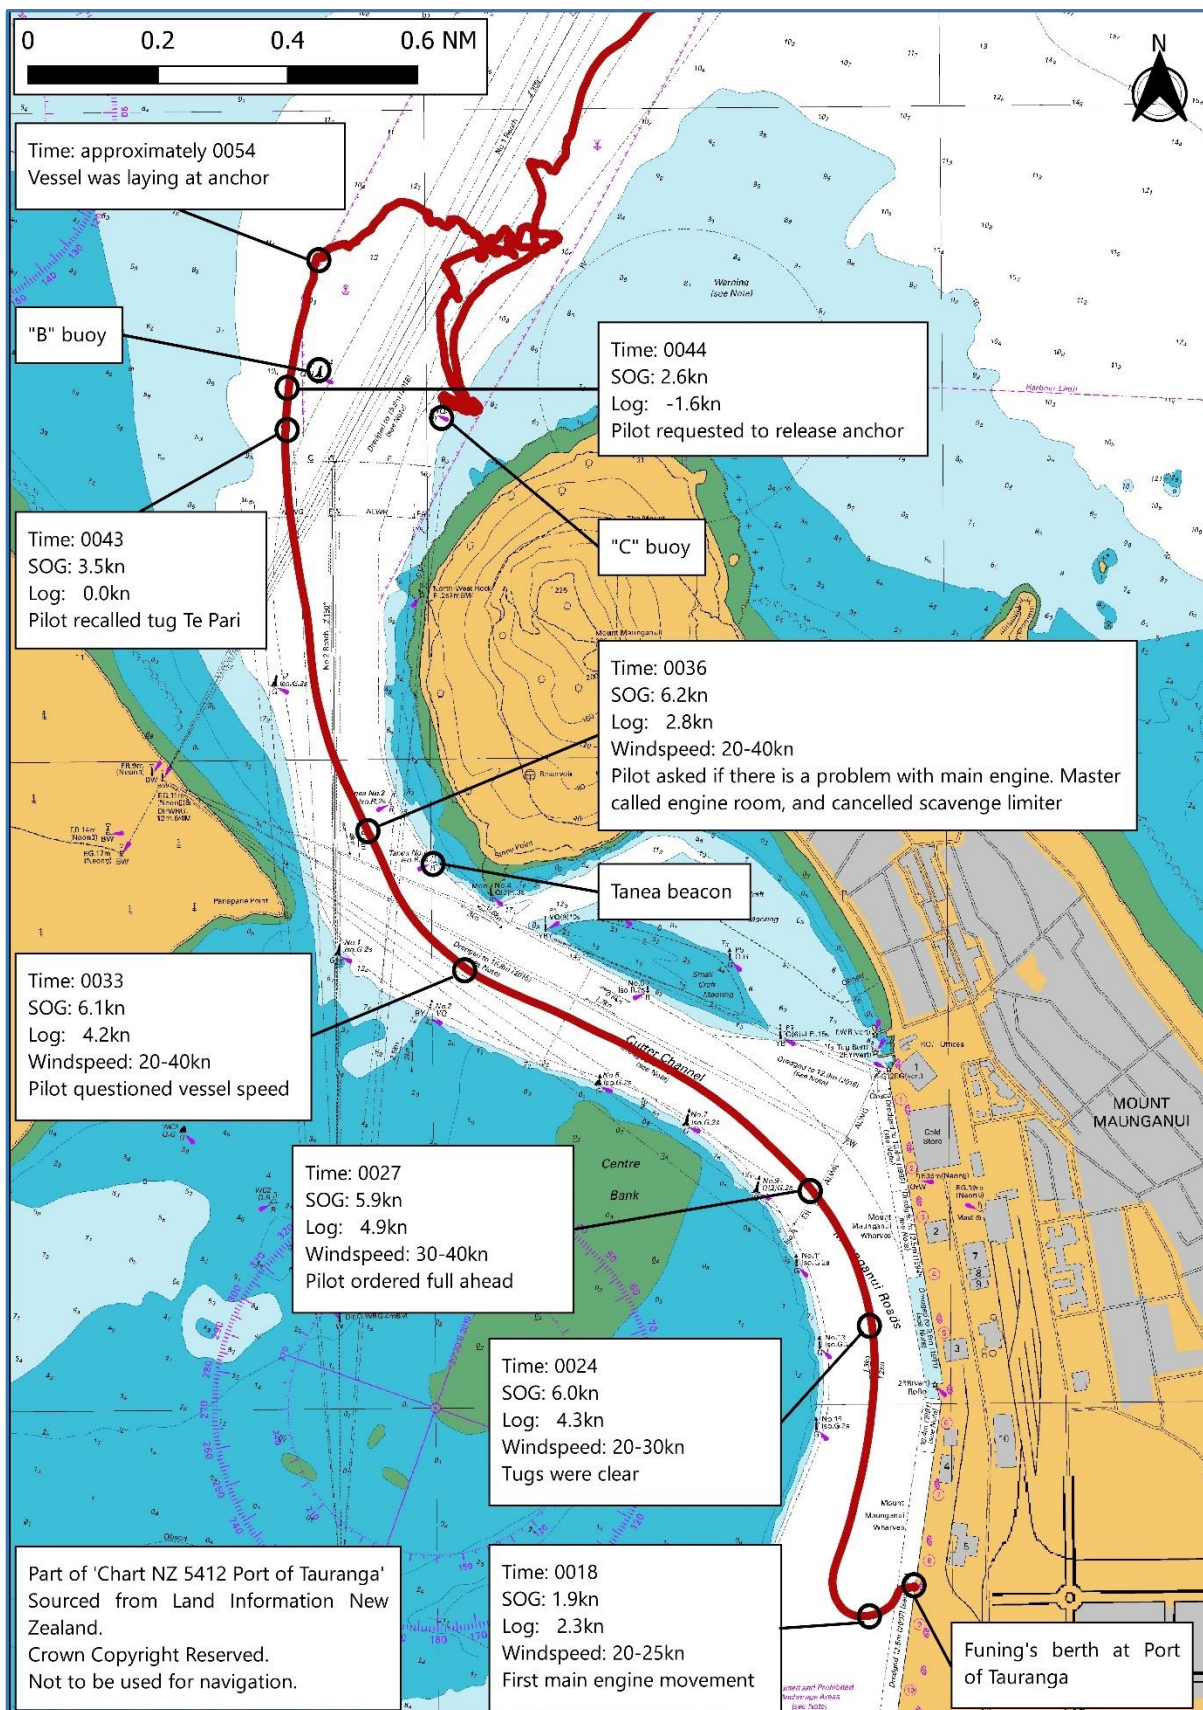
- 2.14 Tugs were secured at about 0006, and all mooring lines were let go and clear at about 0018.
- 2.15 As shown in Figure 3, the first main engine movement was at 0018, and the quantity piston failure alarm for number two cylinder was triggered immediately.

**Figure 3: Excerpt from Chart NZ-5412 Port of Tauranga showing the approximate track of the *Funing* as it departed Port of Tauranga**

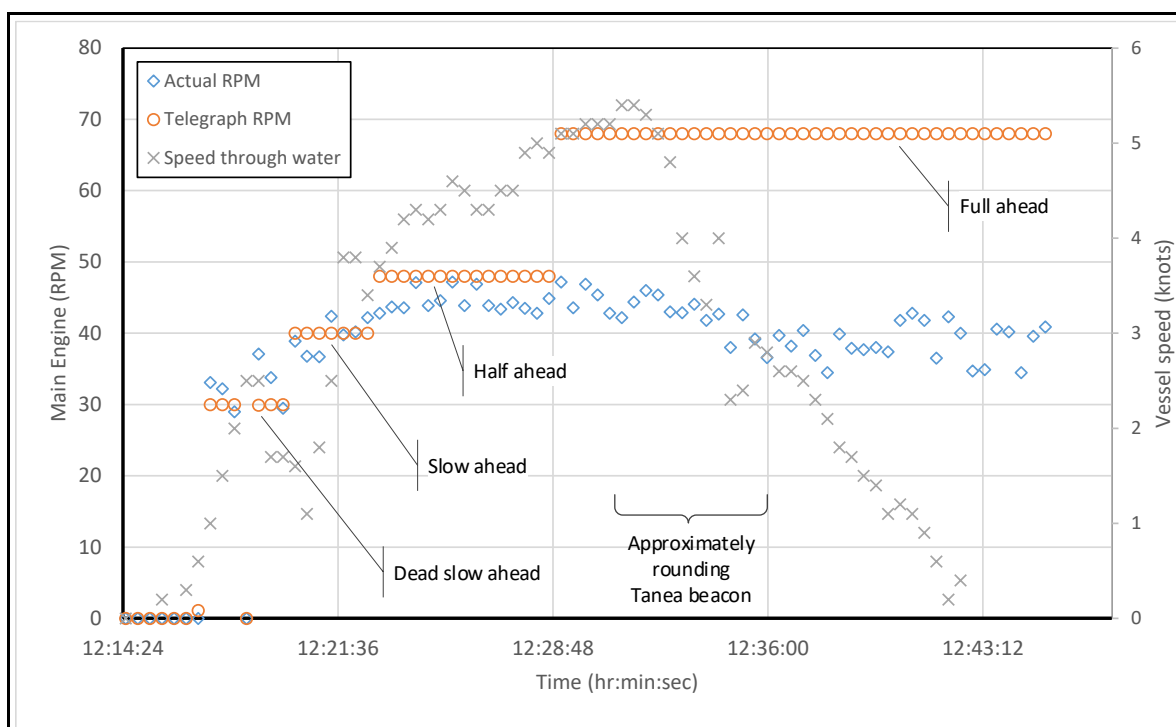
- 3.28 Due to the reduced power of the malfunctioning main engine, the increased drag due to vessel speed and the adverse environmental conditions, the *Funing* did not consistently reach half ahead rpm when commanded by the telegraph.
- 3.29 When the *Funing* rounded Tanea beacon it was more exposed to the head sea and wind. The combination of reduced main engine power and adverse environmental conditions further reduced the vessel's rate of acceleration and its ability to increase speed. As a result, its manoeuvring characteristics were significantly diminished and ultimately overcome by the increasing environmental effect, and the vessel's speed through the water was reduced to near zero knots.

**Figure 15: Main engine RPM as the vessel departed Port of Tauranga**

- 3.39 The primary reason for the vessel being unable to develop sufficient propulsive power was that number two cylinder of the main engine was not firing as a result of a malfunction of number two cylinder's injection control unit. It is possible that other factors, such as hull fouling, propeller fouling<sup>15</sup> and changes in the normal operating conditions of the vessel, further contributed to the main engine's inability to generate sufficient propulsive power to manoeuvre the vessel safely.
