Report on the investigation of
the collision between the rigid inflatable boat
Rib Tickler and a **personal watercraft**
resulting in one fatality
in the Menai Strait, Wales
on 8 August 2020

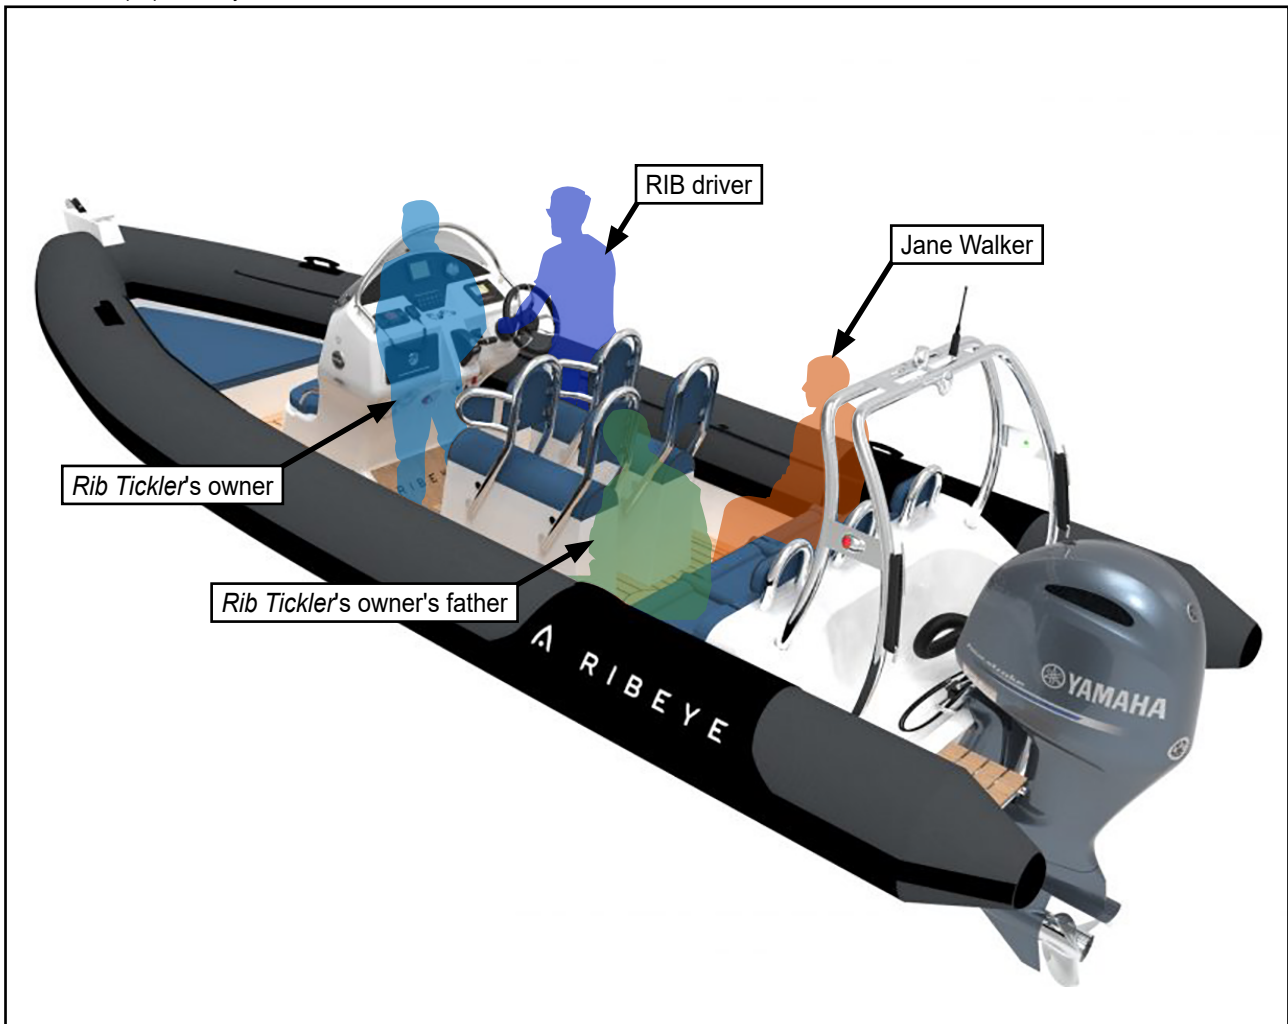
Figure 5: Ribeye S650, showing seating positions on *Rib Tickler* at the time of the accident

When they reached Porth y Wrach, *Rib Tickler's* owner asked his friend if he wanted to drive the RIB. His friend accepted the offer, attached the engine kill cord⁴ and took the helm. *Rib Tickler's* owner was standing on the port side of the RIB's centre console as his friend set the RIB on a north-easterly direction towards Bangor. The owner's father was sitting on the port side of the RIB's aft bench seat and his mother was sitting on the starboard side of the bench seat, facing slightly to port (**Figure 5**).

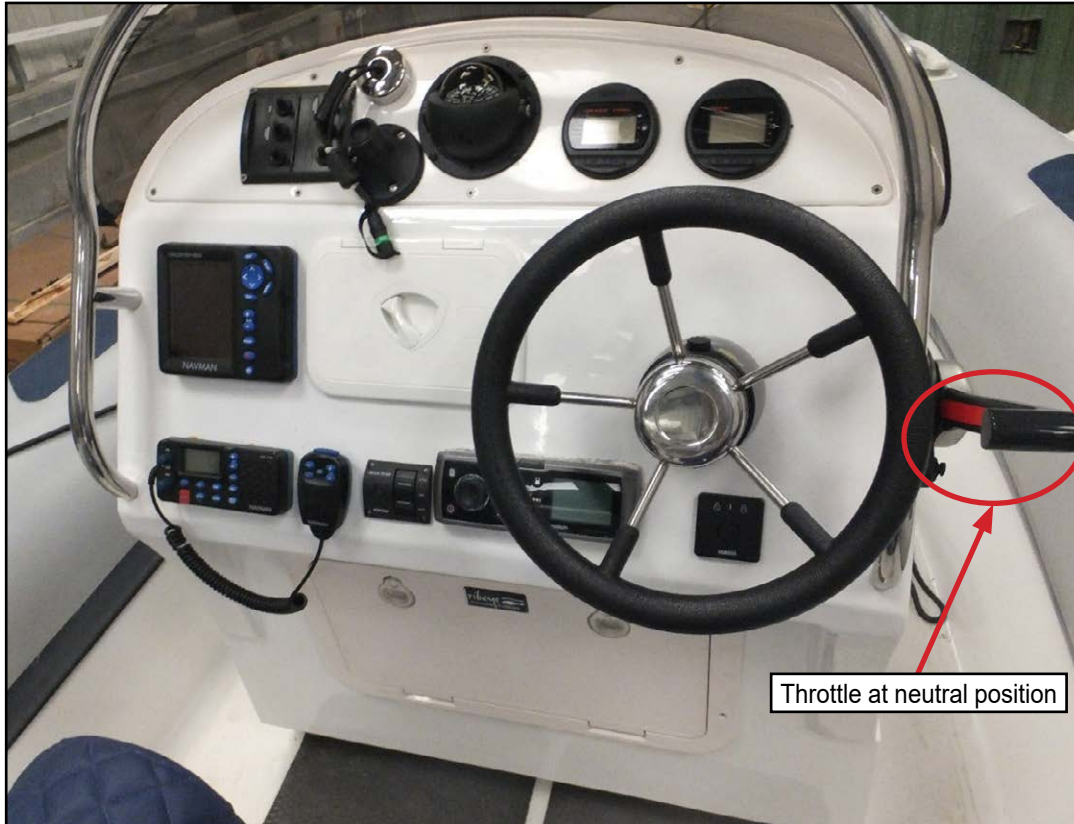
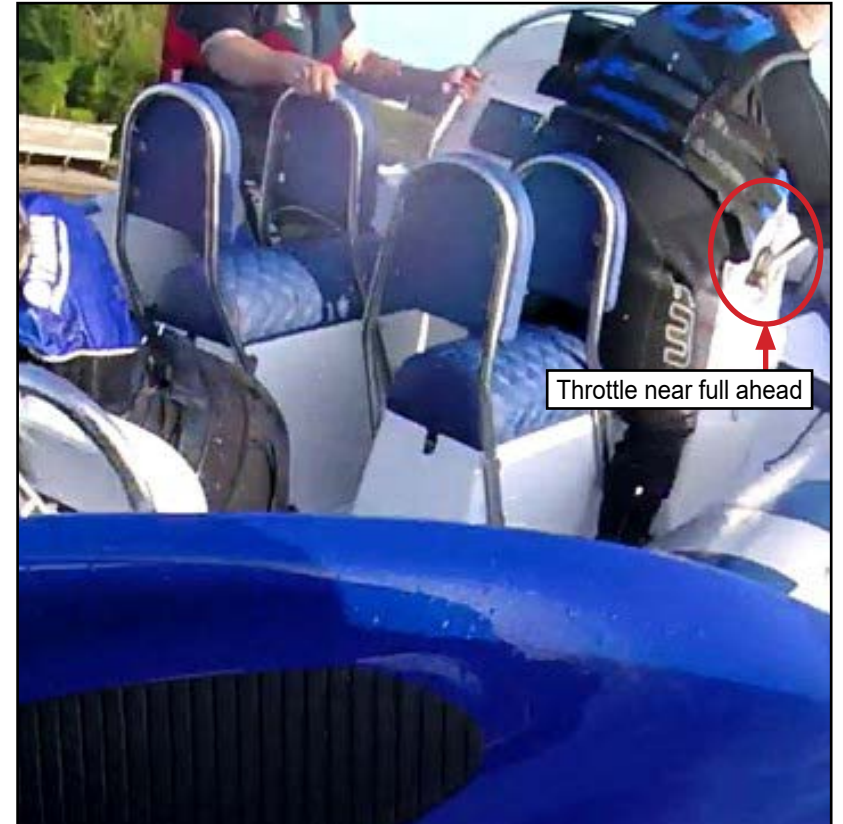
Figure 6: *Rib Tickler* helm console, showing the relative throttle positions for neutral and nearly full ahead

While steering *Rib Tickler* on a straight course, the RIB driver began to increase speed, and within a couple of minutes the RIB was close to full throttle (**Figure 6**) and travelling at about 25 to 30 knots (kts).

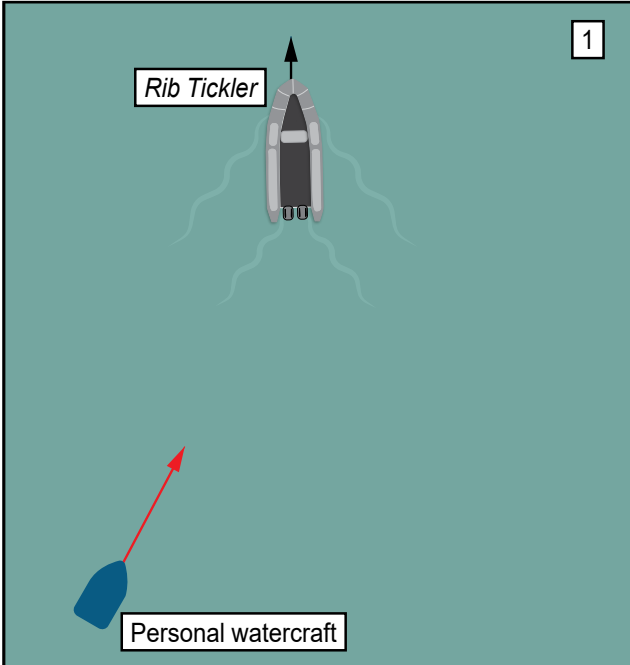
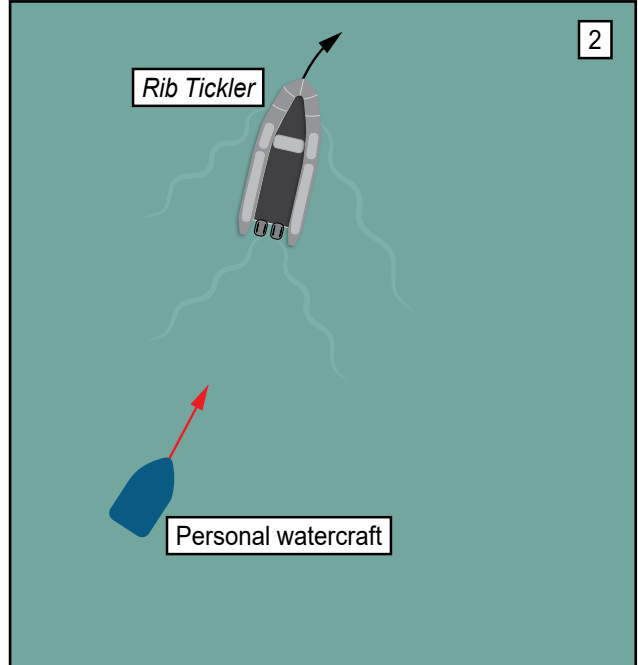
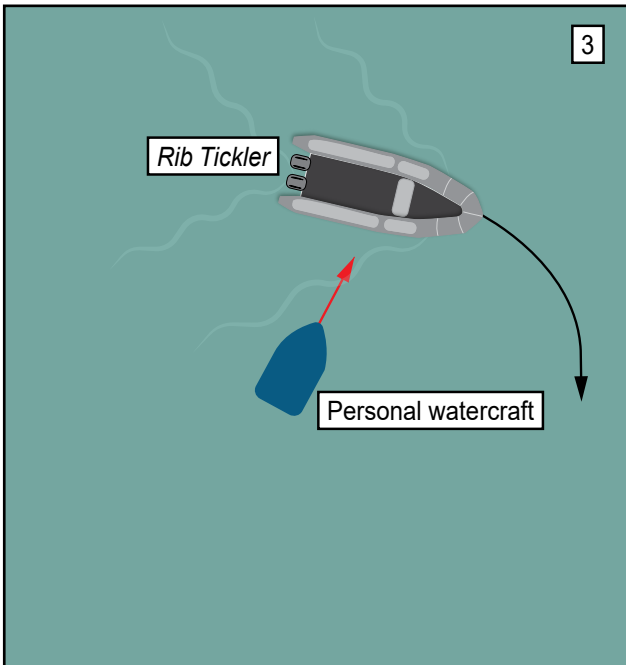
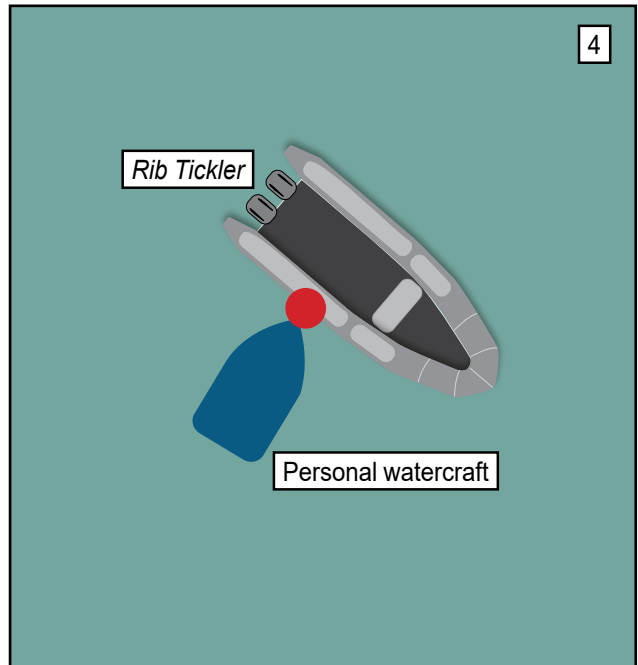
Figure 7: The collision sequence

At 1928, a member of the RIB driver's family, who was following behind *Rib Tickler* on one of the PWs, positioned herself for a high-speed diagonal run from left to right across the RIB's wake. As she accelerated forward and hit the wake, the RIB driver looked over his right shoulder and believing it clear made a sharp turn to starboard. *Rib Tickler's* owner, who had also looked over his right shoulder, saw that the RIB was cutting across the path of the PW and shouted a warning (**Figure 7**).

The PW rider was unable to take avoiding action and the PW and *Rib Tickler* collided. The PW hit the RIB owner's mother and knocked her sideways from the starboard side of the aft bench seat and onto her husband (**Figure 8**). The PW also made contact with the RIB's aft A-frame before pivoting and sliding down the starboard side, landing upright in the water with its rider still on board.

Both craft moving ahead. Personal watercraft on port quarter of Rib Tickler

Personal watercraft cuts across stern of Rib Tickler to jump wake, as Rib Tickler initiates a turn to starboard

Rib Tickler turns to starboard, cutting in front of personal watercraft

Personal watercraft collides with Rib Tickler at starboard aft tubing

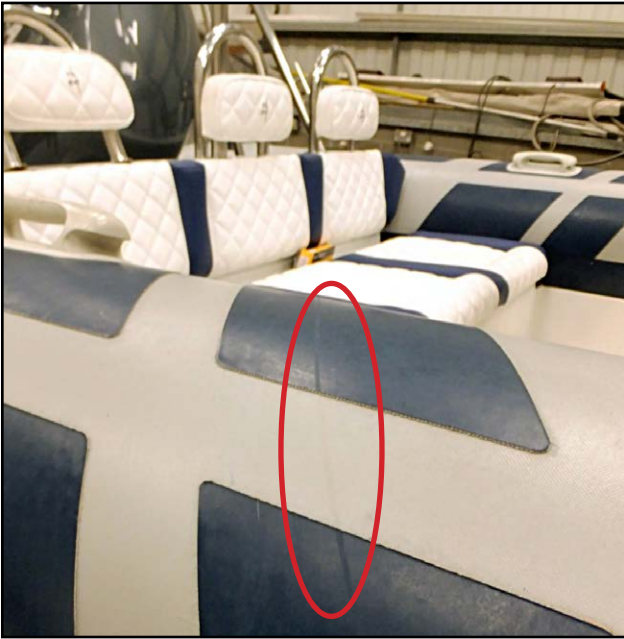
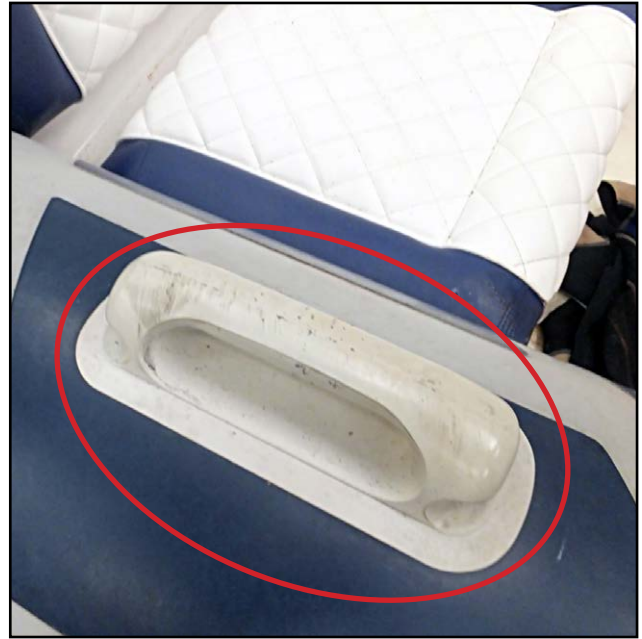
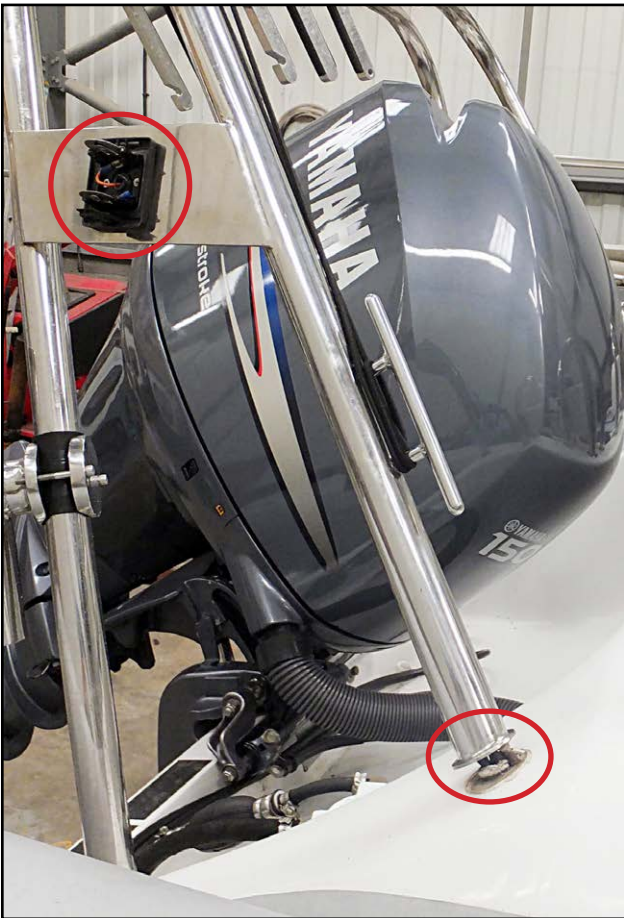
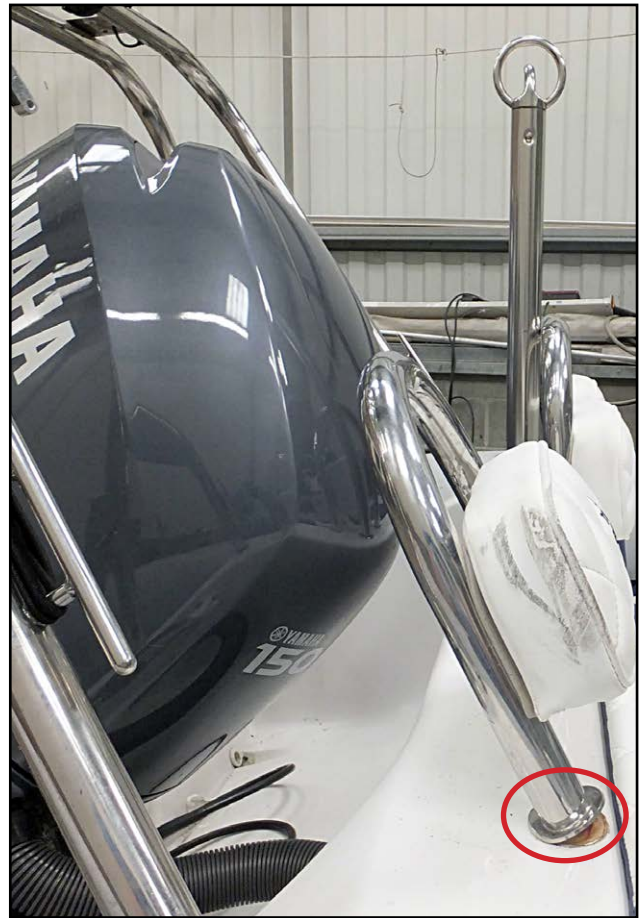
Figure 9: Damage to Rib Tickler

Rib Tickler suffered minor impact damage to the starboard side bench seat head rest and the starboard side A-Frame stanchions. The starboard navigation light was also broken, and there were scuff marks on the starboard tube (**Figure 9**). The PW suffered minor damage to the gel coat and the fender strip on the port side (**Figure 10**).

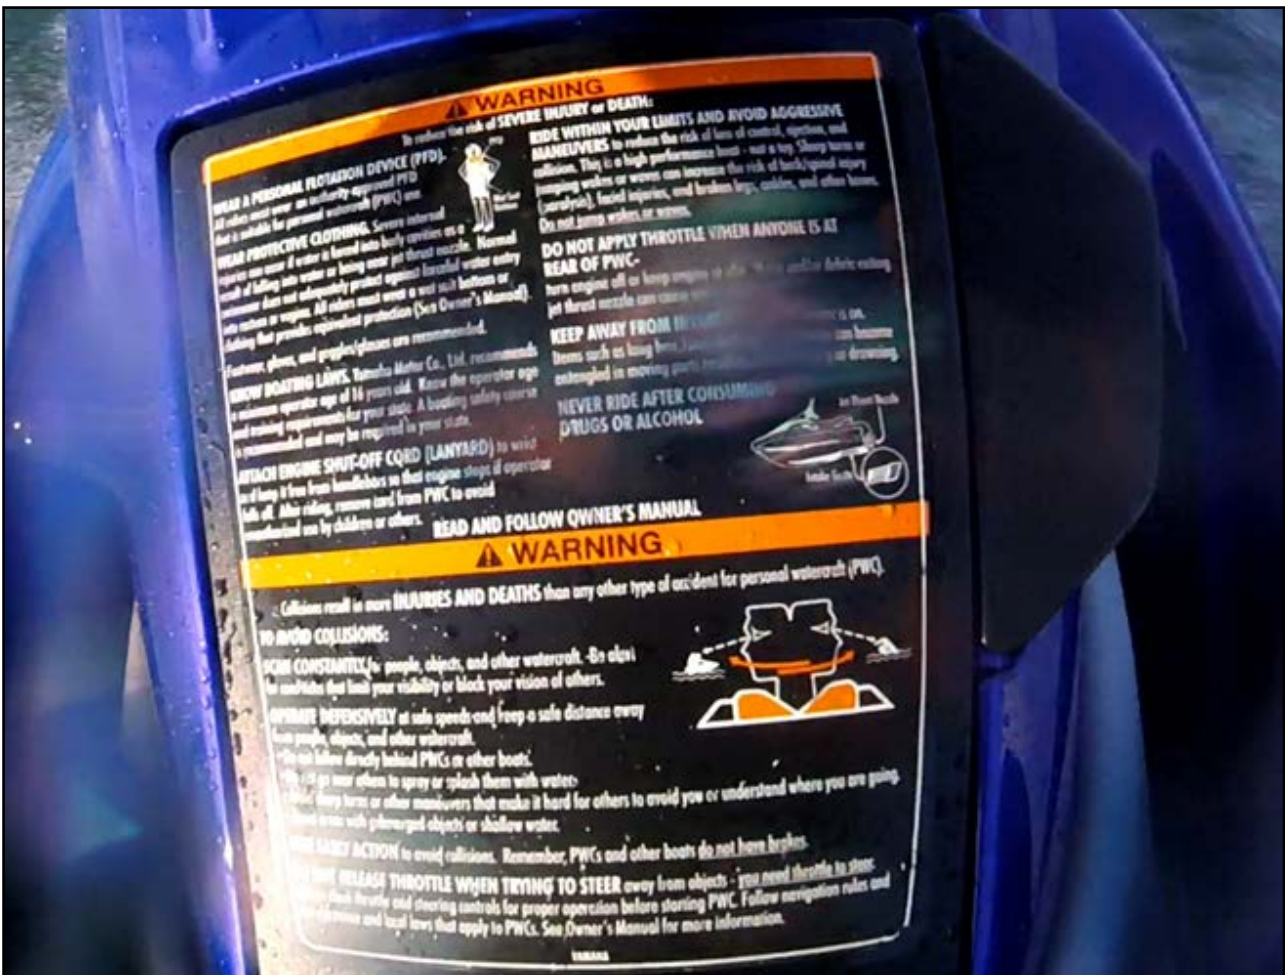
Figure 11: Warning label on the personal watercraft

This is a high performance boat – not a toy. Sharp turns or jumping wakes or waves can increase the risk of back/spinal injury (paralysis), facial injuries and broken legs, ankles, and other bones. Do not jump wakes or waves.

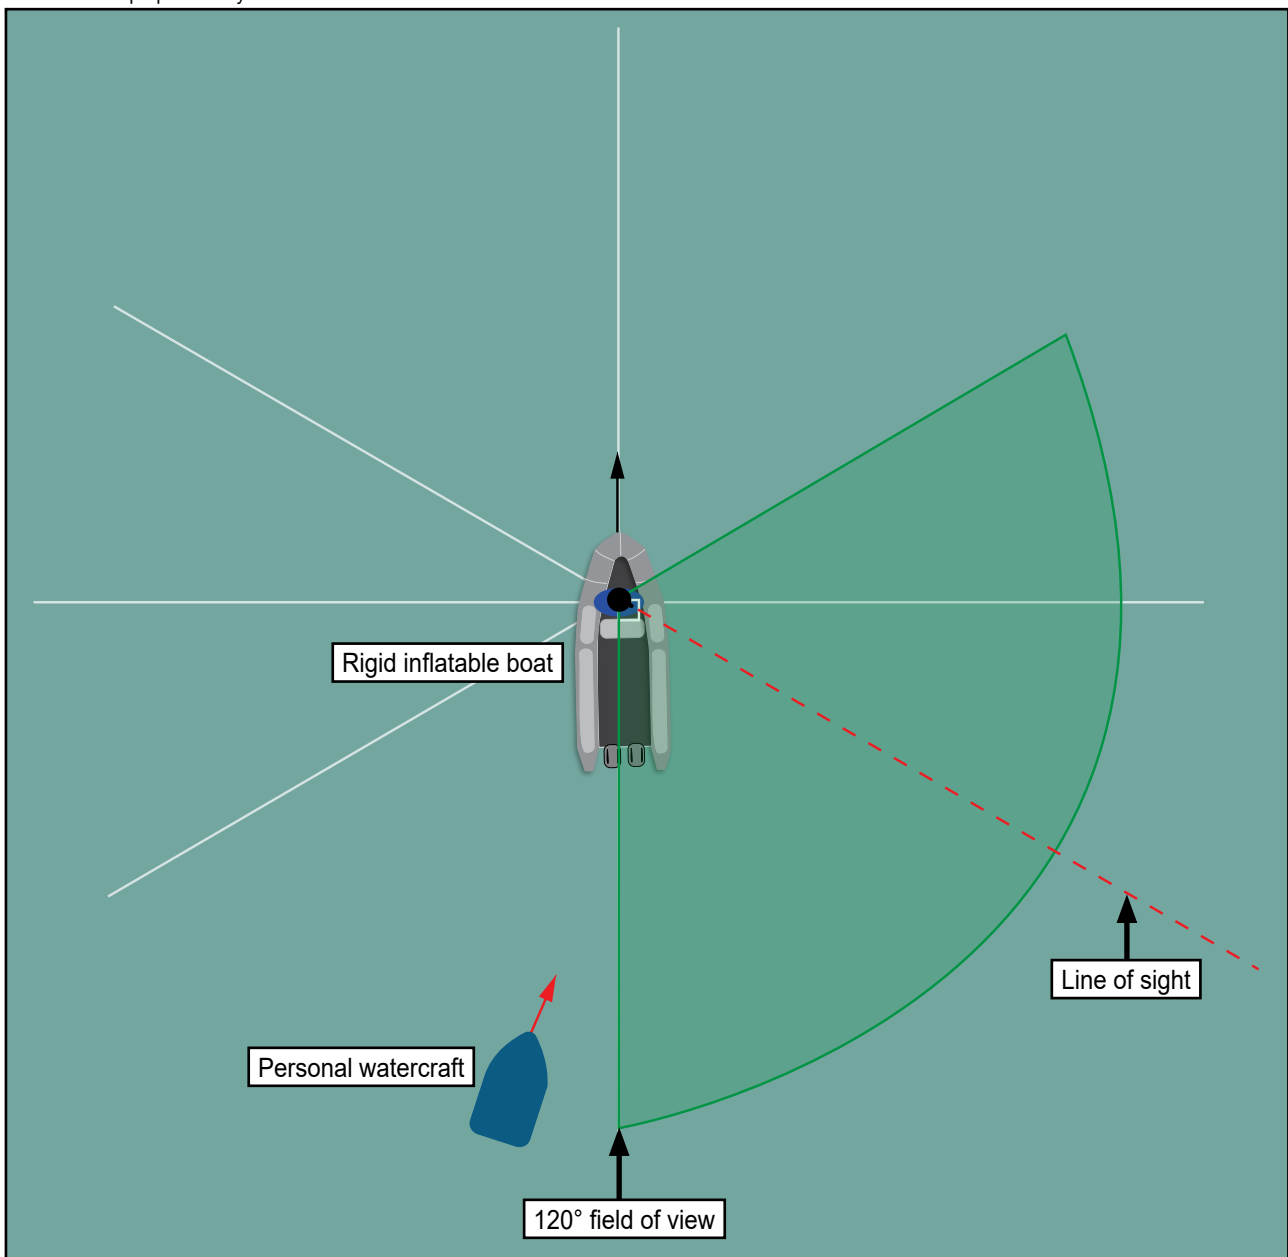
Figure 14: A standard field of view to right astern of the RIB

The RIB driver was more used to riding a PW and so had a false sense of speed and control when helming the less responsive RIB. In common with the collision between the two fire service boats, the helm lacked awareness of the location and movements of other craft in the party, and his attempts to check over his shoulder to starboard before the turn did not provide him with a full 360° view (**Figure 14**)¹².

¹² The commonly accepted static field of view is around 120°, and the average rotation is between 60° and 90°. Even with a rotation of 120° from right ahead, as illustrated in Figure 14, the field of view of the helmsman would only reach to right astern and he would not have seen the PW on the port quarter.
