**Bundesstelle für Seeunfalluntersuchung**  
Federal Bureau of Maritime Casualty Investigation

## **Interim Investigation Report**

### **Very Serious Marine Casualty 103/21**

**Accident with Subsequent Loss of Life  
on Board the Containership SEOUL EXPRESS  
at Sea between Manzanillo and Long Beach  
on 27 March 2021**

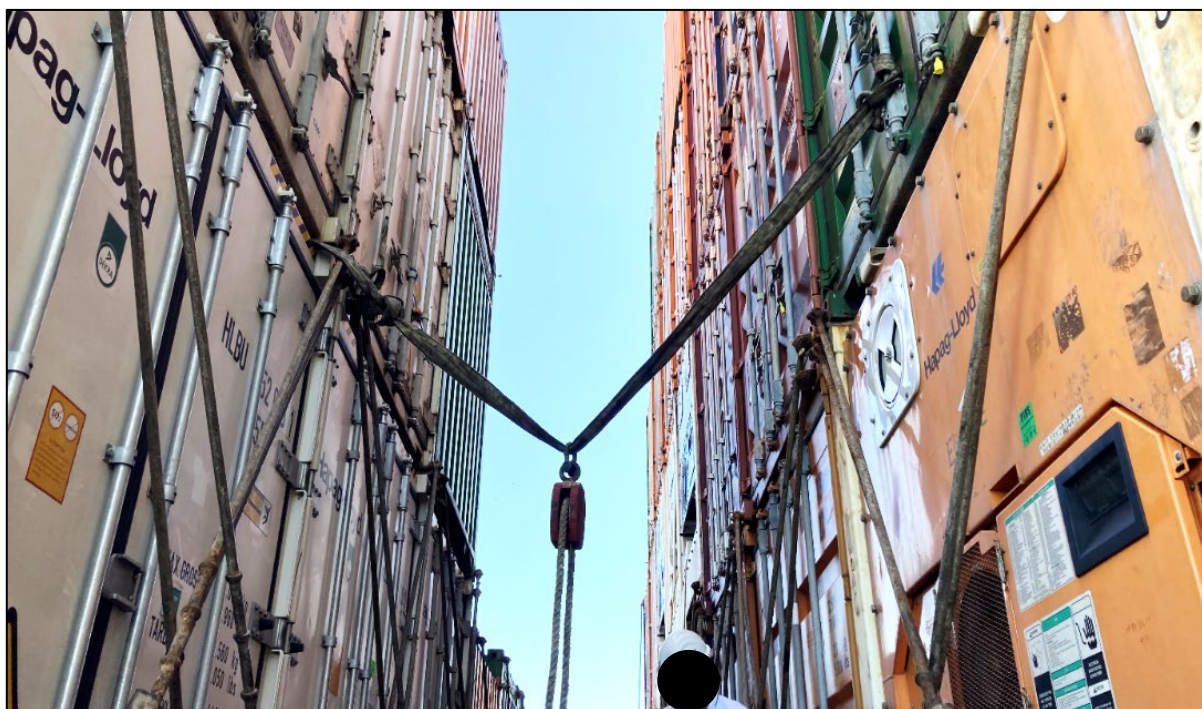
Figure 4: Sling Construction for Evacuation via the Access Hatch (simulated on 19/10/2021)<sup>15</sup>

At about 0817, the Chief Officer and an AB (AB1) descended into the cargo hold No. 3 both wearing a SCBA and reached the casualty two minutes later on the No. 4 stringer deck. He suffered a bleeding wound at the back of his head and showed no reaction. The Chief Officer tried in vain to find a pulse on both the neck and wrist. He informed the Chief Engineer at the access hatch that the injured person should be pulled up by means of a rescue sling. The Chief Officer ascended the ladder again in order to prepare the rescue rope, which had to be attached to the loaded containers or their lashing materials due to the lack of suitable fastening points (see Figure 4). Meanwhile, another AB joined them, equipped himself with a SCBA, descended to the No. 4 stringer deck together with the Chief Officer and AB1, and helped to first lift the unconscious watchman into the sling and then to lead him upwards by the rope. The Chief Engineer and Bosun operated the rope at the access hatch.

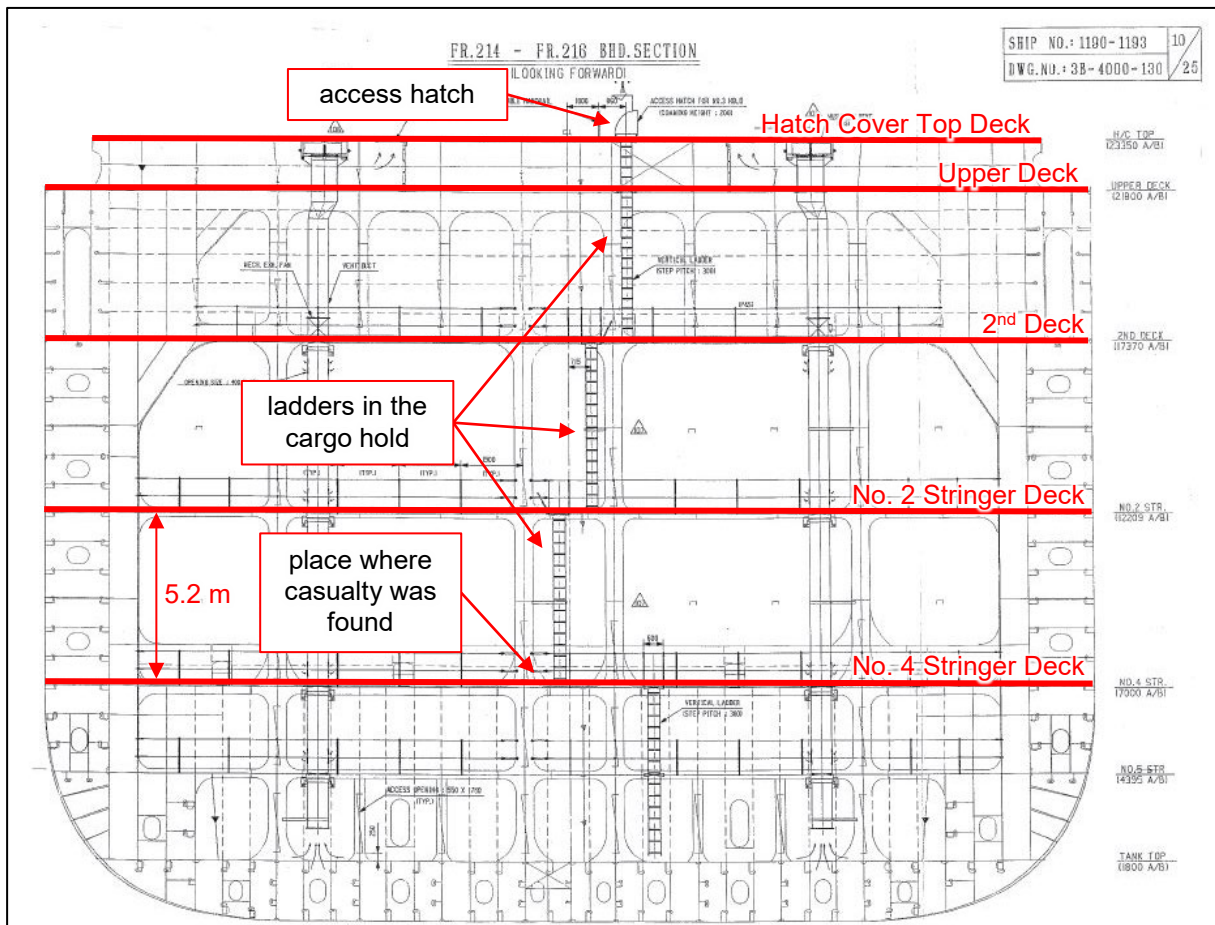
Figure 5: "Ladder Support Plan" Cargo Hold No. 3<sup>16</sup>

From Figure 5, the designation of the individual decks of the SEOUL EXPRESS as well as the descent into the cargo hold via the staggered ladders can be understood:

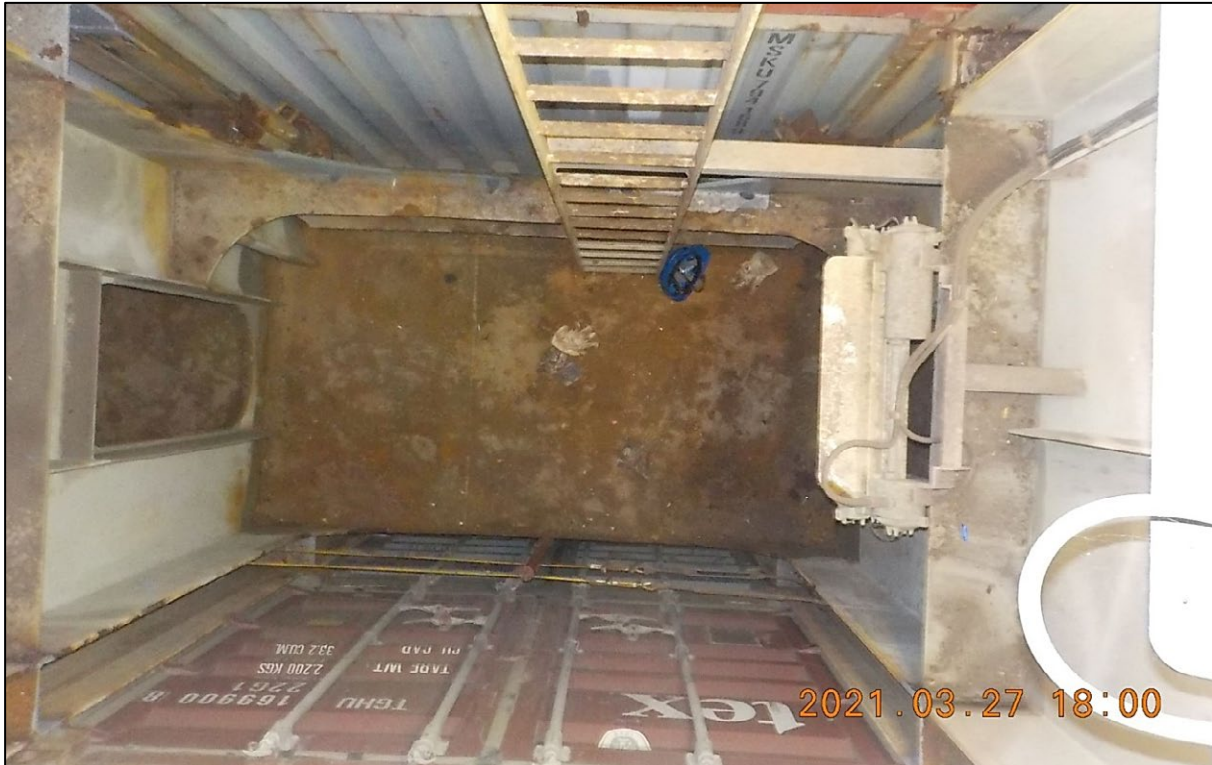
Figure 6: View from Above onto the 4th Stringer Deck in Cargo Hold No. 3, Scene of the Accident<sup>17</sup>

Figure 6 shows the view from the No. 2 stringer deck to the No. 4 stringer deck below, where the injured watchman was found at the base of the vertical ladder, his helmet and gloves also visible in the picture.
