MAERSK ESSEN

Marine accident report on loss of cargo

16 JANUARY 2021

**MARINE ACCIDENT REPORT ON MAERSK ESSEN'S
LOSS OF CARGO ON 16 JANUARY 2021**

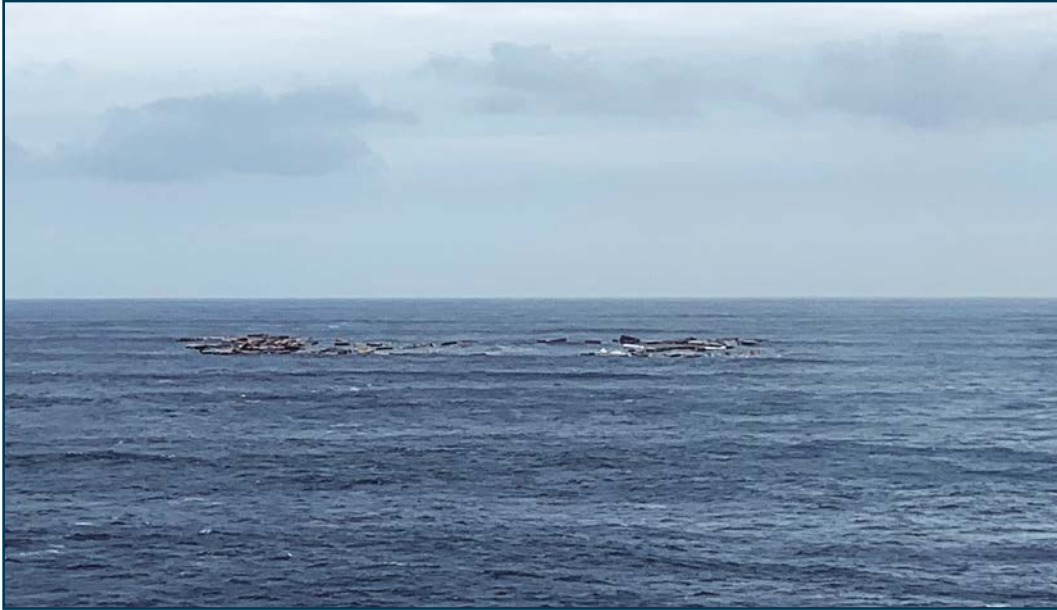
He went to the bridge wing and looked aft and saw containers hanging over the ship's side and floating in the sea (Figure 7). He rushed back into the bridge and instructed the officers to fetch a camera to document the lost containers and to log the time and position. The heavy weather emergency response flowchart was put into use, and the 2nd and 3rd officer assisted the master in communicating with relevant authorities and the company.

Figure 7: Lost containers floating in the water
Source: Maersk A/S

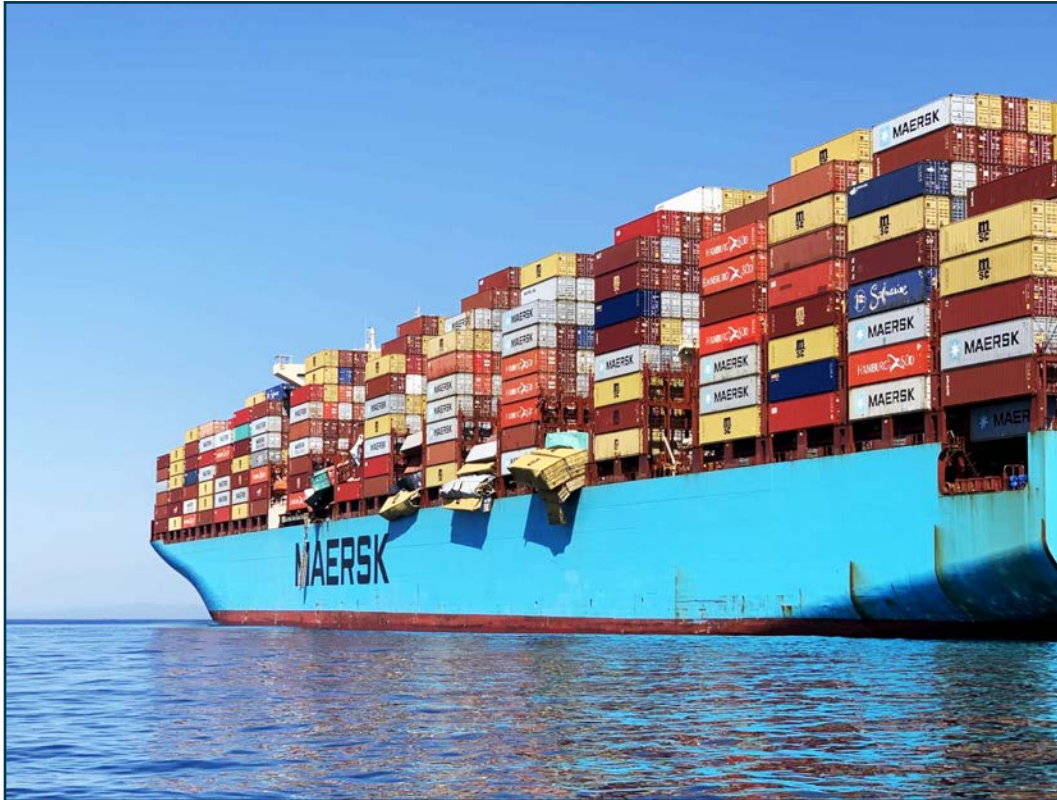
On the cargo deck, the crew found that containers were damaged or lost overboard from eight bays. On some bays few containers were lost, while on others all containers were lost or damaged. During the discharge of the damaged cargo, it was concluded that a total of 689 containers were lost overboard and that 258 were damaged (Figure 8).

Figure 8: MAERSK ESSEN at anchorage off Lázaro Cárdenas, Mexico
Source: Maersk A/S

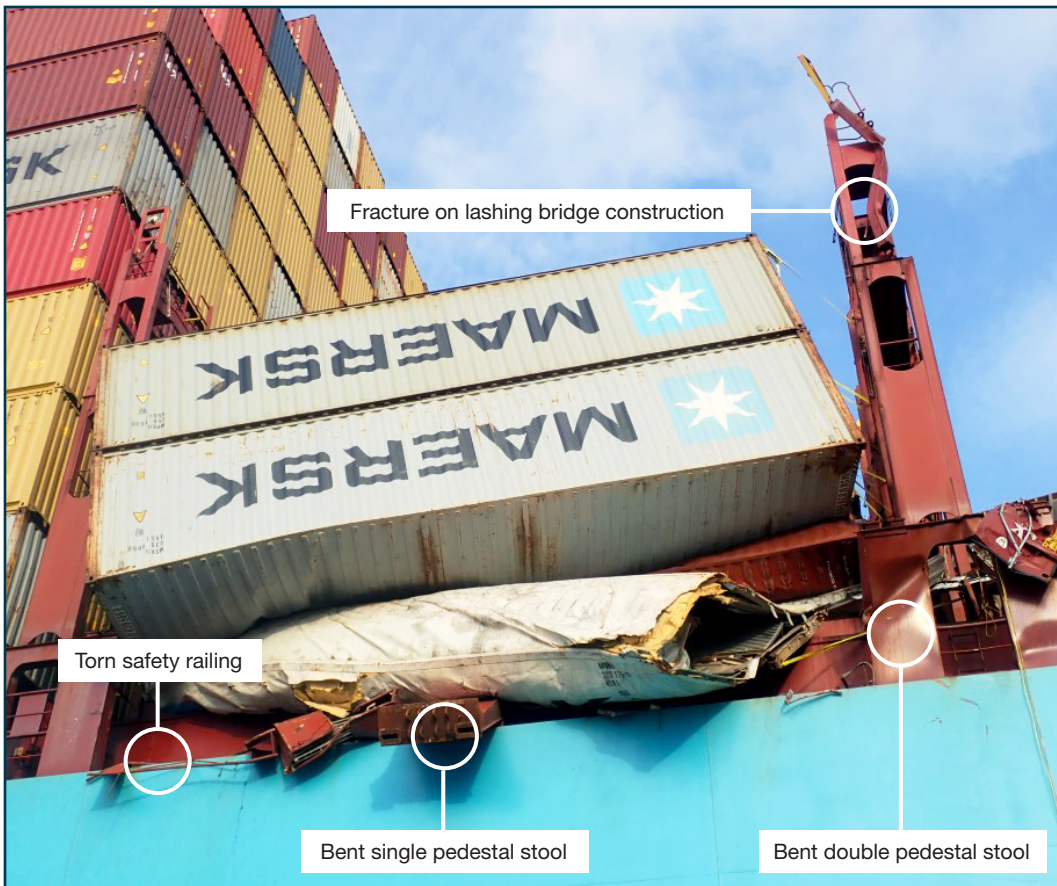
On bays where containers were lost overboard, the container stacks had collapsed and toppled over, causing damage to deck structures. On other bays, where container stacks had also collapsed, containers were hanging over the ship's side, blocking the deck passageways. Pedestal stools were bent, safety railings torn off, and the accommodation ladders on both port and starboard side were damaged (Figures 9 and 10). Several lashing bridges were deformed and fractured having being struck by falling containers, and the passageways on the lashing bridges were blocked and damaged (Figures 11 and 12).

Figure 9: Example of damages on deck structures
Source: Maersk A/S, modified by DMAIB

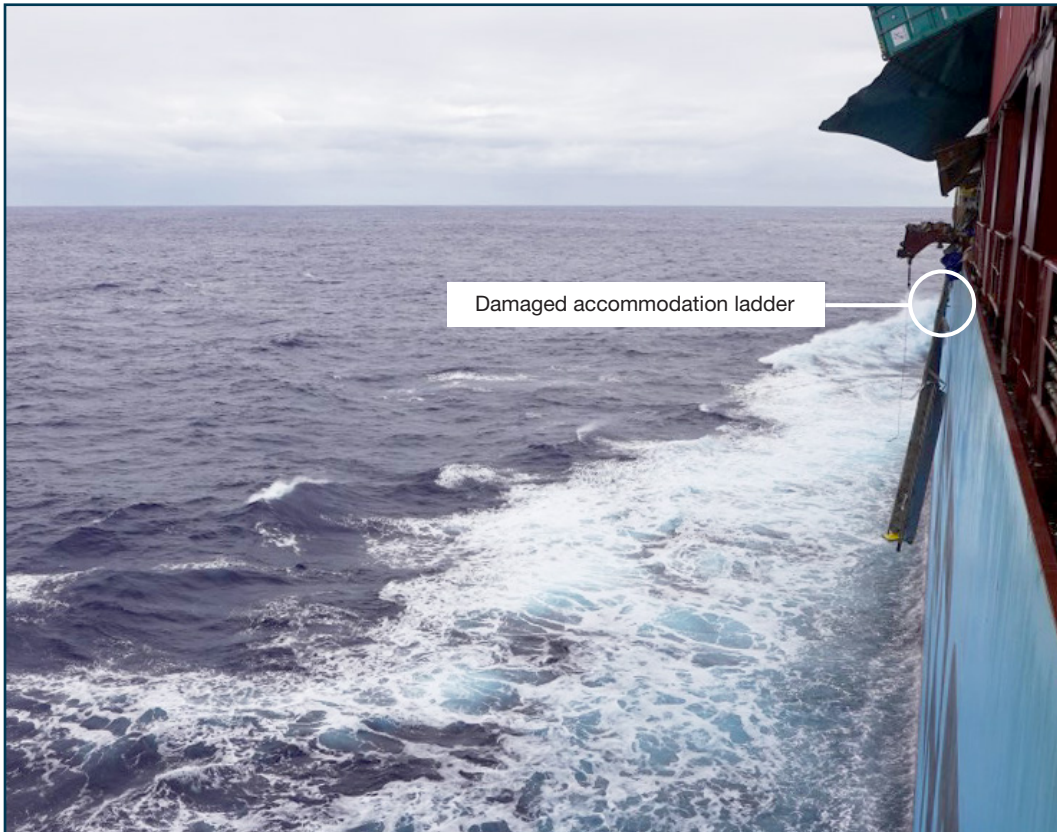
Figure 10: Damage to port side accommodation ladder
 Source: Maersk A/S, modified by DMAIB

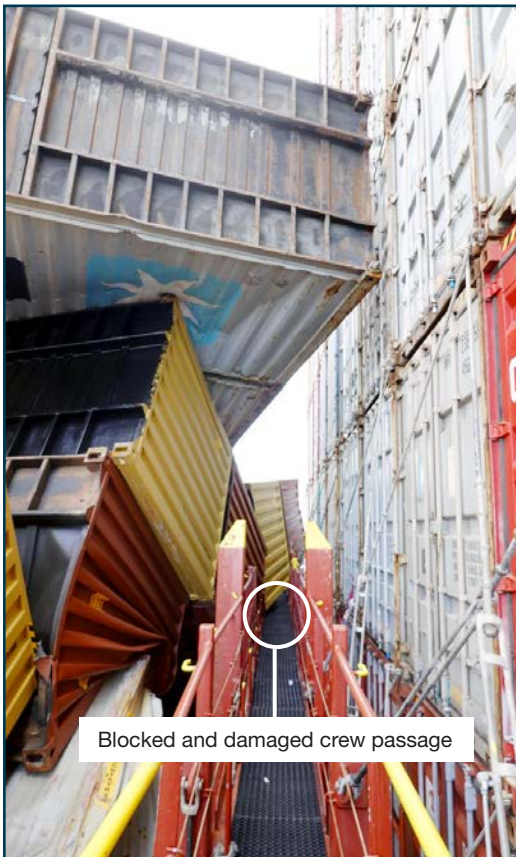
Figure 11: Example of lashing bridge damages
 Source: Maersk A/S, modified by DMAIB

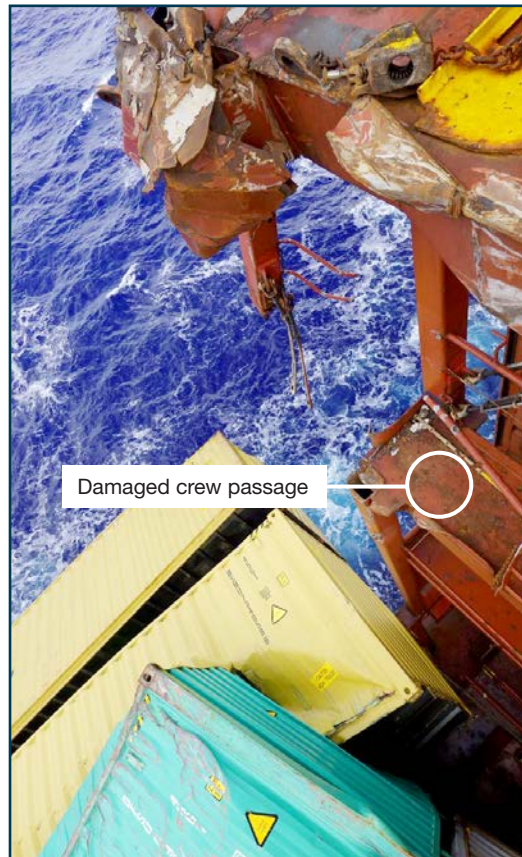
Figure 12: Example of lashing bridge damages
 Source: Maersk A/S, modified by DMAIB

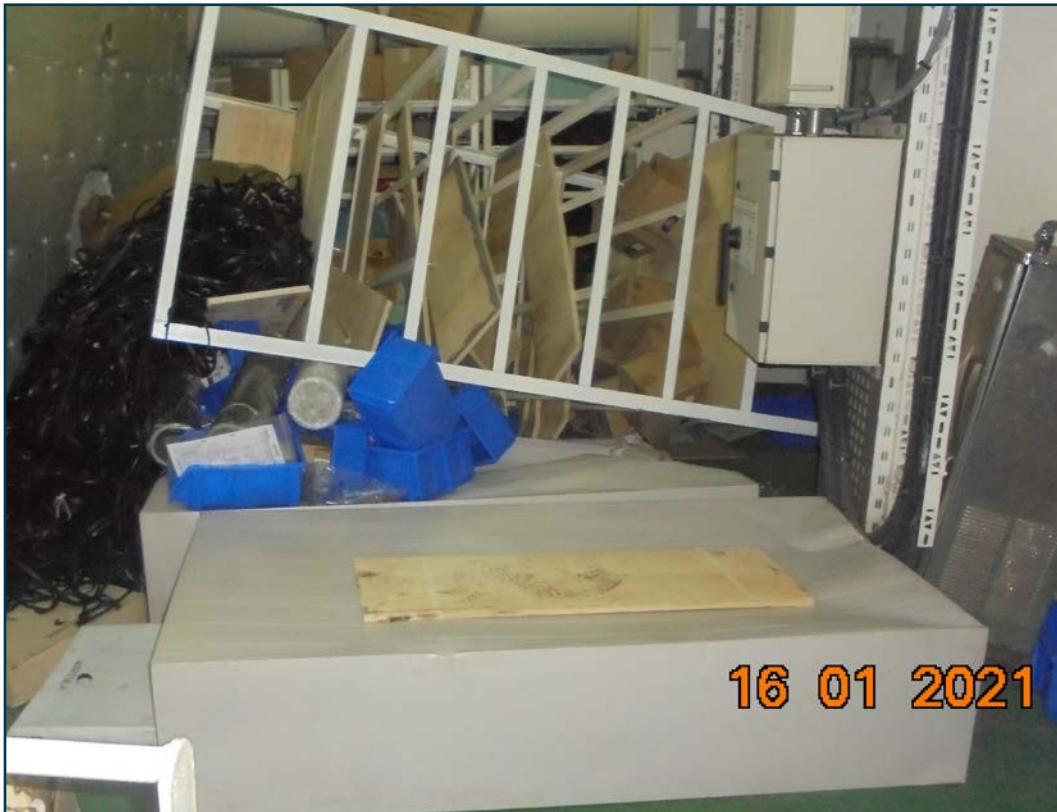
Figure 13: Overturned storage racks
Source: Maersk A/S

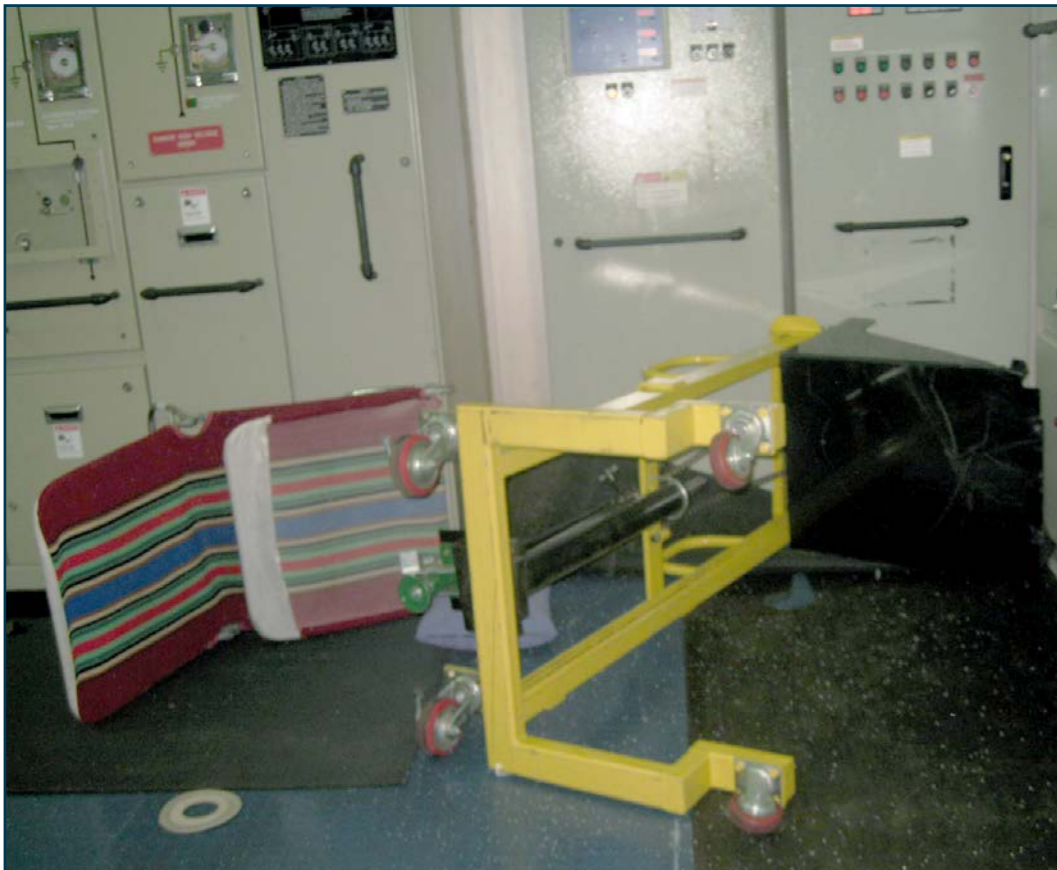
In the accommodation, all compartments were affected. Items which had not been secured had been hurled around, and office equipment, furniture and galley machinery had fallen over. In the paint shop, barrels and cans had fallen to the floor from the shelves. In other storage rooms, entire racks were overturned, and their content hurled off the shelves (Figure 13). In the engine room, the compartment's heavy equipment, including a lifting device and a spare electrical motor, had loosened and slid across the floor (Figure 14 and 15).

Figure 14: Overturned and displaced lifting device near control panels in the engine control room
Source: Maersk A/S

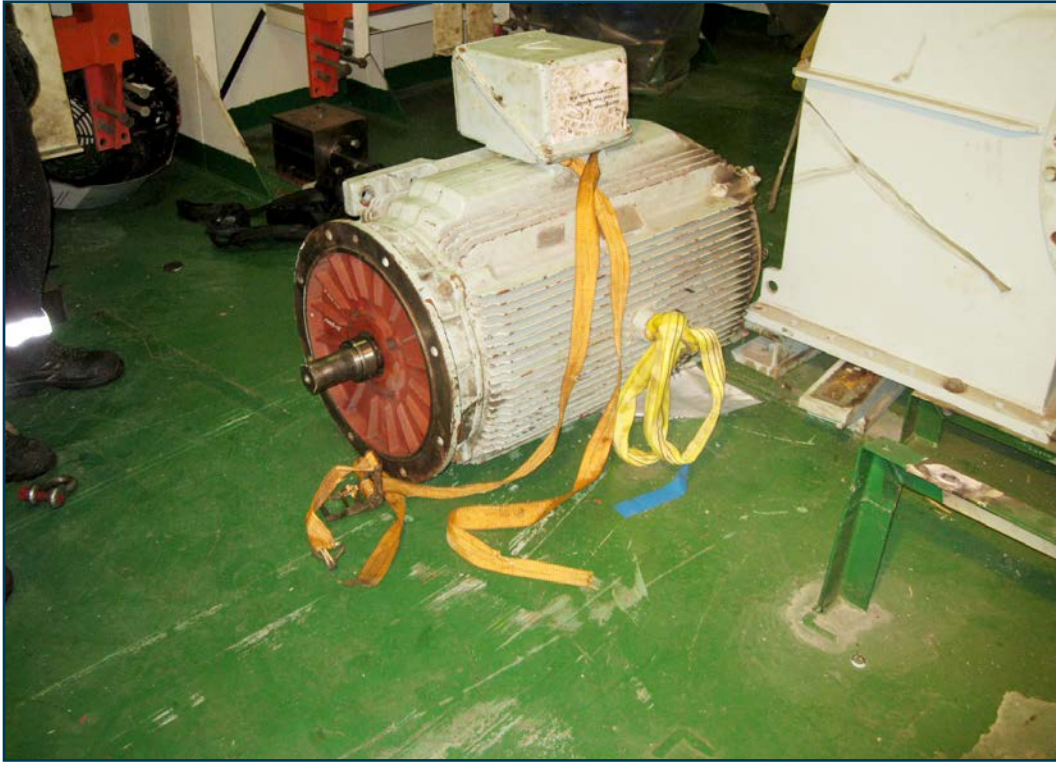
*Figure 15: Electrical spare motor with broken lashings and damages from impact after having slid across the deck and hit other objects and structures.
Source: Maersk A/S*

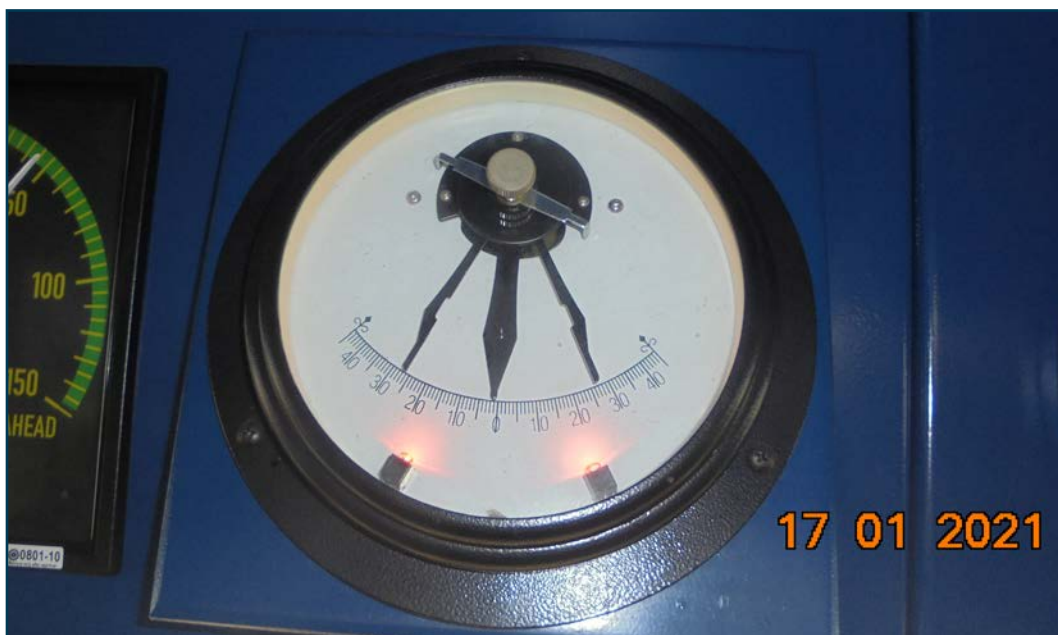
A mechanical inclinometer on the bridge indicated the ship's heel angle and recorded the maximum heel angle. Photographs of the inclinometer taken after the heavy rolling episodes (Figure 19) show that the ship reached angles of 26° to port and starboard. The inclinometer had been reset by the chief officer before the 3rd officer took over the watch, and the 26° hence reflected the heavy rolling episode between 08:04-08:10.

Figure 19: Inclinometer after the heavy rolling occurrence on 16 January 2021

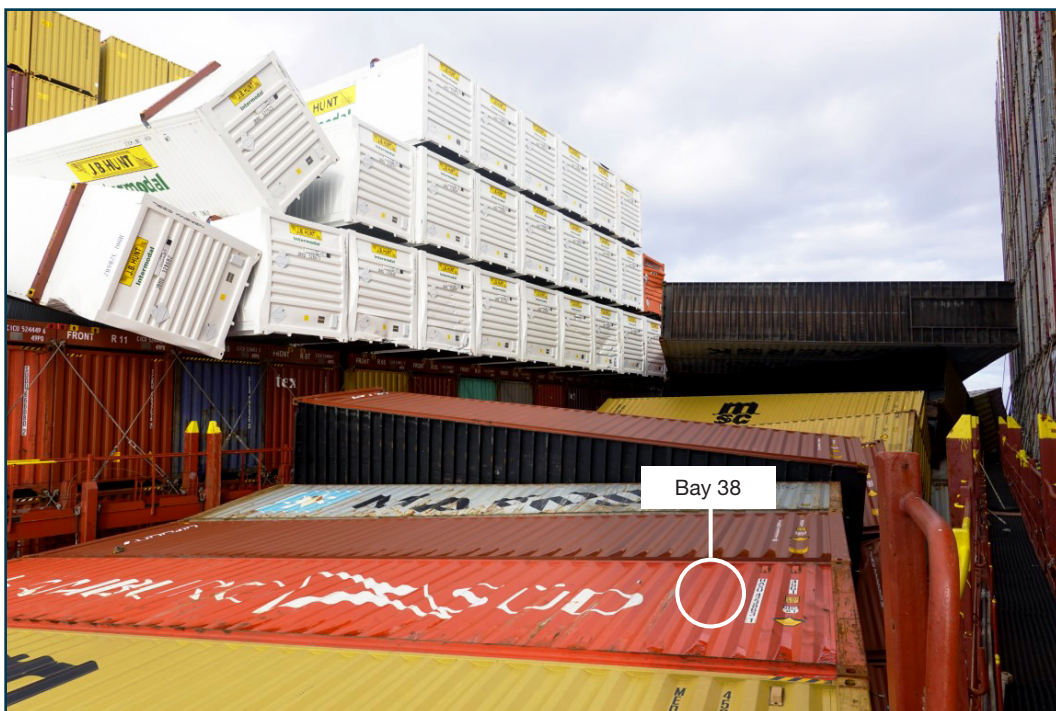
Bays 38, 50 and 66 suffered total collapse, with all containers lost or damaged. The containers remaining on board were fractured with indents to the side plating along with damaged corner posts and corner casts due to excessive loads or pressure compressing from other containers. Containers were hanging over both the port and starboard sides. On bay 50 and 66, the remaining containers were separated from the stacks and had toppled over in a chaotic pattern. On bay 38, containers were toppled over towards the port side and were still partly connected in stacks by twistlocks (Figure 44). This indicates that the bay collapse was mainly affected by a port side roll.

Figure 44: Bay 38 after the accident
Source: Maersk A/S

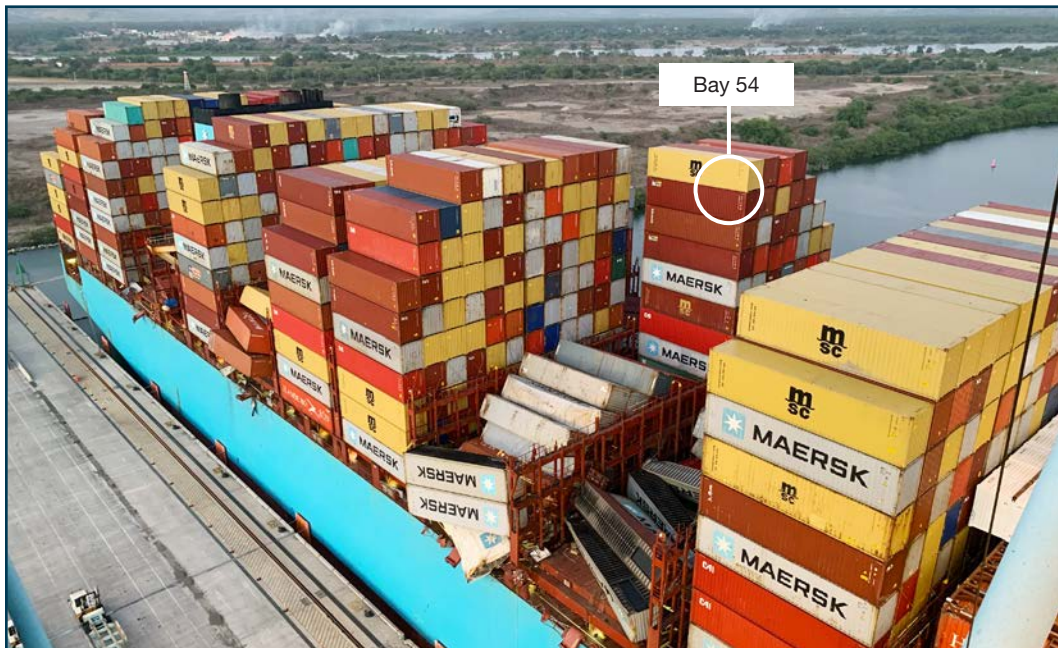
On bay 54 port side, the containers on the seven outermost rows were still in position, while the remaining twelve rows of containers were missing or damaged. The damaged containers were closest to the intact container rows on the port side, while the outermost containers on starboard side had fallen overboard. Figure 45 shows five rows had toppled over towards the starboard side, while still being partly connected by twistlocks, with the top of the stacks missing. This indicates that the entire row had collapsed when the ship rolled to starboard.

Figure 45: Bay 54 after the accident

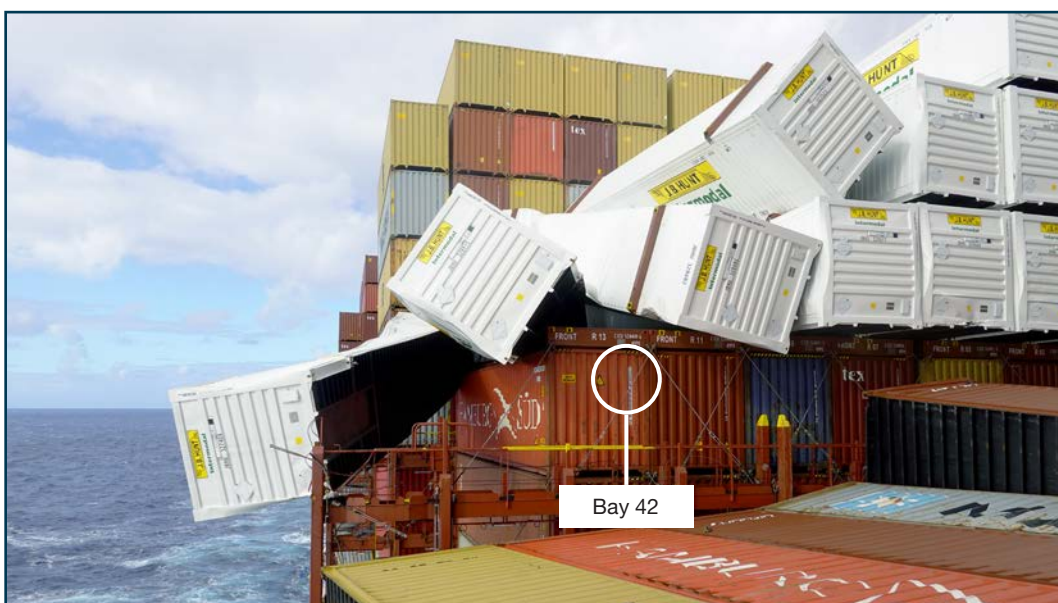
Bay 46 had lost one row on its starboard side, which could have resulted from either acceleration force overload during a starboard roll or from the row being struck by containers tumbling from bay 42 (Figure 46). The remaining rows were sitting in position with their lashings intact.

Figure 46: Bay 42 after the accident. Bay 46 behind the white containers.

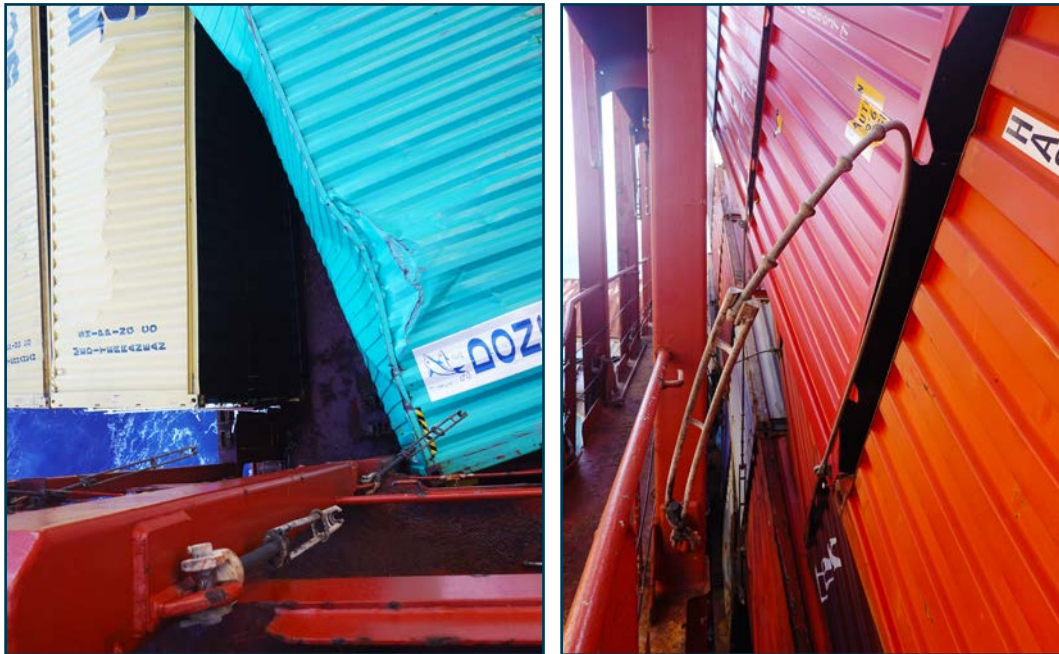
On all affected bays, turnbuckles and lashing bars were hanging loose from lashing bridges and containers, showing signs of having been torn apart (Figure 48). In other places, turnbuckles and lashing rods which were still connected had been bent out of shape, as the container stacks had collapsed (Figure 47).

Figure 47 and 48: Example of detached and bent lashings (bay 66 and 54)
Source: Maersk A/S

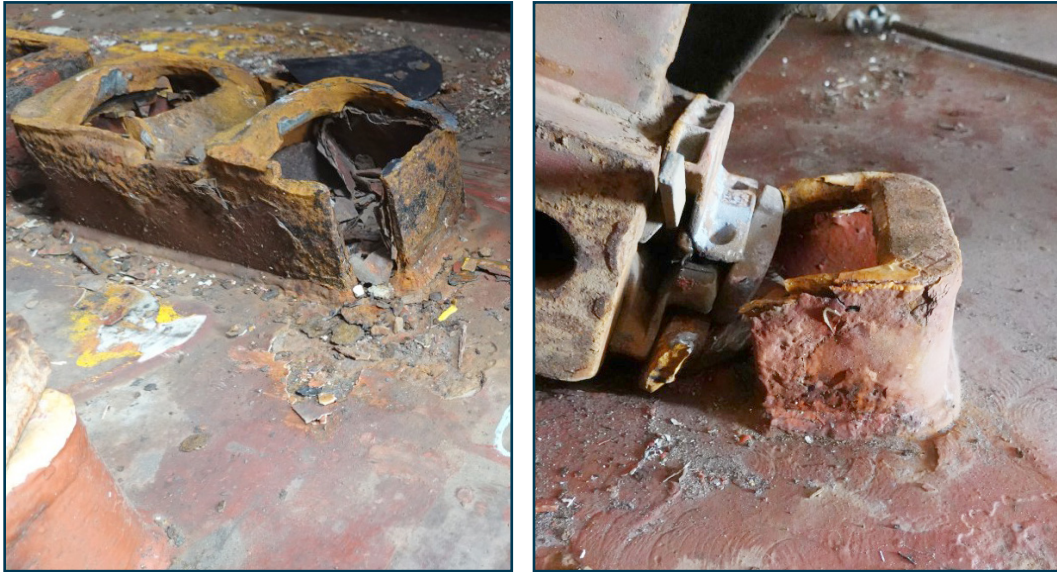
Figures 49 and 50: Example of socket fractures – bay 66 and 38
Source: Maersk A/S

The ISO sockets, which had the lowest holding capacity, were damaged on most of the affected bays. Fractures on sockets, corner castings and base-locks often related to overload caused by lifting and separation forces induced by heavy rolling, which resulted in a tipping moment (Figure 53). However, the corner post load or lifting force might also have resulted from other dynamics within the individual stack, such as acceleration forces at the top leading to racking forces towards the middle of the stack, which then results in lifting/compression in the bottom of the stack (Figure 54). This type of dynamic will increase with stack height, especially for stacks with the tiers above the lashing bridge connected by twistlocks only. Furthermore, impact from collapsing adjacent stacks can also induce a tipping moment.

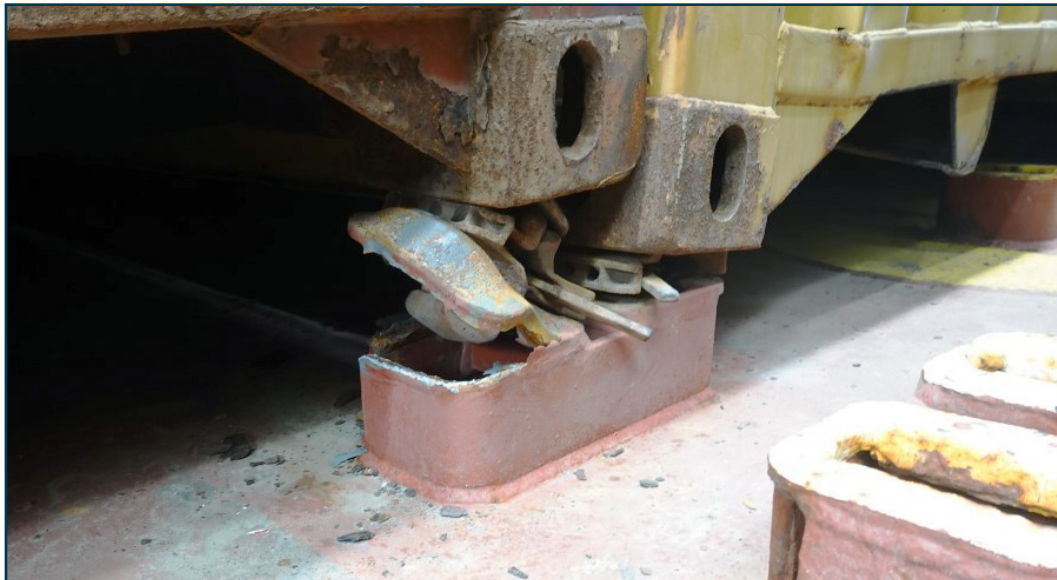
Both damaged and undamaged base locks were found in the sockets on the affected bays. In some cases, the locking pins seemed to be in the open position, but damages to container corner castings and twistlocks indicate they had been locked, but that the locking pins had been forced open when the container stacks toppled (Figure 51 and 52).

Figure 51: Example of twistlock in open position, though socket and twistlock are broken.
Source: Maersk A/S
