Final Report

FIRE ON BOARD MAERSK HONAM AT ARABIAN SEA ON 6 MARCH 2018

MIB/MAI/CAS.035

Transport Safety Investigation Bureau
Ministry of Transport
Singapore

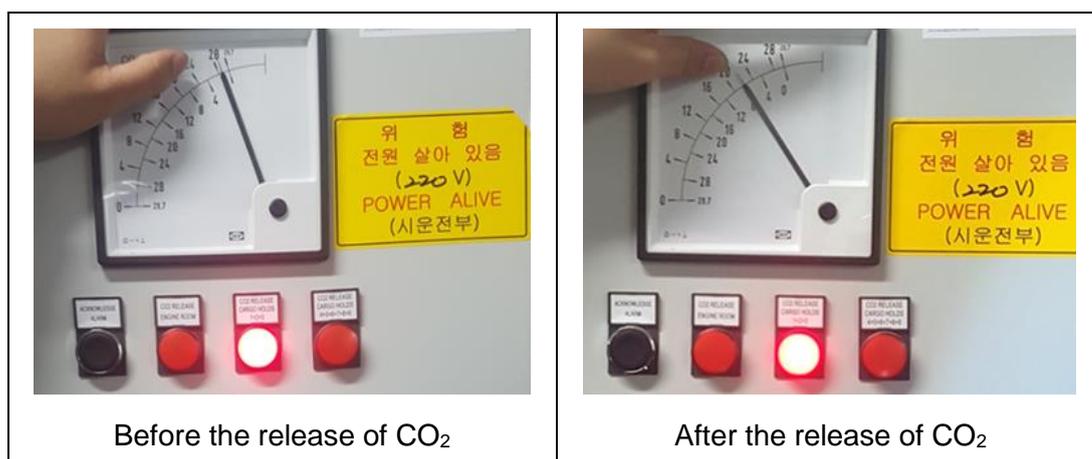
Figure 10 – Photos of CO₂ gauge before and after the discharge

- 1.2.33 The CE reported the initial gauge reading for the CO₂ tank was about 28,500kg (about 28.5tons). As per the discharge table plan, a fully filled cargo hold⁷⁷ would require about 6,000kg of CO₂. The CE stopped the release when the gauge indicated⁷⁸ 22,500kg of CO₂ remaining in the tank. (see **figure 10**).

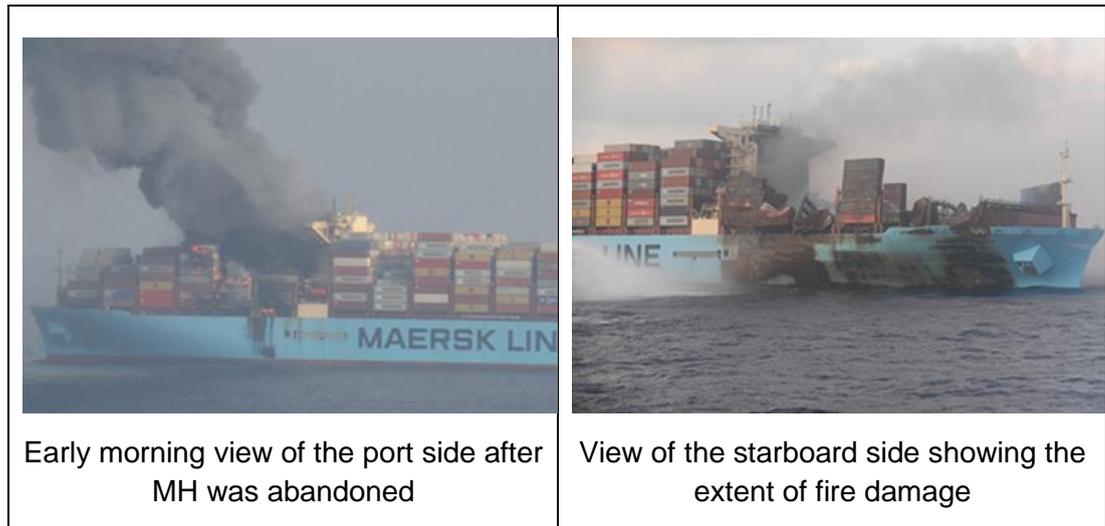
Figure 12 - Images of fire and its aftermath onboard MH

- 1.3.31 According to the 4E, looking from the forecastle deck, thick black smoke and flames were seen coming out from about the fifth tier between no.2 and no.3 cargo hold. Recalling further, the 4E mentioned that orange-coloured flames with burning were seen coming out from the top of the containers. The debris could also be seen being blown to the port side and into the sea (see **figure 12** showing fire and its aftermath on board MH).

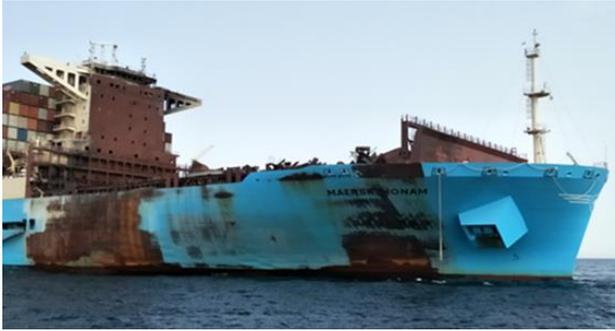
<p>View from sea level showing:</p> <p>Ship's starboard bow with burnt damages at ship's side and forward section of the accommodation</p>

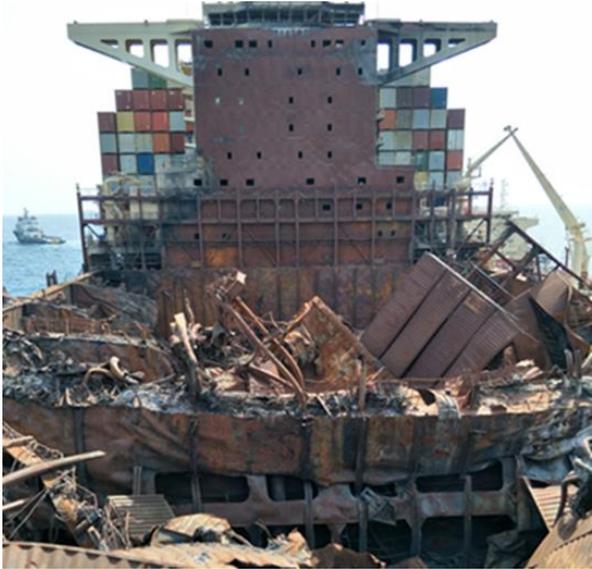
<p>View from the bow facing aft, indicating the extent of damage at the forward section that included:</p> <ul style="list-style-type: none"> • Collapsed containers • No.1, 2 and 3 cargo hold structure and outfitting • Burnt damages at the forward of the accommodation

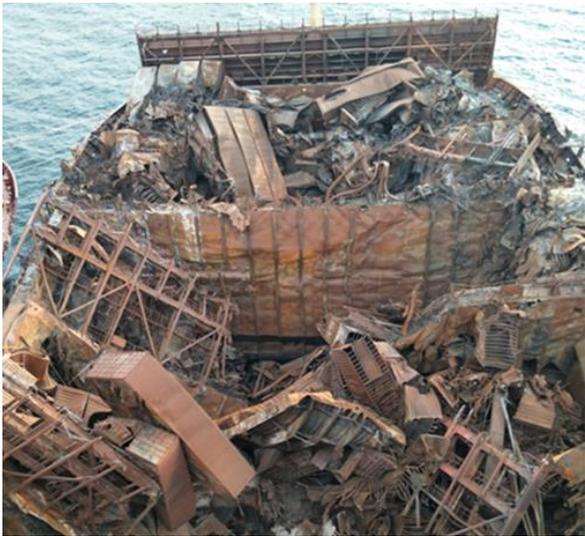
<p>Forward view from the bridge showing the ship's damaged section, which included:</p> <ul style="list-style-type: none"> • Collapsed containers¹⁰⁷ • No.1, 2 and 3 cargo hold structures and outfitting

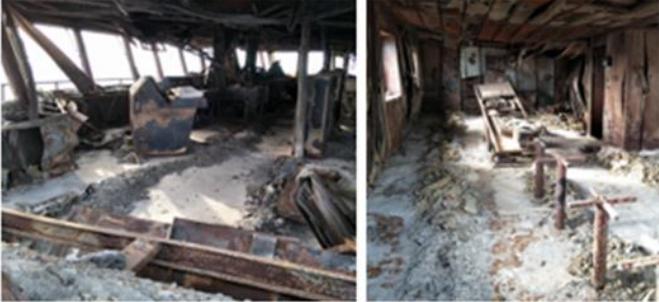
<p>View of the inside of the bridge and mess room (swept by salvors for access) showing burnt equipment, fittings, and structure</p>

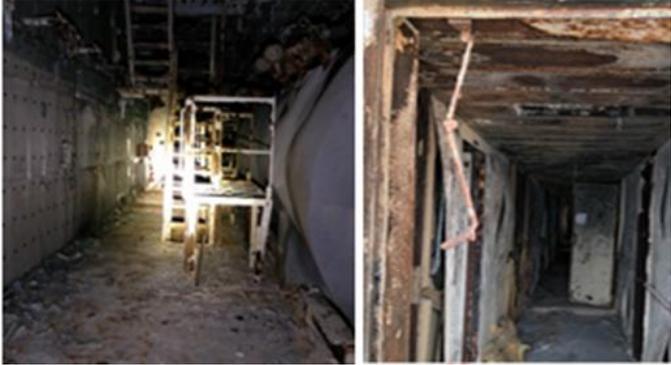
<p>View of the inside of the CO₂ room (swept by salvors for access) and the E-deck alleyway</p>

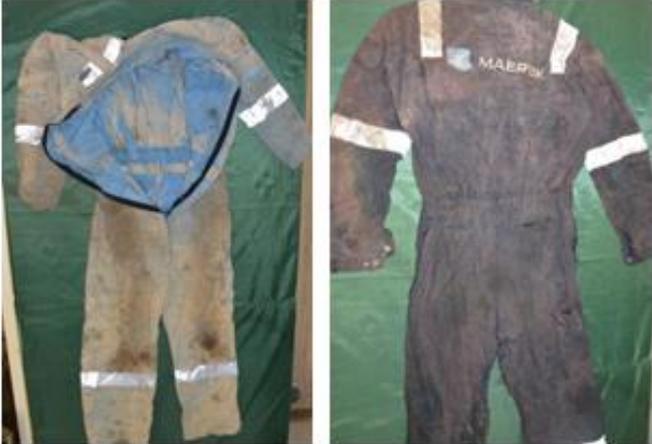
<p>The boiler suit indicated gross discolouration (caused by bleaching) to a near white colour from the original pale blue.</p> <p><i>Source</i> – Fire Forensic Expert</p>

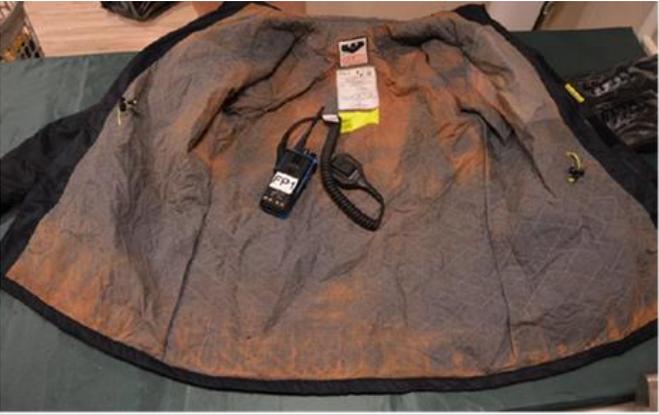
<p>The inner lining of the fireman's jacket shows gross discoloration.</p> <p><i>Source</i> – Fire Forensic Expert</p>

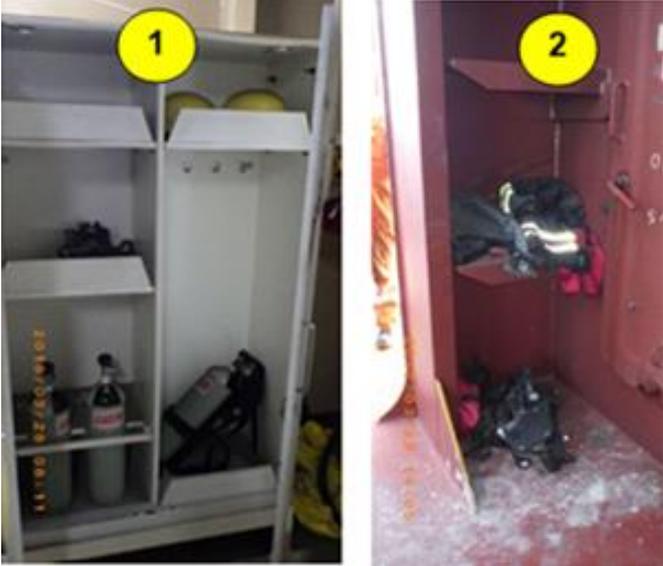
<p>Photographs obtained by the investigation team:</p> <ul style="list-style-type: none"> - Fire locker inside the Bosun store (forward) contains: <ul style="list-style-type: none"> • one BA set with two spare bottles • one complete set of chemical suits - Fire suit, BA set, and two sets of walkie-talkies found outside the forward store

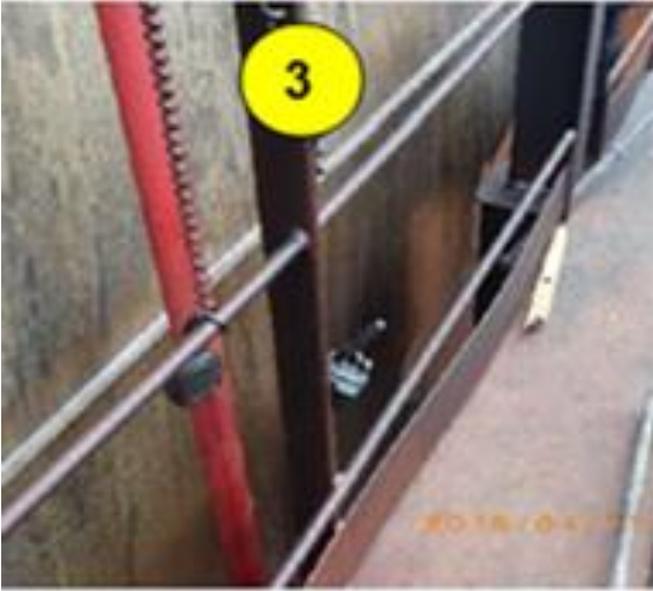
<p>Showing one set of walkie talkie bearing the 2M's tag (annotated no.3 by TSIB) was found at 3rd level lashing bridge forward of the accommodation.</p> <p>Additionally – Four sets of walkie-talkies tagged¹⁰⁸ with various ranks were discovered</p> <ul style="list-style-type: none"> • One in the ECR • Two inside the ER; and • One in the accommodation

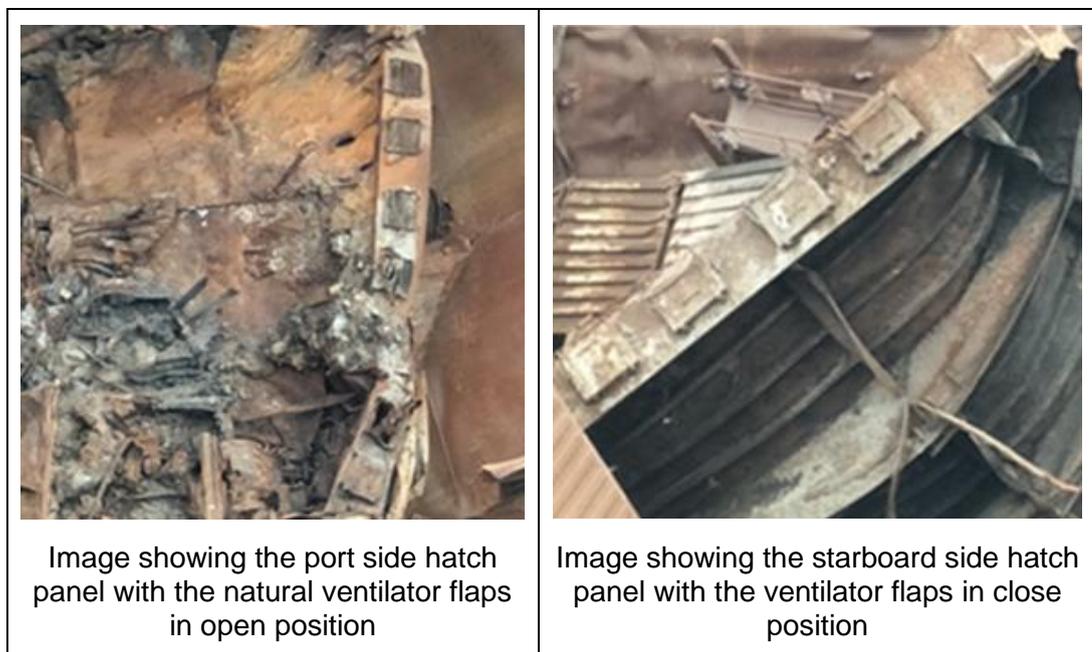
Figure 26 – Shows the condition of hatch panels during post inspection

1.8.21 The investigation team was able to confirm the account of the crew by an inspection of the ship post-incident, that the starboard side natural ventilator flaps were closed while those on the port side were open (see **figure 26**).

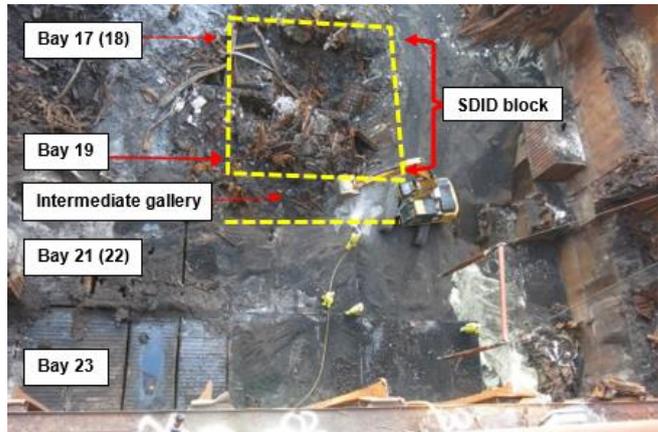
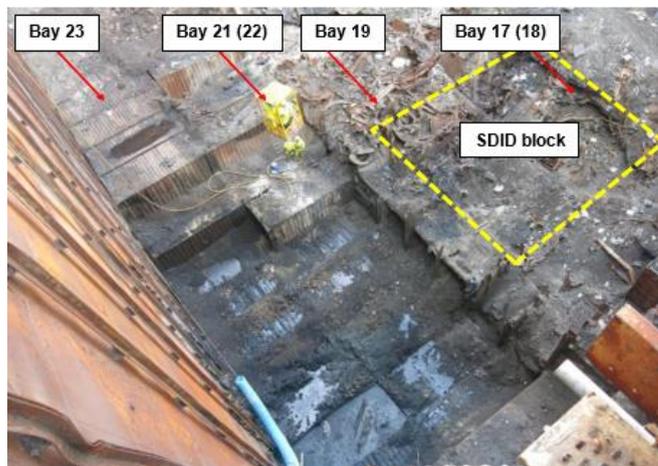
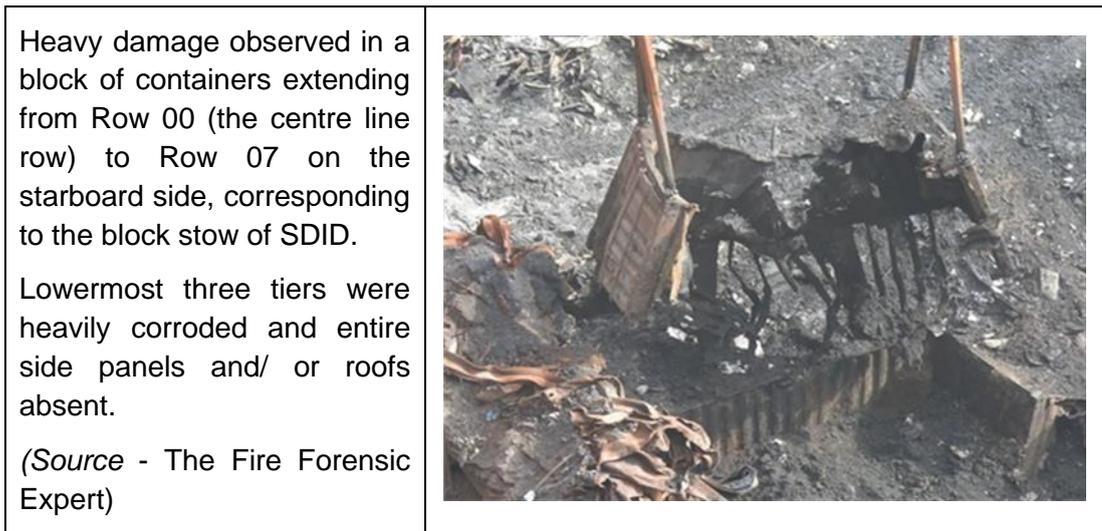
Figure 37 – Condition during excavation

Highlighting the SDID block in no.3 cargo hold at bay 17 (18) 19 as viewed from different angles.
