## Flooding and sinking of the survey workboat *Bella* in the approaches to Lynmouth, England on 6 July 2021

### SUMMARY

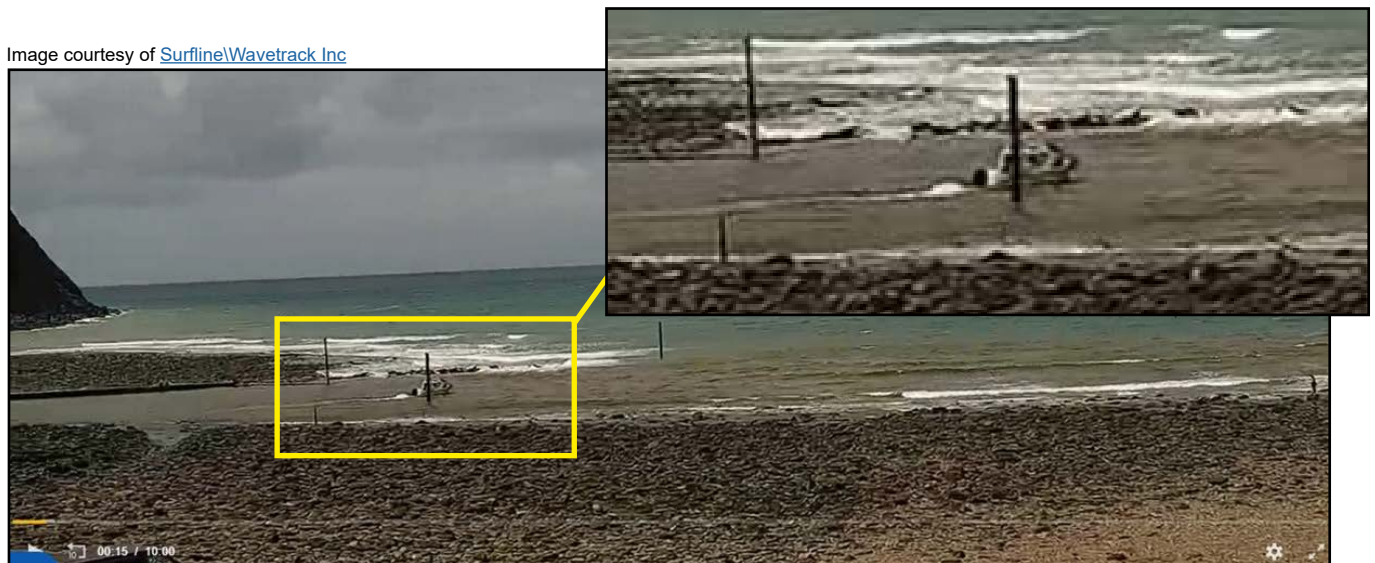
**Figure 1:** Closed-circuit television screenshot of *Bella* leaving Lynmouth, showing sea conditions at 1430 on 6 July 2022

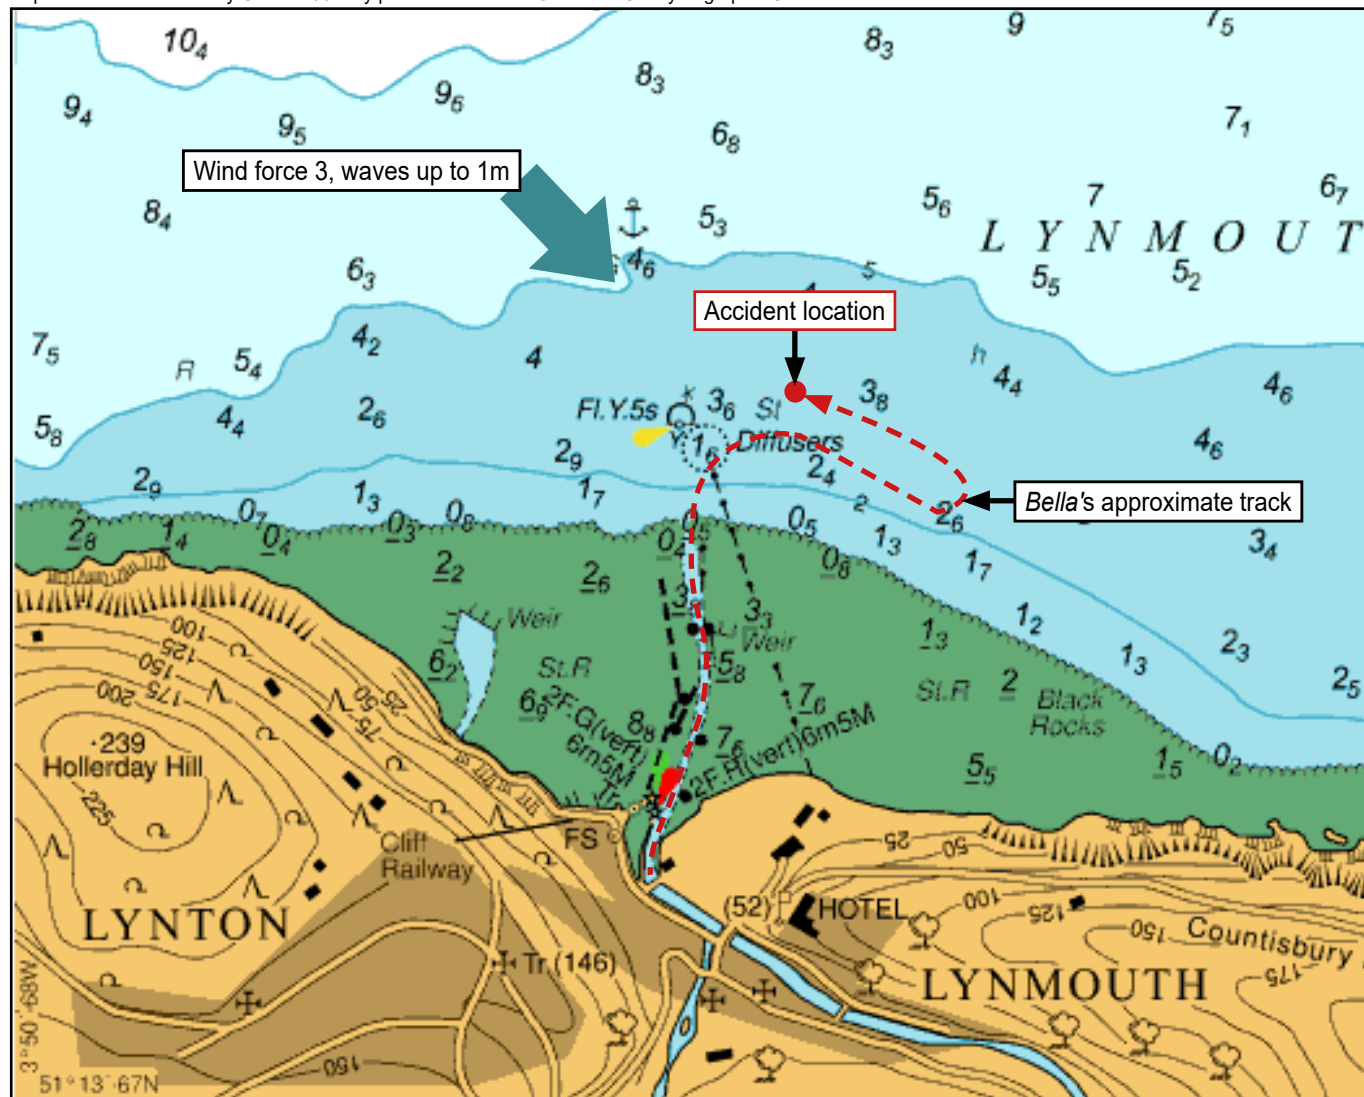
Figure 2: *Bella's* estimated track and accident location

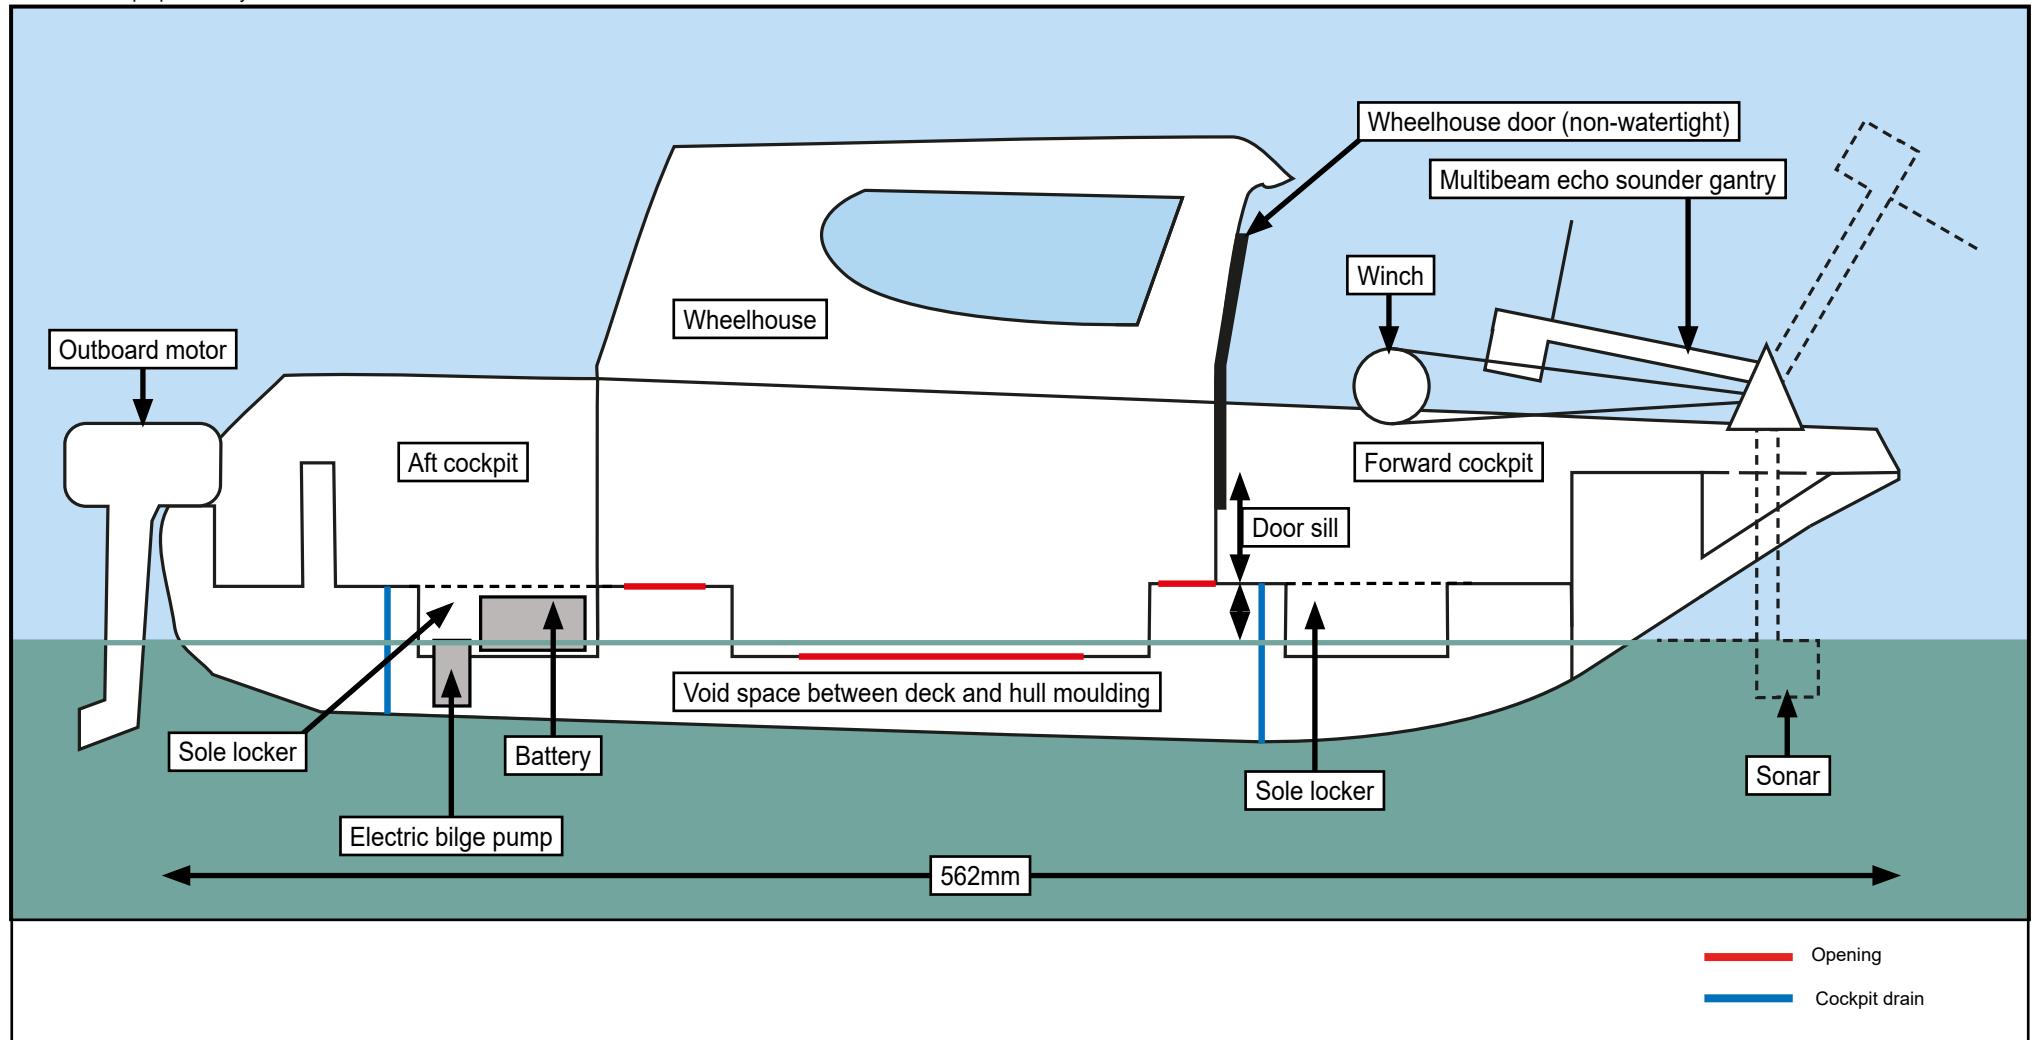
In 2016, a Finnish survey company modified *Bella* by fitting a 100kg MBES system, comprised of a steel winch, gantry and MBES transducer, near the bow for hydrographic surveys (**Figure 3**). The survey company did not have *Bella* certified as a commercial vessel and only operated it in sheltered waters.

Figure 3: Bella's layout

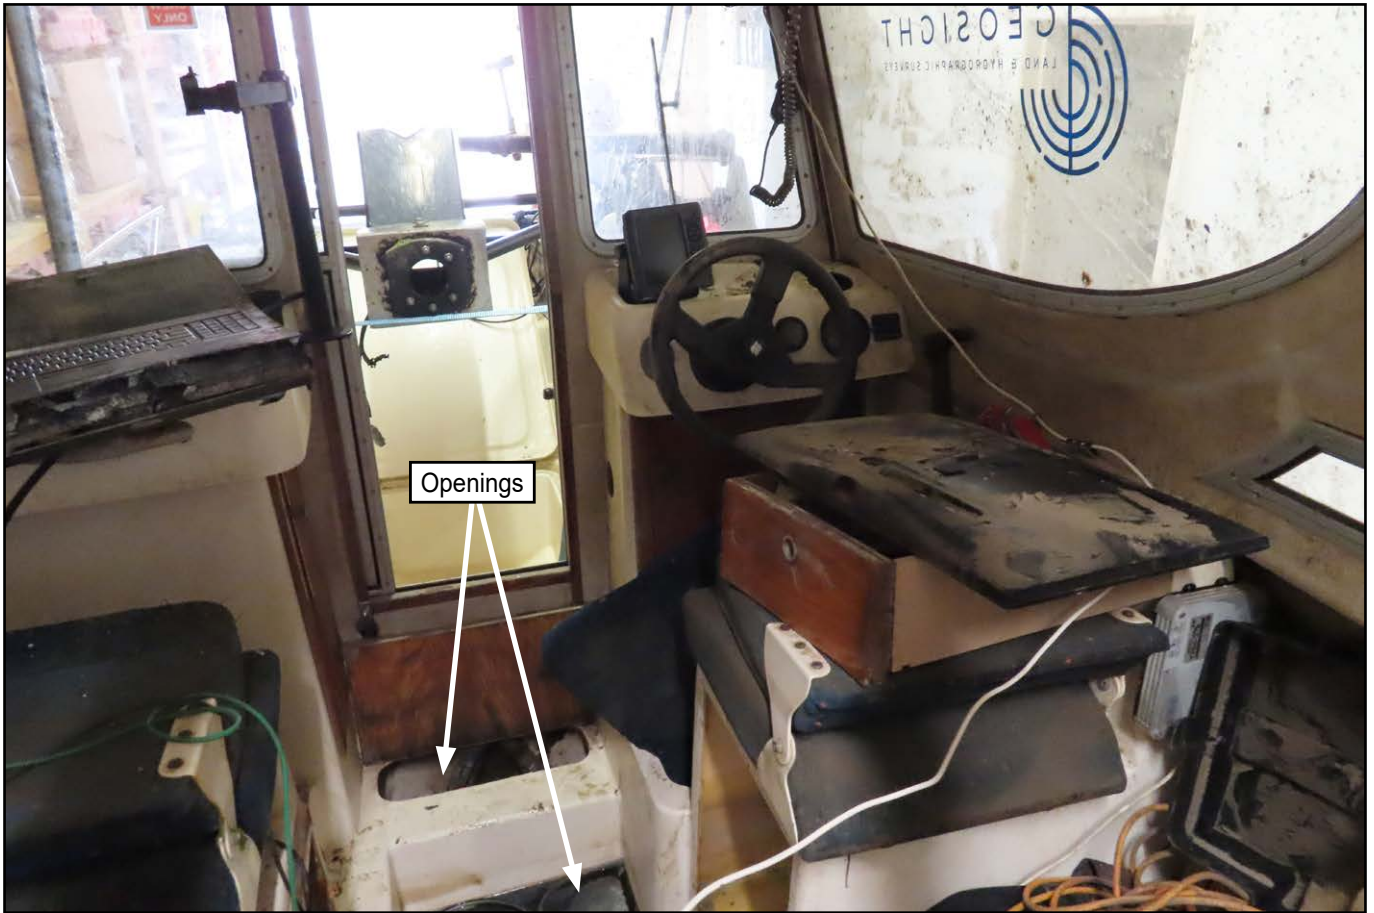
- Openings in the deck of *Bella*'s wheelhouse did not have watertight covers and so allowed water into the void space between the deck and hull moulding. This meant that the vessel did not have a *continuous watertight weather deck which extends from stem to stern*<sup>13</sup> and, for certification, *Bella* should not have been considered a decked vessel (**Figure 4**).

**Figure 4:** Bella's wheelhouse, showing openings into the void between the deck and hull mouldings

When the SMH surveyor certified *Bella* for commercial operations, he used the vessel's RCD information as evidence that it was a decked vessel, which complied with the construction and stability standards of The Workboat Code. In contrast, the MAIB's post-accident inspection concluded that *Bella* did not have a continuous watertight weatherdeck and so should have been surveyed and inspected as an open boat.

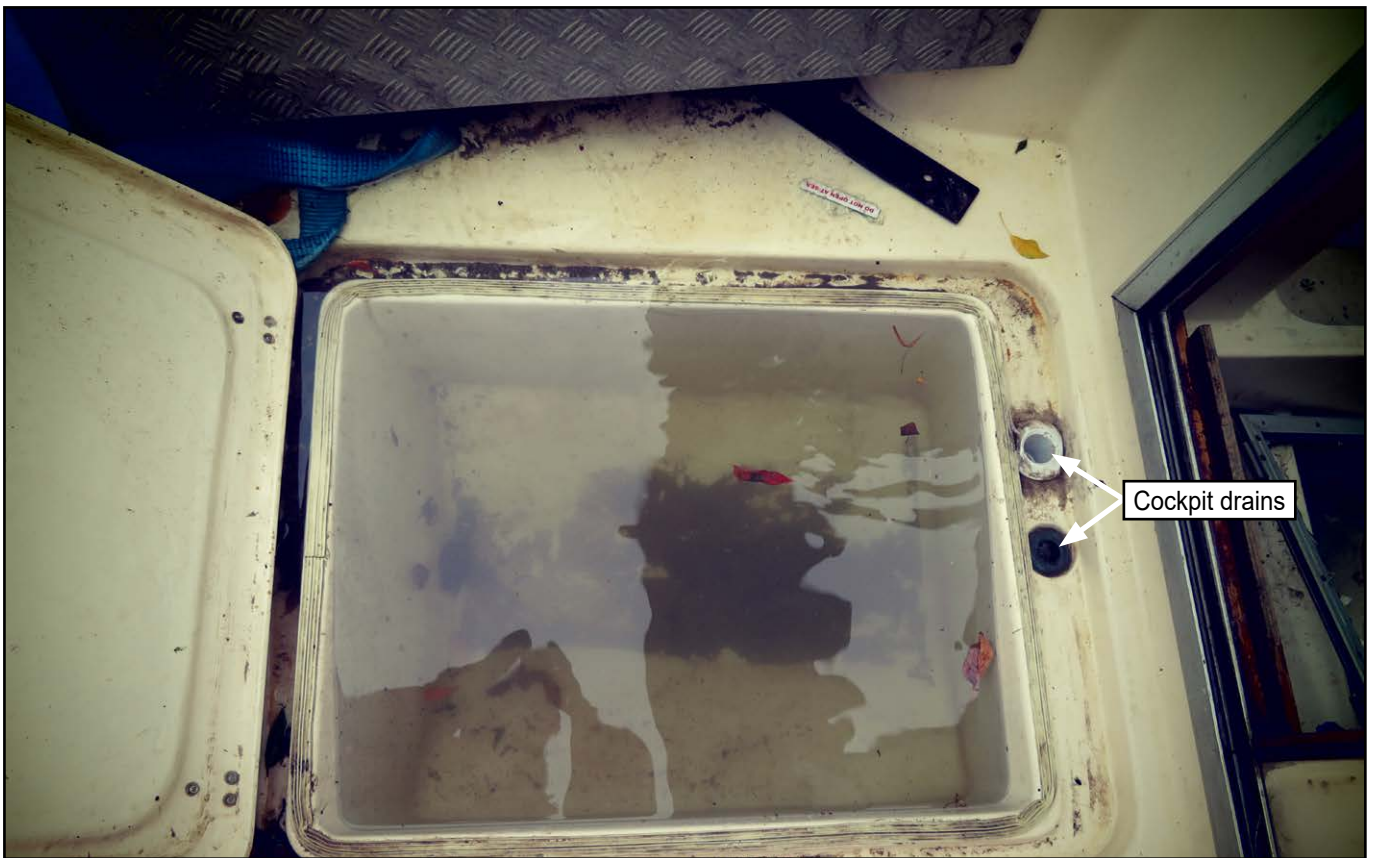
- *Bella* did not have the necessary means of flotation required by an open boat to withstand swamping.
- *Bella*'s forward and aft cockpit sole lockers were not watertight. The forward locker had no means of drainage and it was estimated that it would hold approximately 120kg of seawater when flooded (**Figure 5**). Flooding of the aft locker, which contained *Bella*'s electrical batteries, would lead to failure of the vessel's electric bilge pump, engine start, lighting and radio.
- The RCD certificate supplied by the owner could not be linked to *Bella* because the form's hull identification number had been left blank and the certificate was dated 17 years after *Bella* had been manufactured.
- The RCD information accompanying *Bella* provided insufficient detail to confirm that the vessel met the construction and structural strength requirements of The Workboat Code.

**Figure 5:** Forward sole locker full of water, and cockpit drains

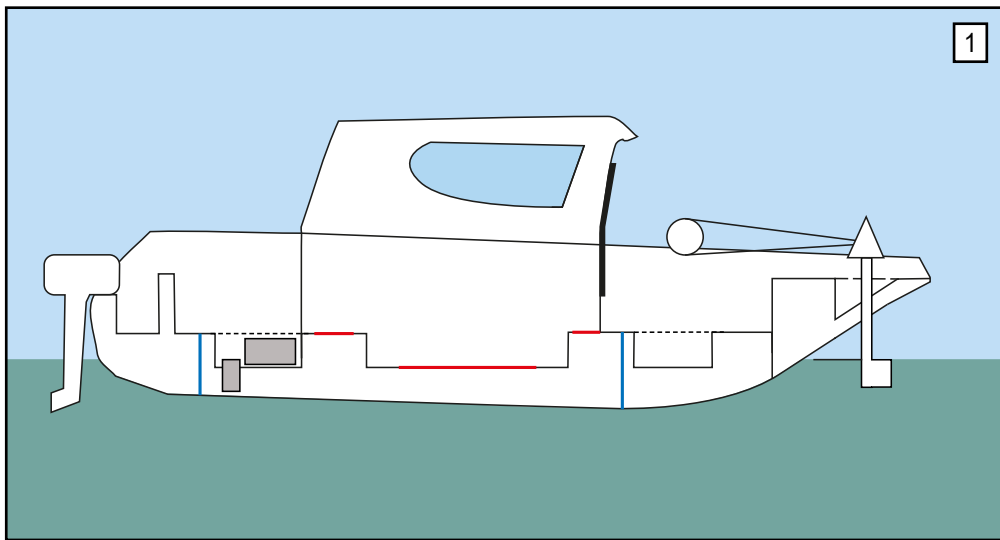
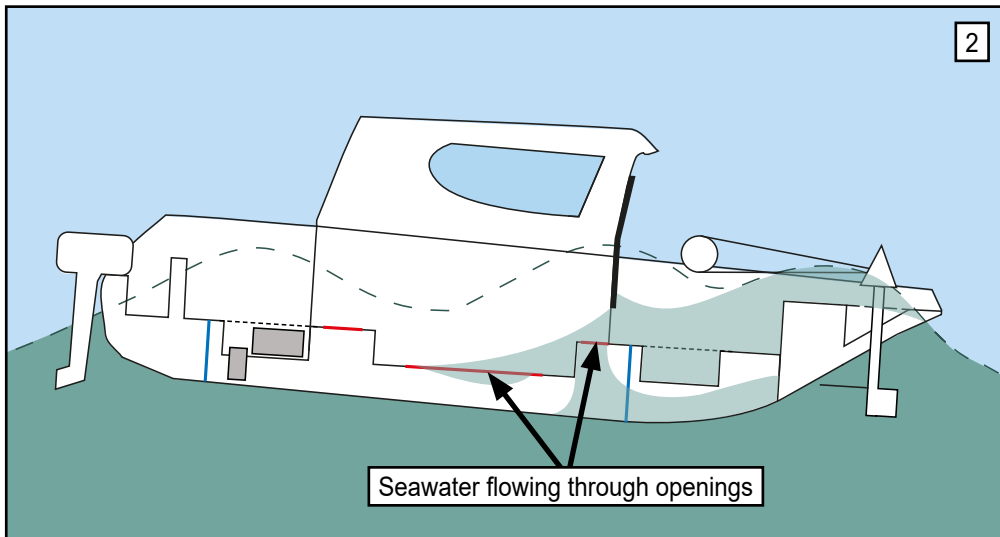
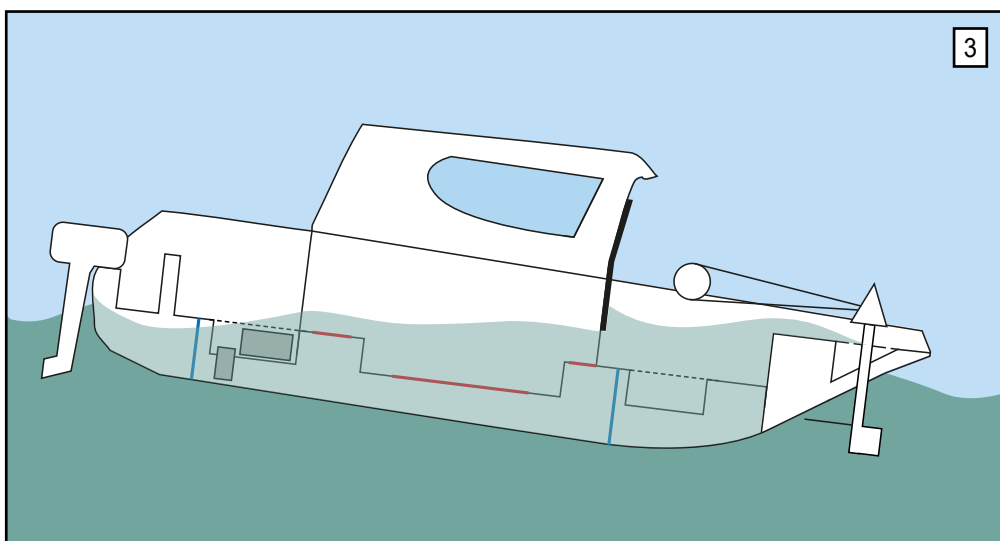
**Figure 6:** Sequence of *Bella* sinking

In 2016, *Bella* had been fitted with an MBES system to enable it to conduct hydrographic surveys. This modification added weight to the bow and reduced its forward freeboard. As *Bella* headed at slow speed into sea, waves were able to break over the bow and flood its forward cockpit. Seawater then filled the forward sole locker, adding additional weight forward, further reducing its freeboard and increasing the flooding. Once the floodwater had reached the height of the forward door sill, it started to flood the wheelhouse and drain down into the void space through the openings in the wheelhouse deck (**Figure 6**).

Gantry lowered

Seawater flowing through openings

Waves break over bow and flood forward cockpit and sole locker. Seawater flows over door sill and enters wheelhouse, flooding void space between deck and hull moulding

Vessel swamps and begins to sink
