MIR-22/21

Sinking of Commercial Fishing Vessel *Emmy Rose*

Atlantic Ocean

November 23, 2020

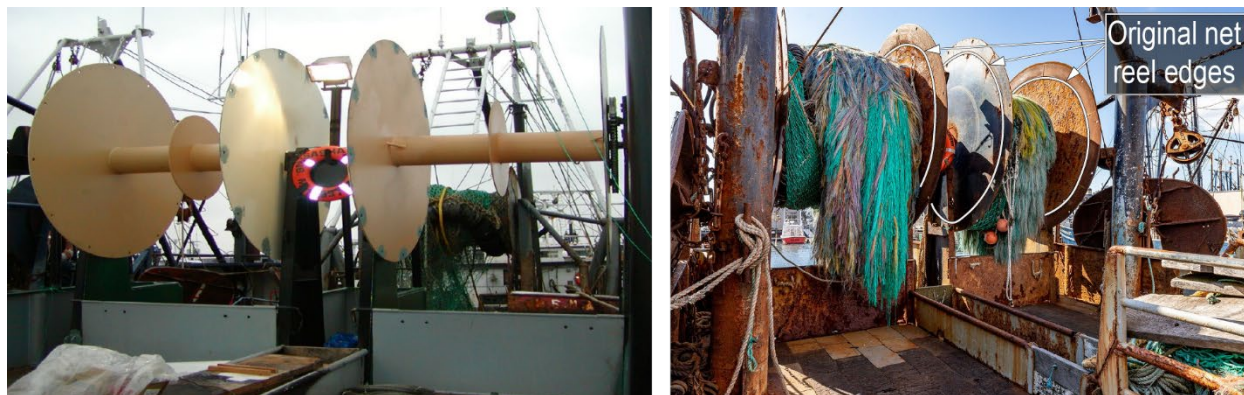
With the change in location and fishery, the *Sasha Lee* was modified to a stern trawling vessel to accommodate the regional fishery. Two 7-foot-diameter steel net drums and mounting frames were added to the stern of the vessel (drums shown in figure 6). The port and starboard walkways were closed off and the bulwarks were extended to provide the crew with protection from the elements on the aft deck. Over the next several years, other changes were made to the vessel: the diameter of the net reels was increased to allow for larger nets, an additional cargo boom was added, two storage bins filled with fishing gear were added on the top deck, and additional fishing and rigging gear was stored aboard the vessel on the working deck. There were no records of whether any of the changes altered the vessel’s lightweight displacement or the position of its vertical center of gravity (see [Appendix C](#) for principles of stability).

Figure 6. *Sasha Lee* net reels in 2001 (*left*) and 2019 (*right*). (Background sources: Farrell and Norton Naval Architects [*left*] and Blue Harvest Fisheries [*right*])

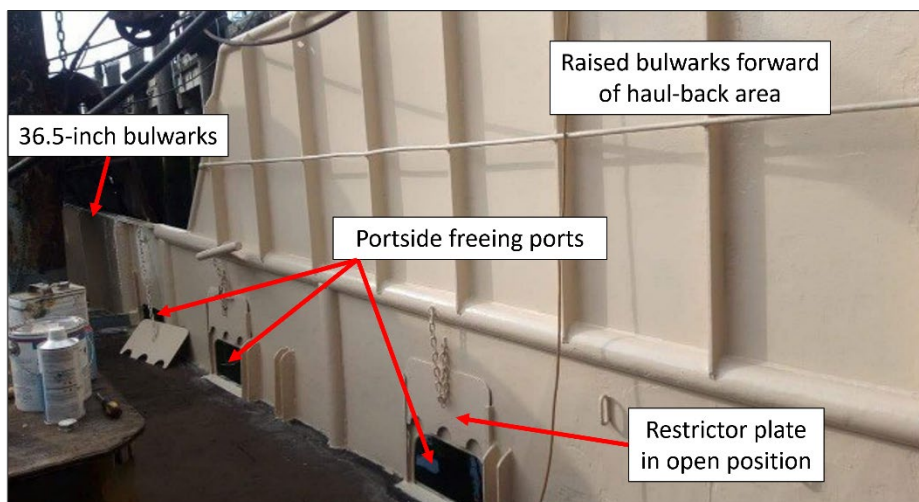
The aft portion of the working deck had 36.5-inch-high steel bulwarks. On each side of the vessel, the bulwarks were fitted with five freeing ports, each measuring 10 inches by 20 inches. A freeing port is any direct opening through a vessel's bulwarks or hull designed to quickly drain water that has accumulated on exposed decks overboard. Each freeing port had a restrictor plate that was held up in the open position by a chain. The restrictor plate could be lowered to block off the opening to prevent catch from going over the side of the vessel during landing and loading. Each restrictor plate contained three half-circle cutouts to allow limited water to drain when in the closed position (see figure 9). There were two freeing ports in the forward portion of the vessel, one on each side below the wheelhouse doors.

Figure 9. Freeing ports on portside bulwarks. (Background source: Boat Aaron & Melissa)

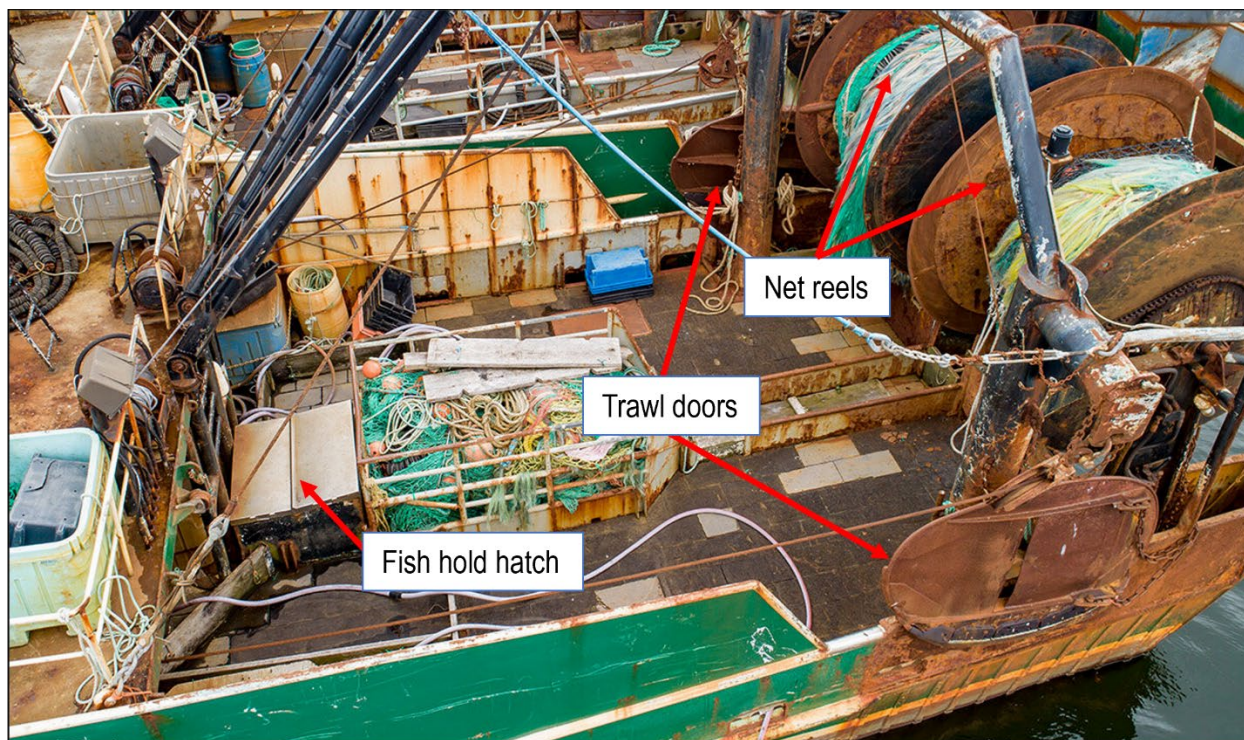
Figure 10. Aft working deck of *Sasha Lee* in 2019 before its purchase by Boat Aaron & Melissa. The storm gates are beneath the net reels and cannot be seen in the photo. (Background source: Blue Harvest Fisheries)

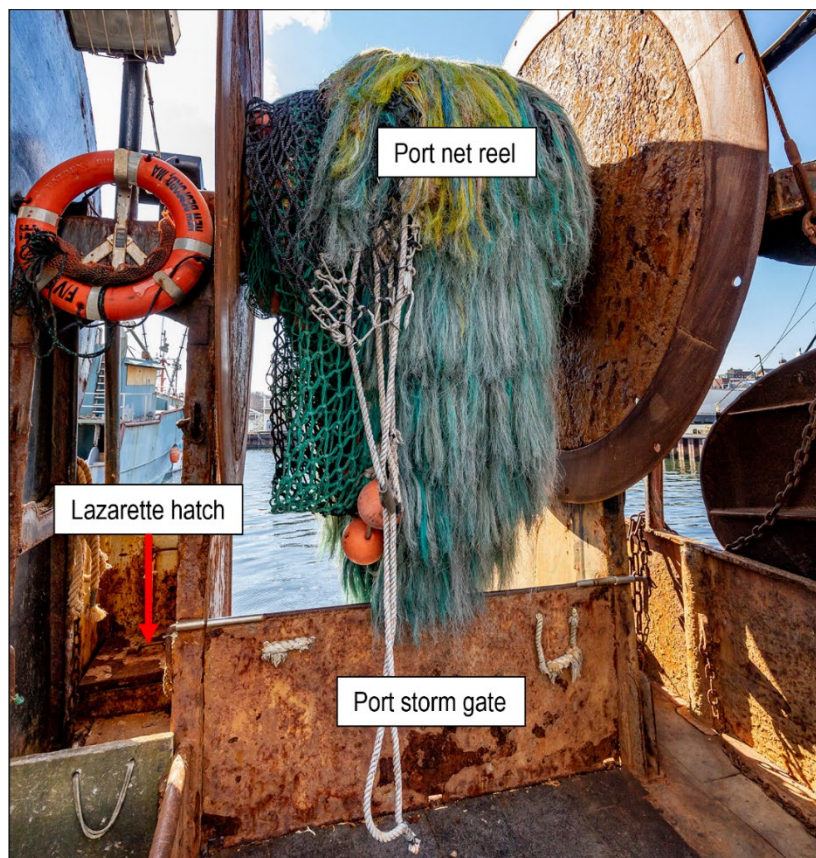
The lazarette was the farthest aft compartment and contained the rudder post and steering rams, a high-water bilge alarm, and a bilge suction. The lazarette was accessed through a 24-inch-by-24-inch hatch (see figure 11). The hatch had a 6-inch raised steel coaming and a nonwatertight steel cover, which, according to the vessel manager, did not have dogs or latches to secure it.

Figure 11. Port net reel, storm gate, and lazarette hatch of *Sasha Lee* in 2019 before its purchase by Boat Aaron & Melissa. (Background source: Blue Harvest Fisheries)

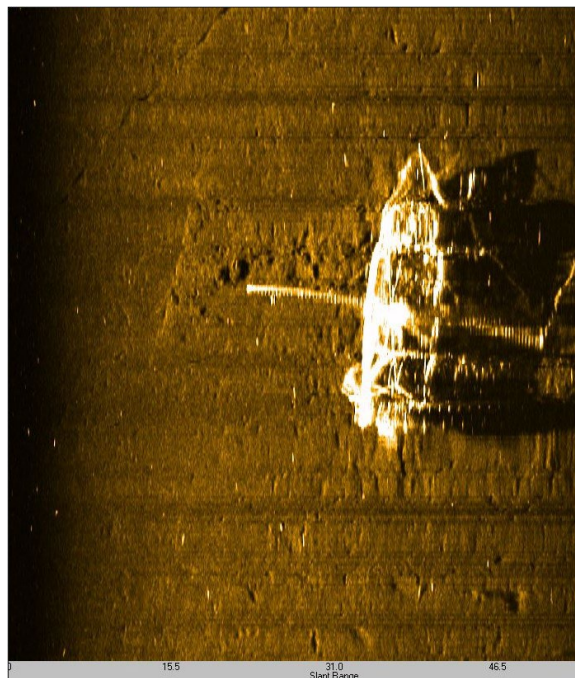
The survey report stated that the *Emmy Rose* was found "sitting upright on the seafloor with the bow oriented at 135° (southeast direction) and both outriggers fully deployed" (see figure 15). The side scan images did not detect any debris field on the seafloor near the sunken vessel. Additionally, the report stated that there was "no visible damage to *Emmy Rose* evident as the mast, wire rigging, and superstructure features all appeared to be intact. The ladders on both port and starboard outriggers were visible in the sonar imagery." Sonar images indicated that both paravanes were deployed from the outriggers. Based on interpretation of imagery, MIND Technologies specialists believed that about 203 feet of cable had been deployed from the port outrigger, and the paravane was that distance ahead of the vessel. The position of both paravanes leading forward of the vessel indicated to the specialists that "the stern sunk to the seafloor before the bow at least just before the vessel made contact with the seafloor."

Figure 15. Side scan sonar image of *Emmy Rose* from 246 feet above at 600 kilohertz. (Source: MIND Technologies)

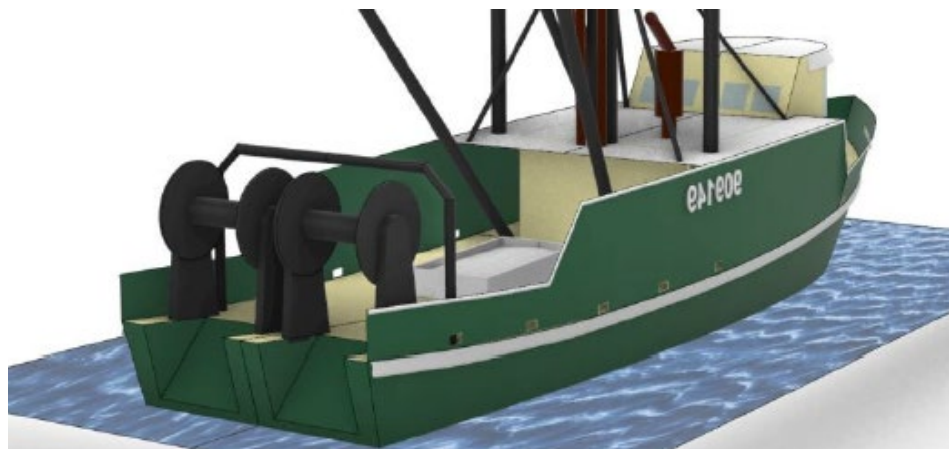
causing water to collect on the aft working deck (see figure 17). The NTSB concludes that the *Emmy Rose's* course toward Gloucester to offload its catch subjected the vessel to quartering winds and seas that likely resulted in the accumulation of seawater on the aft working deck.

Figure 17. MSC model of *Emmy Rose's* starboard quarter showing aft bulwarks and stern ramps (storm gates not shown). (Source: MSC)
