NATIONAL TRANSPORTATION SAFETY BOARD

2021

SAFER SEAS Digest

Lessons Learned from
Marine Investigations

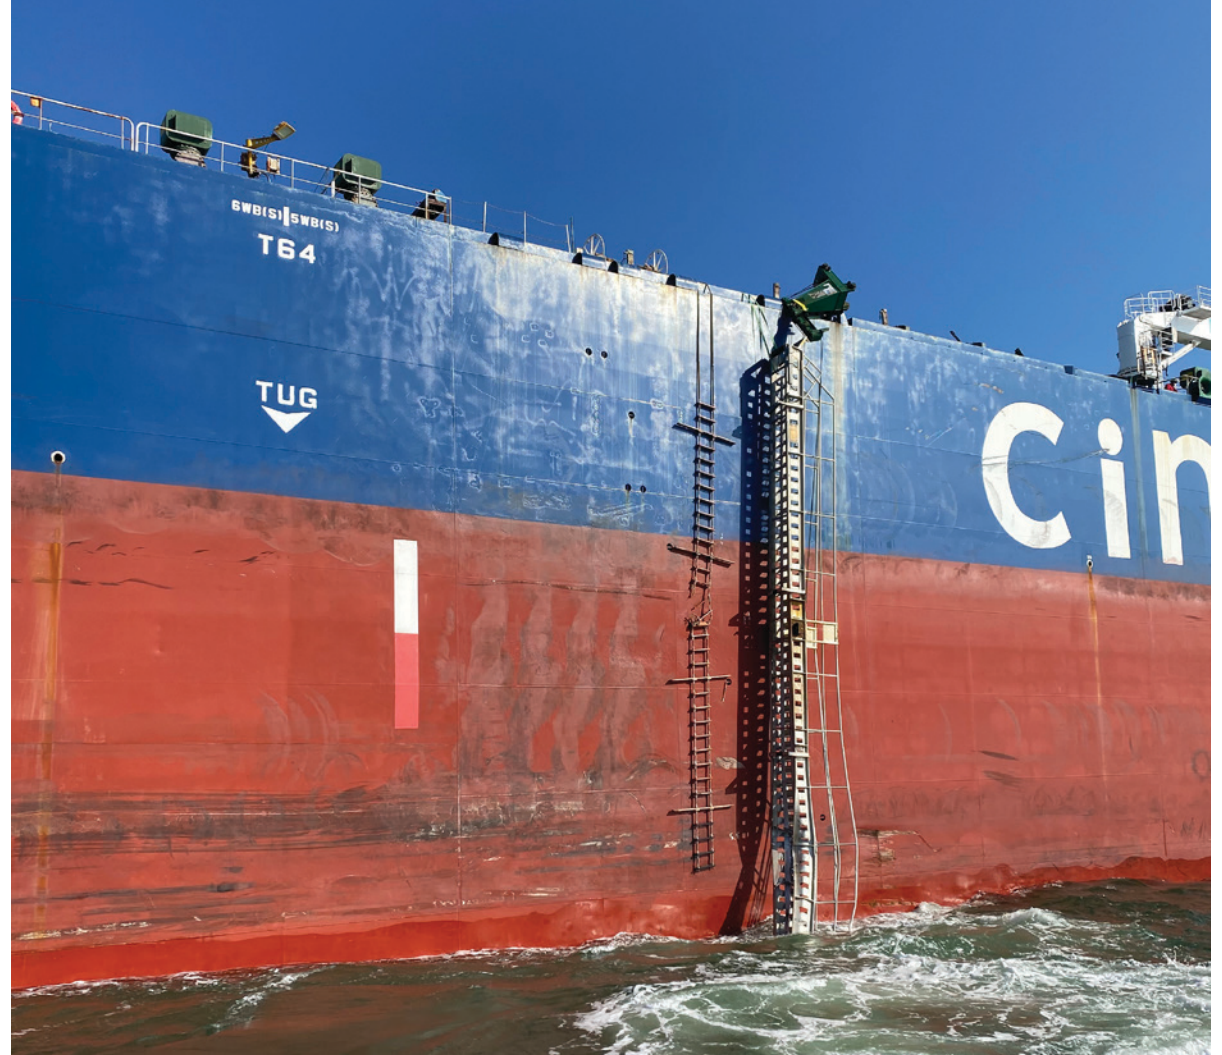
Figure 45. The *Atina*'s damaged accommodation ladder. SOURCE: COAST GUARD

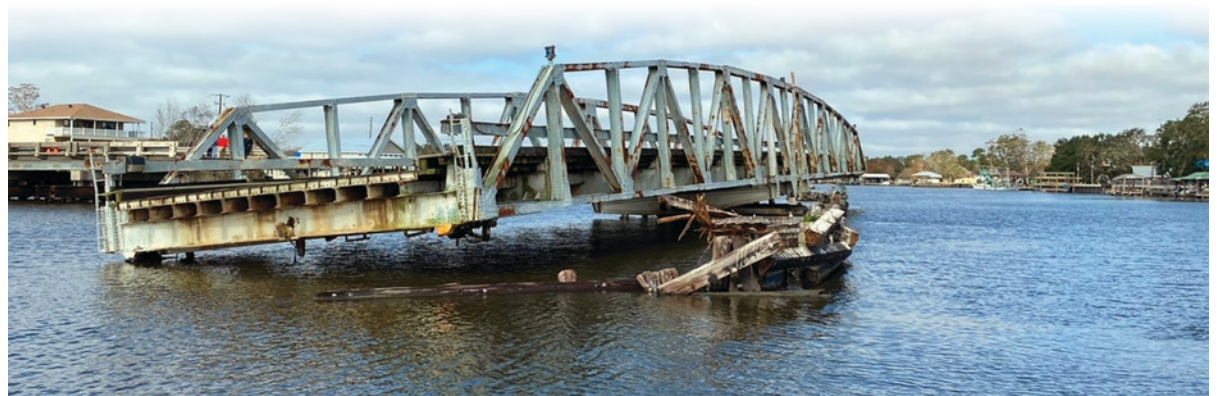
Figure 82. Postaccident damage to Barataria Bridge looking north. SOURCE: ANONYMOUS

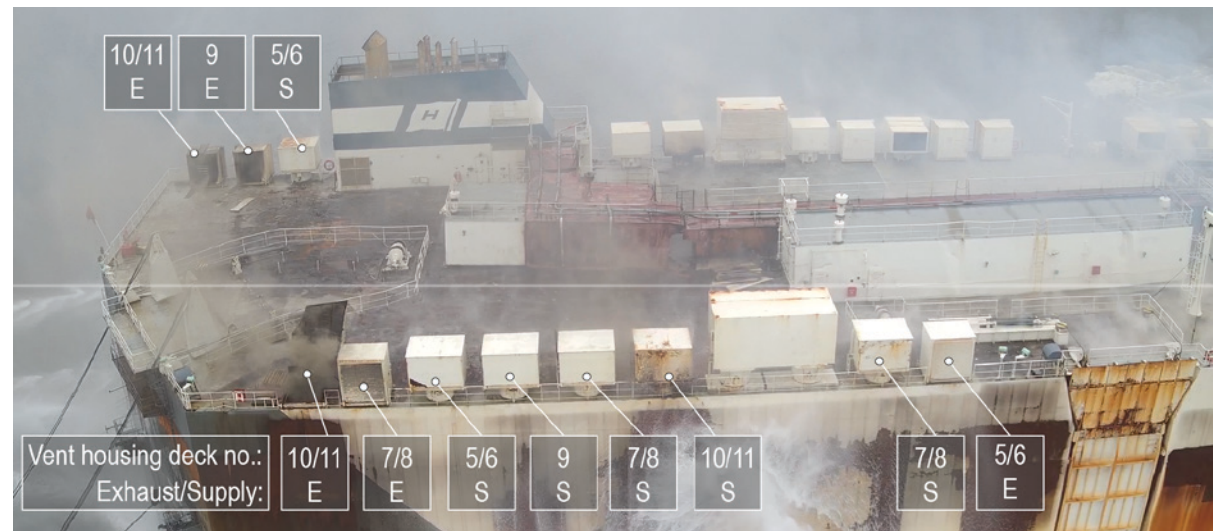
Figure 99. Damaged aft ventilation housings after the reported explosion of portside vent housing for deck 9 (9E in the photo). BACKGROUND SOURCE: JACKSONVILLE FIRE AND RESCUE DEPARTMENT

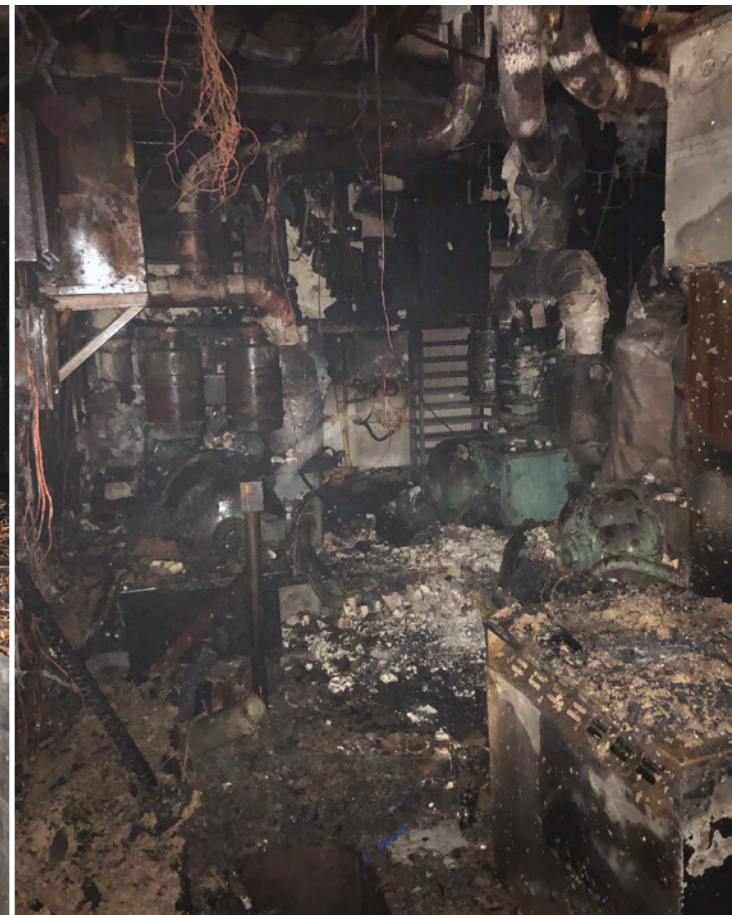
Figure 106. Fire damage to living quarters (left) and generator room (right). SOURCE: COAST GUARD

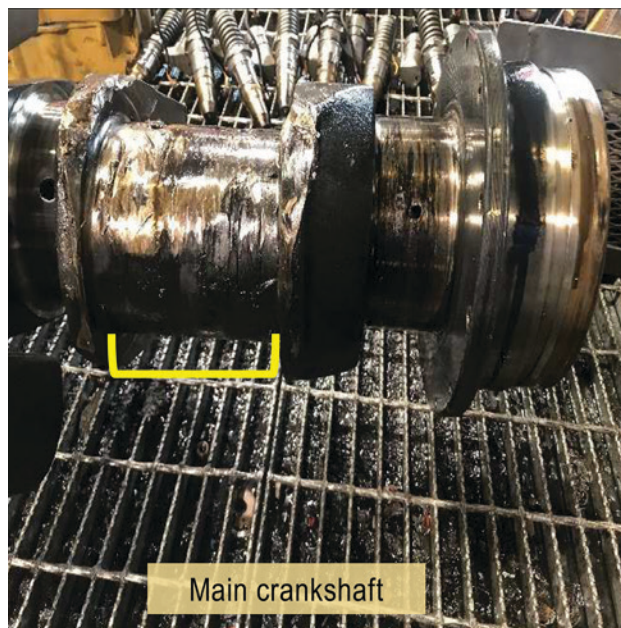
Figure 117. The yellow bracket identifies the damaged area of the main crankshaft of the no. 3 DG (left), where the no. 1 connecting rod bearing failed (right). SOURCE: OCEANEERING INTERNATIONAL, INC.
