# IIMS 2022 Safety & Loss Prevention Briefings Compendium

EDITION II

A COLLECTION OF WORLDWIDE MARINE INCIDENT AND  
ACCIDENT REPORTS, LOSS PREVENTION BRIEFINGS  
AND CASE STUDIES PUBLISHED IN 2022

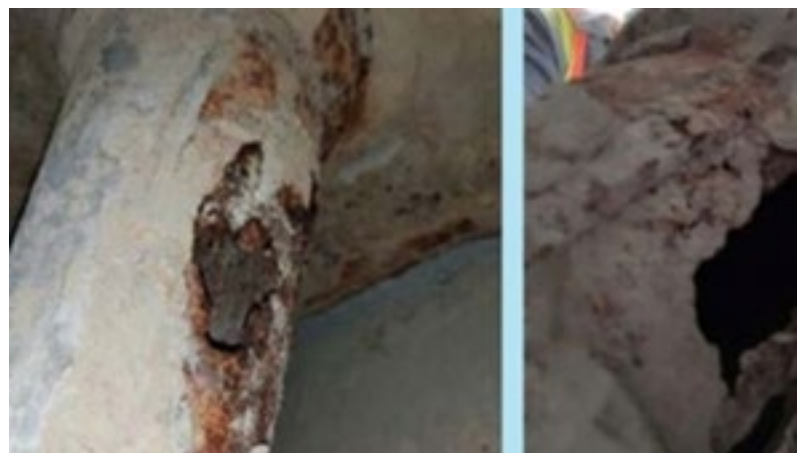
Several fuel oil vent pipes were found to have been holed by severe corrosion while others were so severely corroded and at risk of failure. The holes were found in locations that were not easily accessible. Analysis of fuel oil in the bunker tanks confirmed contamination from the cargo.

- Fuel oil tank vent pipes should be inspected regularly and thoroughly to ensure that: the fuel is not contaminated by cargo; cargo is not contaminated by the fuel or fuel vapors; and fuel vapors do not enter spaces not designed for fuel vapors.
- Particular attention should be paid to fuel oil tank vent pipes that are: vulnerable to damage during cargo operations; or partially hidden or less visible, especially if corrosive or abrasive cargos are to be loaded or have been carried.
- A corroded fuel oil tank vent pipe in one cargo hold should immediately raise concerns about similar vent pipe problems in other cargo holds.

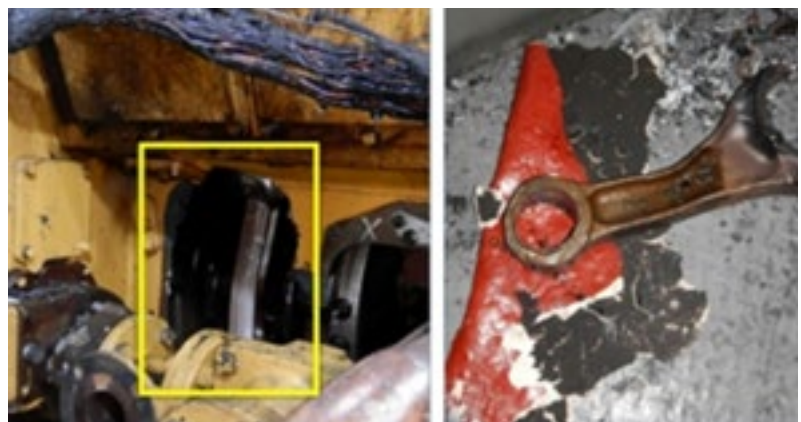
While at an anchorage, the Ocean Intervention crew had been troubleshooting speed variation issues related to the number 1 and number 3 diesel generator engines, which involved replacement and calibration of several electrical components and multiple engine restarts. When later carrying the vessel's electrical load, the number 3 diesel generator suffered catastrophic mechanical failure. The NTSB said this resulted in cylinder number 1's connecting rod being ejected through the engine crankcase while running at rated speed. The ejection of the connecting rod allowed atomized oil to be released from the engine and ignite, starting a fire in the engine room. The crew's quick and effective actions to prevent the spread of the fire resulted in the fire extinguishing itself without putting crewmembers at risk.

*Damaged section of the engine (left) from where the connecting rod from the no. 3 DG (right) was ejected. (Credit: Oceaneering International).*

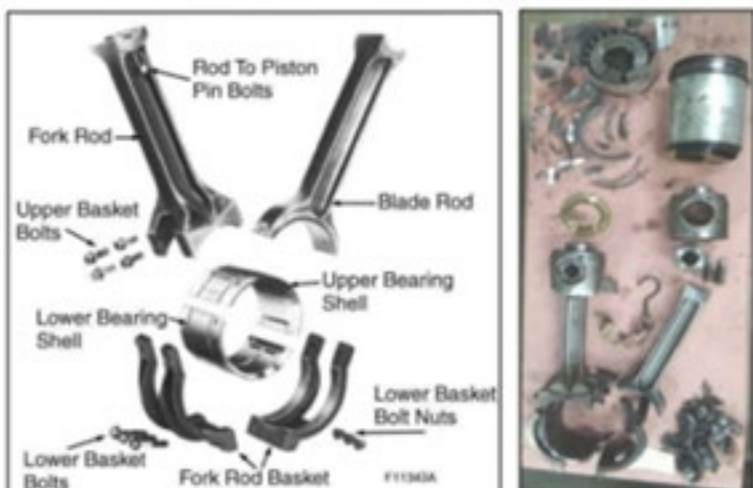
Left: EMD 710 cylinder arrangement showing the affected area in red. Center: EMD 710 connecting rod arrangement. (Photo credit: Dynamark Engineering)

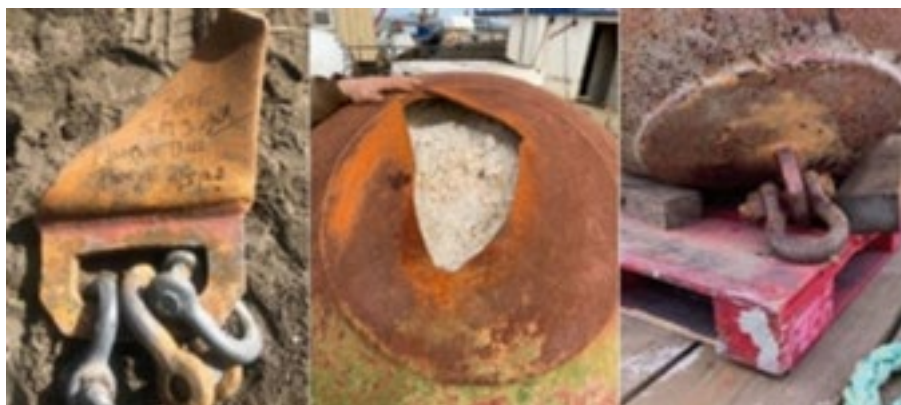
The fatigue failure of an unrated mooring buoy led to the grounding of a fishing tender during a storm near Bristol Bay, Alaska in 2020, according to the National Transportation Safety Board (NTSB).

SM-3 mooring buoy: failed padeye (with three shackles) that separated from buoy (left), damaged top with padeye missing (center), and undamaged bottom padeye (right). (Source: Alaska Marine Surveyors and Northline Seafoods).

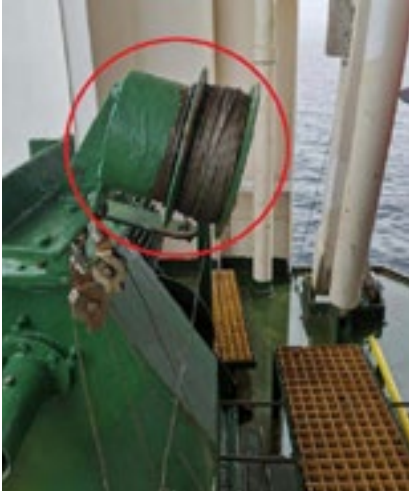
Brake release wire drum overpainted

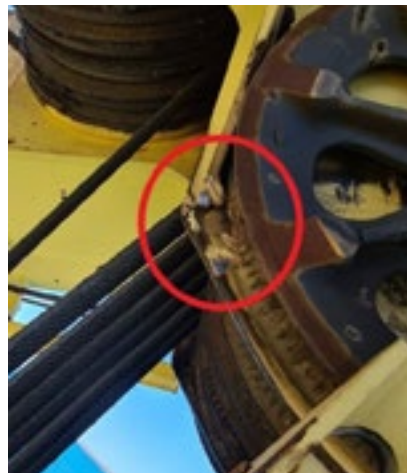
Damaged sheave

- The damaged sheave was reshaped. Thorough examination of the sheave surface and inspection by means of dye penetration testing showed that there were no cracks;
- Ensure close monitoring the crane movements after each order given and when working near any of the crane limits;
- Test alarms after maintenance on the crane;
- After maintenance process/painting check that all equipment parts are still movable and fully operational.

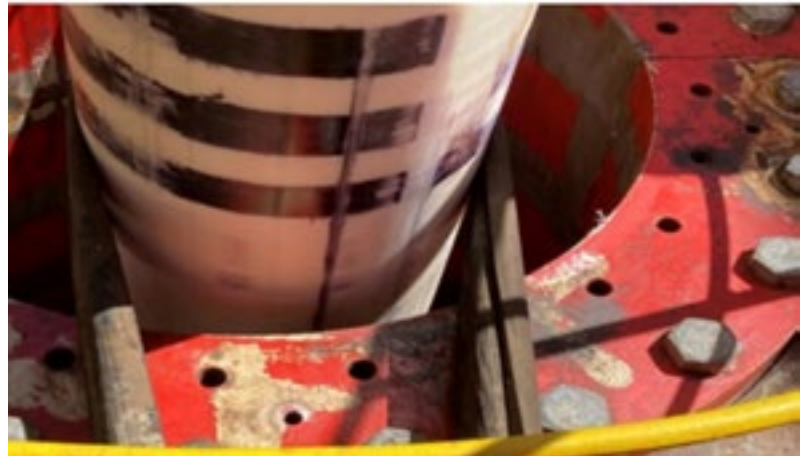
During deployment of a water injection riser from a vessel, damage to the outer coating occurred when it came into contact with the sharp edge of the flare in the moonpool area. A water injection riser was being installed through a project-supplied flare in the moonpool via the vessel's Tiltable Lay System (TLS) at an angle of 6.8°. The flare had been designed to direct and protect the riser at the exit. However, design reviews, subsequent risk assessments and inspections had failed to identify the hazard of the sharp upper lip of the flare with the potential to damage the riser.

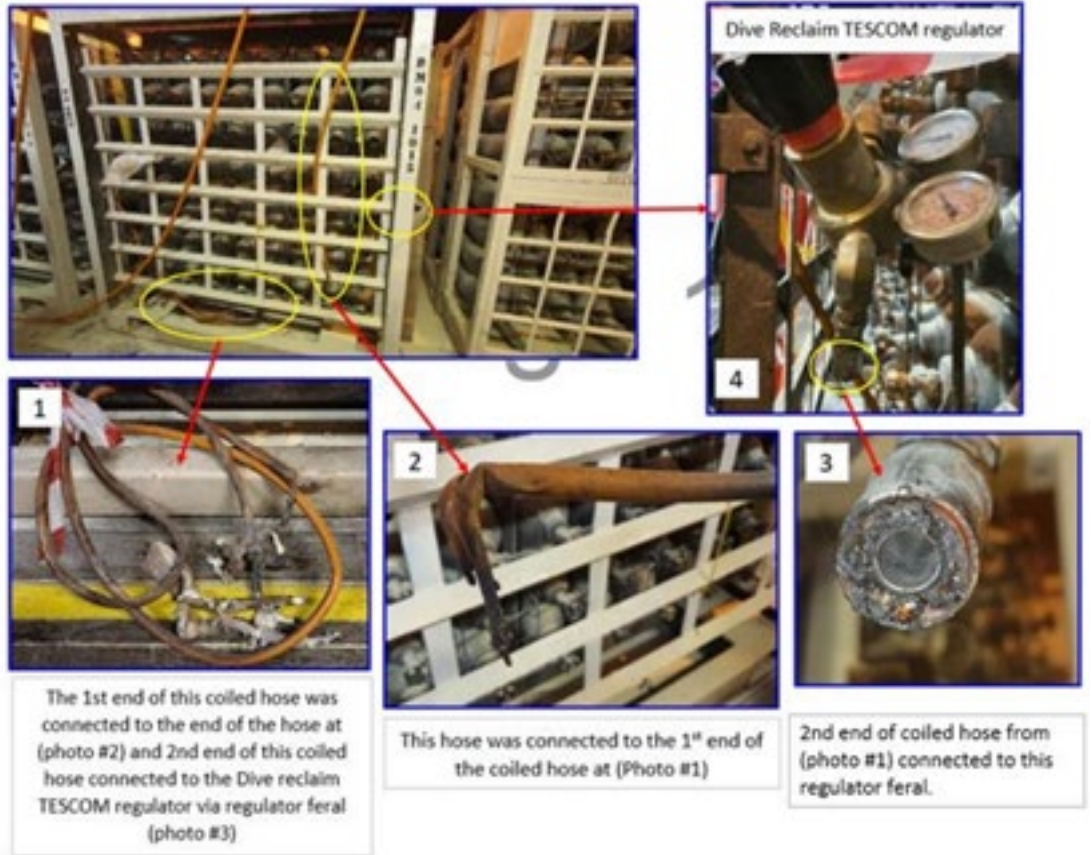
There was a flash fire on an Oxygen hose line onboard a DSV. The incident occurred during routine checks, when an LST (Life Support Technician) reported that the Oxygen supply pressure to dive control was low (25 Bar). SAT control informed Dive Control and agreed that a new Oxygen supply was required. The LST went to the appropriate quad (on the main deck), and started by closing the row of eight bottles of Oxygen before opening a new row. Whilst opening the new row of Oxygen supply bottles the LST heard an unfamiliar noise (a flapping sound from the regulator) and immediately closed the cylinder pillar valve and closed the valve on both regulators (SAT control and reclaim regulator valve) and quickly moved away from the Oxygen quad. The LST immediately returned to SAT control and reported to his supervisor. Shortly afterwards, the Oxygen hose burst followed by an explosion and flash fire at the reclaimed Oxygen hose line.

Investigation showed that the bullnose inlet (connection to the pillar valve) had no filter to stop rust contaminant from the cylinder going into the regulator. Small particles of rust from inside the cylinder accumulated inside the regulator causing high friction after the Oxygen release, resulting in heat and contributing to the spark, explosion and fire.

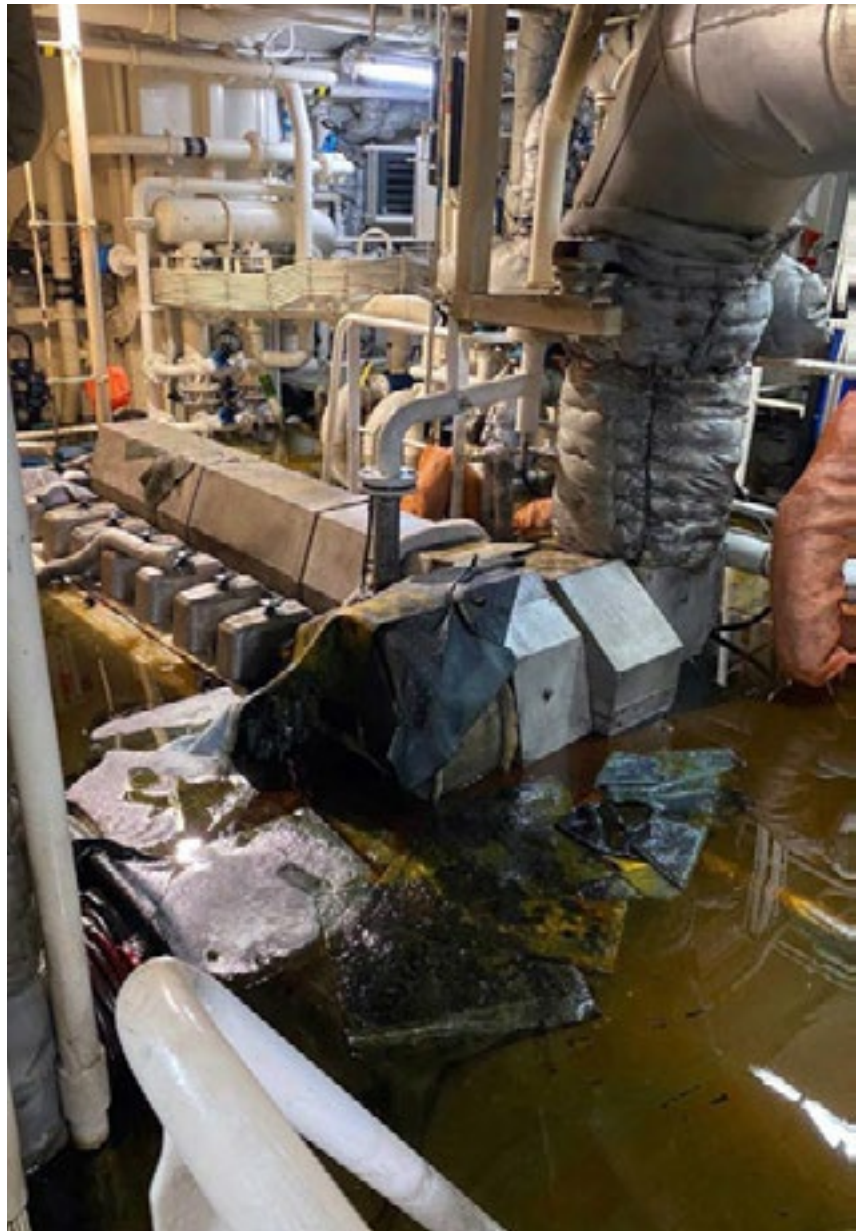
After the accident, a technical investigation identified that the automatic butterfly hull valve was defective, and had remained partially open when indicated as shut on the ballast control panel. This investigation also found that the strainer was clean but that a ballast pump defect had caused the slow ballasting operations. The company has provided a revised safe system of work for strainer cleaning.

Figure 2: The flooded engine room

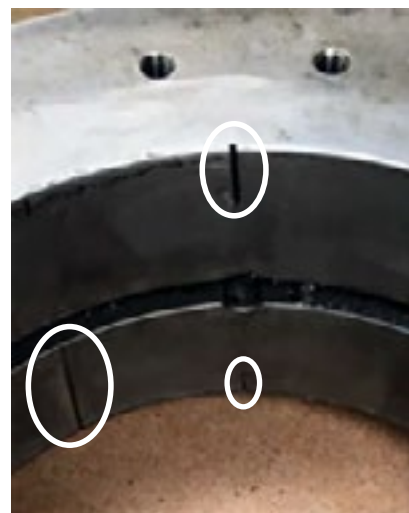
Figure 1: Bearing housing notches from disc cutter

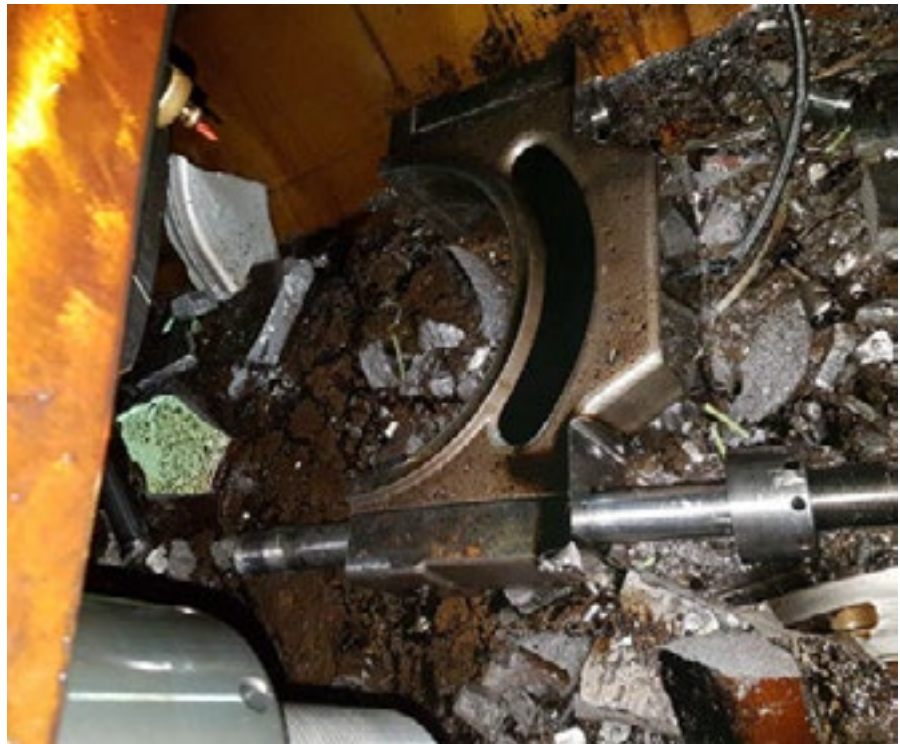
Figure 2: Post-failure engine component debris in sump

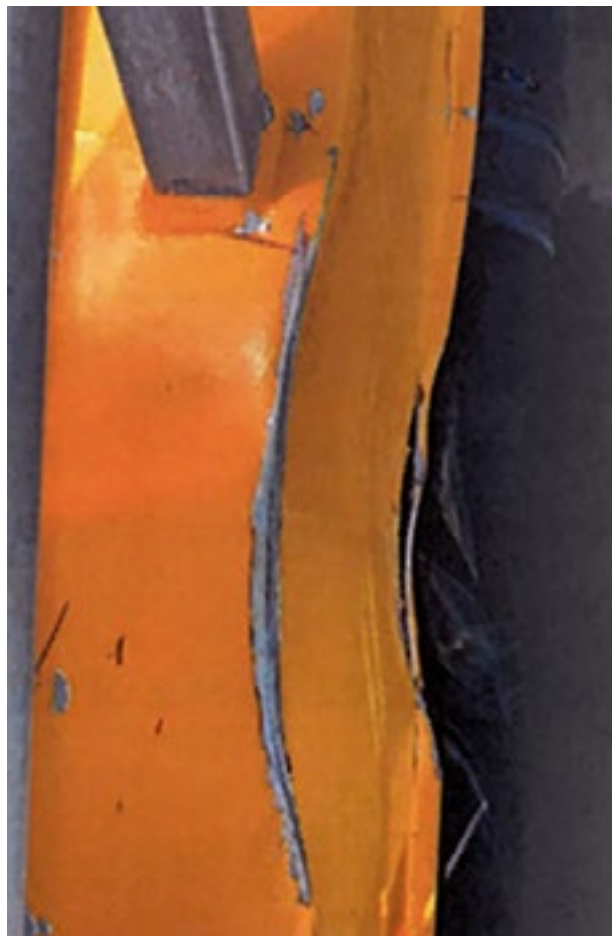
Figure 1: Indentation damage to the passenger transfer vessel's bow area

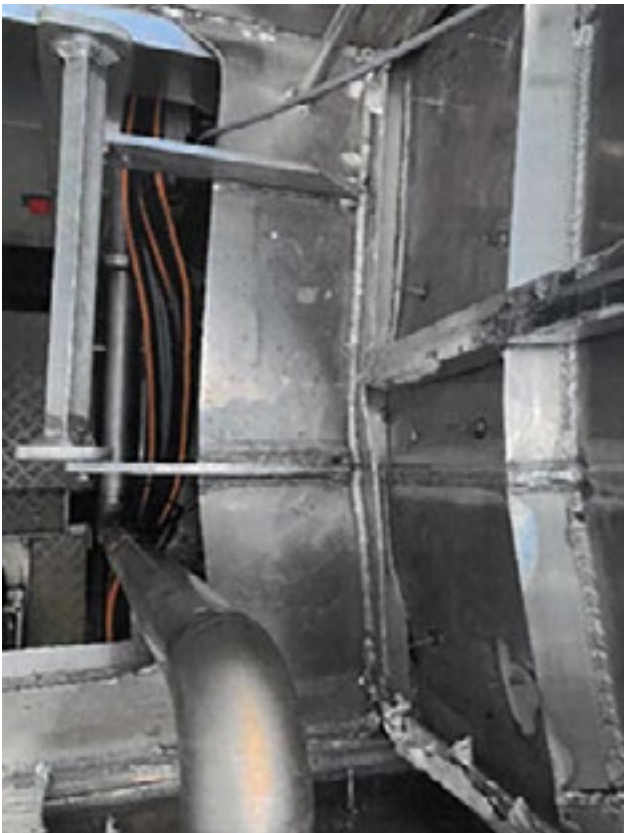
Figure 2: Deformed internal frames

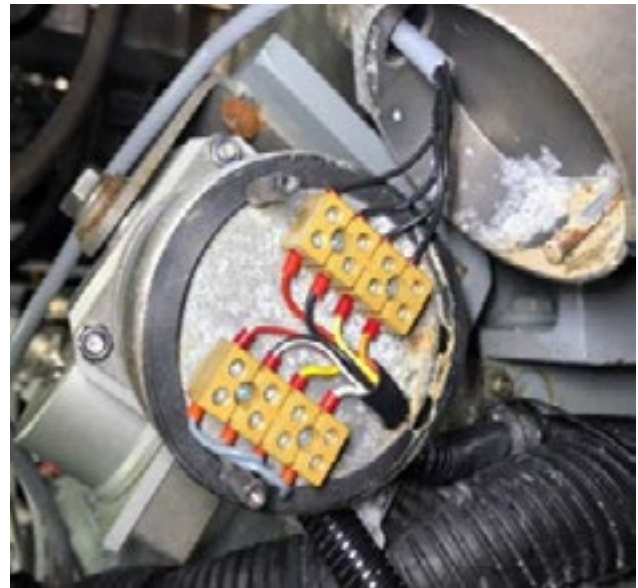
Figure 3: Water ingress damage (unrelated to the propulsion control loss)

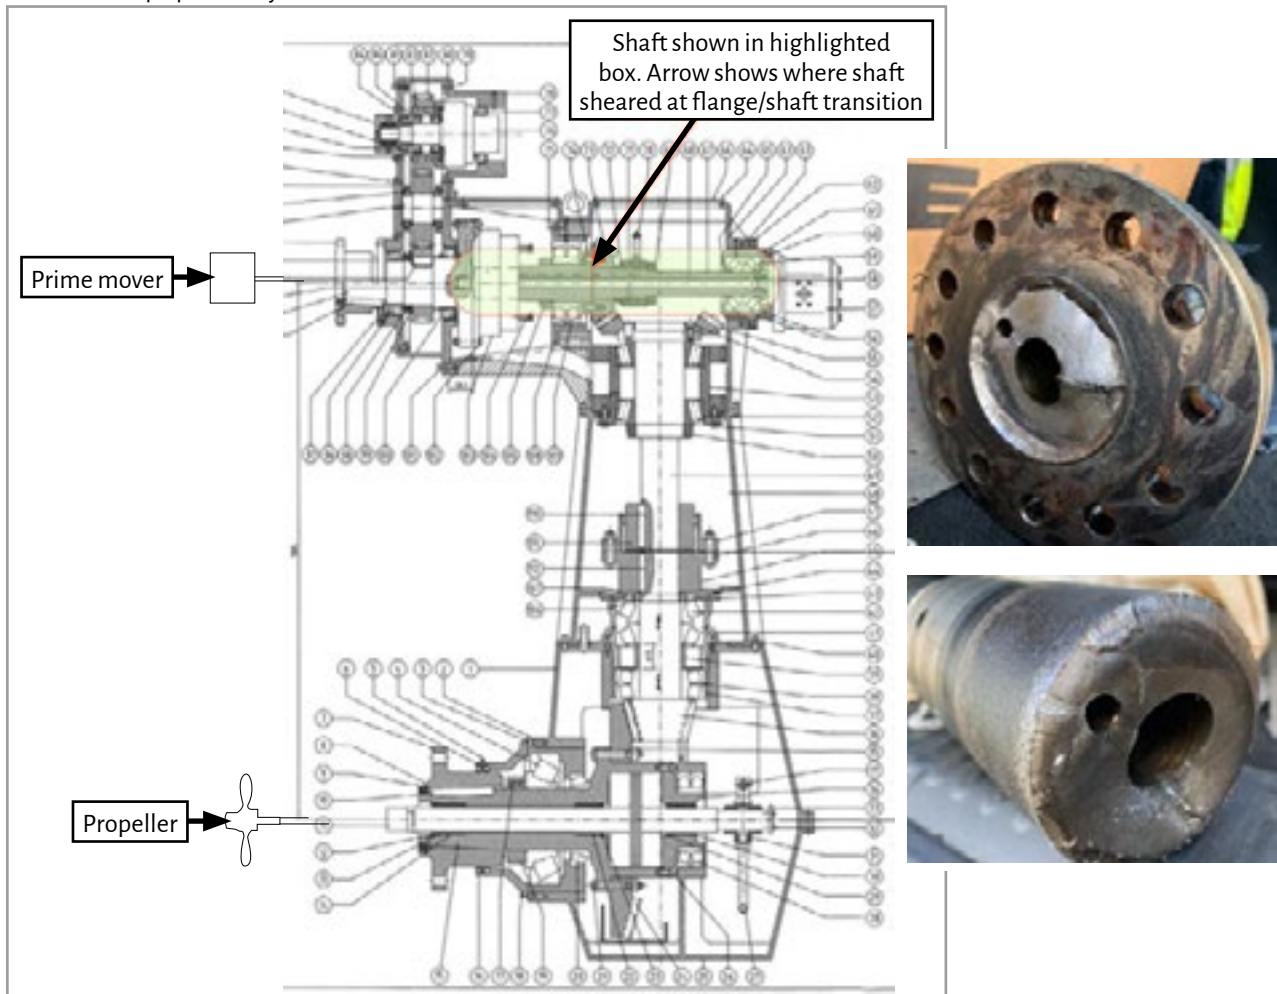
Figure: Gearbox damage and (inset) broken shaft

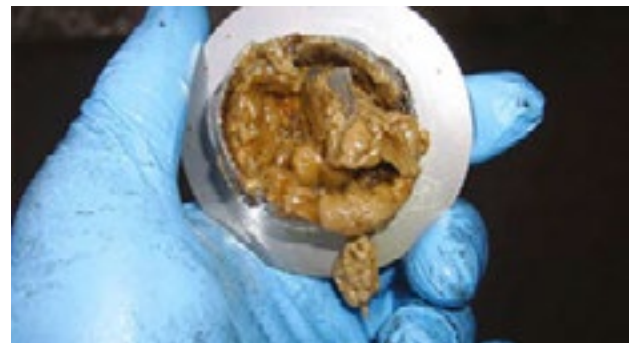
Figure: Fuel filter clogged with diesel bugs

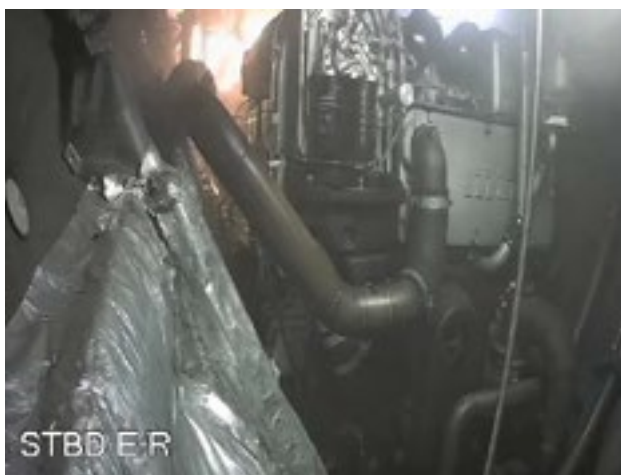
Figure 1: Engine fire seen on the CCTV

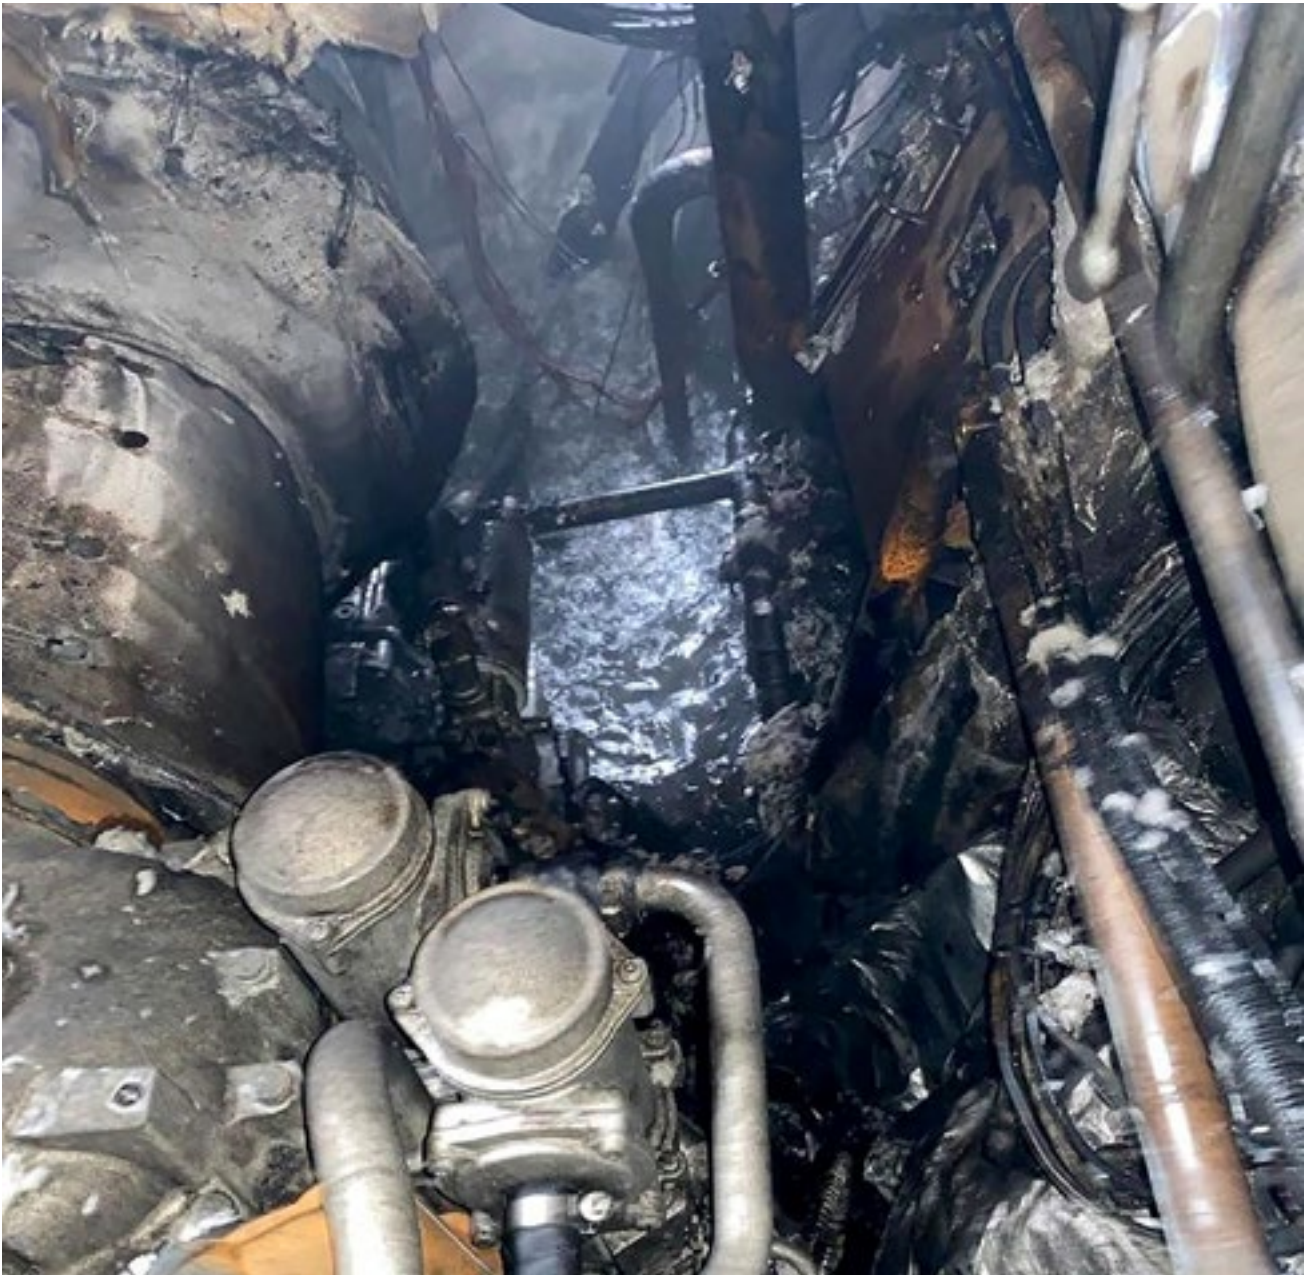
Figure 3: Fire damage in the engine compartment

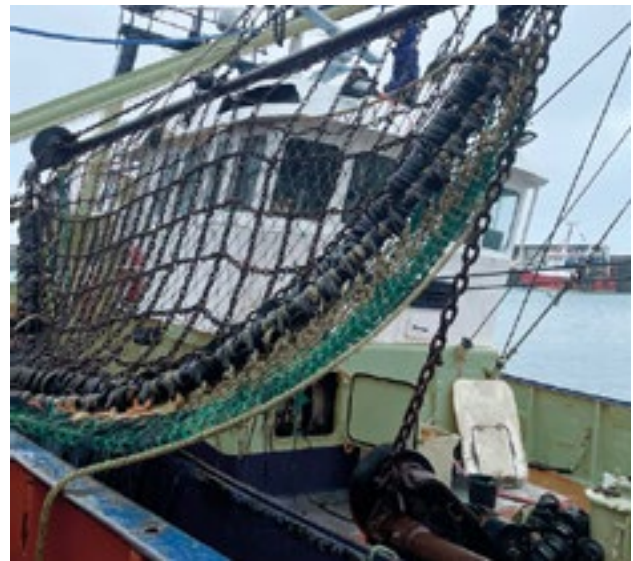
Figure 1: The fallen fishing gear on the outboard fishing vessel

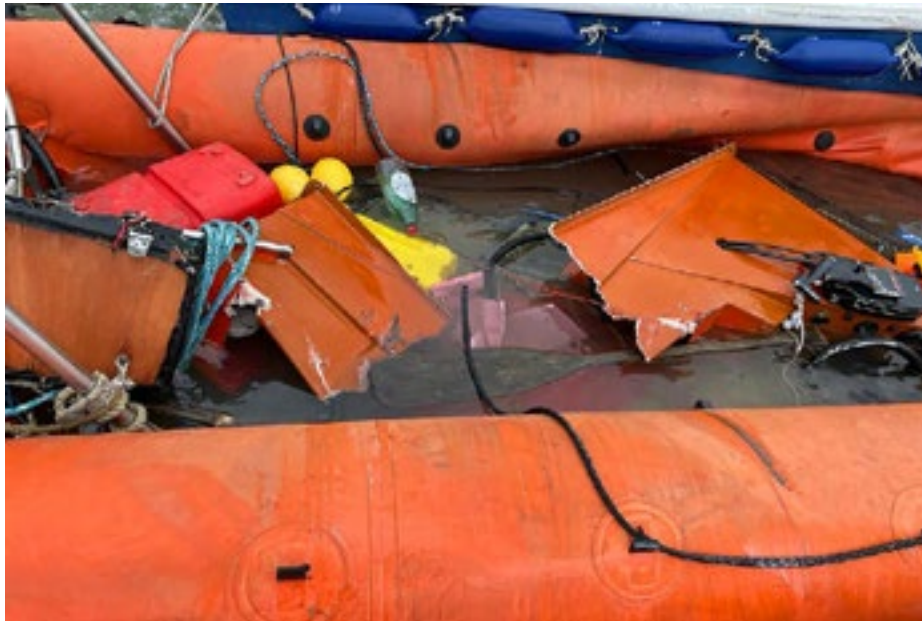
Figure 2: Damage to the unmanned moored tender
