THE SWEDISH CLUB CASEBOOK

Contents & Introduction

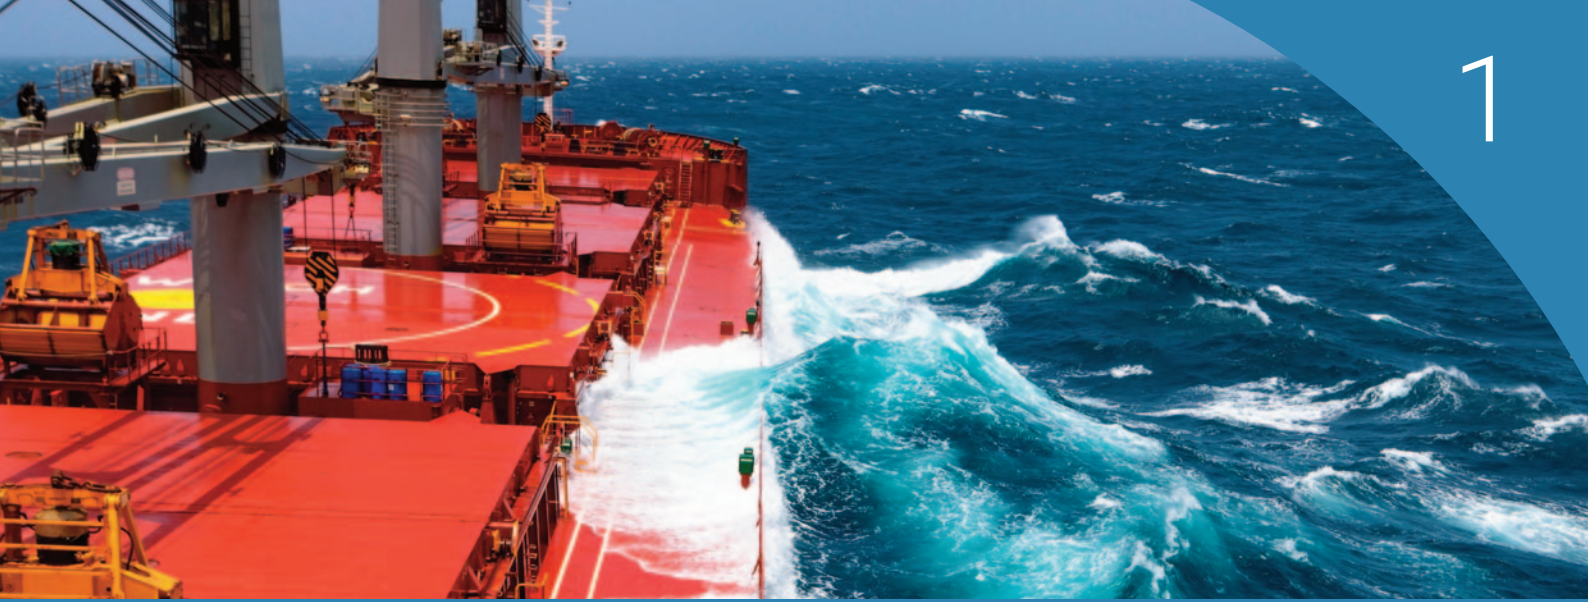
1.2

Crack in the cargo hatch cover caused wet damage

When the weather had calmed down the Master asked the Chief Officer to inspect the cargo holds. The Chief Officer found that water had entered cargo hold 1 and caused wet damage. No water had leaked

into the other holds. The Chief Officer also inspected the hatch coaming and the hatch cover for hold 1, and found a crack on the hatch coaming. The drain pipes for the non-return drain valves were also full of debris and cargo.

During discharge the surveyor found that the sounding pipes for the cargo bilges were also blocked by debris. When the vessel was alongside and the cargo hatch covers were removed, puddles could be seen in hold 1. It took several extra days to get the wet cargo off the vessel and most of the cargo was refused by the buyer.

- The sounding pipes should be clear of any debris or cargo, as they are important for taking soundings before loading and during the voyage.
- It is important to be aware that zinc concentrate may liquefy if shipped with a moisture content in excess of its transportable moisture limit (TML) as per the IMSBC code. Puddles of water will obviously exceed the TML.

- It should be a PMS job to check that the drainpipes and drain valves are not clogged and that the float (ball inside) moves freely.
- Hatch covers, and coaming steel structures are heavily loaded elements. Their condition has a direct effect on the load carrying capacity and the safety of the vessel. The steel construction should always be inspected after an unusual loading case, and there should also be regular checks as per the PMS.

- When repairs are carried out, only steel approved by the classification society should be used. High tensile steel is commonly used for cargo hatches and coamings.

- The classification society should be contacted before making any structural steel repairs.
- Weather routing should be considered as it provides the vessel with the option of avoiding heavy weather, but also ensures that vessels are provided with a new and updated ETA to the discharge port. This helps the crew on board the vessel, shoreside personnel, and cargo owners, to plan accordingly.

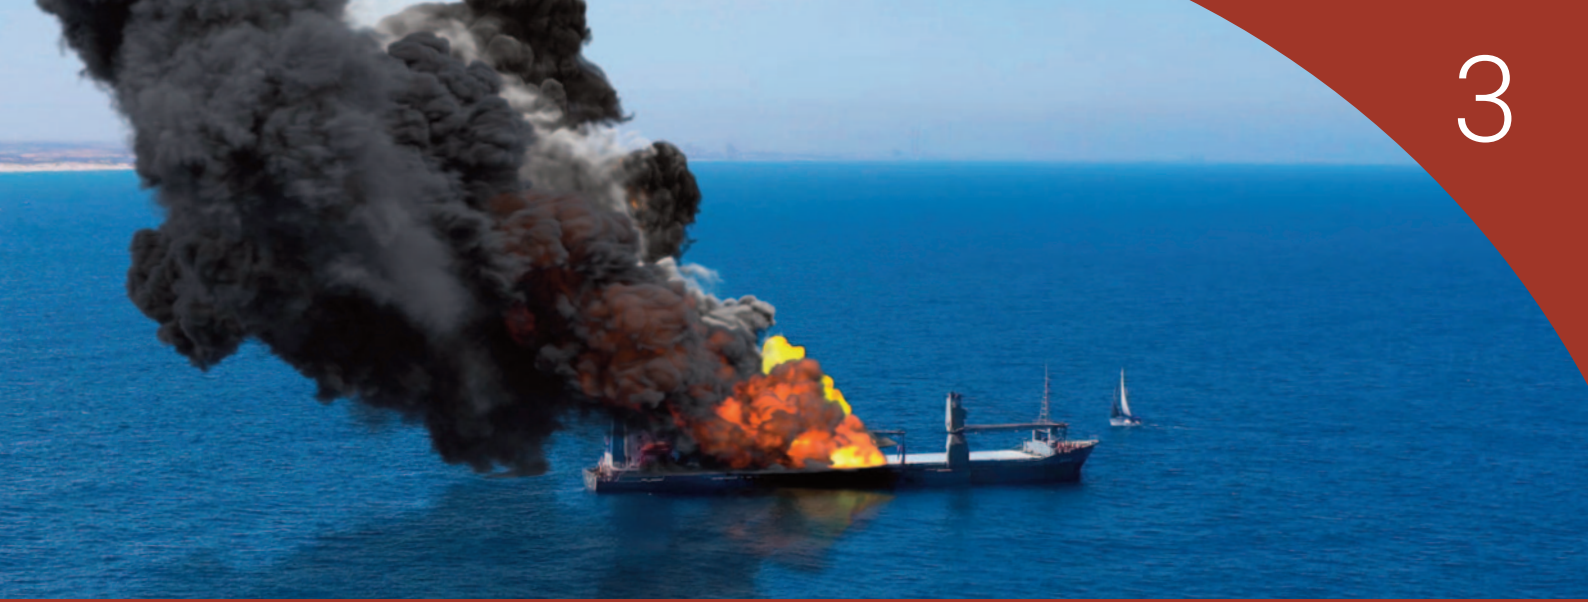
3.3

Floodlights caused cargo fire on bulk carrier

About 4 metres below the cargo surface the cargo was in good condition. It was discovered that the cargo in hold 3 had been damaged by condensation and tainted by smoke. There were clear burn marks around the floodlights and distinct burn marks by the coaming at the same locations where the hot spots had been discovered.

The floodlights were situated 1 metre below the cargo surface in holds 2 and 3 and there was black, burned cargo covering the floodlights. There were two floodlights fitted in cargo hold 1, port and starboard and four floodlights fitted in both cargo holds 2 and 3. All the floodlights were installed in recesses in the hatch coaming. The floodlights were protected by round bars preventing crane hooks, grabs etc from hitting them, but these bars do not prevent cargo like sugar beet pellets from covering the lights. The floodlights were controlled from the bridge on a panel with four key-switches. These switches were marked 1, 2, 3 and 4 respectively. No drawings or legends were attached clarifying which areas these key-switches served.

- The fire was caused because a number of cargo lights were operating while cargo covered them, so the lights ignited the cargo. There was a lack of information on board about how the light circuits were connected and how the light system should be operated. There was also a lack of records concerning use of the lights.

- Cargo lights in holds need to be properly isolated before cargo is loaded. This is best done by removing fuses or other physical links in the electrical circuits so that the lights cannot be switched on by mistake. In container ships the lights need to be properly placed so that they do not overheat cargo or other combustibles and thus cause damage or fire. Lights in car carriers and ferries are usually fluorescent, which are unlikely to cause ignition. Nonetheless it makes sense to leave lights switched off when they are not needed, particularly in cargo areas where combustibles are present.

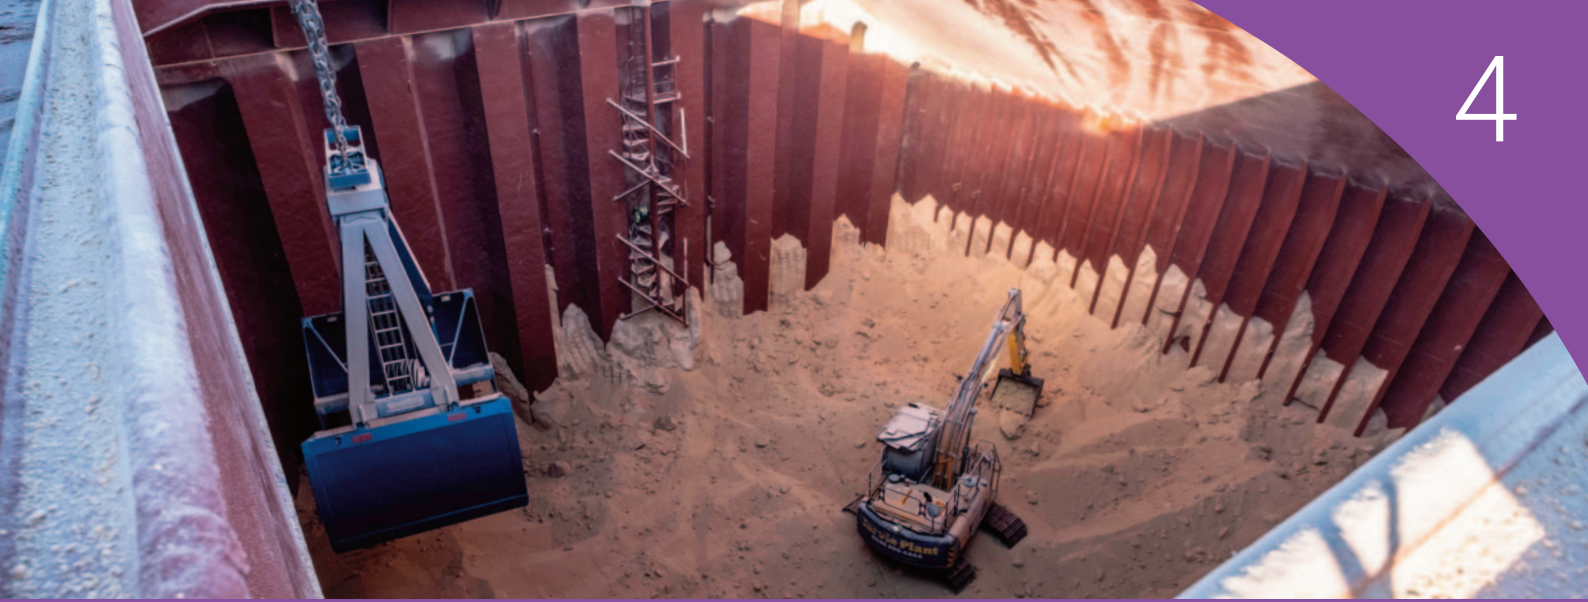
4.1 Fatal fall from ladder

It was later found that a steel bar was missing from one of the lower railings at the beginning of the spiral ladder. The railing was most likely damaged during the loading by one of the crane grabs, or an excavator as it was covered by the cargo when it arrived at the discharge port.

- It is understood that many ports require that stevedores wear a safety harness when climbing the cargo ladder. It is important that the Chief Officer emphasises the importance of complying with this requirement.

- After both loading and discharging, the Chief Officer should inspect the ladders to ensure they have not been damaged during the cargo operation.
- This accident highlights the minimal effort it takes to do a job safely, and the consequences of not making that effort.
