# MARINE TRANSPORTATION SAFETY INVESTIGATION REPORT M19C0403

## **ENGINE ROOM FIRE**

Bulk carrier *Tecumseh*  
Detroit River  
Windsor, Ontario  
15 December 2019

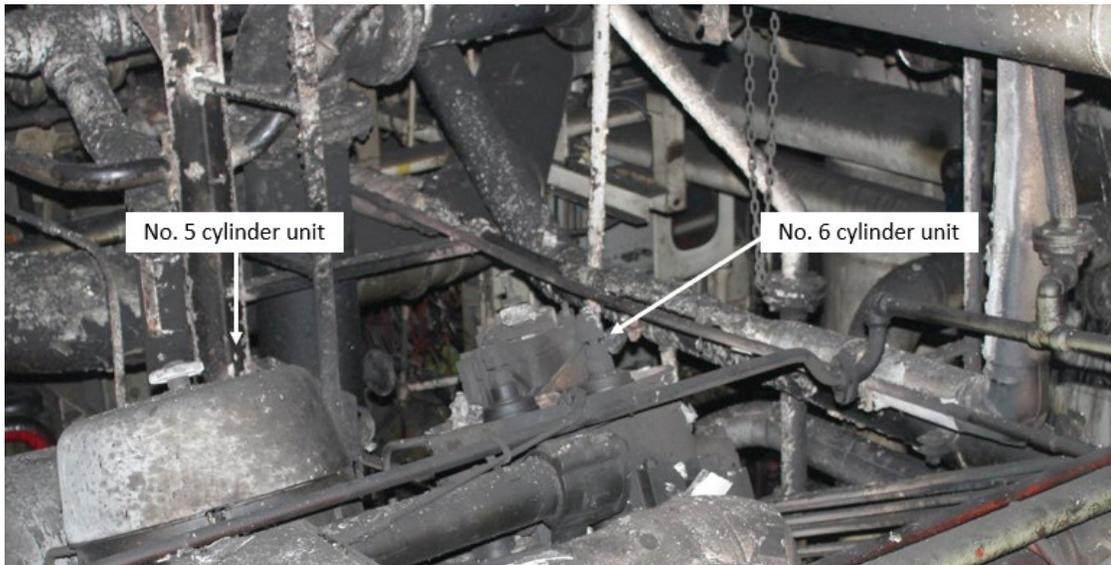
The *Tecumseh's* engine room and associated machinery sustained heat, smoke, and soot damage from the fire. The port main engine (Figure 9) and various electrical cables and equipment (Figure 10) sustained moderate to severe fire damage, while the ECR, including the main switchboard and control consoles, was completely destroyed (Figure 11).

Figure 9. Damage to the port main engine's No. 5 and No. 6 cylinder units and surrounding areas. The No. 6 cylinder unit cover was destroyed during the fire. (Source: TSB)

Cylinder heads No. 6 and No. 7 on the port main engine and the scavenge manifold had signs of carbon/oil residue buildup, consistent with the long-term ingestion of lubricating oil. Cylinder No. 7 was immediately adjacent to the turbocharger, and the oil buildup in the intake port strongly suggested that a long term oil leak from the turbocharger had been allowing lubrication oil to enter the intake tract. The No. 6 crankcase inspection door had separated from the crankcase at some point during the occurrence, but there was no indication of a crankcase explosion. The port main engine showed no indication of catastrophic mechanical failure.

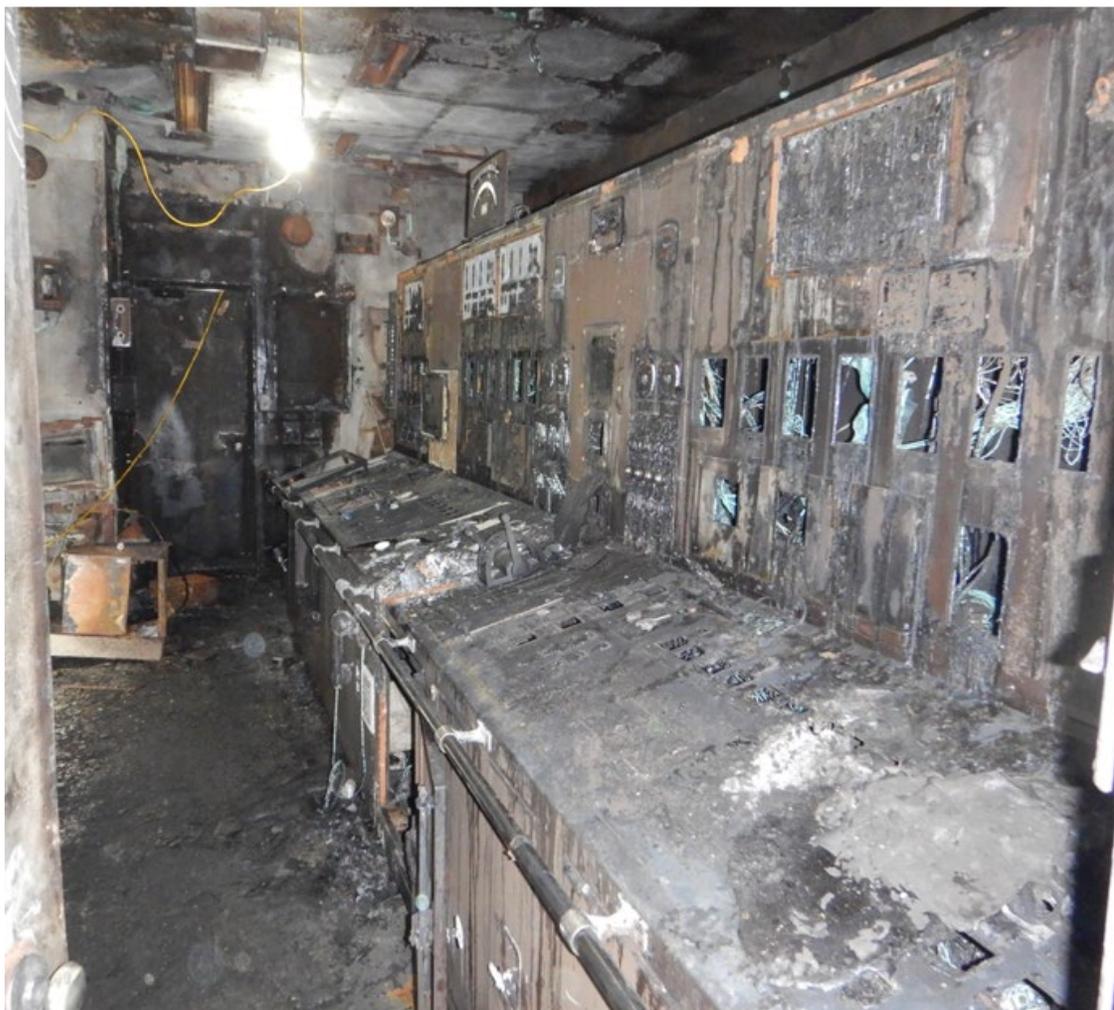
Figure 11. Engine control room consoles, showing fire damage (Source: TSB)

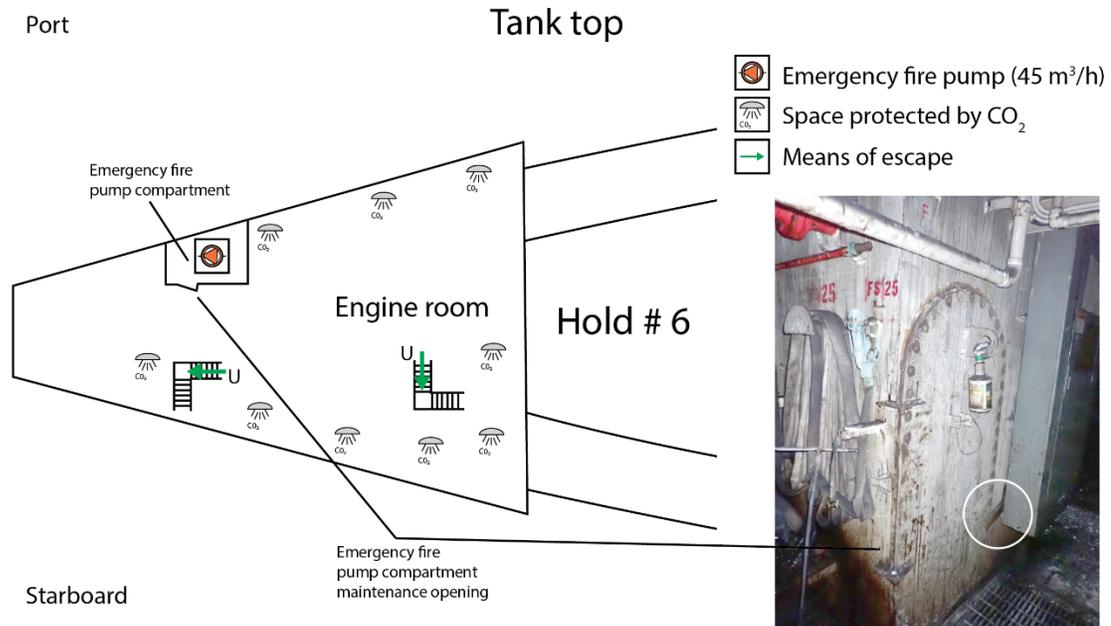
was faster than exiting the engine room to use the compartment's dedicated access point on deck A. The maintenance opening was represented inaccurately as a door on the fire control plan.

Figure 12. Diagram showing the location of the maintenance opening of the emergency fire pump compartment from the engine room, and photo of the opening without bolts and pinned shut by a wrench (circled) (Source of diagram: TSB, based on Lower Lakes Towing Ltd. fire control plan. Source of photo: TSB)

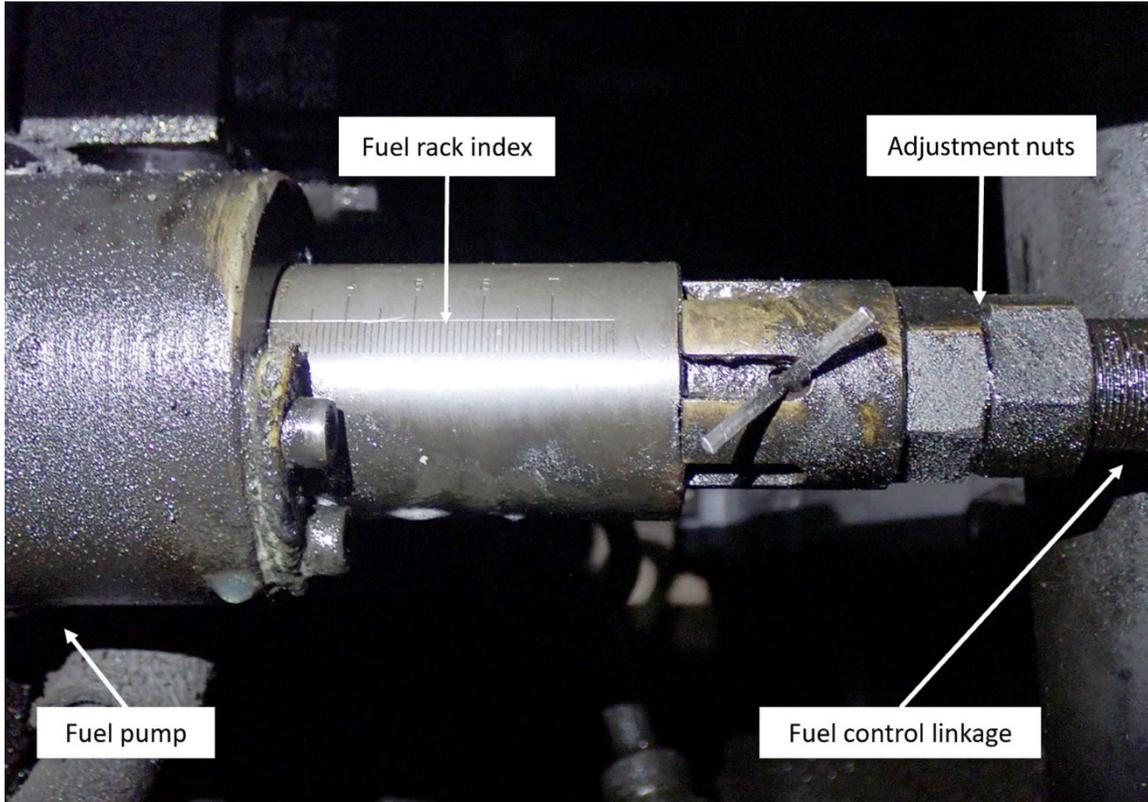
Figure 15. The fuel rack index and manual adjustment nuts of one of the Tecumseh's fuel injection pumps (Source: TSB)

The datum positions of the fuel rack indexes varied in excess of the manufacturer-recommended 2 mm. The adjustment nuts for the fuel rack indexes were all properly secured, and there was no indication that they had come loose on their own over time. The datum positions of the fuel rack indexes had been manually adjusted in order to minimize the impact of differences in peak cylinder pressures and exhaust gas temperatures.

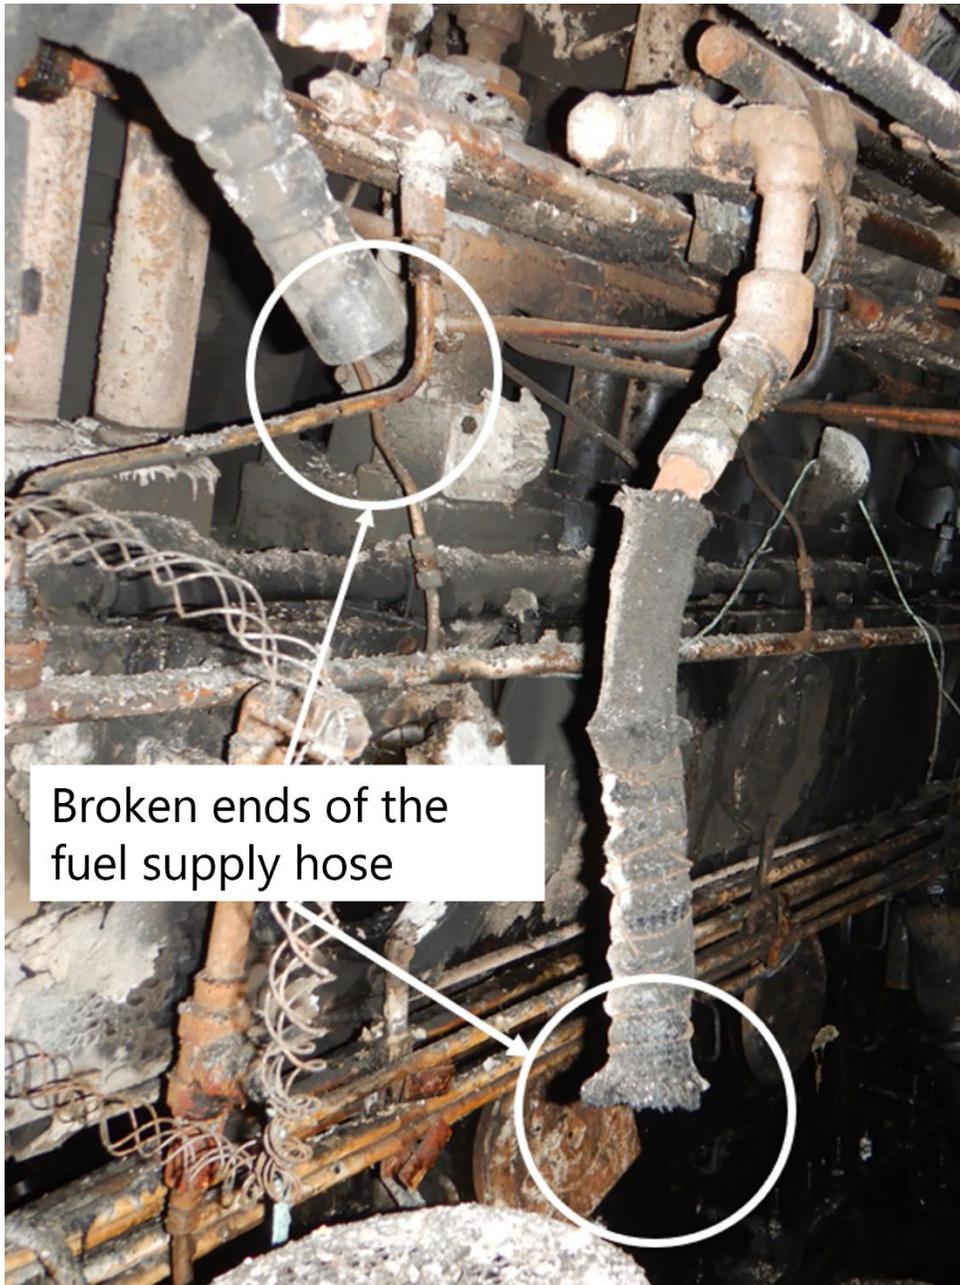
The TSB laboratory examined the port side fuel line on the port main engine and found that one of the flexible fuel hose assemblies had separated (Figure 16). The assembly consisted of a portion of flexible hose approximately 76 cm long and 2 threaded-crimp fittings that attached the flexible hose to the hard piping. The separated fuel hose assembly was located on the forward part of the outboard bank of cylinders, close to cylinder unit No. 6. The assembly had separated at the point where a threaded-crimp fitting connected the flexible fuel hose to the hard piping (Figure 17).

Figure 16. Separated fuel hose assembly (Source: TSB)

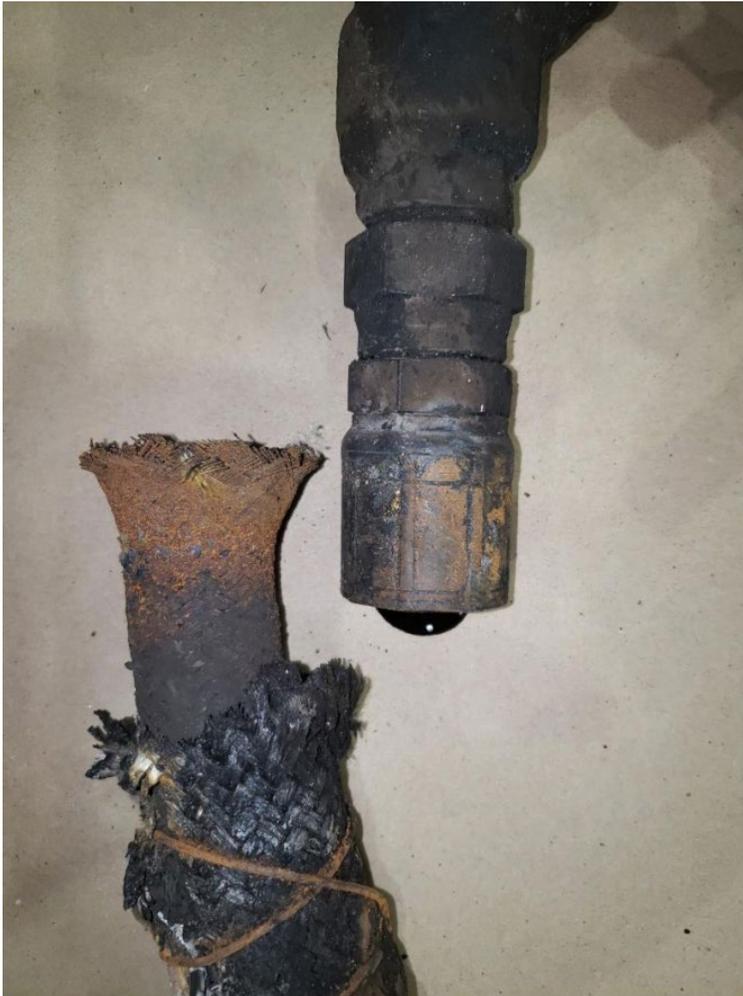
Figure 17. Fuel line aligned to show separation at crimp (Source: TSB)

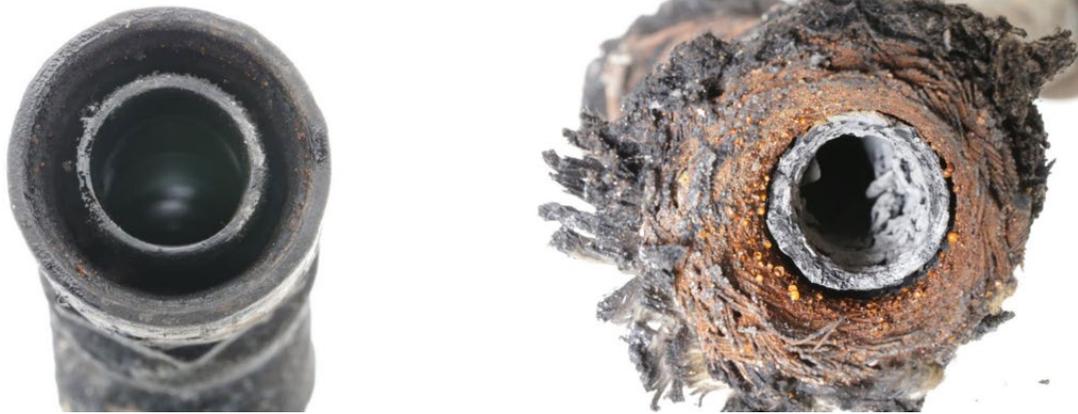
Examination of the crimp fitting showed that no portion of hose remained inside the crimp fitting, and examination of the end of the hose showed that the full hose cross-section was present (Figure 18). This suggests that the crimp fitting itself failed in service.

Figure 18. Crimp side of separation (left) and flexible hose side of separation (right) (Source: TSB)

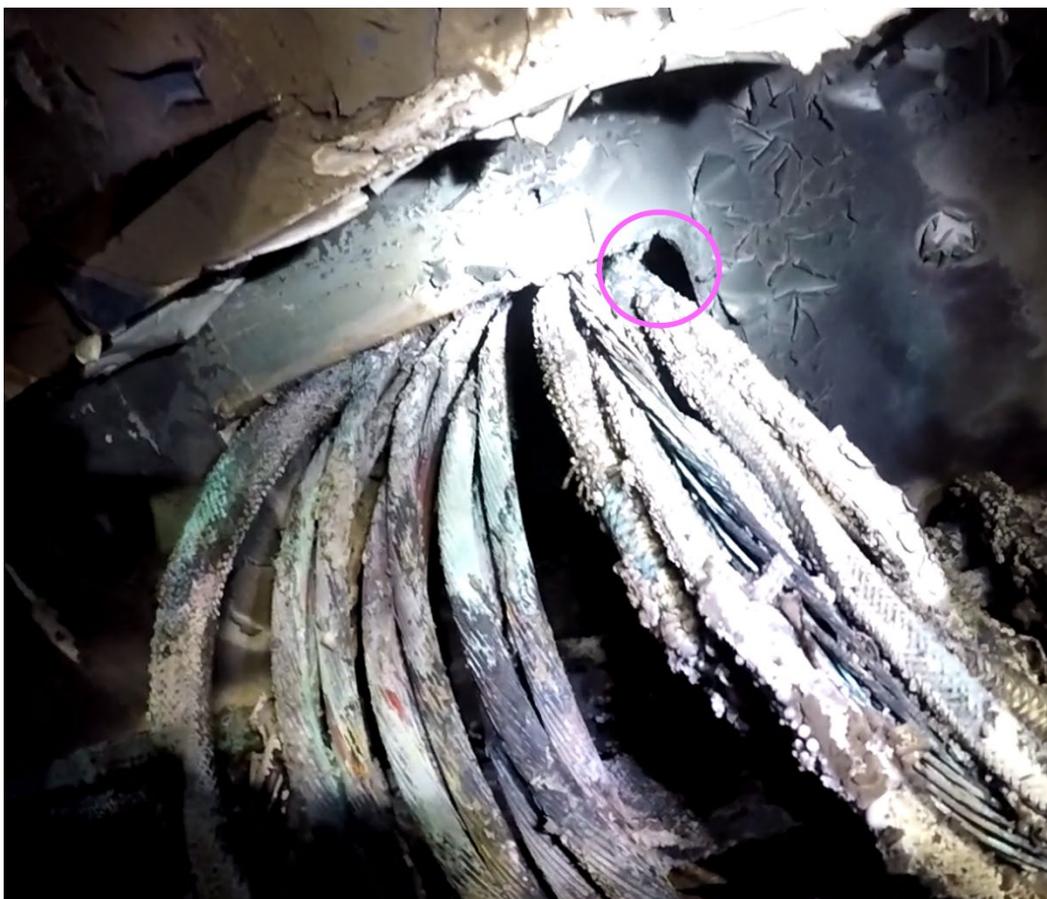
The auxiliary generators had been replaced in 2005. At that time, the cables that passed between the engine room and ECR were also replaced, which would have required any sealant in place to be removed. Once the new cables were installed, the sealant should have been replaced. There were no records that any work had been done with respect to the cables after 2005. Following the occurrence, only traces of sealant were found at the deck penetrations between the engine room and the ECR.

Figure 19. Unsealed deck penetration (circled) (Source: TSB)
