**Bundesstelle für Seeunfalluntersuchung**  
**Federal Bureau of Maritime Casualty Investigation**  
Federal Higher Authority subordinated to the Federal Ministry  
for Digital and Transport

## **Investigation Report No. 261/20**

### **Less serious marine casualty**

**Fire in the engine room on board the ferry BERLIN in  
the access to the port of Rostock on 13 August 2020**

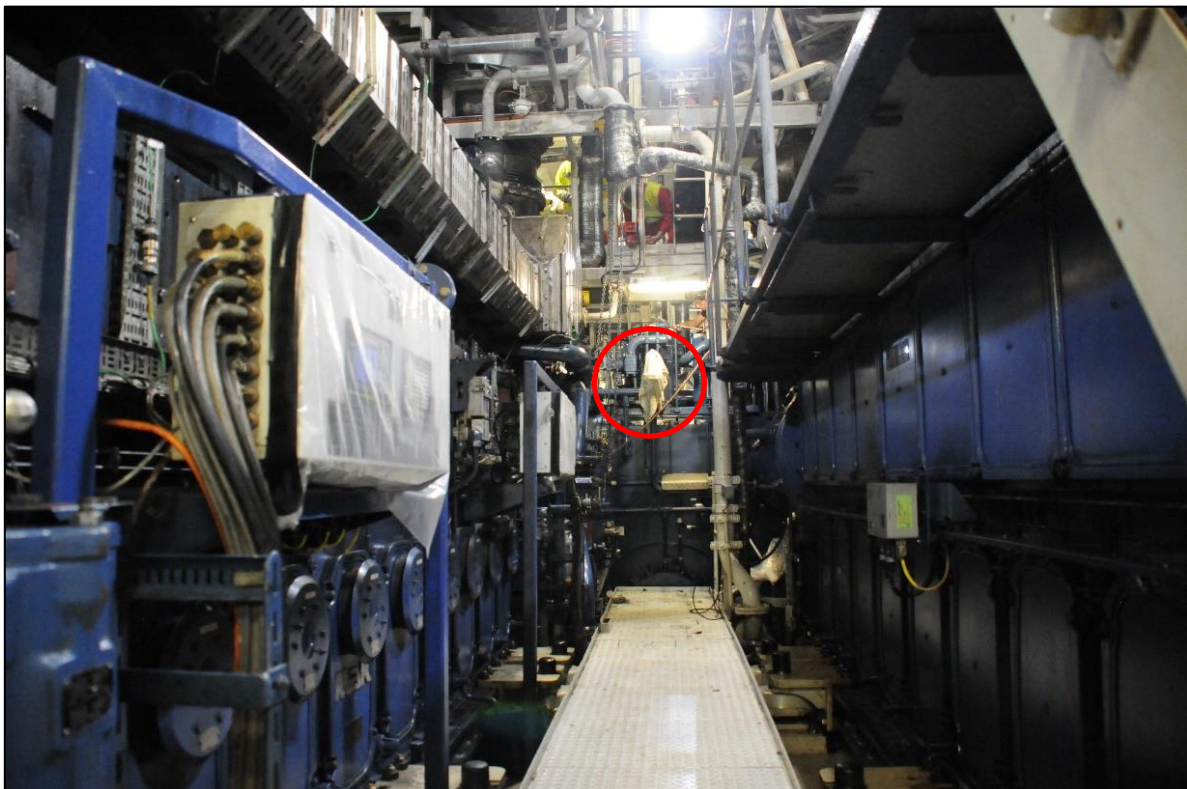
There was little to no fire damage to equipment, systems and built-in components in the main engine room. The damage was limited to partially burned insulation of the ME 2 exhaust duct. In the direct vicinity, there was a leak from the gearbox (pressure gauge pipe situated centrally on the gearbox between ME 1 and ME 2).

Adjacent areas, especially the exhaust duct, were extensively covered in oil due to a massive leak of hydraulic oil from the main gearbox. Before restarting the main engines, the oily insulation mats had to be completely replaced and the main engine room thoroughly cleaned. No persons were harmed as a result of the fire. Apparently, the firefighting measures and/or the boundary conditions of the event meant that the fire could be extinguished swiftly. It was possible to prevent the fire from spreading to neighbouring areas.

Figure 8: Leakage at the gearbox between ME 2 and ME 1

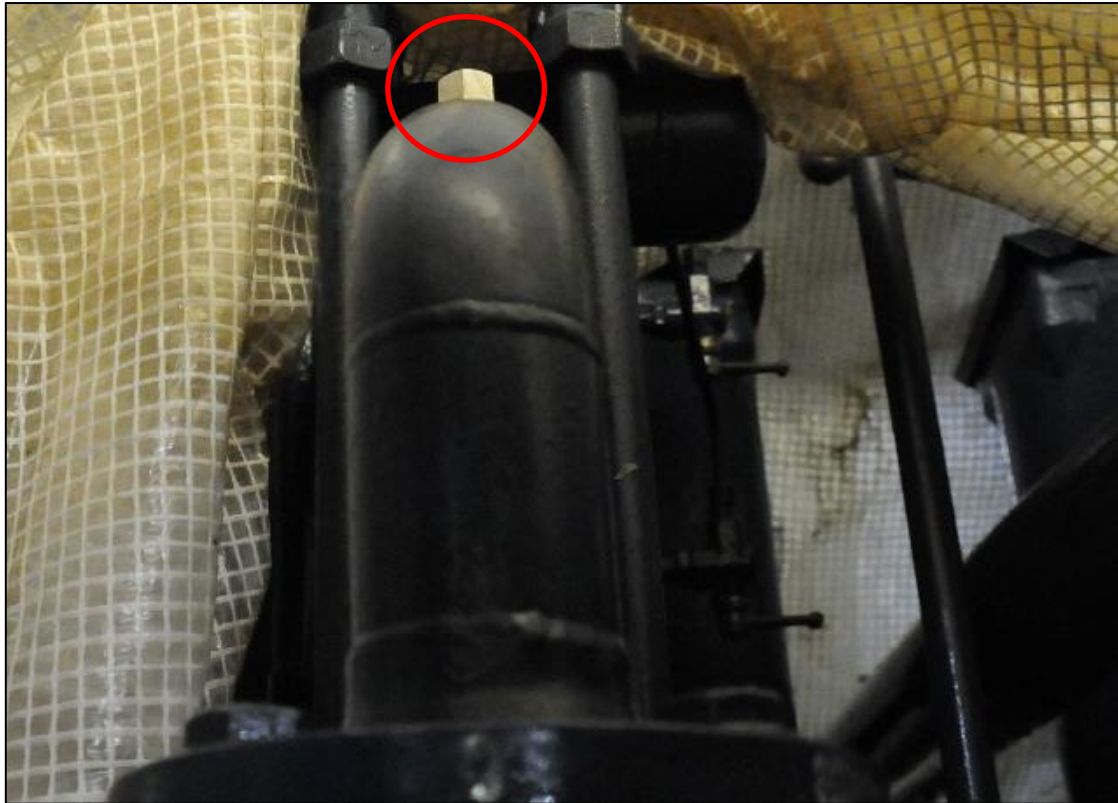
A broken double nipple was found to be the cause of the leakage. It is installed on the pipe of a gear oil transmission pipe and obviously broke due to material fatigue. Figures 9 to 16 illustrate this.

Figure 9: Cover of broken pressure gauge pipe

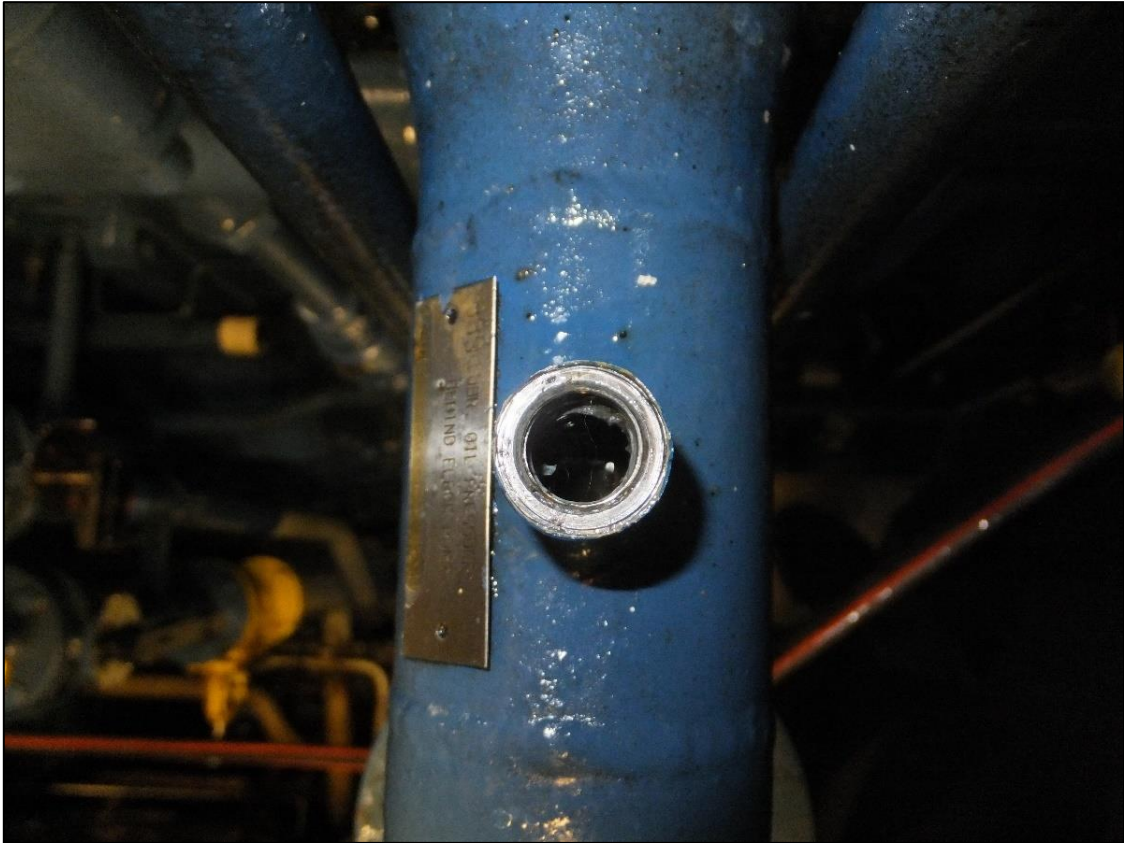
Figure 10: Open connecting piece (without double nipple)

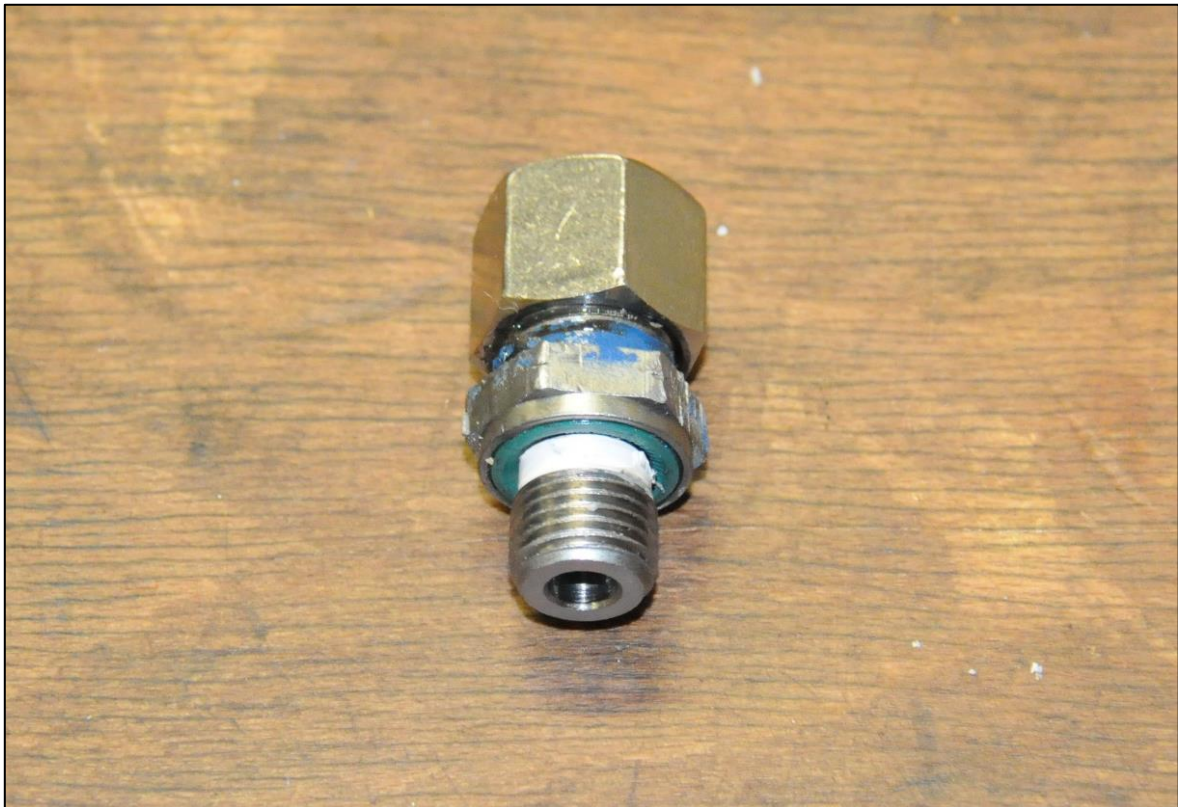
Figure 11: Double nipple Ermeto L10 with cap nut

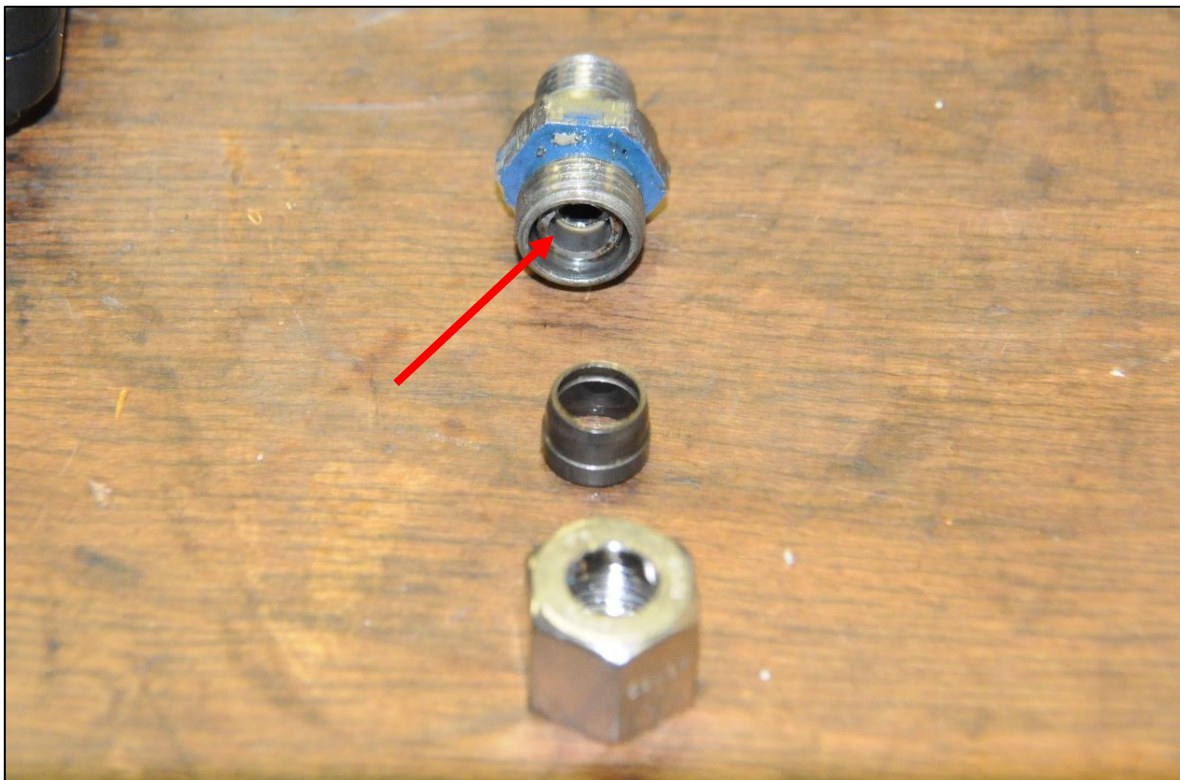
Figure 13: Cutting ring<sup>15</sup> and pipe fragment of double nipple on the inside

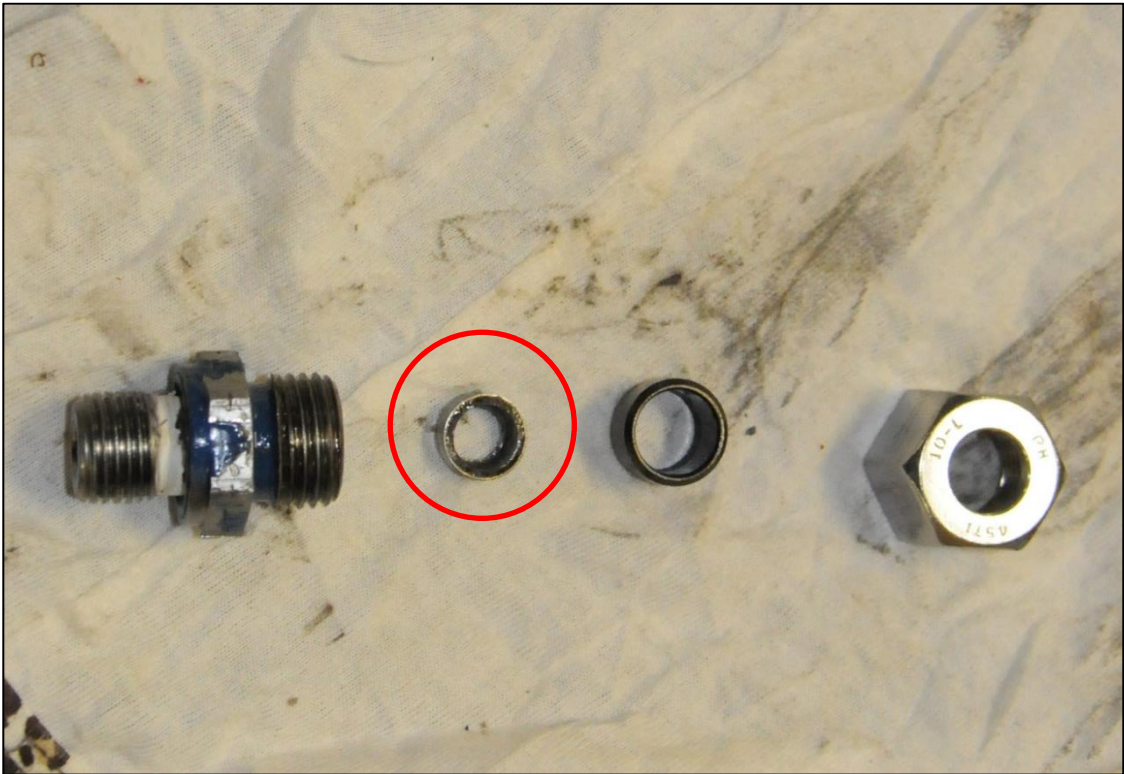
Figure 14: Fitting with broken-off piece of pipe

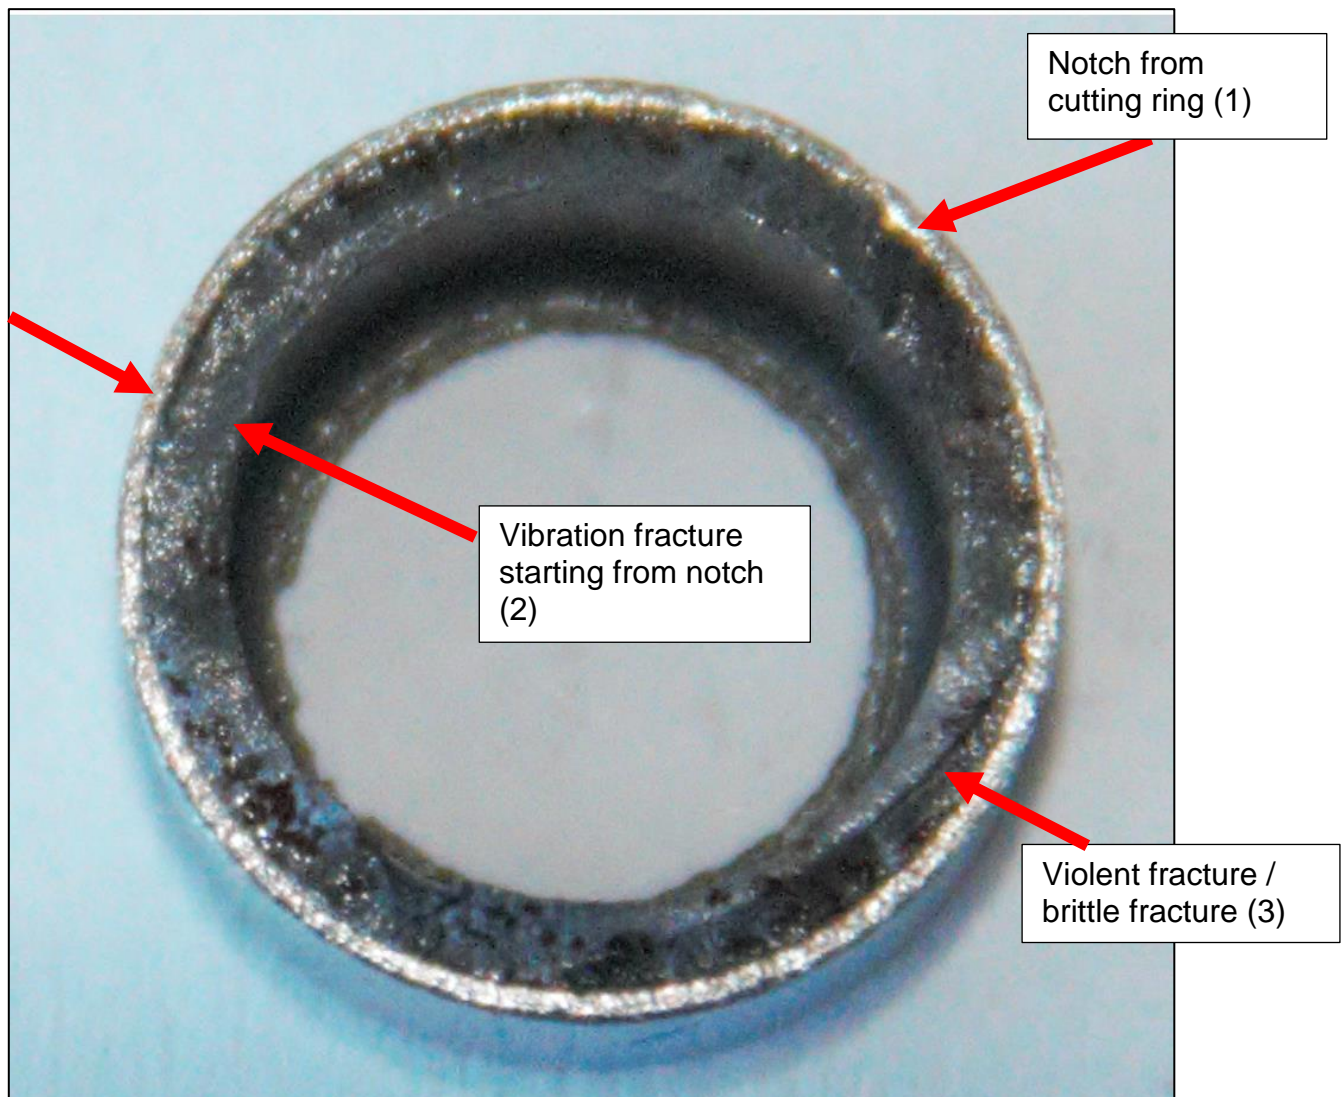
Figure 15: Pipe segment, notch from cutting ring outside and inner fracture surface

Figure 15 shows the fracture surface of the pipe inside the cutting ring connection (2). Component vibration promoted the propagation of the vibration fracture out from the notch edge (1). At some point, due to pressure and vibration load, the material was so weak that the remaining material broke abruptly (3).

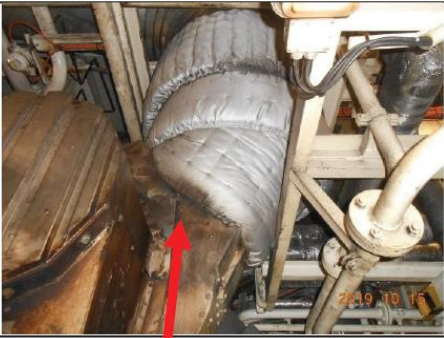
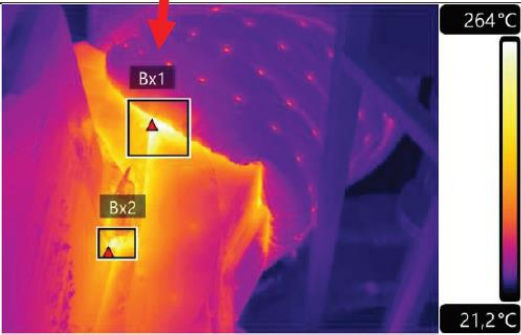
<b>Customer:</b>	M/F Berlin	<b>Inspection date:</b>	15. oktober 2019								
<b>Position:</b>	ME No. 2										
<b>Area:</b>	Insulation around the flange between T/C and exhaust pipe

<b>Remarks:</b>  <i>Temperatures above 220 degrees Celsius.</i>

The points of maximum temperature Bx1 with 295.3°C and Bx2 with 297.5°C found in Figure 17 are clearly reflected in the post-fire damage pattern in Figure 18.

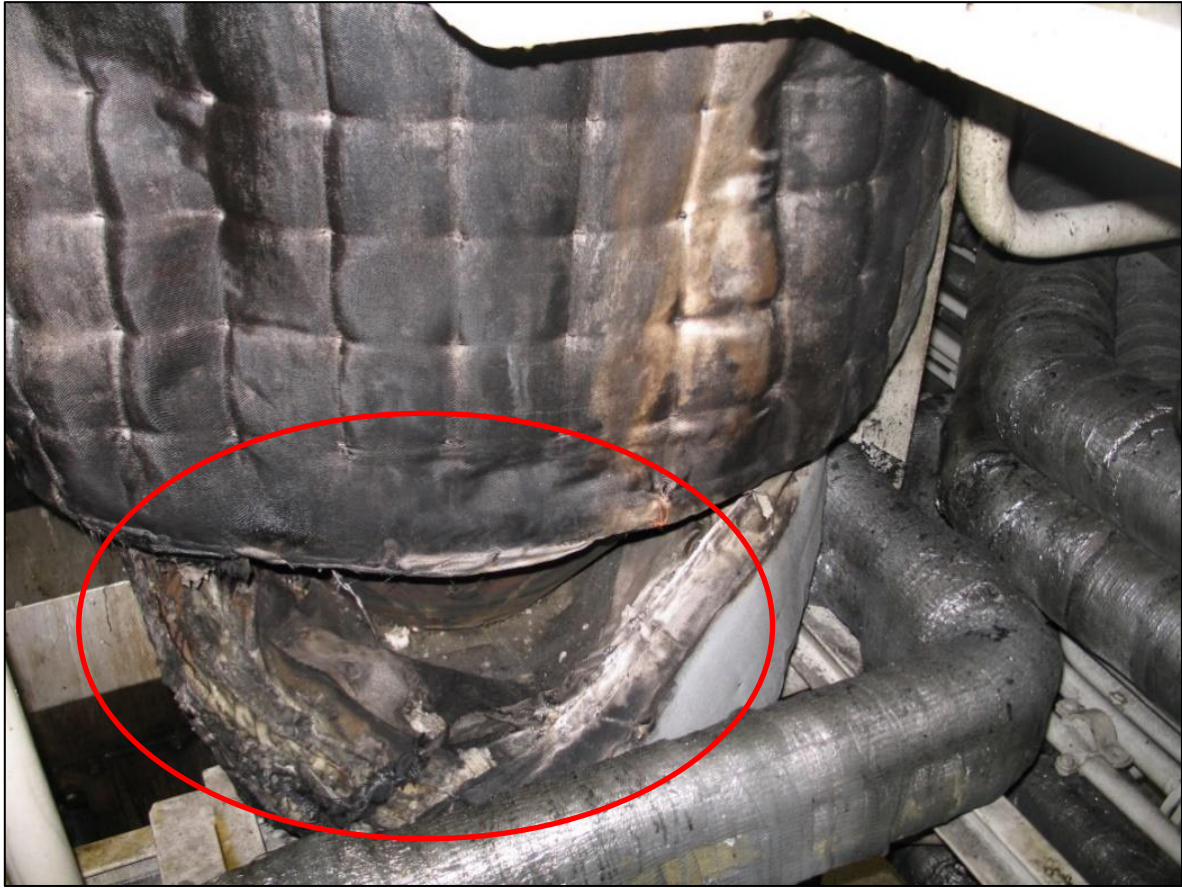
Figure 18: Burn marks on insulation mats of exhaust pipe

It is therefore not surprising that it was precisely these spots that showed particularly severe fire damage. It is highly probable that the escaping oil ignited immediately here.

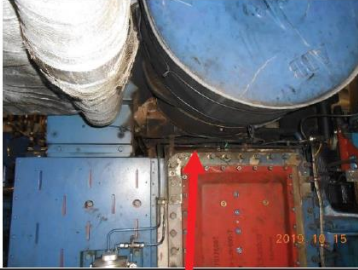
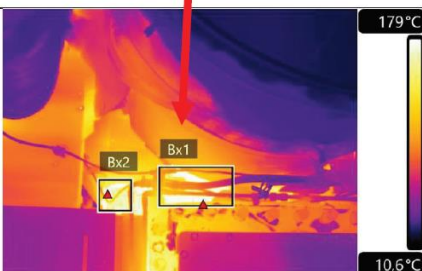
<b>Customer:</b> M/F Berlin	<b>Inspection date:</b> 15. oktober 2019										
<b>Position:</b> ME No. 2											
<b>Area:</b> Engine

<b>Remarks:</b>  <i>Temperatures above 220 degrees Celsius.</i>

FLIR0388		Objektemissivitet	0,95	Punkter	-	Bx1 Maksimum	255,2 °C	Bx2 Maksimum	239,9 °C
FLIR0388											
Objektemissivitet	0,95										
Punkter	-										
Bx1 Maksimum	255,2 °C										
Bx2 Maksimum	239,9 °C

Figure 19: Area below turbocharger (air side)<sup>20</sup>

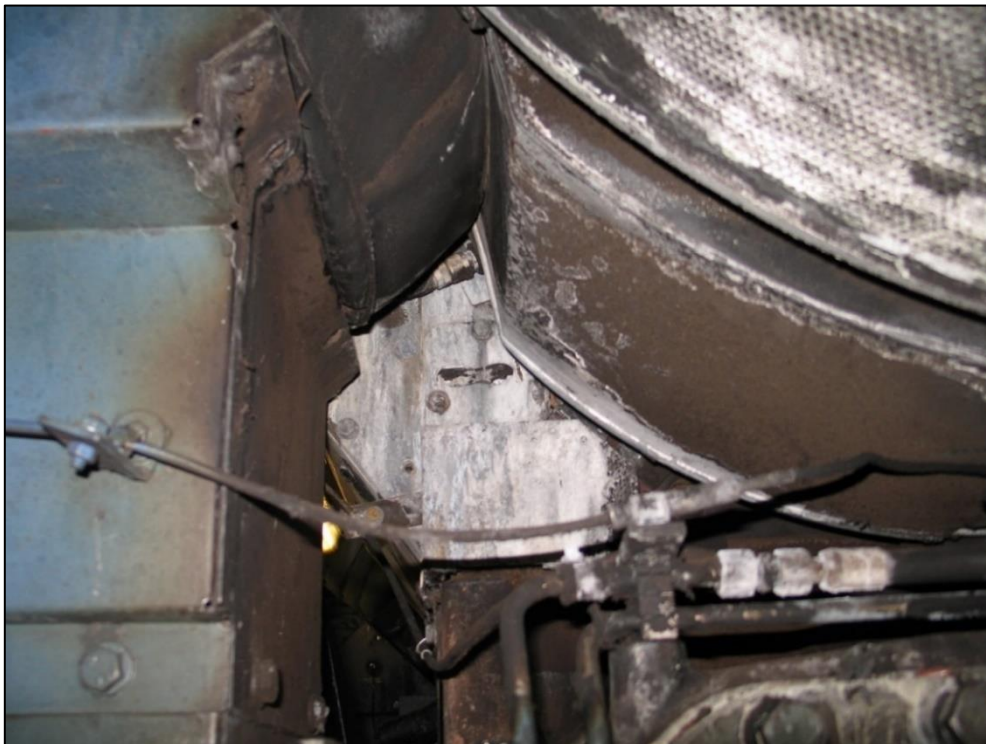
The same applies to the area below the turbocharger, see Figures 19 and 20.

Figure 20: Fire damage to turbocharger insulation (air side)

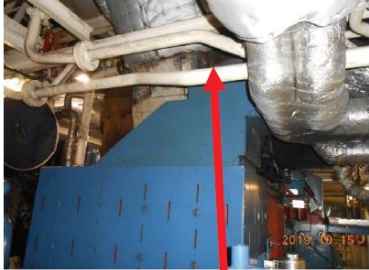
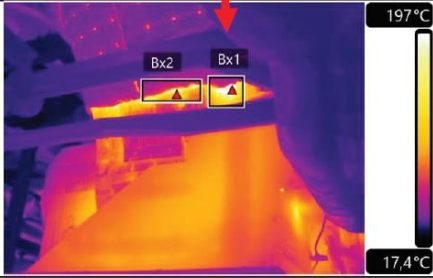
<b>Customer:</b> M/F Berlin	<b>Inspection date:</b> 15. oktober 2019								
<b>Position:</b> ME No. 2									
<b>Area:</b> Insulation around the flange between T/C and exhaust pipe

<p><b>Remarks:</b></p> <p><i>Temperatures above 220 degrees Celsius.</i></p>

Objektemissivitet	0,95	Punkter	-	Bx1 Maksimum	247,6 °C	Bx2 Maksimum	204,1 °C
Objektemissivitet	0,95								
Punkter	-								
Bx1 Maksimum	247,6 °C								
Bx2 Maksimum	204,1 °C

Figure 21: Area of turbocharger exhaust duct <sup>21</sup>

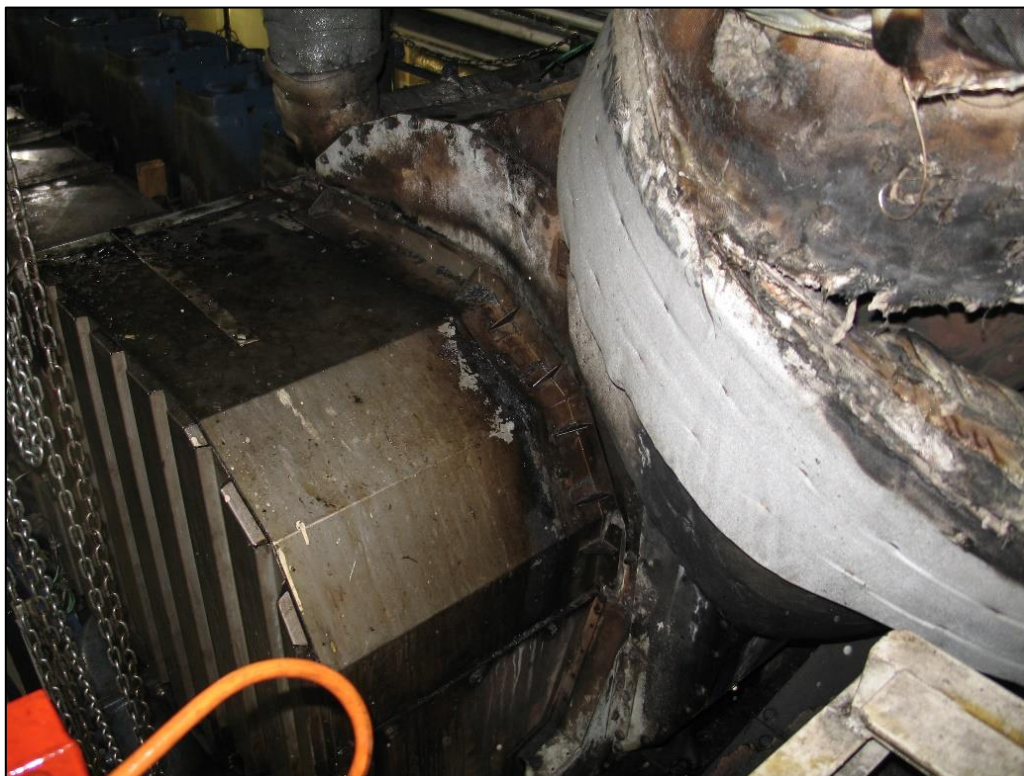
Figure 22: Fire damage to exhaust side insulation in area of turbocharger

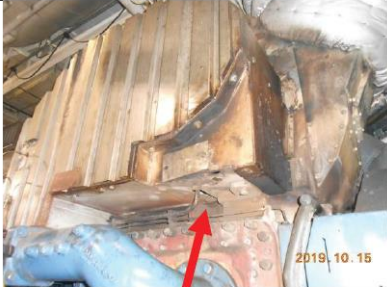
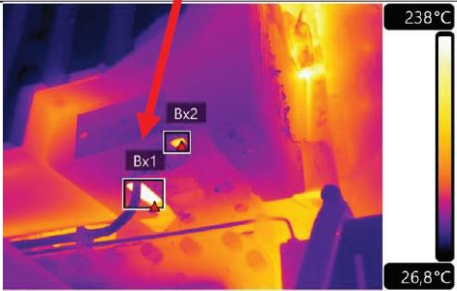
<b>Customer:</b> M/F Berlin	<b>Inspection date:</b> 15. oktober 2019								
<b>Position:</b> ME No. 2									
<b>Area:</b> Engine

<p><b>Remarks:</b></p> <p><i>Temperatures above 220 degrees Celsius.</i></p>

Figure 23: Area below turbocharger (exhaust side)<sup>22</sup>

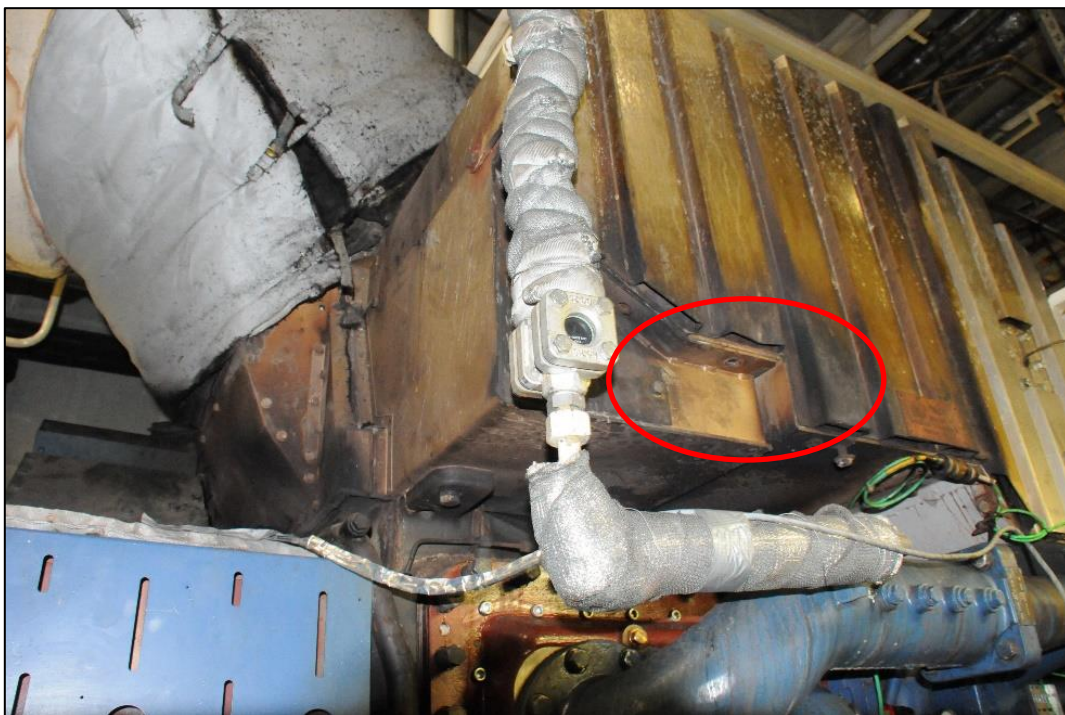
Figure 24: Burn marks on outside of turbocharger (exhaust side)

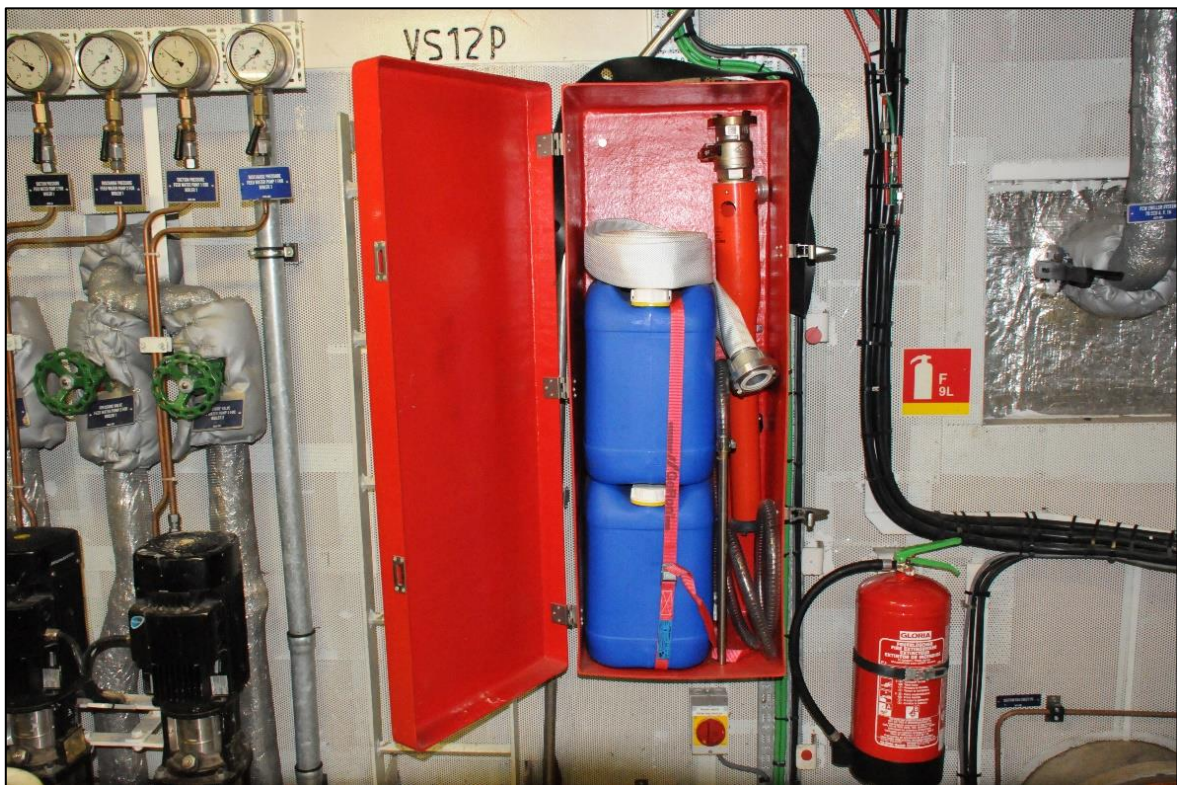
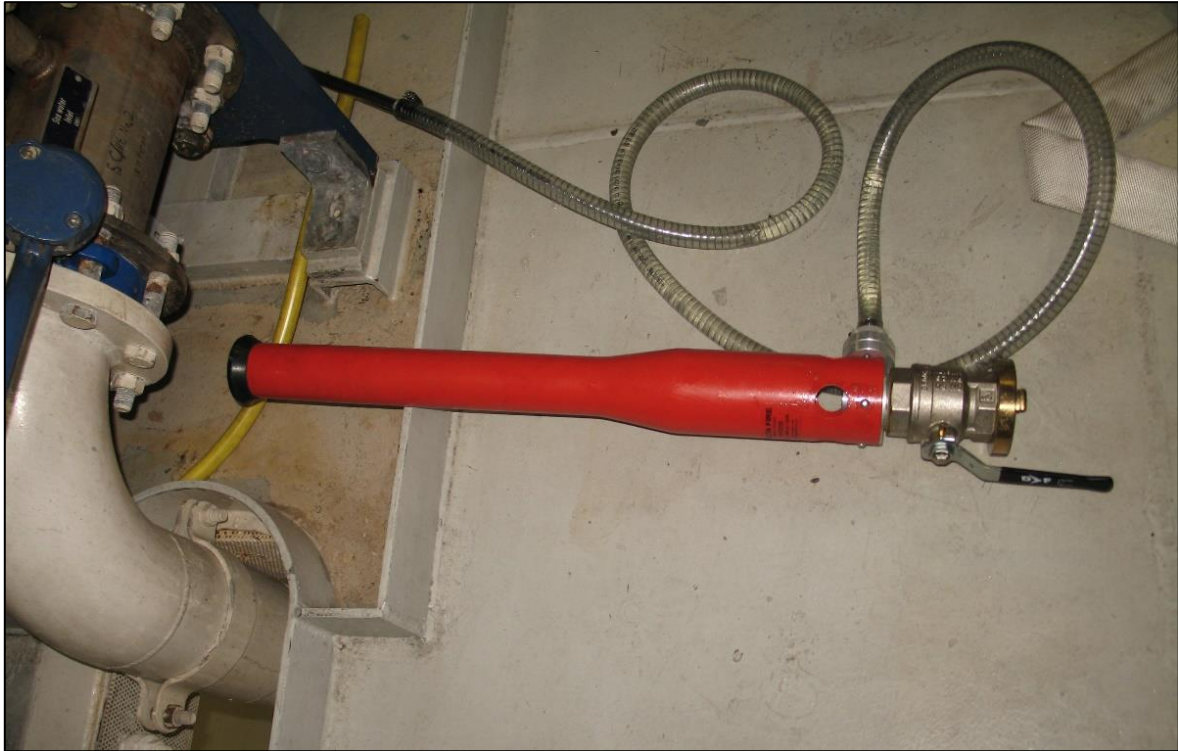
- Effectively not usable under real-life conditions, since the foam agent container (approx. 20 kg) must be carried along all the time. Also, the suction hose with its length of approx. 1.2 m allows hardly any free movement and thus no effective firefighting effort. (see Figure 26 and Figure 27)
