**REPORT OF AN INVESTIGATION
INTO A
FIRE ONBOARD THE FERRY
“FRAZER TINTERN”
MIDWAY BETWEEN
BALLYHACK CO. WEXFORD
AND PASSAGE EAST
CO. WATERFORD
5 AUGUST 2021**

**REPORT NO. MCIB/311
(No.7 OF 2022)**

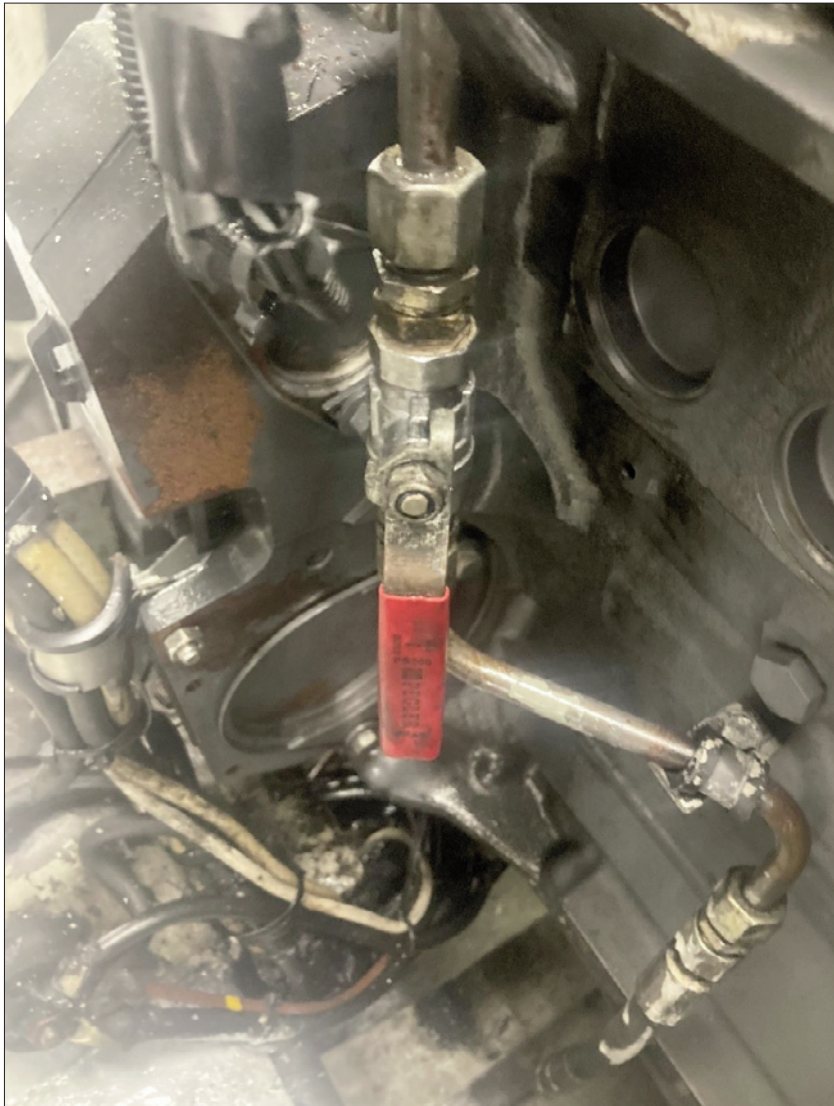
Appendix 7.3 Photograph No. 1 - Return Fuel Line Shut Off Valve

The fuel for No. 1 engine is taken from the main fuel tank via filters to the lift pump, from here the fuel is fed through a secondary filter to the injection pumps and returned via a pressure regulating valve to the fuel tank. Unusually the return line on all main engines has a lever shut off valve fitted. They were apparently fitted to assist priming of the fuel system.

- 3.15 It was not possible to establish whether the shut off valve in No.1 engine fuel return line was open or closed at the time of the fire. It was noted during inspection after the repairs were done that the shut off valves on the fuel return lines on the other three engines were in the open position when the engines were running.

- 5.7 The fuel systems on this vessel include a shut off valve on the return line. If this valve is closed while the engines are in operation this would lead to over pressurisation of the fuel system leading to component failure and considerable fuel leakage at pressure.

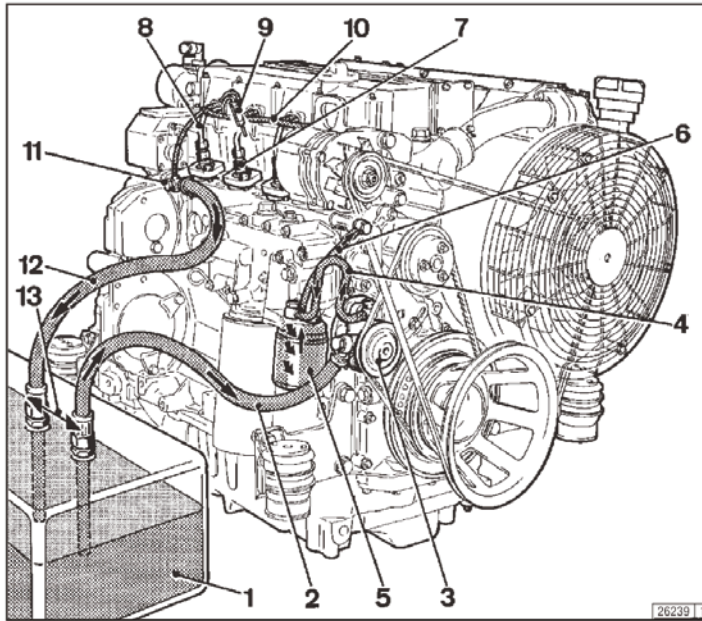
2.4.1 Fuel System Schematic

considerable amount of fuel being released was likely to have been from the fuel lift pump. Should the fuel return line be blocked off in any way the pressure regulating valve will become inoperative resulting in a significant increase in fuel pressure on the return side of the system, consequently leading to a pipe failure. Note that the isolating valve shown in the photograph at Appendix 7.3 which is located in the return line pipework in series with the back pressure regulating valve is not indicated in the fuel diagram shown at Appendix 7.4.

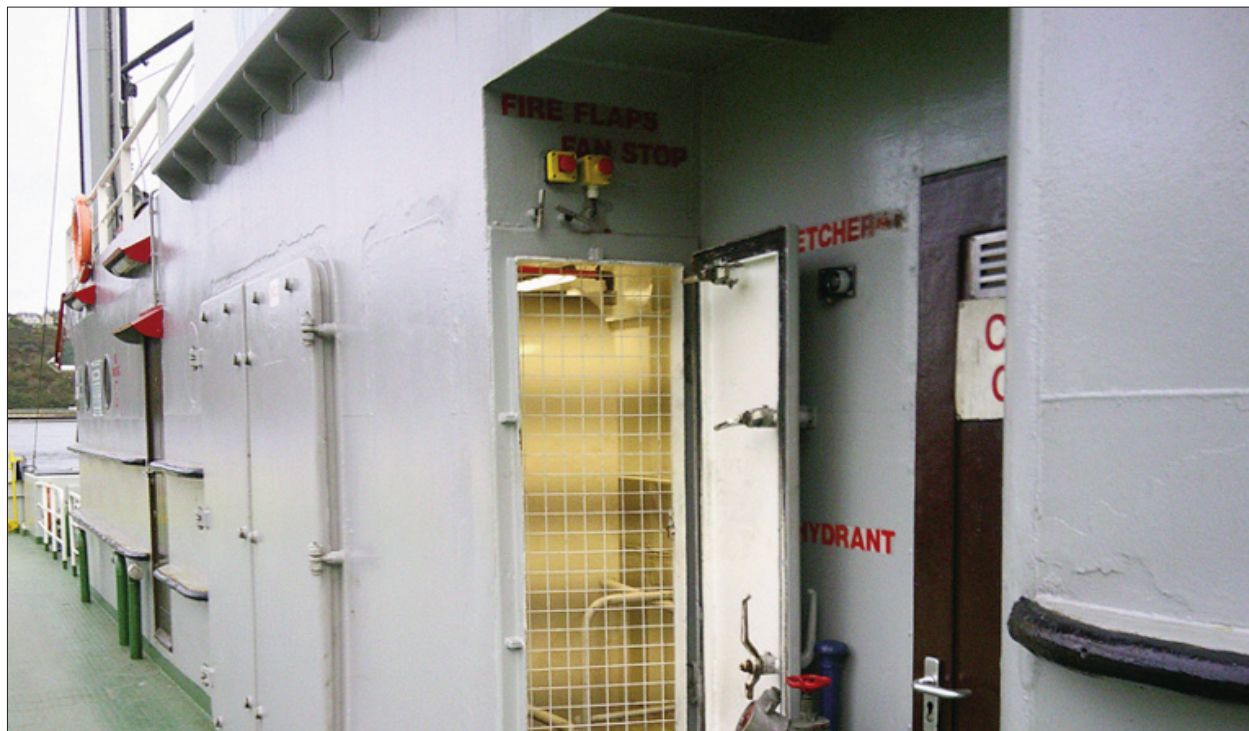
Appendix 7.5 Photograph No. 2 - Starboard Machinery Space Access Door

2.4.3 The vessel had a major refit prior to taking up service in Ireland. All modifications carried out at this refit were agreed between the company and the MSO. As well as major re-plating of the hull this included the fitting of two diesel engine driven, three phase alternating current (AC) generators. One of these was fitted in the port side workshop and the other in the crossover space between the engine compartments. The switch gear for the AC system was also located in the port side workshop. One of the main reasons for fitting the AC system was to power forced draft and extraction fans to increase the airflow through the machinery spaces to assist cooling of the main engines. The forced draft fans are on the port side and the extraction fans on the starboard side of the superstructures. The airflow through the extraction fans however was insufficient which necessitated the access door to the starboard machinery space being left open when the engines are running. A grid was fitted to this access to deter members of the public entering the machinery space.

- 5.6 Due to the airflow from No. 1 engine access door, the fire spread onto the car deck in an area open to the public. This also prevented access to the port side fire flaps and fan stops. Although the door has been modified to close on activation of the fire alarm, in this instance the fire would have spread to the public space prior to the door closing.

- 3.14 Since the incident the door leading to No.1 engine compartment was fitted with a weight and magnetic lock so that it closes automatically when the fire alarm is activated.

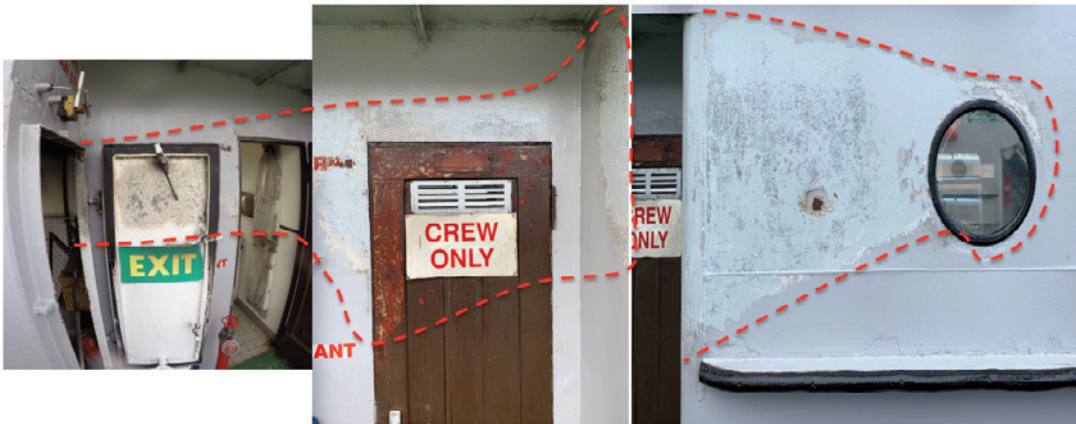
Photograph No. 3 – Flame Impingement Path

- 3.10 The incident was reported to the MSO and the vessel was inspected prior to and on completion of repairs at New Ross, Co. Wexford Boat Yard.
- 3.11 No.1 engine was extensively damaged by fire as was the wiring loom and ancillary equipment. The machinery space around No.1 engine suffered heat and smoke contamination causing extensive damage to surface coatings. The area on the car deck between the access to No.1 engine compartment and the crew welfare space was badly scorched. The glass porthole in the welfare space was cracked because of the heat generated by the fire.

Flame Path is Outlined in Dashed Red Lines, from Left to Right. Flames scorched bulkhead surfaces aft to the Galley PortLight, cracking the Tempered Glass.

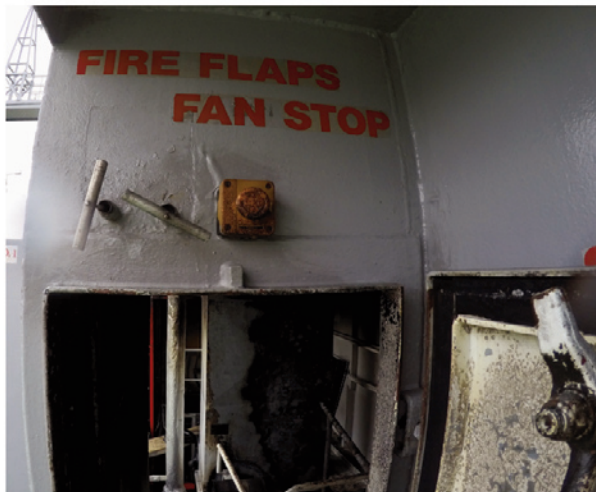
Photograph No. 4 – Stop and Pull Handles

Manual Pull Handles & Ventilation Fan Shut- off Control, Scorched from Fire.

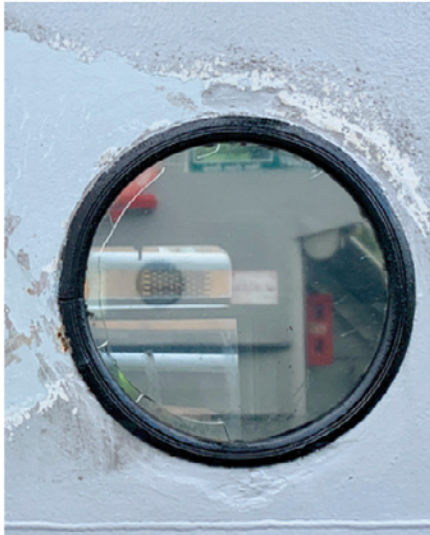
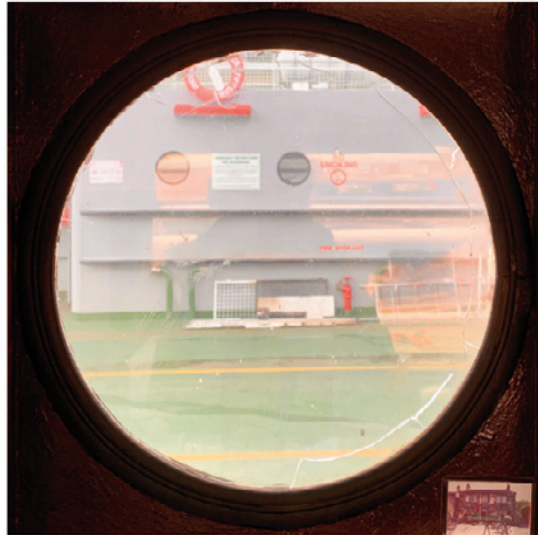
Photograph No. 5 Galley Porthole

Flame Front extended aft to crack the Port-Light Glass

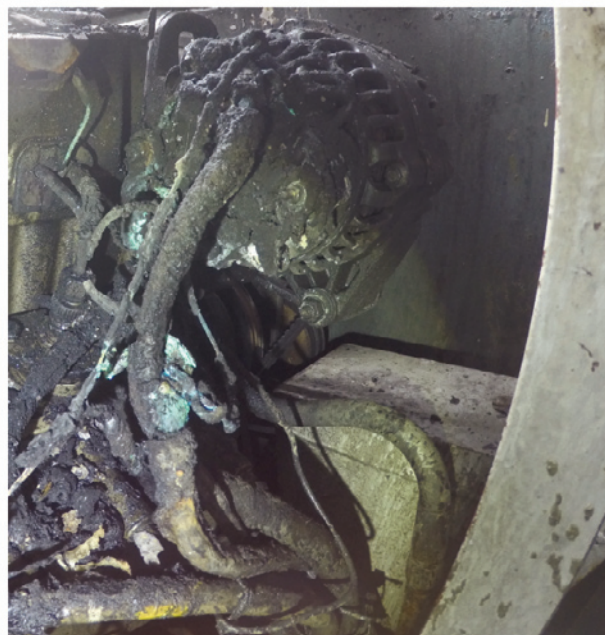
Photograph No. 6 – Alternator

- 4.3 The ignition source of the fire may have been arcing, causing sparks in the engine mounted alternator, but more likely to have been the hot exhaust manifold or turbocharger casing of No.1 engine that was not lagged or enclosed. The exposed hot surfaces of the manifold and turbocharger would have provided an ignition source for the fuel.

Remains of Engine Driven Alternator & Cables

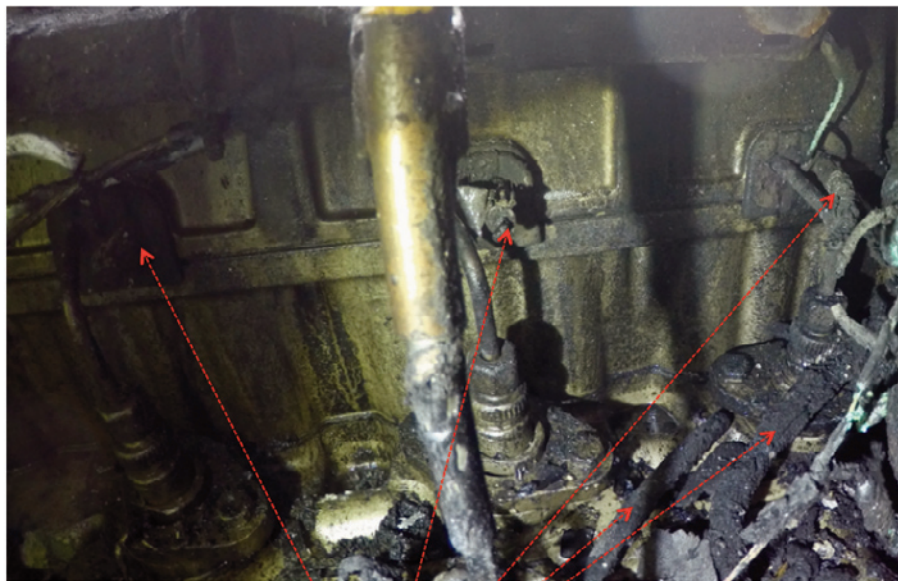
Photograph No. 8 – Charred Fuel Hoses

Charred Fuel Return Hose Remnants.

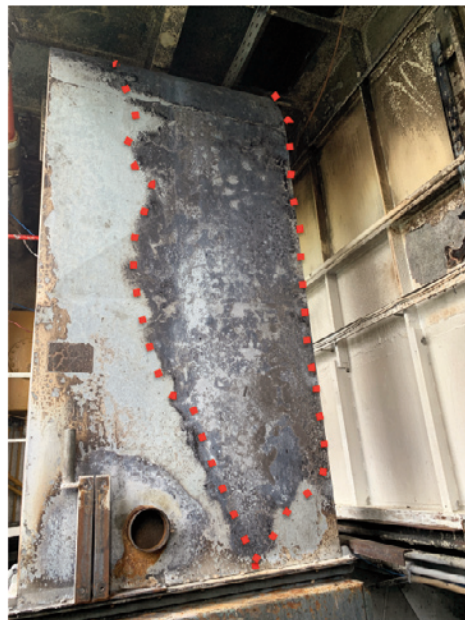
Photograph No. 10 – Flame Impingement on Air Ducting

The Spray Pattern of Fuel & Flame Impingement on Air Intake Ducting

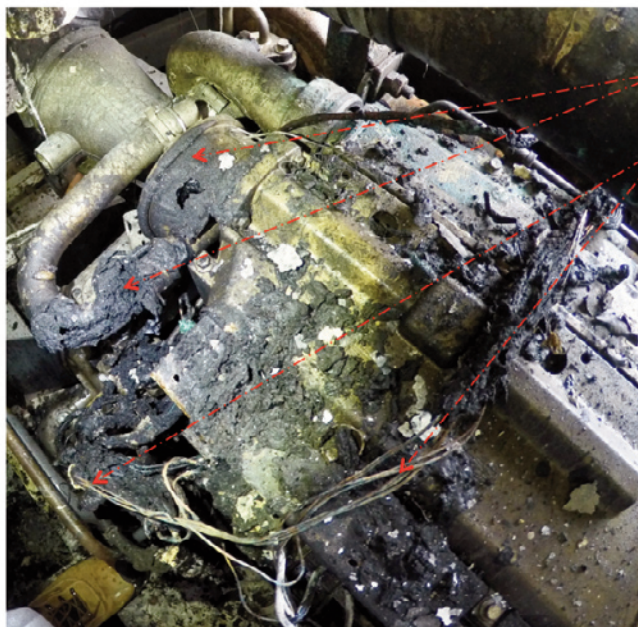
Photograph No. 11 – Drive End of Engine

Intake Boot & Breather hoses.

Engine Control Cables

Totally Damaged beyond repair.

- See Appendix 7.7 - Photographs No. 3 to No. 11.
- 3.12 Due to the extent of the damage to No.1 engine it was replaced together with the wiring loom and ancillary equipment. Areas of surface coating damaged by heat and smoke were taken back, prepared, and re-coated. These repairs were specified by the company's marine engineer and agreed by the MSO.

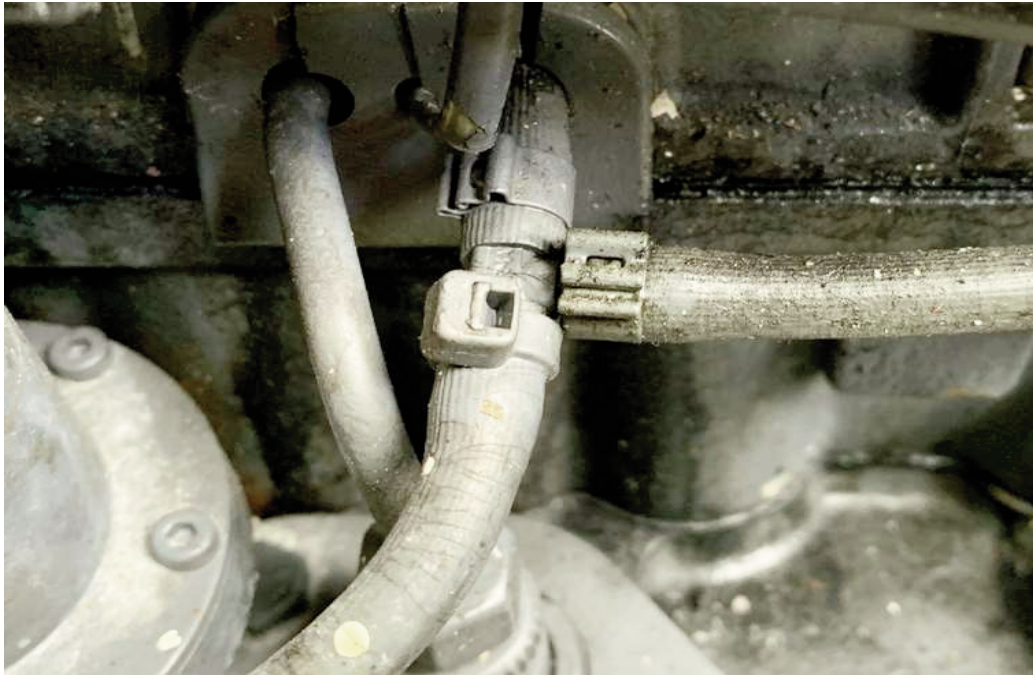
Appendix 7.8 Photograph No. 12 - Return Fuel Line Attachments

- 4.4 The return fuel lines on the main engines on the vessel were seen to be fixed using three distinct methods. The original fixing by the manufacturer was by use of spring clips, but other pipes were attached using cable ties or hose (jubilee) clips. The repair to the fuel line on the morning of the incident was made by fitting a hose clip. This may have contributed to return fuel line failure.

Refurbished Core Engine Fuel Return Hoses,
Typical arrangement.

- 6.1 The owners/operators should ensure that all return line flexible fuel hoses are fixed as per the engine manufacturer's recommendations.
- 6.2 The owners/operators should arrange to have the airflow from the machinery space ducted away from the main car deck and clear of any public areas. This is to ensure that a fire in the machinery space will not impinge on public areas.
