National Transportation Safety Board

Marine Accident Brief

Overtuning of the Liftboat *Kristin Faye*

Accident type	Other	No. DCA19FM050
Vessel name	<i>Kristin Faye</i>	
Location	Gulf of Mexico, Main Pass Block 64, about 18 miles east of Venice, Louisiana 29°18.10' N, 89°03.30 W	
Date	September 8, 2019	
Time	1015 central daylight time (coordinated universal time – 5 hours)	
Injuries	1 minor	
Property damage	\$750,000 est.	
Environmental damage	120 gallons of diesel fuel released (sheen 3 miles x 67 feet)	
Weather	Visibility 10 miles, cloudy, winds northwest at 6-7 knots, seas northwest 1-2 feet, air temperature 85°F, water temperature 82°F	
Waterway information	The Main Pass lease area of the Gulf of Mexico lies northeast of the Pass A Loutre entrance to the Mississippi River and abuts the Louisiana coastline.

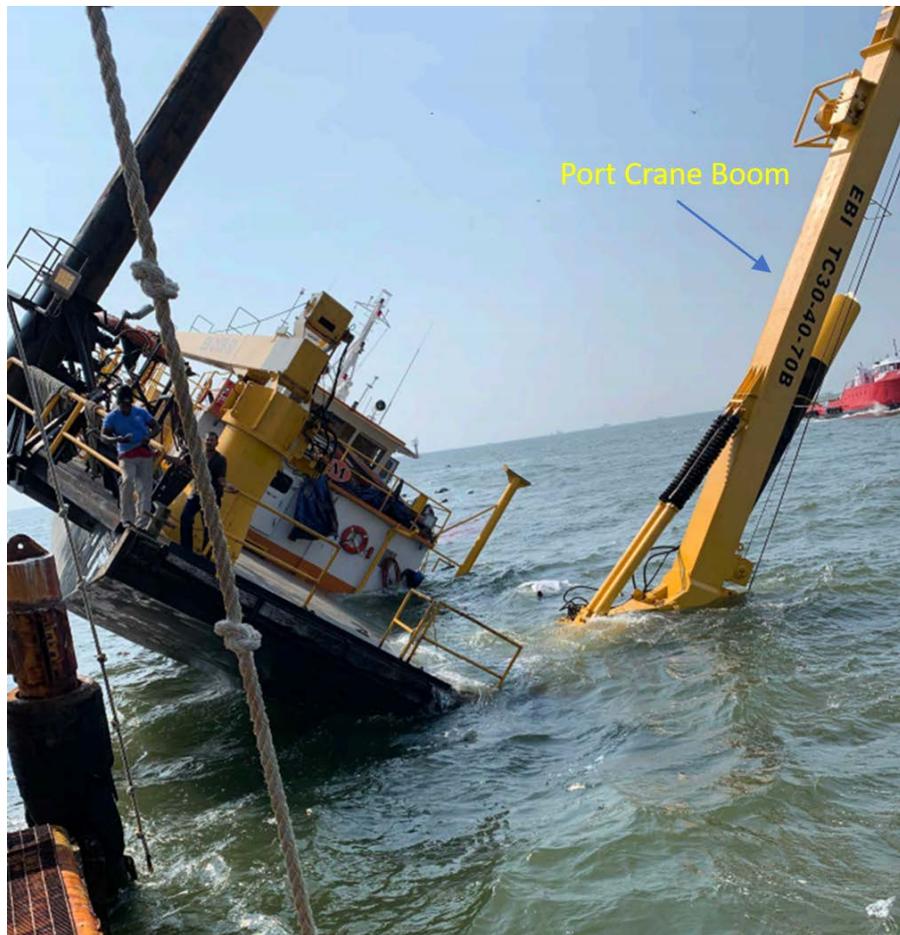
The *Kristin Faye* tilting over into the water with two crewmembers on the starboard side of the bow. (Source: Sanare Energy Partners, LLC)

Because the *Kristin Faye* overturned in less than a minute, it is likely that the seabed below the port leg became unstable, causing the leg to settle very quickly in what is known as a “punch through” in the industry. This caused the liftboat to lean over despite the effort of the captain to raise (retract) the other two legs.

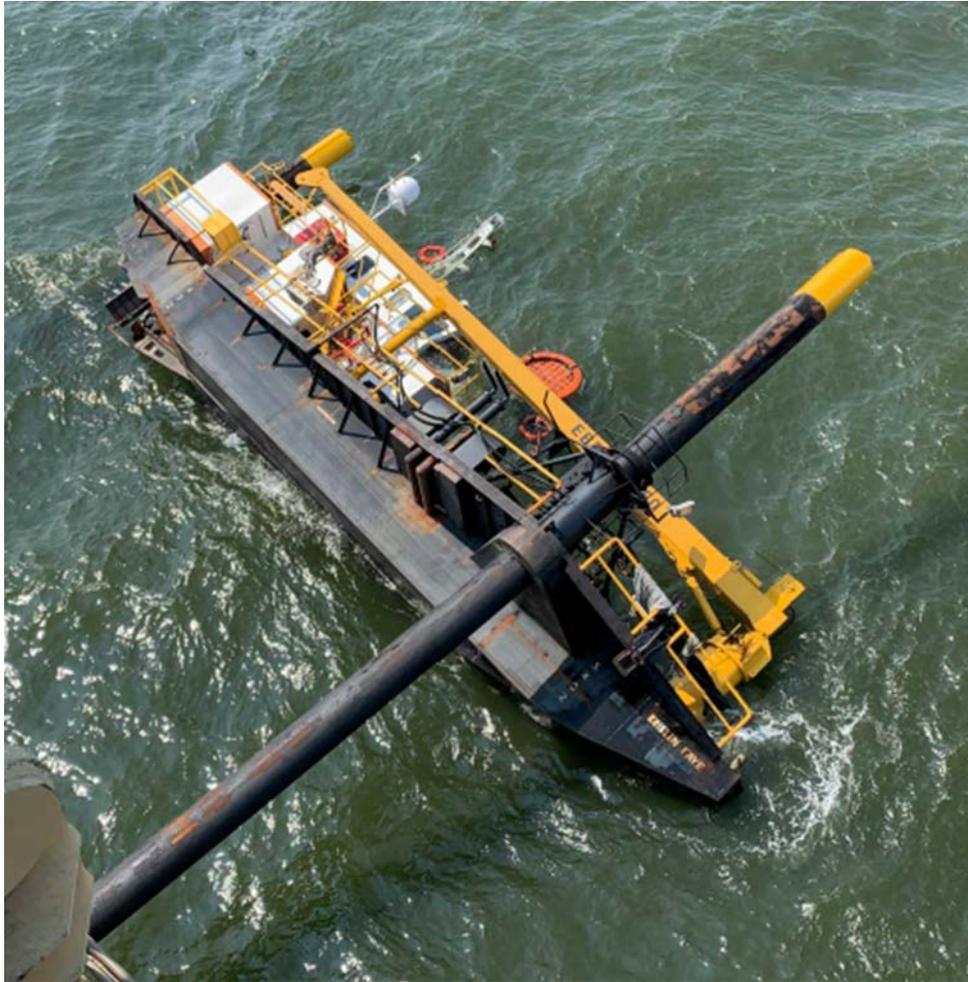
About 5 hours later, the *Kristin Faye* was resting on the seafloor nearly submerged, with just a small part of the starboard bow protruding out of the water. On September 12, a contractor began salvage operations. Salvage divers reported that the port leg had penetrated roughly 40 feet down into the mud, and the port side of the vessel was completely embedded in the mud. Salvage operations continued daily; however, challenging weather conditions impeded a successful salvage. On September 13, the vessel's owner declared the *Kristin Faye* a total constructive loss, with estimated cost of damages at \$750,000. The salvage company was eventually able to right the *Kristin Faye* and transport it to a scrapyards in Belle Chase, Louisiana, where it arrived on October 7.

Starboard side of the toppled *Kristin Faye*, taken from *Platform AQ*. (Source: Sanare Energy Partners, LLC)

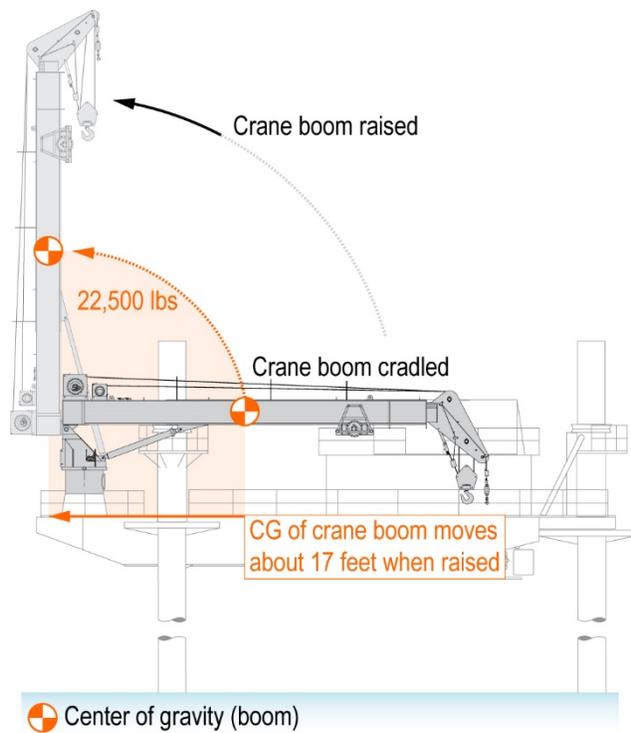
After waiting for an hour at the elevated level, the captain raised the boom. Once the port crane boom was moved from its cradle (horizontal position) to the vertical position, the 22,500-pound boom’s center of gravity shifted about 17 feet toward the port crane pedestal at the forward port corner of the liftboat. With this shift, the weight supported by the port forward leg pad increased due to the boom’s weight shift toward it. The weight supported on the forward port pad increased until the pad suddenly “punched through” the bottom, resulting in the vessel overturning

When the captain raised the *Kristin Faye's* port crane boom, its center of gravity shifted about 17 feet.

The National Transportation Safety Board determines that the probable cause of the overturning of the liftboat *Kristin Faye* was the company's inadequate preload procedure that did not account for crane movements or the planned loads (weights) to be lifted, resulting in a "punch through" of one of the vessel's three legs.

Prior to jacking up to expected operating height and commencing operations, liftboat operators should conduct preload tests, with the hull close to the water, that simulate all planned operational loads.

A preload test should account for the most extreme loading conditions the liftboat will experience at the elevated level. In anticipation of lifting a 17,000-pound pressure vessel onto the platform, the preload test for the *Kristin Faye*, a liftboat without preload tanks, should have included sufficient weights, appropriately placed to replicate the load on each of the pads. For instance, the *Kristin Faye's* preload test could have included locating the boom, with the pressure vessel attached, in the position that would have applied the greatest force on the respective pad.
