SAFETY INVESTIGATION REPORT

REPORT NO.: 03/2023

MT PEARL LNG

Serious injury to three crew members during maintenance work on the fire jockey hydrophore tank in position 46° 53.9' N 006° 41.2' W 23 February 2022

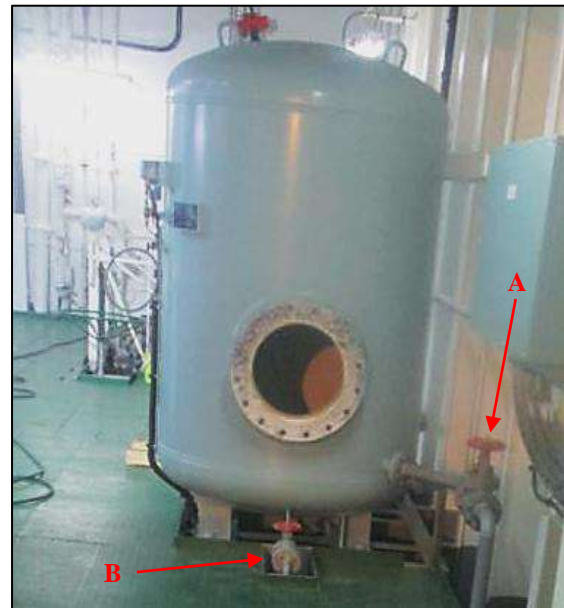
Figure 4: Hydrophore showing the discharge valve (A) and drain valve (B)

Soon after, the jockey pump was disconnected and engineer 3/E_B opened the drain valve (**Figure 4**).

Some water was observed escaping from the drain outlet. Considering the weight of the pump, engineer 3/E_A went to the engine-room workshop to get a stop, chain blocks and a trolley. Once on the trolley, the jockey pump was transferred to the workshop to be overhauled at a later stage.

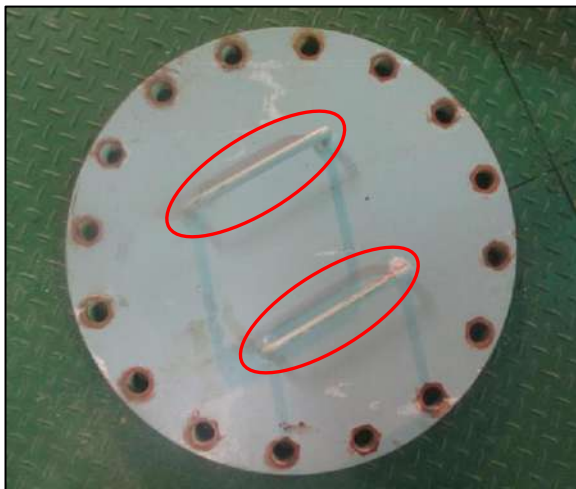
Figure 5: Inspection cover lifting handles

The chief engineer hammered the inspection cover hard to break the seal to the flange face on the hydrophore. Initially, the inspection cover did not dislodge. However, following either the second or third strike by the hammer, the inspection cover dislodged abruptly and forcefully. Still holding to the inspection cover, the second engineer was

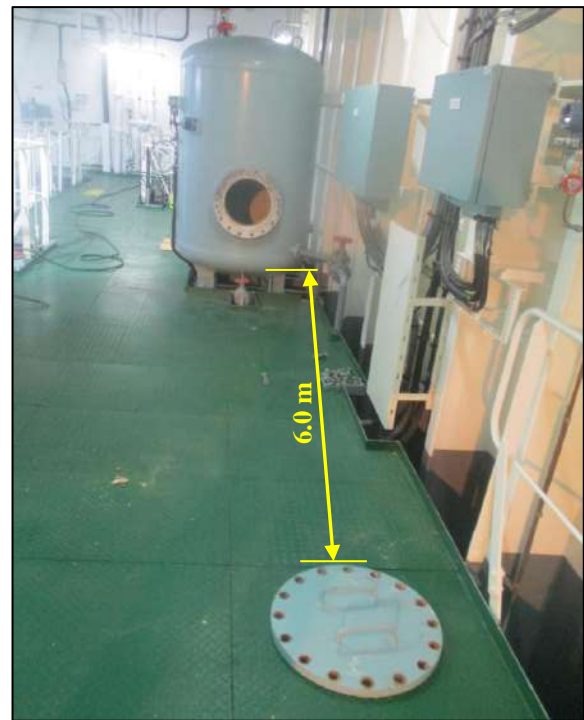
Figure 6: Position of the inspection cover after the accident

pushed several metres away from the hydrophore, until eventually he let go of the heavy inspection cover (**Figure 6**).

The third engineer, standing close by, was missed although the strong rush of air which he felt, contained some debris particles, which hit him in the eyes. The chief engineer was physically hit by the inspection cover, sustaining visible injuries to his leg.

It was immediately clear to the crew members that the ‘violent’ dislodging of the inspection cover could only be the result of a hydrophore whose internal pressure (behind the inspection cover) was higher than atmospheric pressure.

Taking into consideration the effective area of the inspection cover opening and the (residual) pressure inside the hydrophore, the force acting on the inspection cover at the time of the accident was approximately 2.74 tonnes-force (26.88 kN). This force (acting against the second engineer’s chest as soon as the inspection cover was dislodged), was significant, considering also that the inspection cover weighed 54 kg.

The safety investigation concluded that prior to the removal of the inspection cover, the crew members used air to push the water out of the hydrophore but that was not enough to depressurise the vessel.

4. has carried out an internal audit on board the vessel;
5. has placed safety notices on all pressure vessels hatches to prevent improper dismantling and to ensure that safety bolts remain in place until de-pressurisation is completed;

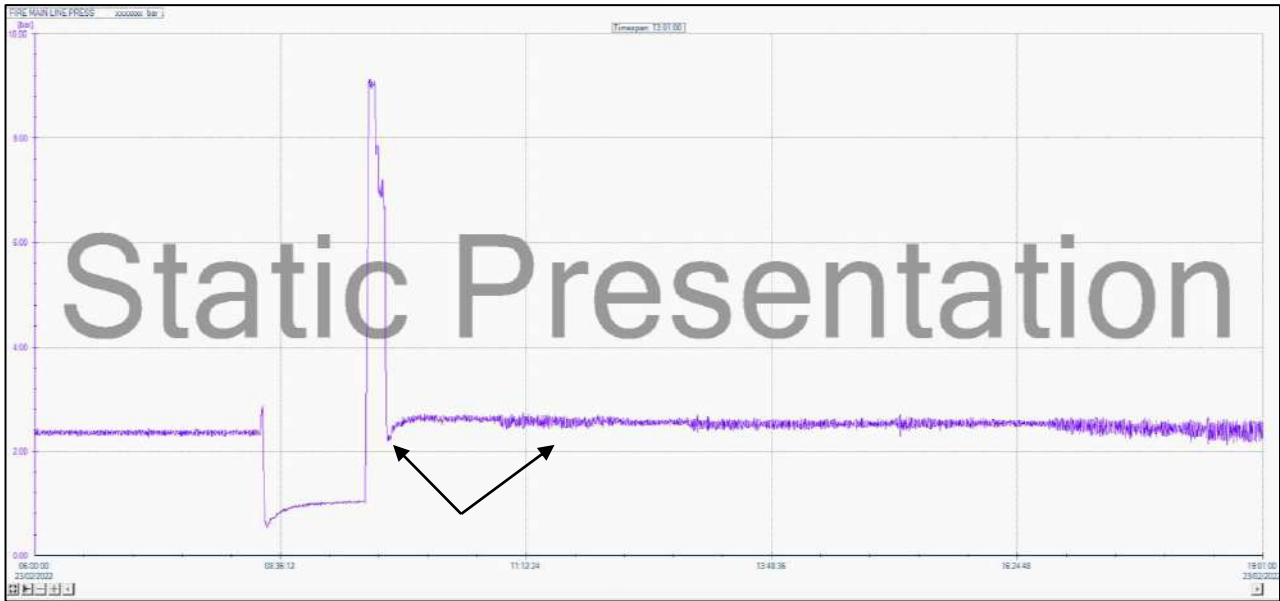
It was noted that the pressure records indicated only 2.5 bar in the fire main at a very early time and before the accident happened (**Figure 7**). However, the system was working well, and the low pressure was merely because the jockey pump had been stopped for the scheduled overhaul later during the day. At 0830, the pressure card indicated a slight pressure peak inside the fire main, attributed to the moment the discharge valve on the hydrophore was opened to push the water inside the line. As soon as the level of water in the hydrophore tank dropped to the height of the discharge valve, air from the hydrophore escaped through the valve to the fire main, resulting in a ‘false’ reading of 0.5 bar.

Figure 7: Pressure trend, showing a fire main pressure of approximately 2.5 bar (discharge valve was closed)

It was also noticed that at about 0930, the pressure in the fire main increased to 9.0 bars. This increase in pressure was due to the starting of the fire and general service pump when water was required on deck. The pump was only run for about 10 minutes, following which, it was stopped, and the pressure dropped again to 2.5 bar.

Pearl LNG had the anchor wash valves open⁶. Nonetheless, the pressure gauge still read 2.5 bar before the accident happened. This was attributed to the height between the engine-room flat, where the hydrophore was fitted, and the location of the main fire line on Deck A. The vessel's drawings showed that the difference in height was about 27 m, *i.e.*, the system had a water column of about 27 m, explaining the 2.5 bar of pressure read by the transmitter.

An efficient way to reduce the 2.5 bar pressure in the fire main was to open a fire hydrant in the engine-room (opening the drain valve on the hydrophore would not have helped because the hydrophore and the fire main were connected through a screw-

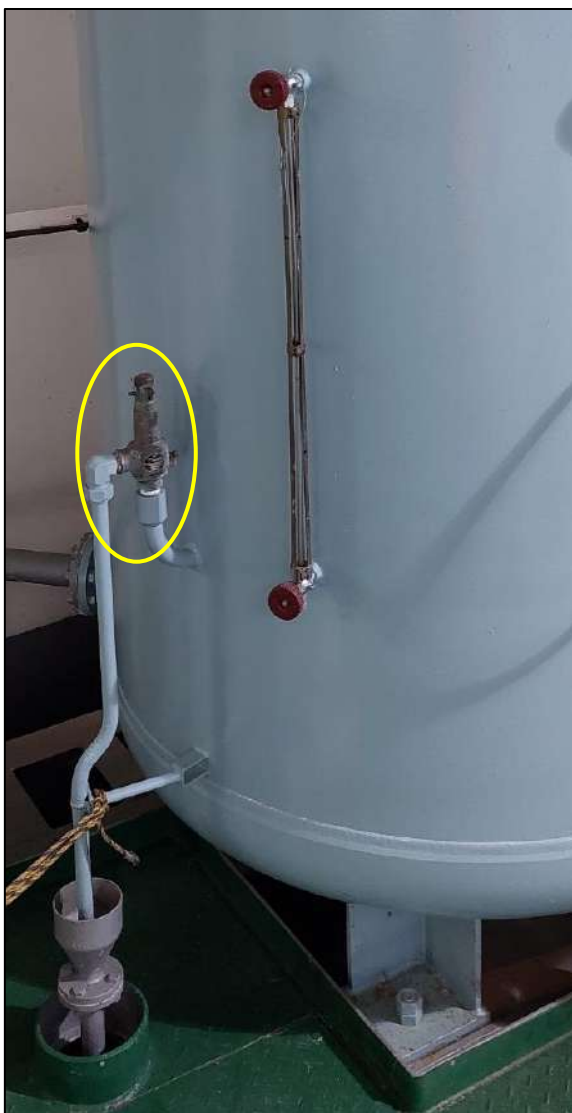
Figure 8: Safety valve to bilges

The hydrophore's safety valve (**Figure 8**) post-accident popping test confirmed that the valve was stuck in the closed position and did not open at the set pressure of 9.9 bar. In fact, the valve eventually opened at a pressure of 14.0 bar. It was also confirmed that manual release of the pressure through

the safety valve (by operating the attached lever) was not possible.

The safety investigation believes that the stuck guts of the safety valve did not contribute to the accident in a direct way. However, it misled the second engineer when he ‘operated’ the safety valve. Observing no relief of pressure (accompanied with a previous drop in the water level observed in the sight glass), he thought that the hydrophore was at atmospheric pressure and therefore safe for the engineers to open the inspection cover.
