Report on the investigation of  
the capsize and full inversion of the self-righting keelboat

**RS Venture Connect sail number 307**

resulting in the death of a disabled sailor  
on Windermere, Cumbria

12 June 2019

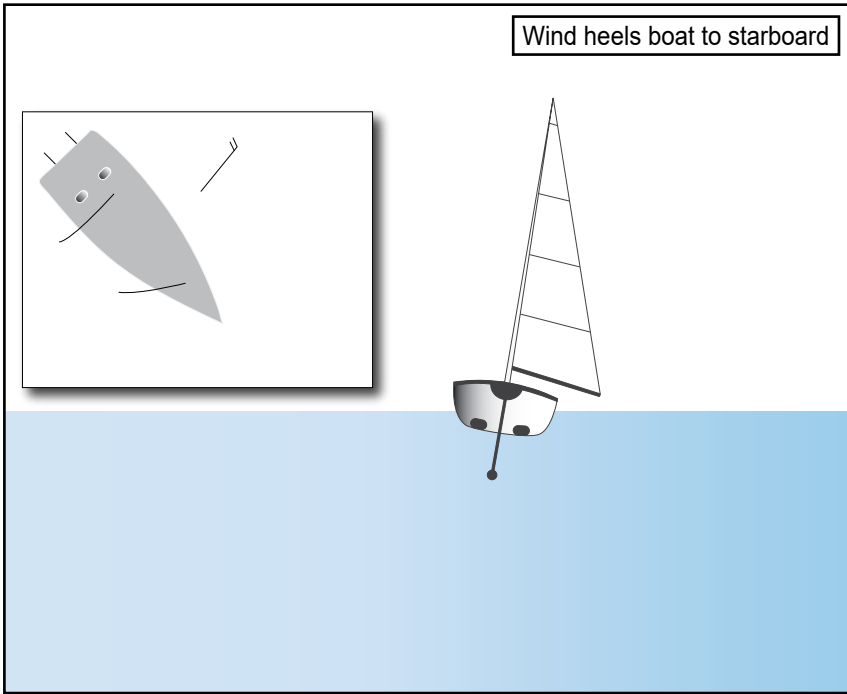
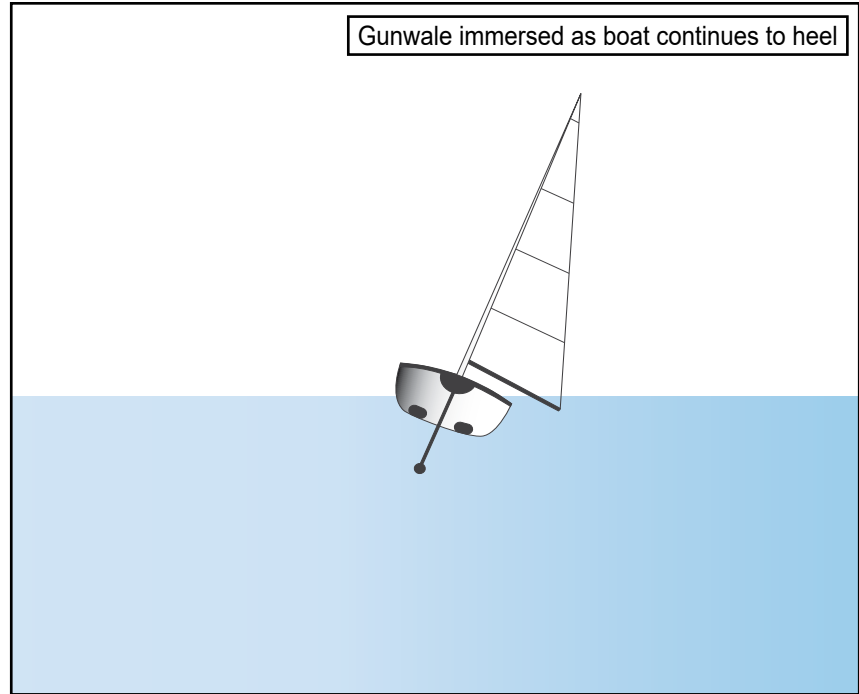
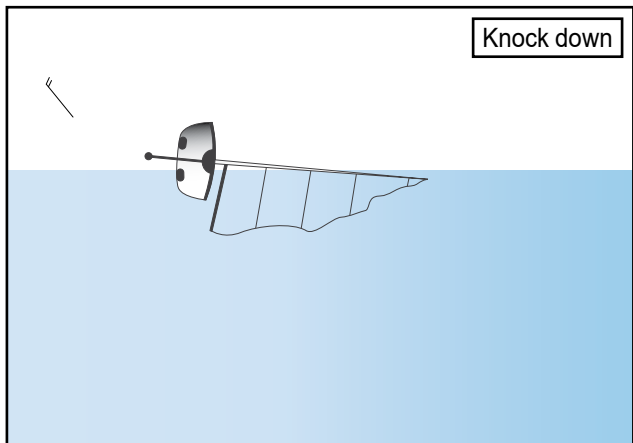
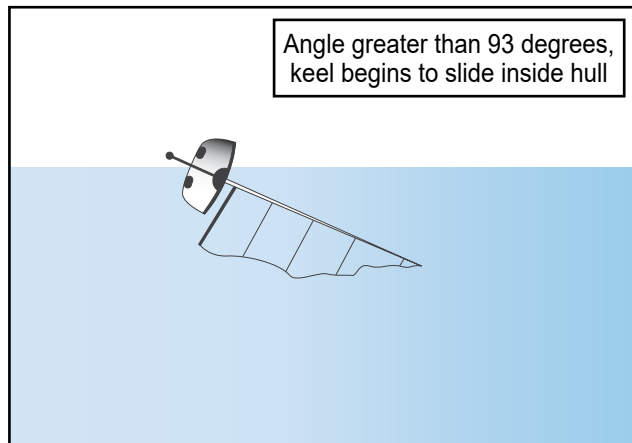
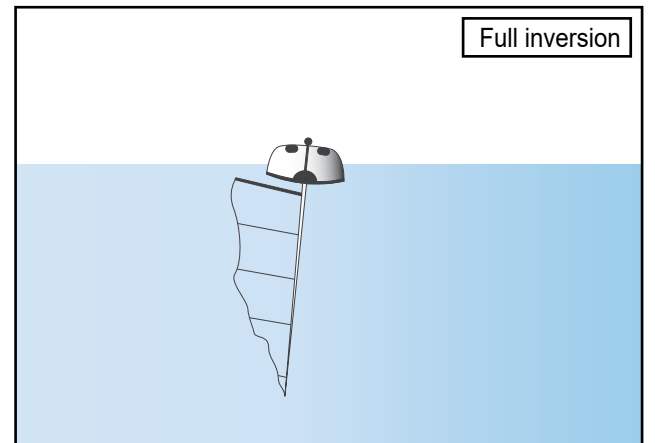
Figure 4: Diagram of inversion

After a few seconds on its side, *RSVC 307* inverted completely (**Figure 4**). As it did so, Stephen and his crewman were caught under the boat's upturned hull. Almost immediately, the crewman pushed himself out of his seat and swam clear as his lifejacket automatically inflated. Once clear, he could not see Stephen and realised that he must be trapped under the upturned hull. Knowing that there would be very little space for an air pocket, the crewman took hold of the port side of the boat and tried to lift its gunwale.

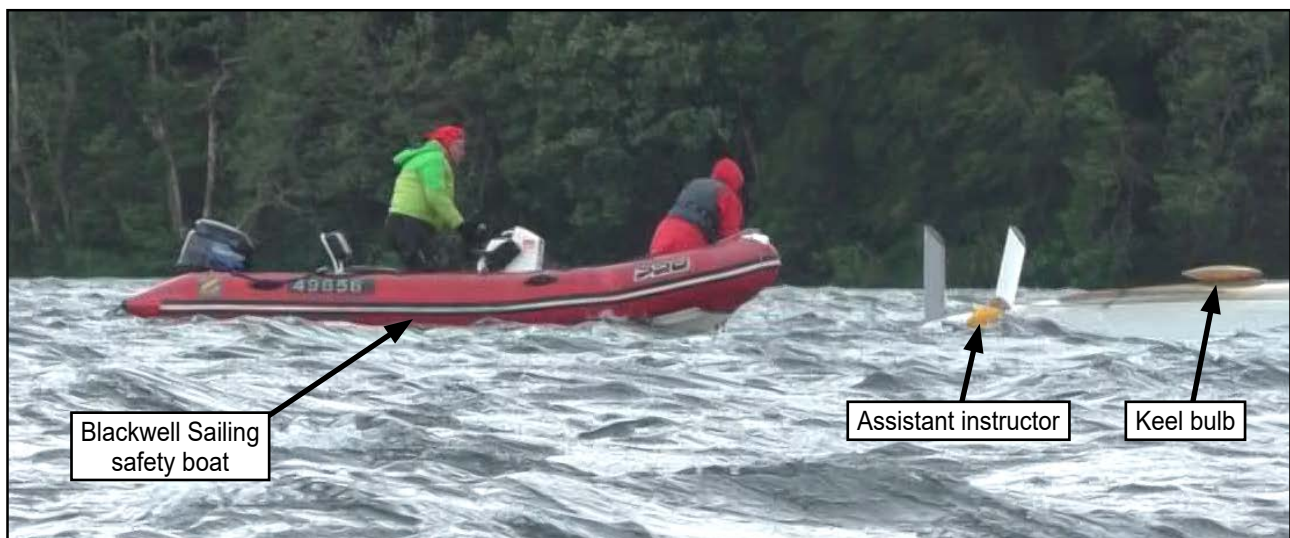
**Figure 5:** *RSVC 307* inverted showing keel bulb – still from video footage

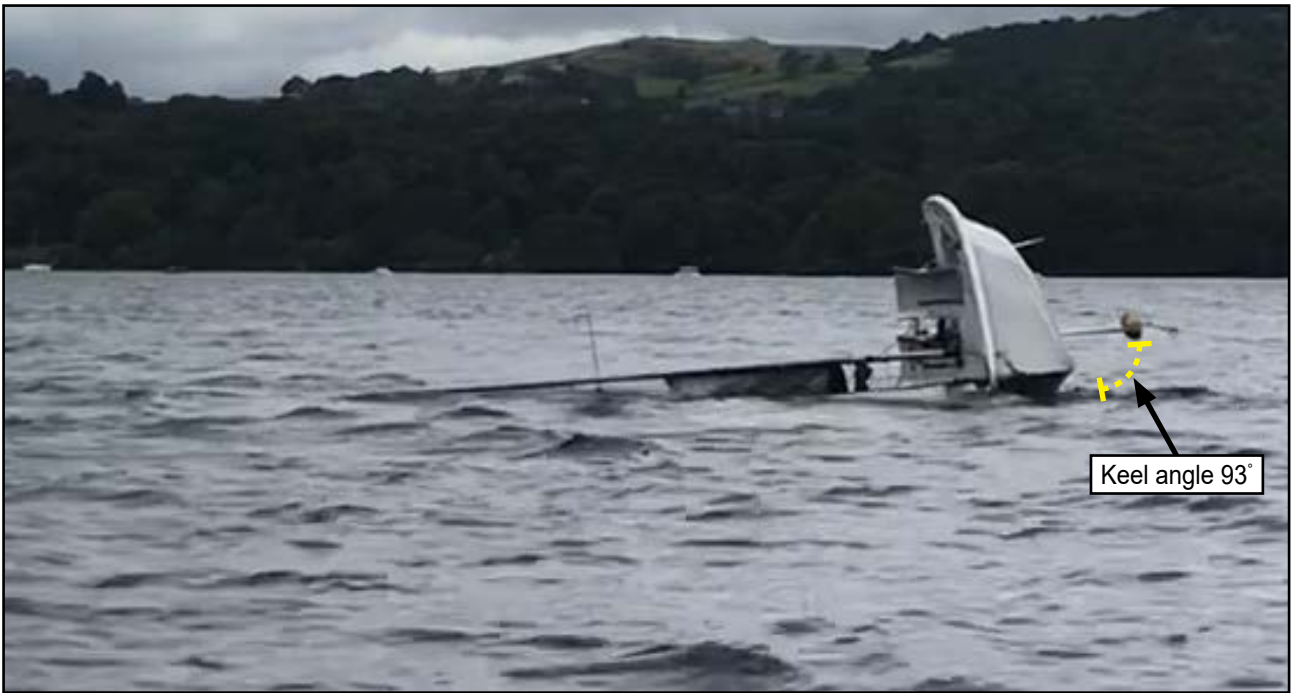
**Figure 10:** RS Venture Connect at 93°

1. Be heeled over to an angle exceeding  $93^\circ$ , at which point an un-restrained keel would retract into the hull under its own weight, and the boat would invert fully (**Figure 10**).
2. With the keel strap in place, the keel would remain deployed and the boat would quickly self-right from its knocked down position.

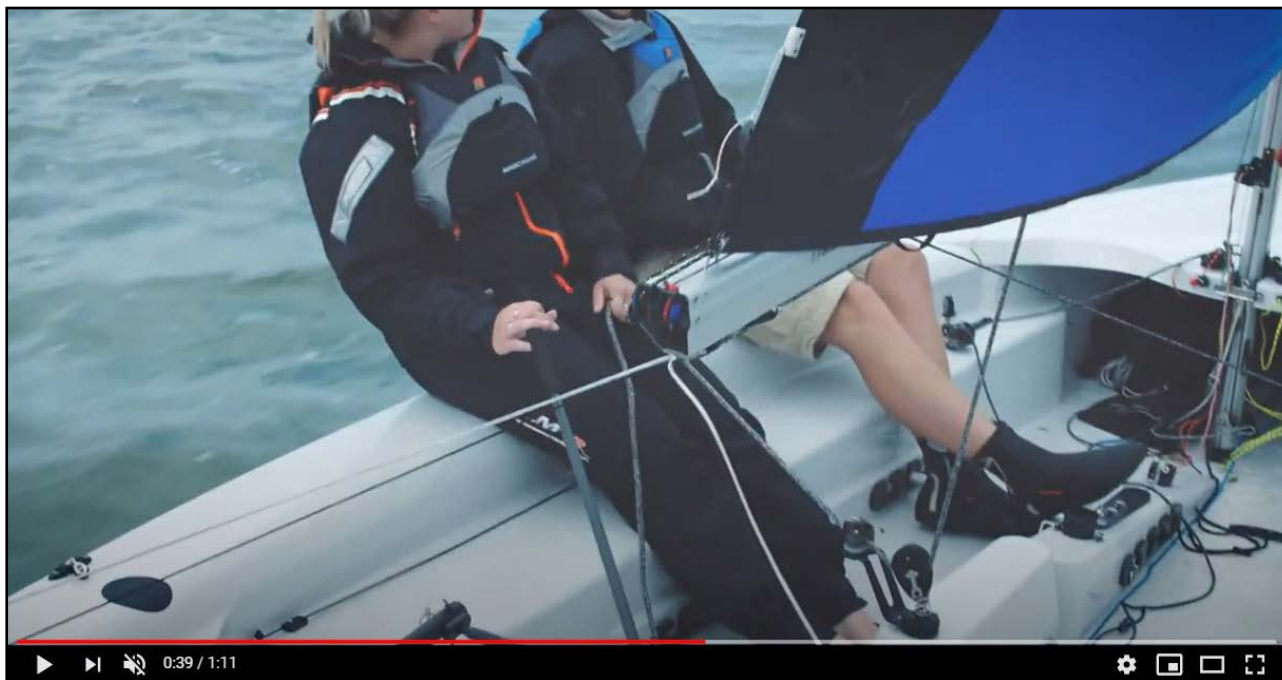
In the context of the activities at Blackwell Sailing, the predominant use of the Lune Whammels for sailing, and the Rigging Guide being available only online, it is easy to see how the keel strap could be overlooked. Of note, RS's own promotional video for the RS Venture Connect also showed the boat being sailed without the keel strap in place (**Figure 18**).

**Figure 18:** Still taken from RS Venture Connect's promotional video
