Flooding and foundering of the fishing vessel *Ocean Quest* (FR 375) 70 miles north-east of Fraserburgh on 18 August 2019

SUMMARY

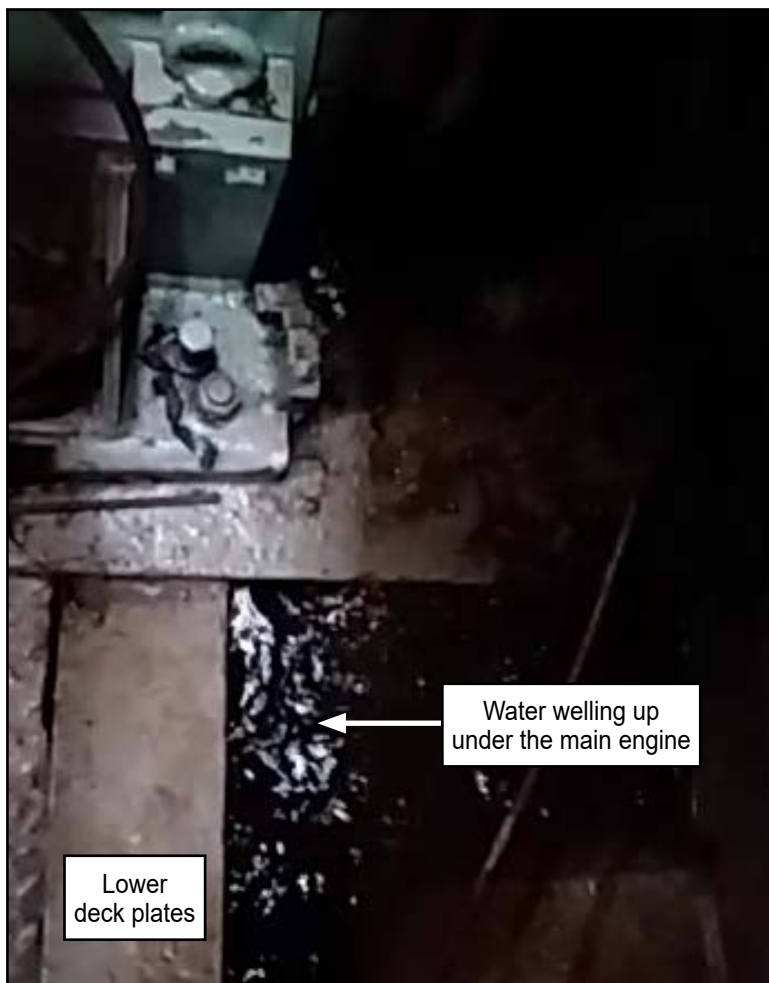
When the skipper arrived in the engine room, he saw the water in the bilges and also observed that it was welling up underneath the main engine. The skipper knew that a serious situation was developing and instructed the deckhand to set up the port general service pump to draw from the engine room bilge, and to start the pump. The skipper also took a short video of the flooding on his mobile phone (**Figure 2**).

Figure 2: Water welling up under the main engine (image retrieved from the skipper's mobile phone)

Given the evidence available, especially the observation of water welling up underneath the main engine, it is almost certain that the flood was a shell plating or weld failure beneath the main engine.

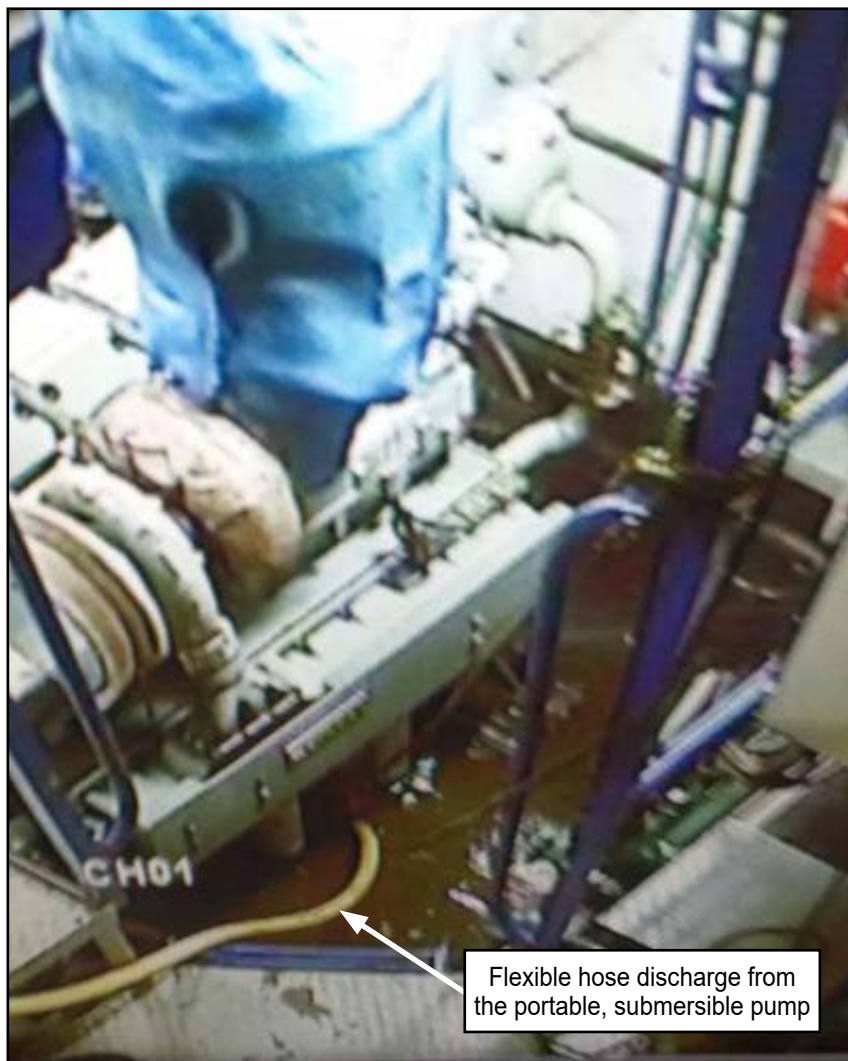
The floodwater continued to rise in the engine room and the skipper stopped the main engine when the water started splashing around the compartment from contact with the flywheel. At 0625, *Ocean Quest's* skipper informed the coastguard that the flooding had not been brought under control and that the water level was halfway up the side of the engine and rising (**Figure 3**). The starboard auxiliary engine, which was supplying electrical power, stopped when it became flooded by the rising water. The skipper then started the port auxiliary engine and connected its generator to the vessel's switchboard to supply electrical power to the general service pumps.

Figure 3: CCTV image showing floodwater about halfway up the main engine (image retrieved from the skipper's mobile phone)

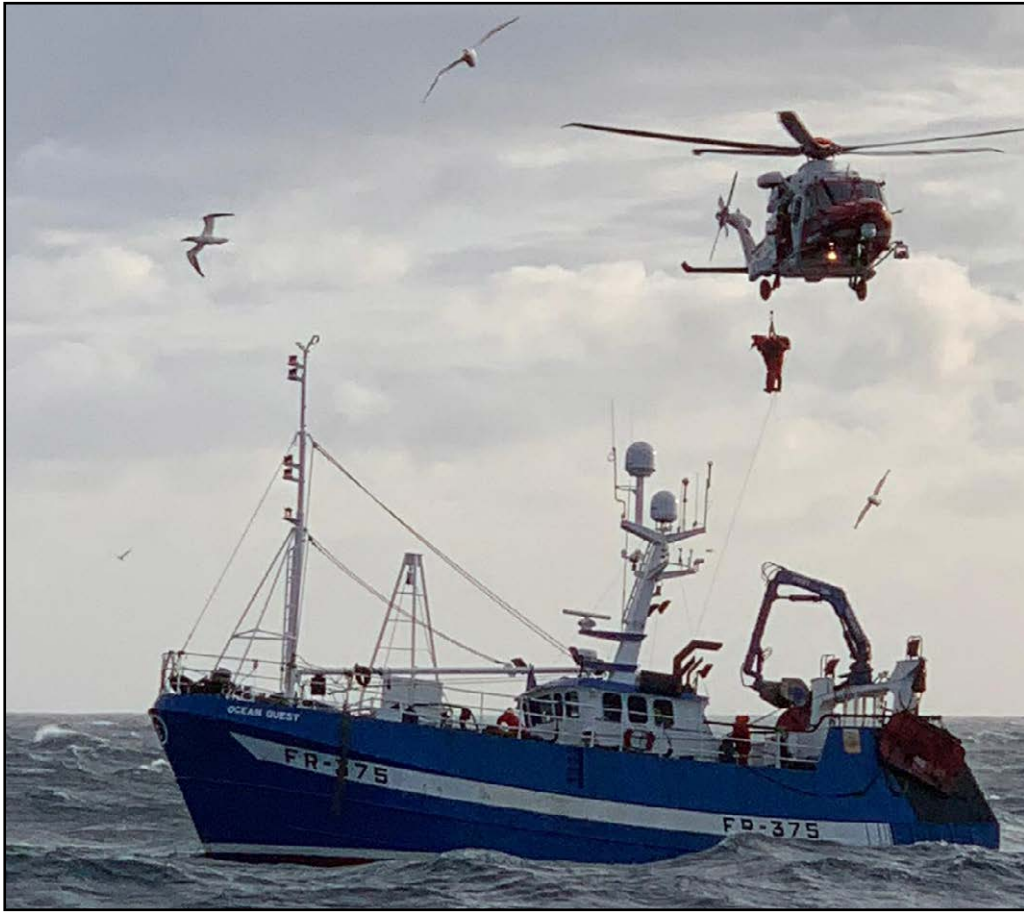
pump. Two of *Ocean Quest's* crew were then winched up into the helicopter (**Figure 4**). Although the helicopter's salvage pump was working effectively, it was apparent to the skipper and helicopter winchman that it was having little effect. By this time, floodwater had entered the cabin space and *Ocean Quest* had developed a significant list to starboard (**Figure 5**).

Figure 4: Crew being winched up to the rescue helicopter

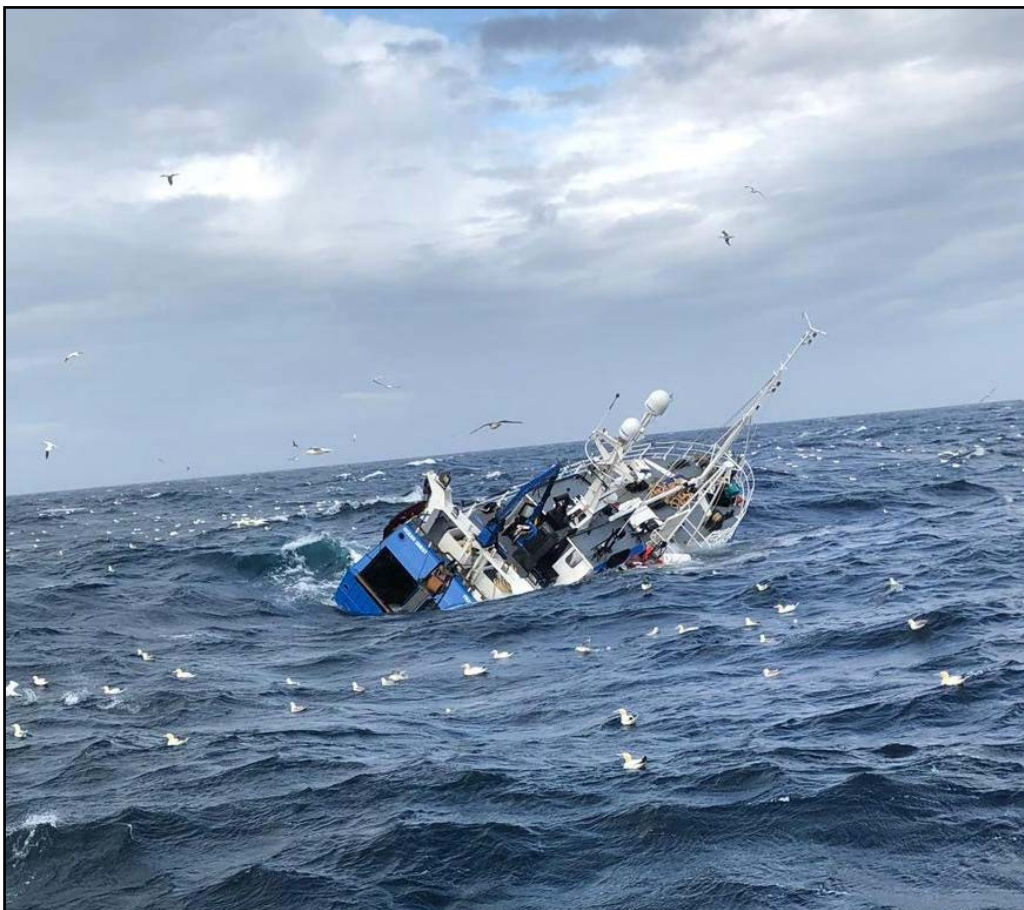
Figure 5: *Ocean Quest* listing heavily to starboard prior to foundering

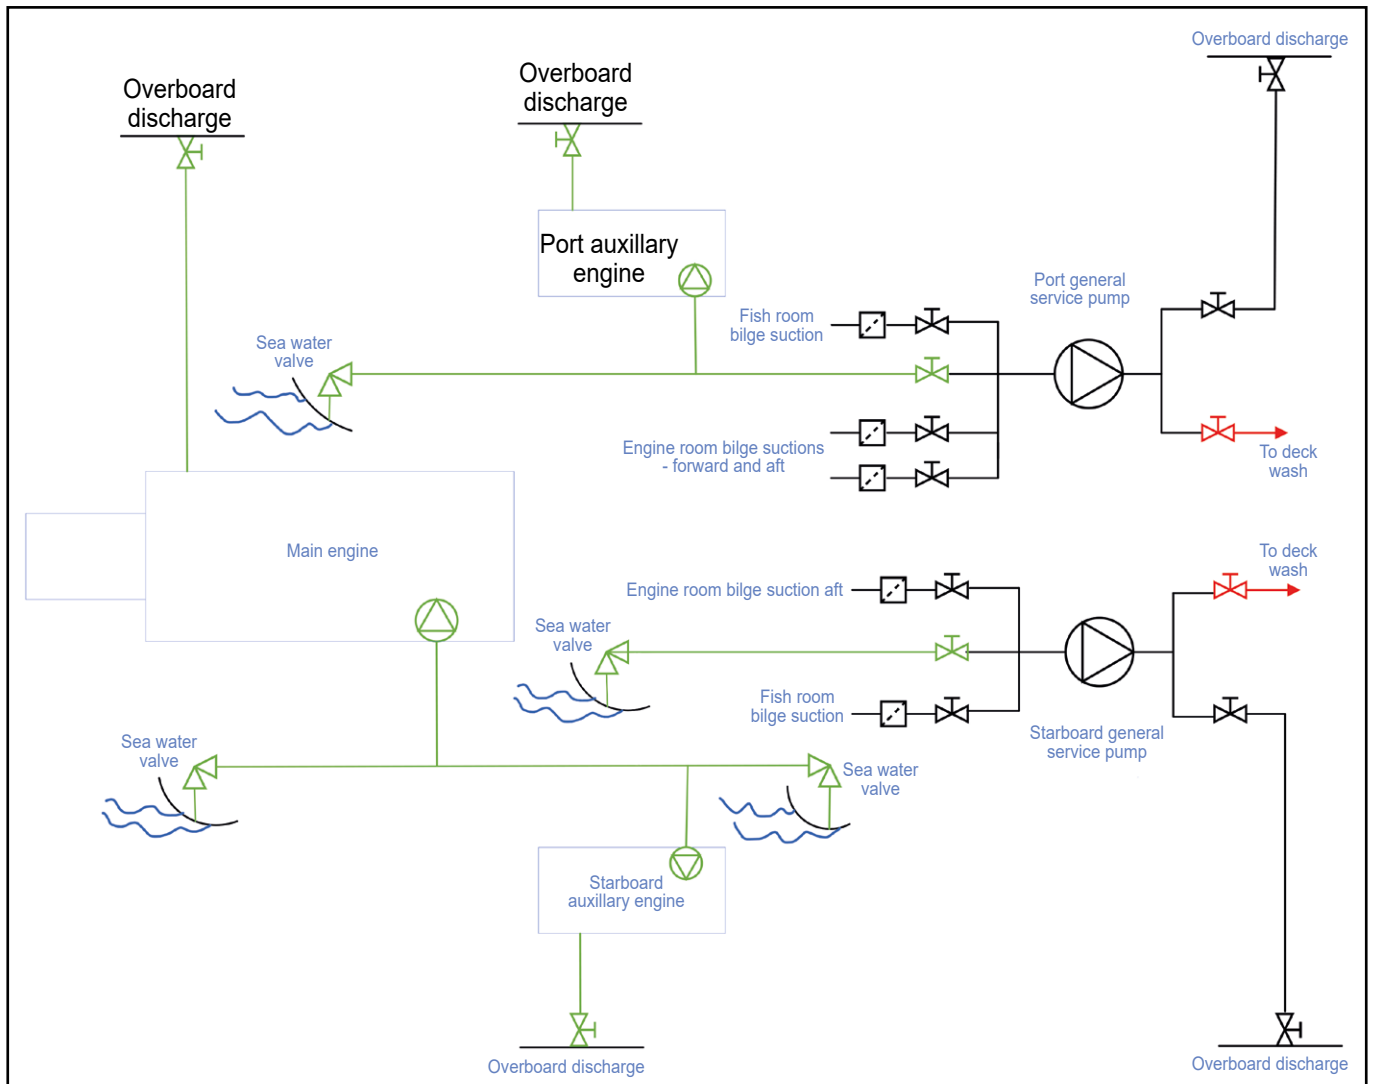
Figure 7: Simplified sea water and bilge system

Pipework below the engine room lower floor plates was restricted to the sea water valves and risers; the remaining sea water pipework was above the lower floor plate level. All the sea water valves were open at the time of the accident. Sea water for the general service pumps entered via the sea water valves, then a sea water suction that was part of a system valve block on the port and starboard sides. A simplified schematic diagram of the sea water system is at **Figure 7**.

The starboard general service pump was located at the engine room's intermediate level adjacent to the starboard auxiliary engine and was primarily used by the crew for bilge pumping. The port general service pump was located at the lower plate level adjacent to the main engine, and the crew used it primarily for deck washing. Each pump had a dedicated bilge suction line drawing water from the engine room's aft bilge well and the fish room. The port pump also had a suction line from the forward engine room bilge well (**Figure 7**). Each suction line was fitted with a strainer.

Although the skipper had checked that both bilge pumps were working by sighting the discharges over the vessel's side, their effectiveness would have been reduced from their maximum capacity because the sea suction were left partially open. Under normal circumstances, the onboard practice was to open the sea suction as well as the bilge suction when pumping bilges. The purpose of this was to protect the pump and system from running dry when pumping out relatively small volumes of water. However, this could lead to a situation whereby the bilge pump was simply pumping sea water and not bilge water. On this occasion, once the bilge pump was running, shutting the sea suction would have ensured maximum emergency pumping capacity.

- The effectiveness of the general service pumps to remove the floodwater would have been degraded by leaving the sea suction valves partly open; a common practice on board for routine draining of bilges, but not appropriate during a flooding emergency.
