## Carbon monoxide poisoning on board motor cruiser *Diversion*, resulting in two fatalities at the Museum Gardens quay, River Ouse, York on 4 December 2019

### SUMMARY

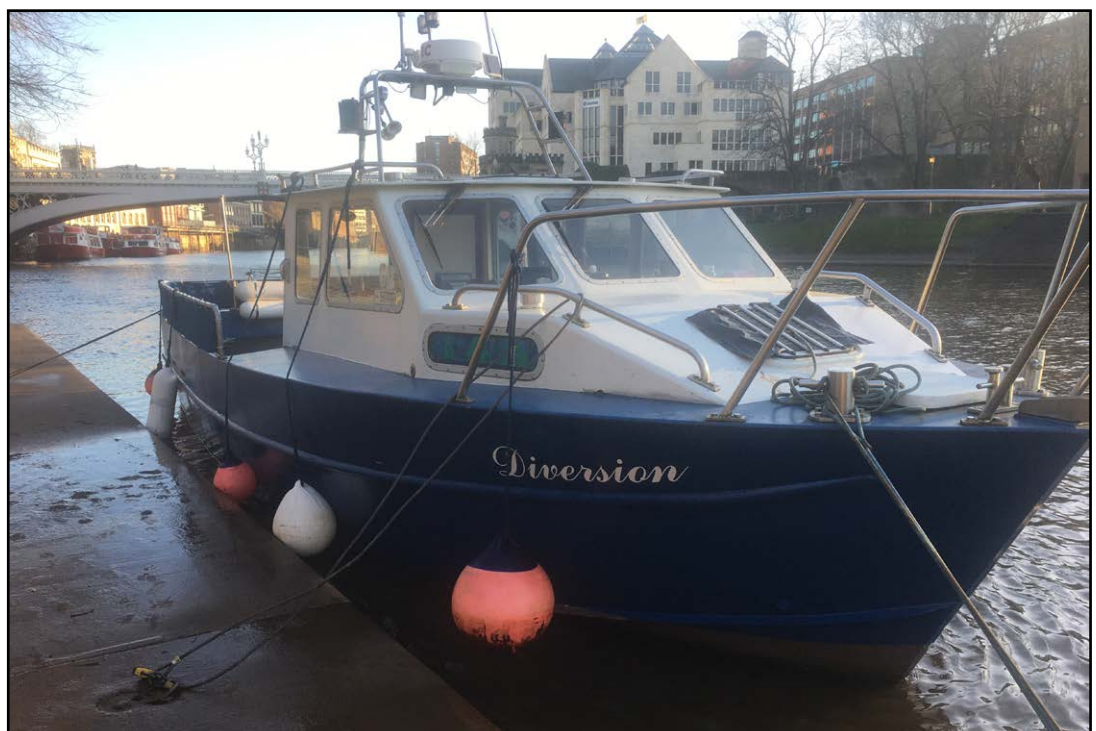
At about 2000 on 4 December 2019, the bodies of two men were discovered in the forward cabin of the 9.14m motor cruiser *Diversion*, which was moored to a quay on the River Ouse (**Figure 1**) in the centre of York, England. The bodies were those of the vessel owner and his friend who had spent the previous evening in the city centre socialising with former work colleagues and were spending the night on board. Both men had died as a result of carbon monoxide poisoning.

Figure 1: *Diversion* moored in York

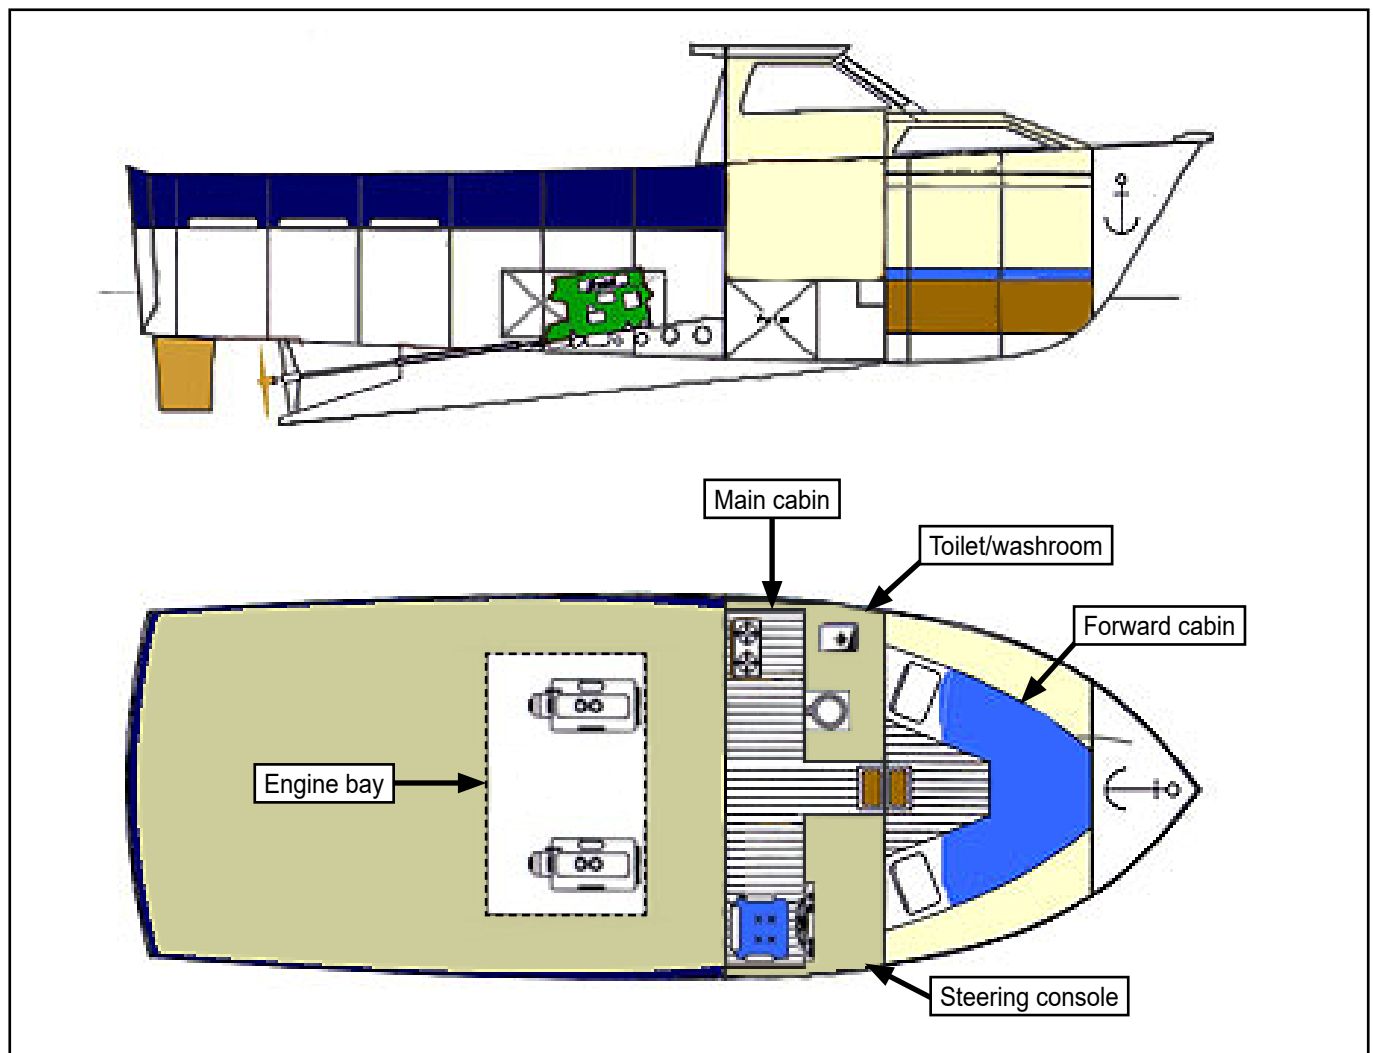
*Diversion* was a 9.14m steel hulled boat (**Figure 2**) that had been built by its owner based on plans purchased from boat designer Bruce Roberts. The owner had started the construction of *Diversion* in 1990 and built it over a period of 11 years on land behind his home. The boat was launched at York Marina in 2001, where it was based for the next 19 years. The owner used *Diversion* predominantly on the River Ouse, and frequently entertained family and friends on board.

During the build, the owner had made several alterations to the design, which included the installation of a second engine and changes to the cabin arrangements. The forward cabin was fitted with twin bunk beds and was wood lined, but it had no thermal insulation to the hull. The steering wheel, engine throttles and engine control console were located on the starboard side of the main cabin, and there was a 4kW<sup>1</sup> twin burner methyated spirit stove on the port side. In 2018, the owner fitted a second-hand diesel-fuelled cabin heater that he had purchased from an auction website. The owner had also purchased a portable petrol generator and coupled it up to a 24V battery charger in the engine space. Two spare back-up batteries had been placed in the engine bay by the owner before they left York Marina.

**Figure 2:** *Diversion* general arrangement

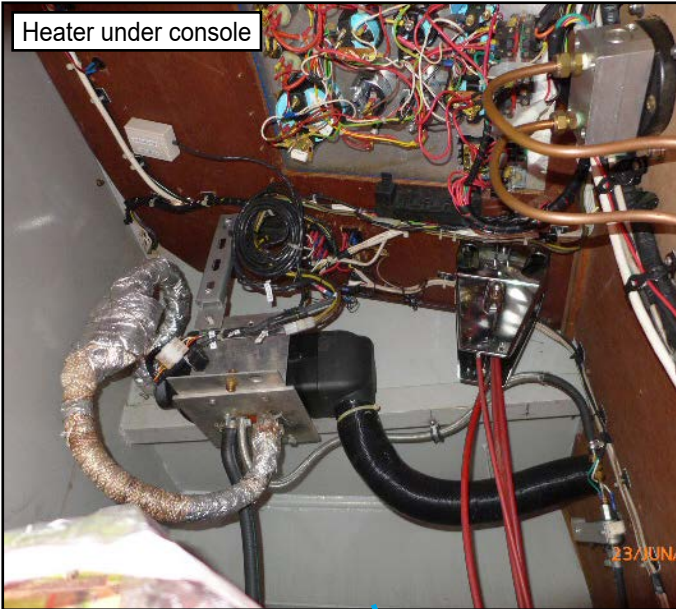
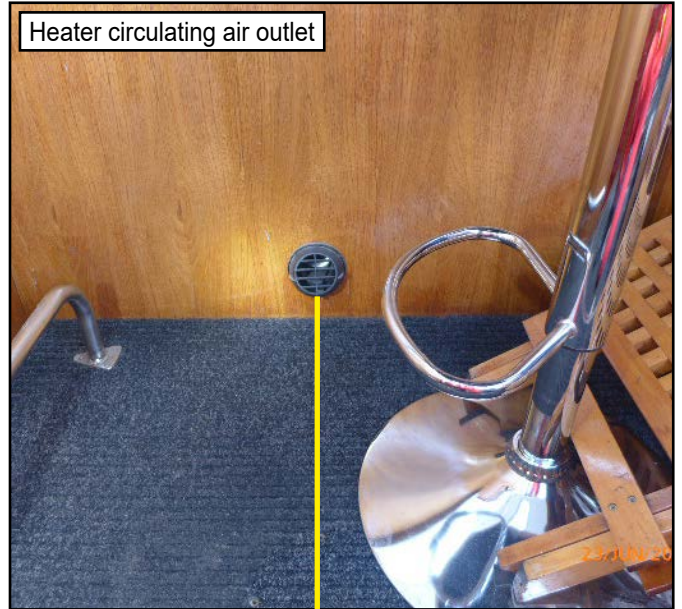
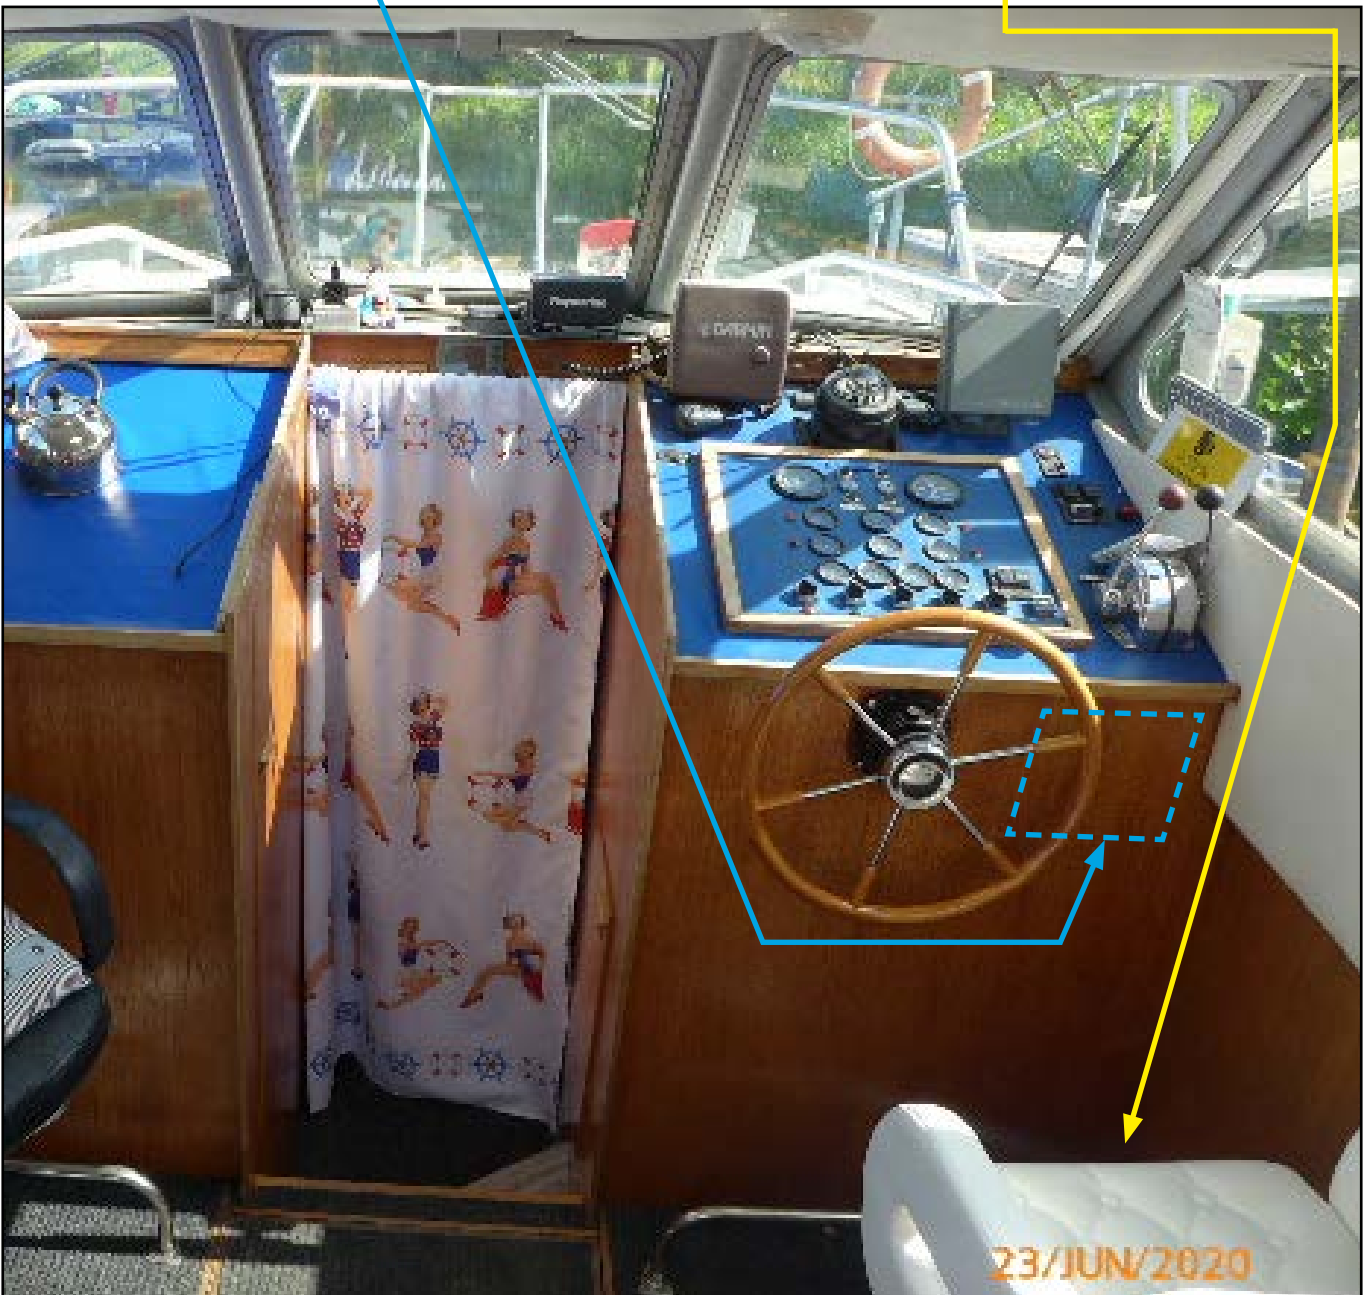
*Diversión's* cabin heater was an Eberspächer 1.8kW D1LC air heater. It was installed in a cabinet in the main cabin beneath the steering console and was operated from a panel mounted on the top of the console. Circulating air was drawn from inside the cabinet, warmed by the heater, and discharged to the boat's main cabin via a nozzle mounted at deck level next to the steering position (**Figure 3**). The cabin temperature was set by means of an adjustable control knob, and the heater started and stopped thermostatically. The heater also drew its combustion air from inside the cabinet, and a pump supplied diesel fuel from the boat's port side fuel tank. The fuel/air mixture was burned in the heater,

Figure 3: Installation of *Diversion's* cabin heater

and the exhaust gases containing CO and carbon dioxide (CO<sub>2</sub>) were discharged outside via a silencer connected to a through-hull fitting on the starboard side. The exhaust system was fully insulated with heat proof fibreglass and covered by foil tape.

The manufacturer's installation instructions, available via the internet, provided guidance regarding the requirements of the heater's fuel system, exhaust, combustion air, electrical connection and circulating air. It is unknown if the owner read the instructions before he installed the heater and there was no record to indicate the installation was checked by an approved Eberspächer agent, or of the heater being serviced since it was fitted.

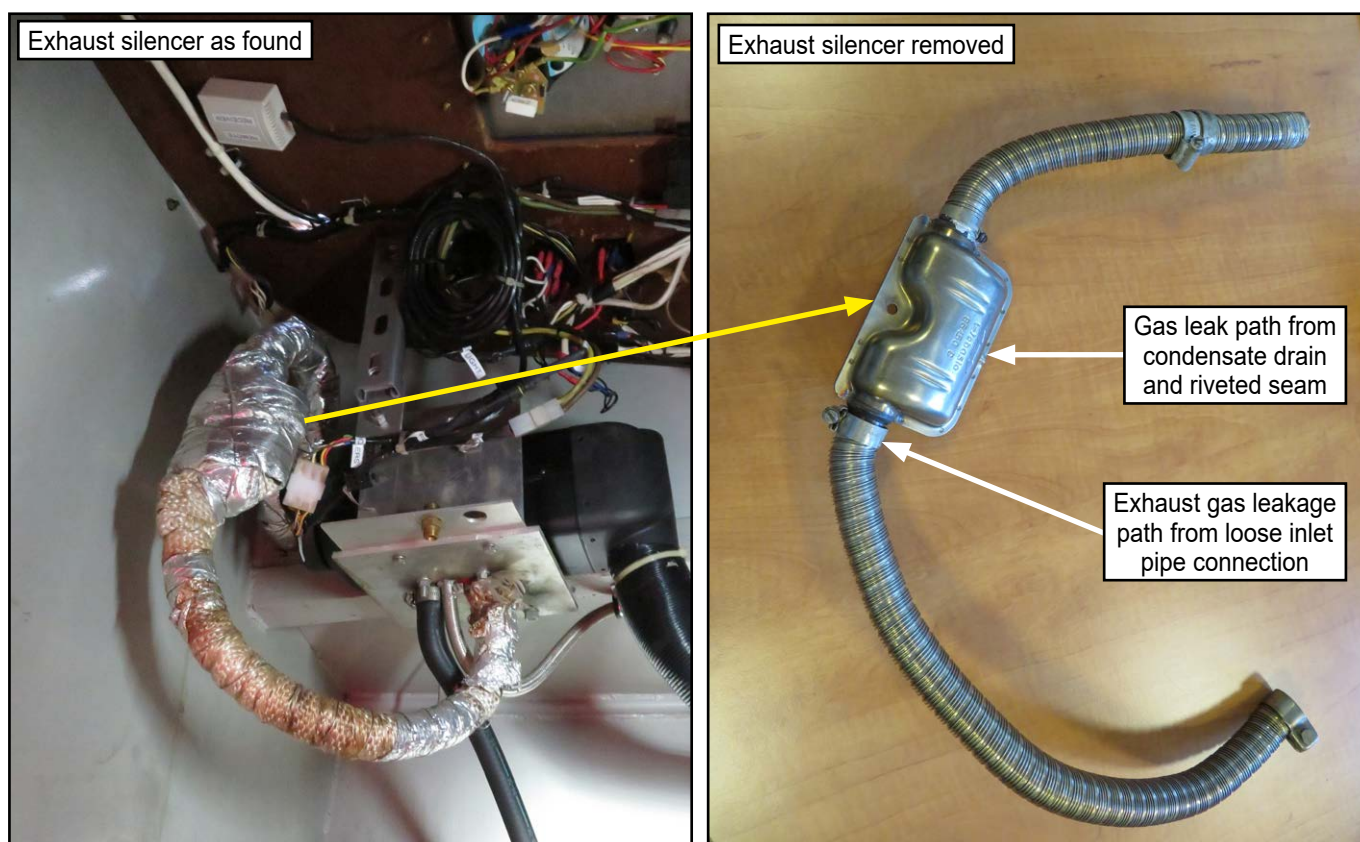
The heater's exhaust lagging was removed to enable closer inspection of the system, which comprised of a Webasto exhaust silencer, connected to the heater and boat's side via flexible pipes. The Eberspächer heater exhaust port had a 24mm outside diameter stub pipe, but the Webasto silencer inlet had a 22mm outside diameter stub pipe. This meant that the two sizes were incompatible, and the flexible exhaust that connected the heater to the silencer was loose, and leaked exhaust gas. In addition, the silencer had spot welded seams and a condensate drain hole, which also leaked exhaust gas when the heater ran (**Figure 4**).

**Figure 4:** Gas leak path from condensate drain and spot welded seam

It is not known whether the Webasto exhaust silencer was an original fit to a previous heater, was supplied with the replacement Eberspächer heater unit, or was purchased separately. However, the silencer was not approved for marine use and was designed to be fitted externally. The gas leaks from its body, the condensate drain hole, and from the loose pipe connection, were obscured by the exhaust insulation and were probably not noticed by the owner when he installed the heater.

An Eberspächer service agent appraisal of the heater installation, which is recommended by BSS, would probably have highlighted the issues with both of these items. Also, a service agent's circulating air test from the running heater would have shown the presence of CO, and both of these areas of concern would have been pointed out to *Diversión*'s owner for rectification.

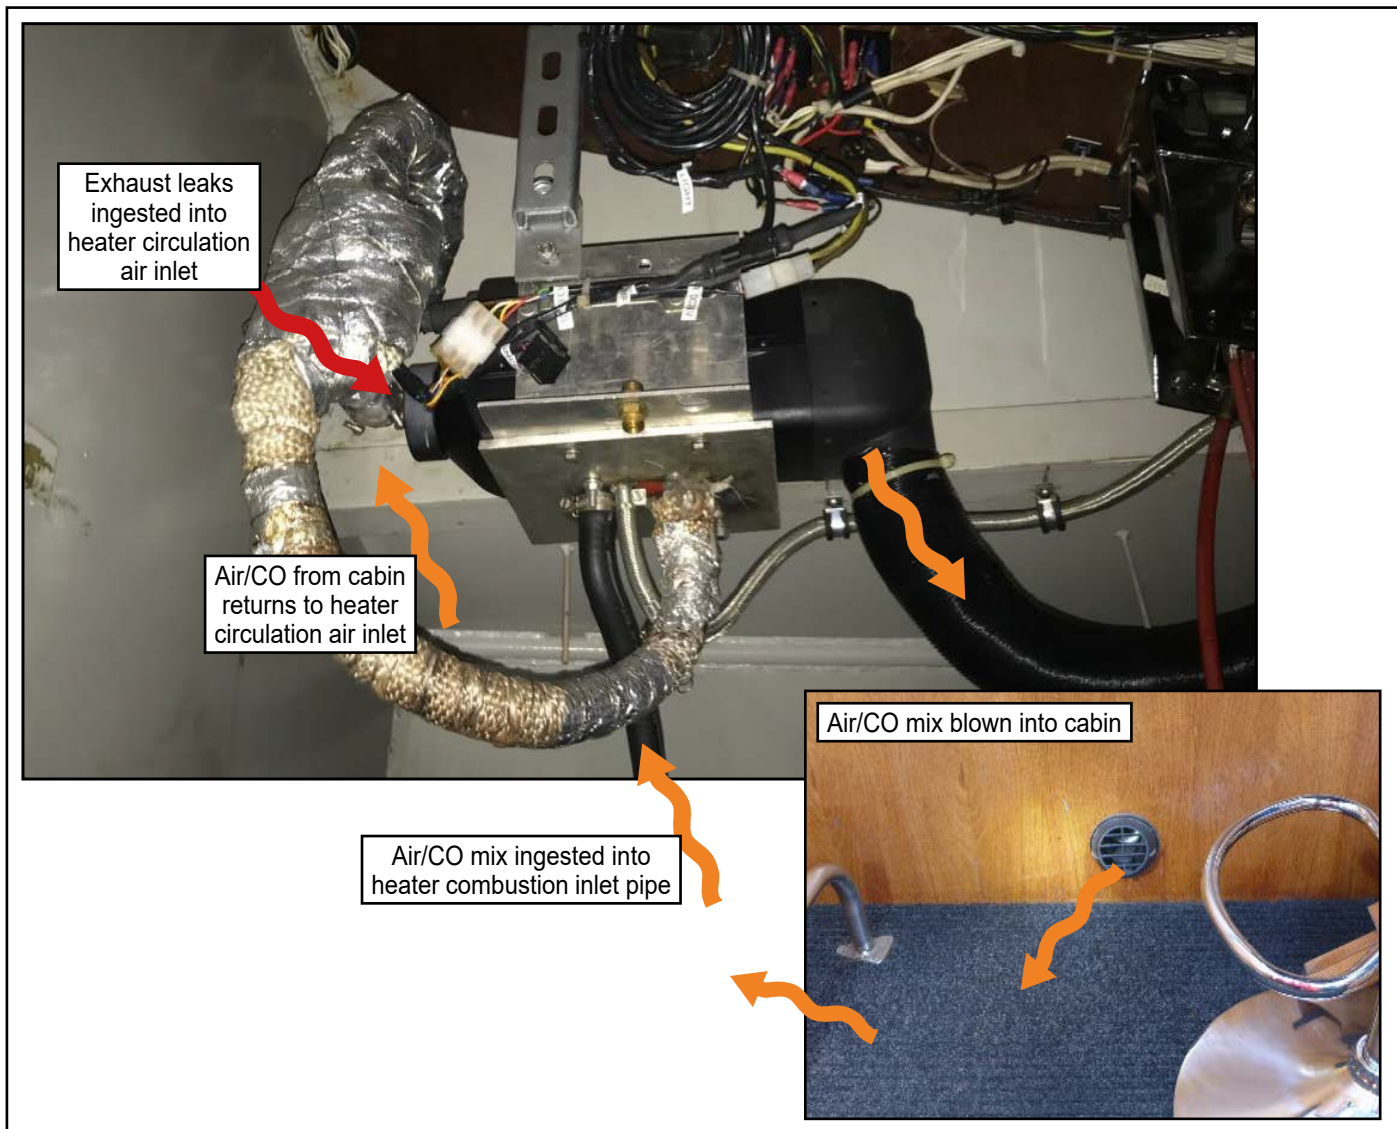
The most well-known brands of diesel-fuelled heaters are Webasto and Eberspächer. These are commonly installed into lorries, earth moving machinery, caravans and boats. *Diversion's* Webasto silencer was not designed to be fitted in marine installations because it was not gas tight and it was incompatible with the exhaust piping. As a result, the leaking exhaust gas was drawn into the heater's circulating air inlet and then blown into the main cabin (**Figure 5**).

**Figure 5:** Leakage path of exhaust gas through cabin heater

When the heater was running, small amounts of the leaking exhaust gas were drawn into the heater's circulating air intake and then discharged into the main cabin. Over a period of hours, the air in the main and forward cabins became increasingly polluted with CO and CO<sub>2</sub>. As the heater continued to operate, its combustion air drawn from inside the boat also became increasingly saturated with exhaust gases, and as a result the quality of combustion within the heater reduced. This added to the increased amount of CO in the exhaust gas and further polluted the air inside the boat.

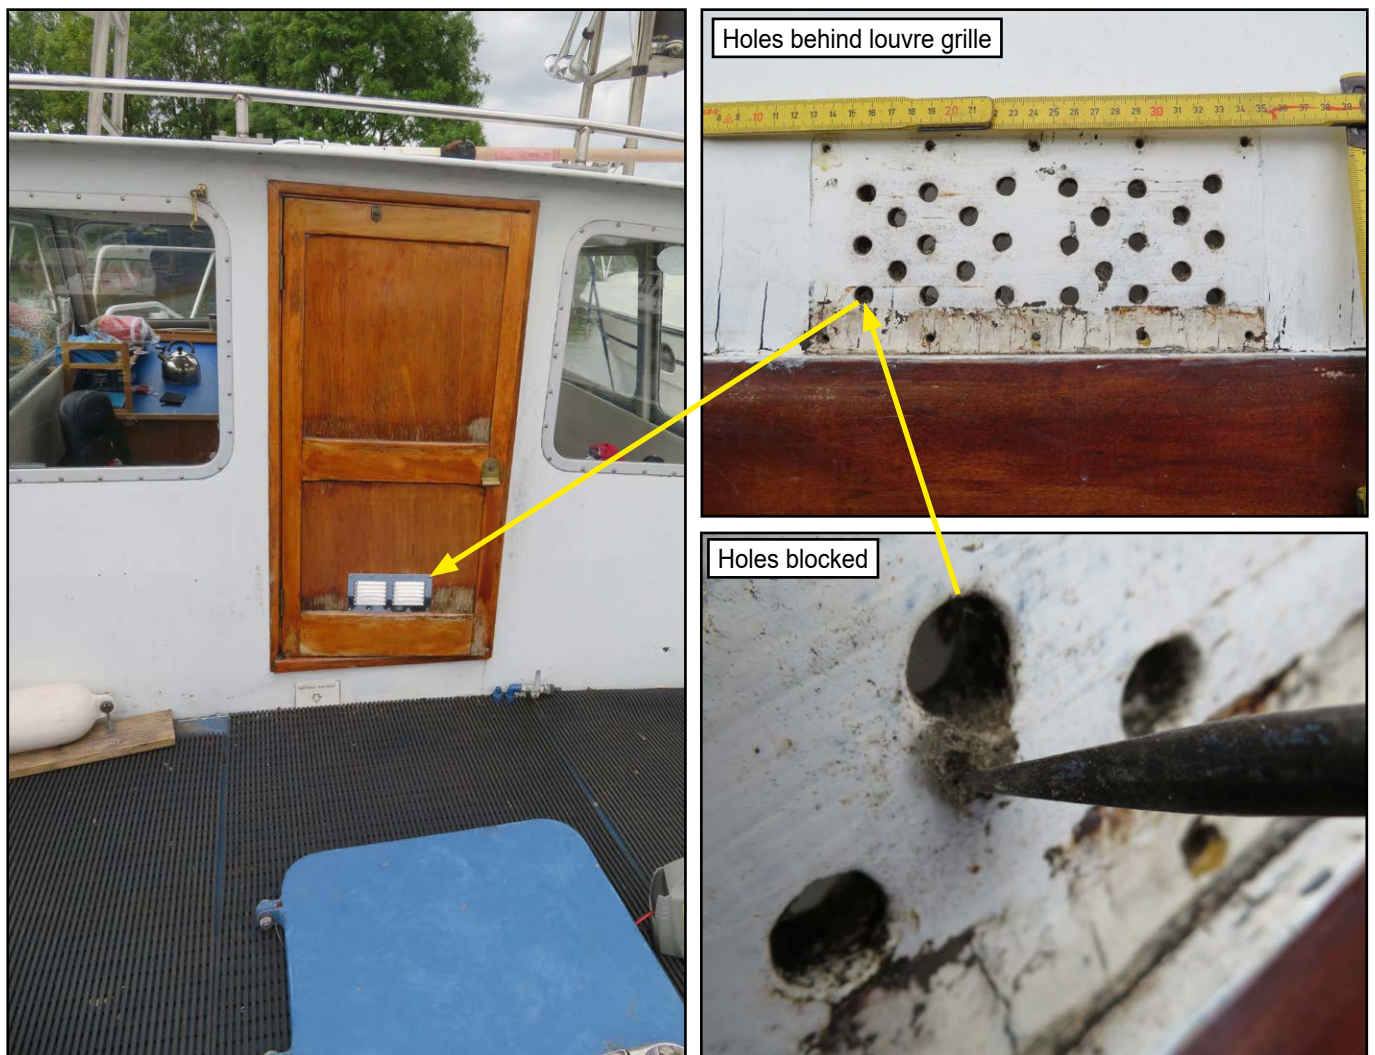
Low level ventilation was provided via a louvre type grille mounted in the bottom of the cabin door. Holes had been drilled through the door behind the grille, and approximately half of these were found to be blocked with dust. This reduced the effective capability of the ventilator grille (**Figure 6**).

**Figure 6:** Wheelhouse door louvre vent

Without removing the louvre grille from the door, it was impossible to tell that the drilled holes behind it were mostly blocked. While this did not cause a problem when the door was opened frequently, allowing fresh air into the main cabin, when it was closed for long periods the air flow through the boat was impeded.

Because the calculation used at the time of the BSS examination of the boat was not accurate, the correct level of ventilation required was mis-identified, and the levels of available ventilation were overstated. The situation was made worse, because the ventilation holes in the main cabin door were partially blocked.
