FINAL ACTION OF MAJOR INCIDENT INVESTIGATION REPORT INTO THE CIRCUMSTANCES SURROUNDING THE FATALITY OF A MEMBER ASSIGNED TO CGC HICKORY IN HOMER, ALASKA, ON 31 JAN 2019

Subj: MAJOR INCIDENT INVESTIGATION (MII) BOARD REPORT ON THE
CIRCUMSTANCES SURROUNDING THE FATALITY OF A USCGC HICKORY
(WLB-212) CREWMEMBER IN HOMER, AK ON 31 JAN 2019

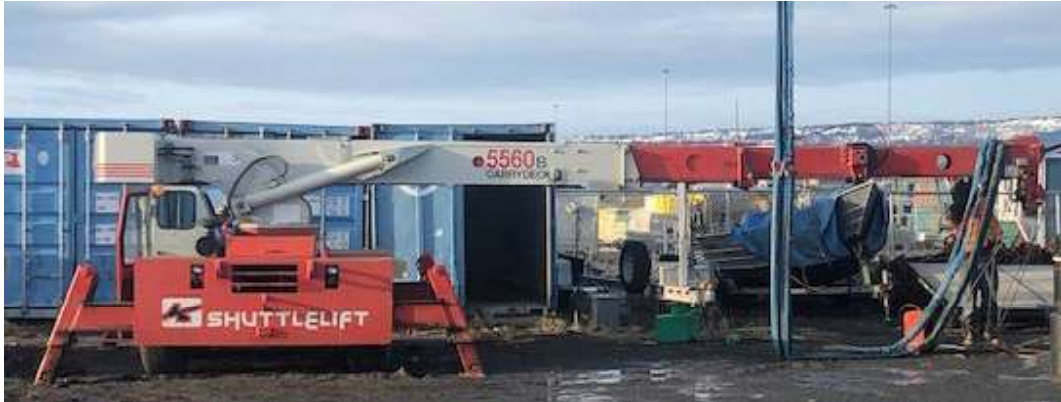
Mishap Crane after Righting with Outriggers Extended and Down

- 9) MC was fully functional following the mishap with the exception of boom retraction due to deformation and, “visible structural damage on the third section of the four-section boom. The boom nose (i.e. boom tip) and anti-two block device appeared to have visible damage as it was the primary impact point when the crane overturned.” (Exhibits 47, 48, 54, 55, 66)

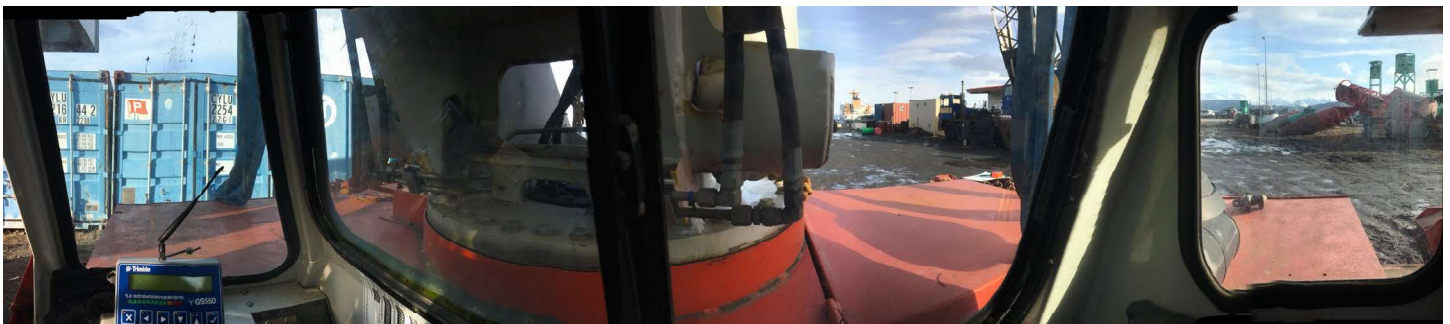
Panoramic View from MC Operators Seat

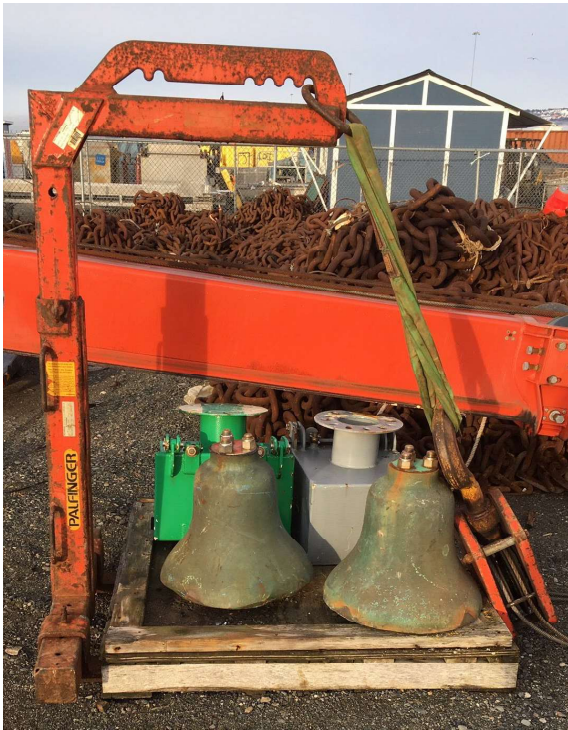
Mishap Load Profile and Elevation Views

- 39) The ML was not balanced on the pallet. The two bells with bell stands on one side of the pallet were more than double the weight of the battery boxes on the opposite side of the pallet. (Exhibits 43, 53)

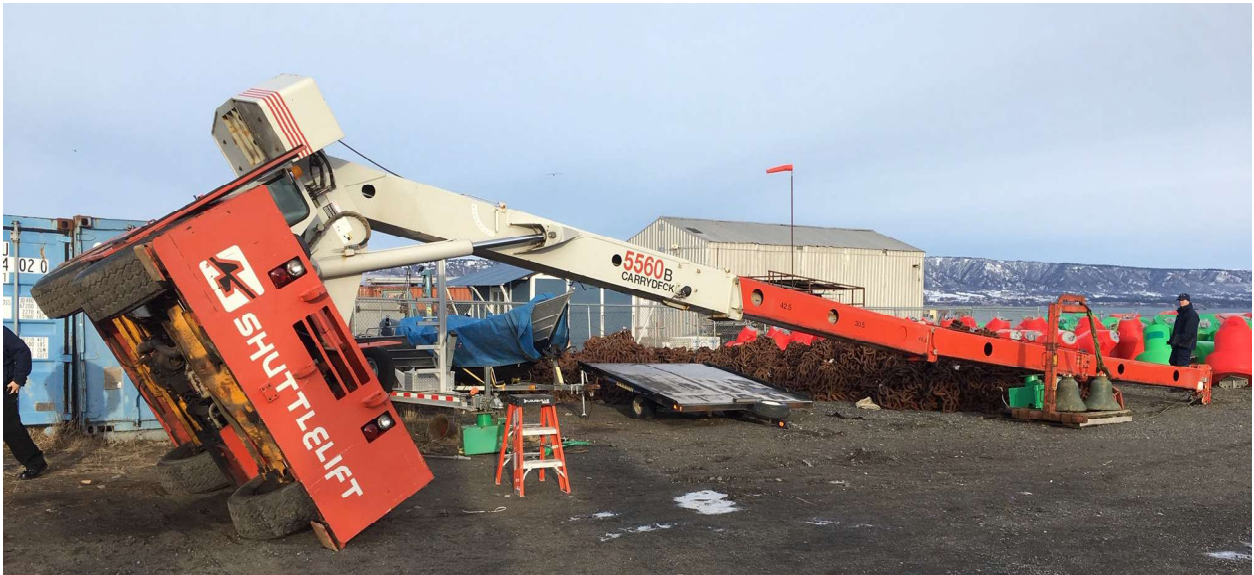
- 49) During the slewing motion, the Mishap Operator felt the crane shudder and jumped out of the cab when the driver (port) side wheels were a few inches off the ground. (Exhibits 13, 51, 52)

Overtured Mishap Crane

- 51) The boom's impact with the ground caused permanent deformation of the boom at the beginning of the third extension. (Exhibits 54, 66, 72, 73)
- 52) The boom tip dug into the ground approximately 6 inches. (Exhibits 55, 64, 65)
