# No. 84 CONTAINER SHIPS

(2005)  
(Rev.1  
Nov 2017)

## Guidelines for Surveys, Assessment and Repair of Hull Structures

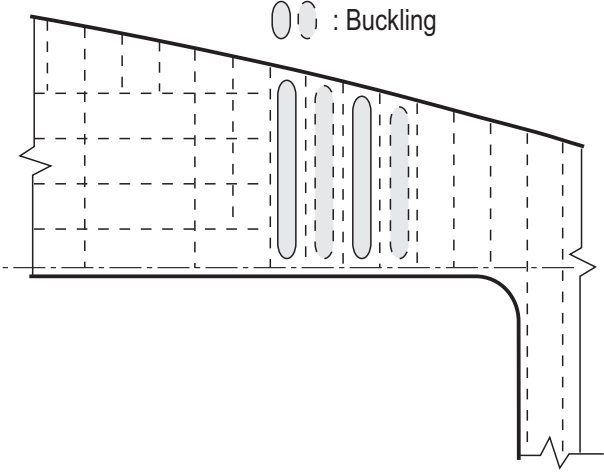
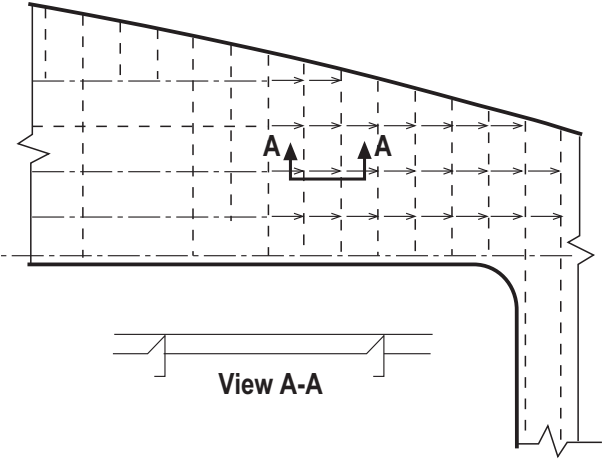
<b>Notes on possible cause of damage</b>		<b>Notes on repairs</b>	
<ol style="list-style-type: none"> <li>Excessive compressive stress due to slamming or bow flare effect.</li> <li>Insufficient longitudinal stiffening of deck plating.</li> </ol>		<ol style="list-style-type: none"> <li>Buckled plating should be cropped and renewed. Longitudinal internal stiffeners should be provided. (Instead of longitudinal stiffeners, renewal by thicker deck plating can be accepted.)</li> <li>Stress concentration may occur at the end of sniped stiffener resulting in fatigue fracture. For locations where high cyclic stress may occur, appropriate connection such as lug-connection should be considered.</li> </ol>

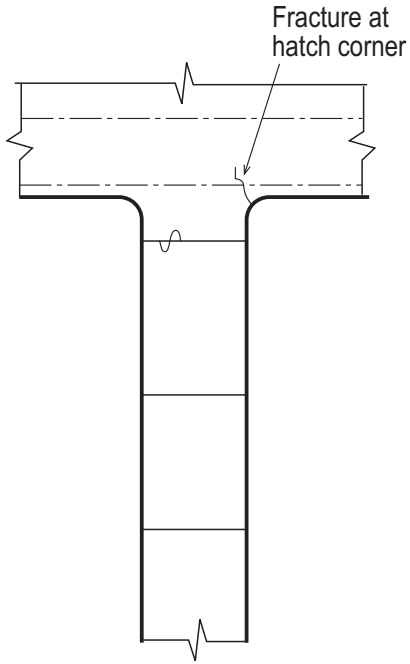
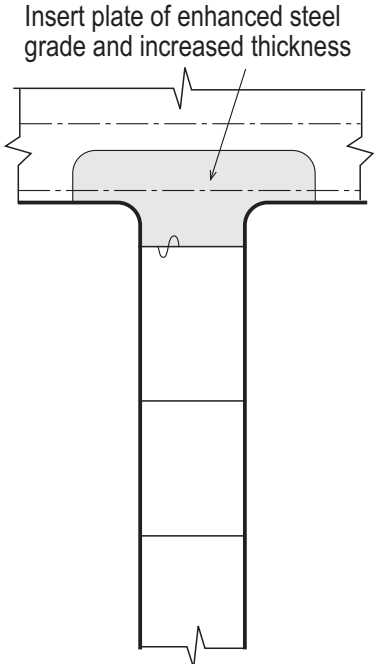
<b>Notes on possible cause of damage</b>		<b>Notes on repairs</b>	
<p>1. Stress concentration at hatch corners, i.e. radius of corner.</p>		<p>1. The corner plating in way of the fracture is to be cropped and renewed. If stress concentration is primary cause, insert plate should be increased thickness, enhanced steel grade and/or improved geometry.</p> <p>Insert plate should be continued beyond the longitudinal and transverse extent of the hatch corner radius ellipse or parabola, and the butt welds to the adjacent deck plating should be located well clear of the butts in the hatch coaming.</p> <p>It is recommended that the edges of the insert plate and the butt welds connecting the insert plates to the surrounding deck plating be made smooth by grinding. In this respect caution should be taken to ensure that the micro grooves of the grinding are parallel to the plate edge.</p>

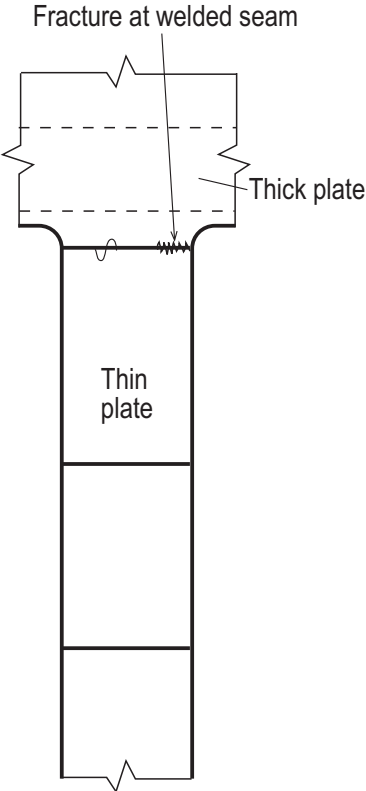
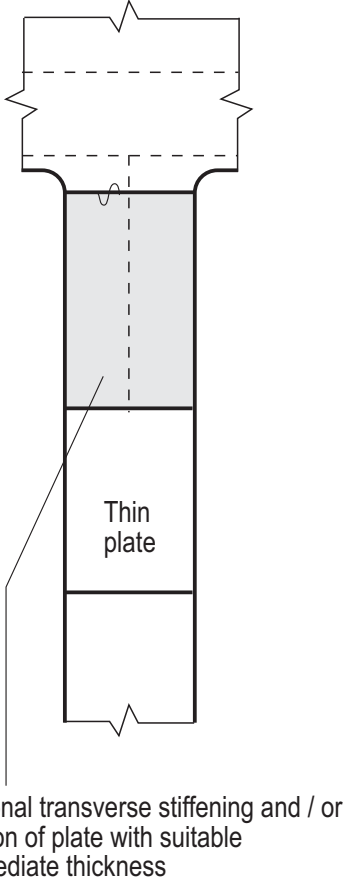
<b>Notes on possible cause of damage</b>		<b>Notes on repairs</b>	
<ol style="list-style-type: none"> <li>1. Stress concentration created by abrupt change in deck plating thickness.</li> <li>2. In-plane bending in cross deck strip due to torsional (longitudinal) movements of ship sides.</li> <li>3. Welded seam not clear of tangent point of hatch corner.</li> </ol>		<ol style="list-style-type: none"> <li>1. Insert plate of intermediate thickness is recommended.</li> <li>2. Smooth transition between plates (beveling) should be considered.</li> </ol>

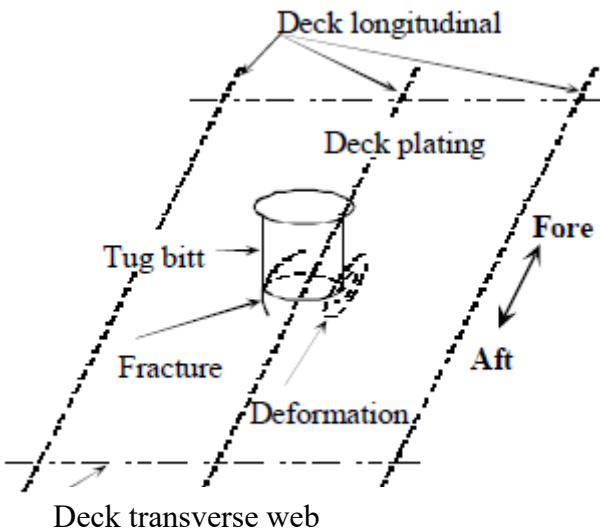
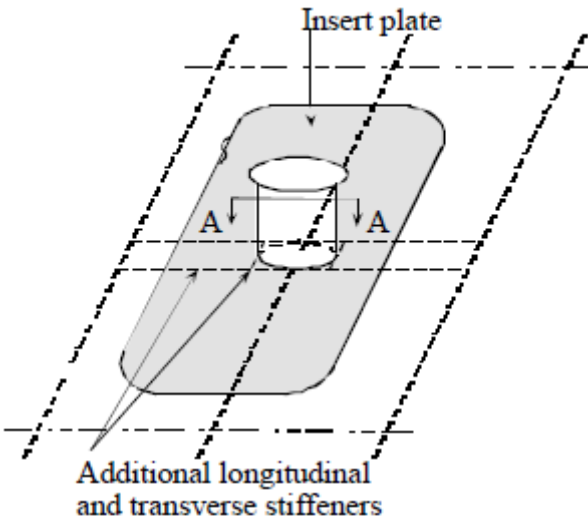
<p style="text-align: center;"><b>View A-A</b></p>		
<b>Notes on possible cause of damage</b>	<p>1. Insufficient strength</p>		
<b>Notes on repairs</b>	<p>1. Fractured/deformed deck plating should be cropped and part renewed.</p> <p>2.Reinforcement by stiffeners should be considered.</p>

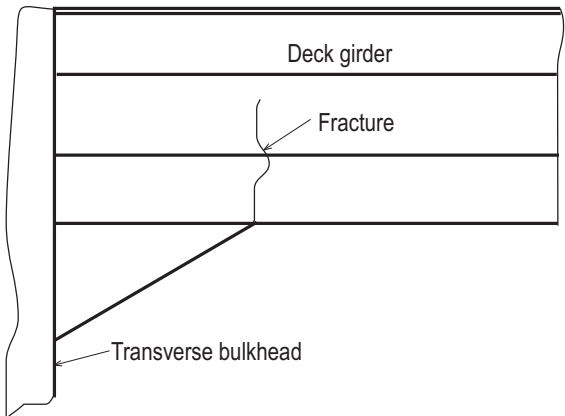
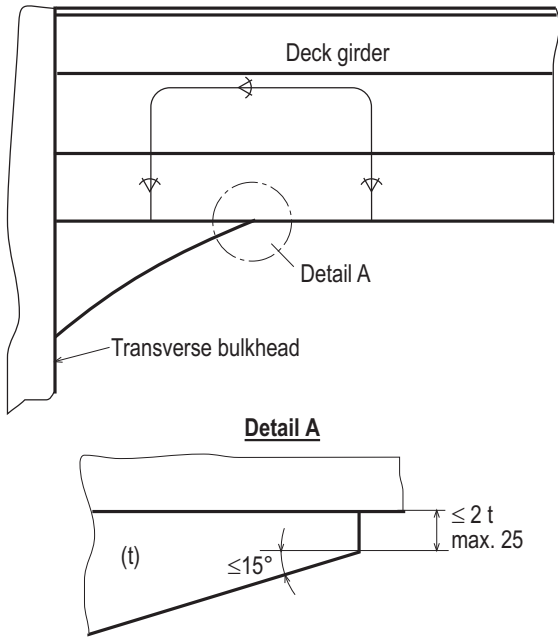
<p>Labels: Deck girder, Transverse bulkhead, Detail A</p> <p><b>Detail A</b></p> <p>(t) <math>\leq 15^\circ</math> <math>\leq 2t</math> max. 25</p>	
<b>Notes on possible cause of damage</b>		<b>Notes on repairs</b>	
<ol style="list-style-type: none"> <li>1. Stress concentration at the toe of deck girder bracket</li> </ol>		<ol style="list-style-type: none"> <li>1. Fractured plating should be cropped and part renewed.</li> <li>2. Modified soft bracket should be considered.</li> </ol>

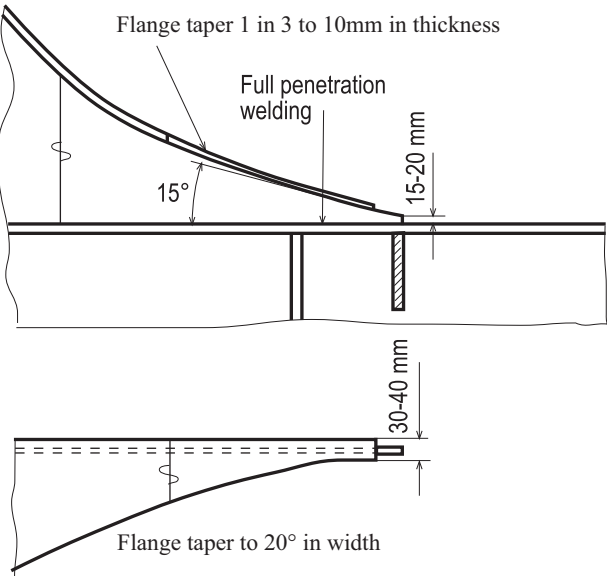
Notes on possible cause of damage	Notes on repairs		
<ol style="list-style-type: none"> <li>1. Flange force at the end of the flange too high due to insufficient tapering (<b>Fracture Type A</b>, propagating in the web).</li> <li>2. Shear force in the web plate too high due to insufficient reduction of the web height at the end (<b>Fracture Type B</b>, propagating in the web at the undercut or HAZ of the fillet weld).</li> <li>3. Insufficient support of the extension bracket below the deck (<b>Fracture Type C</b>, starting from undercut or HAZ of the fillet weld and propagating in the deck plating).</li> </ol>	<ol style="list-style-type: none"> <li>1. Extend the extension bracket as long as possible to arrange a gradual transition.</li> <li>2. Reduce the web height at the end of the bracket; in case of high stress areas grind smooth the transition to the deck plating welding.</li> <li>3. Reduce the cross sectional area of the flange at the end as far as possible. Such as flange taper 1 in 3 to 10mm in thickness and taper 20° in width.</li> <li>4. Provide longitudinal structure in way of the web of the extension bracket to the next transverse structure or provide a new transverse structure.</li> <li>5. The web plate to be cropped and renewed with new plate which increase in thickness of 30-50%, if it does not become excessive</li> </ol>

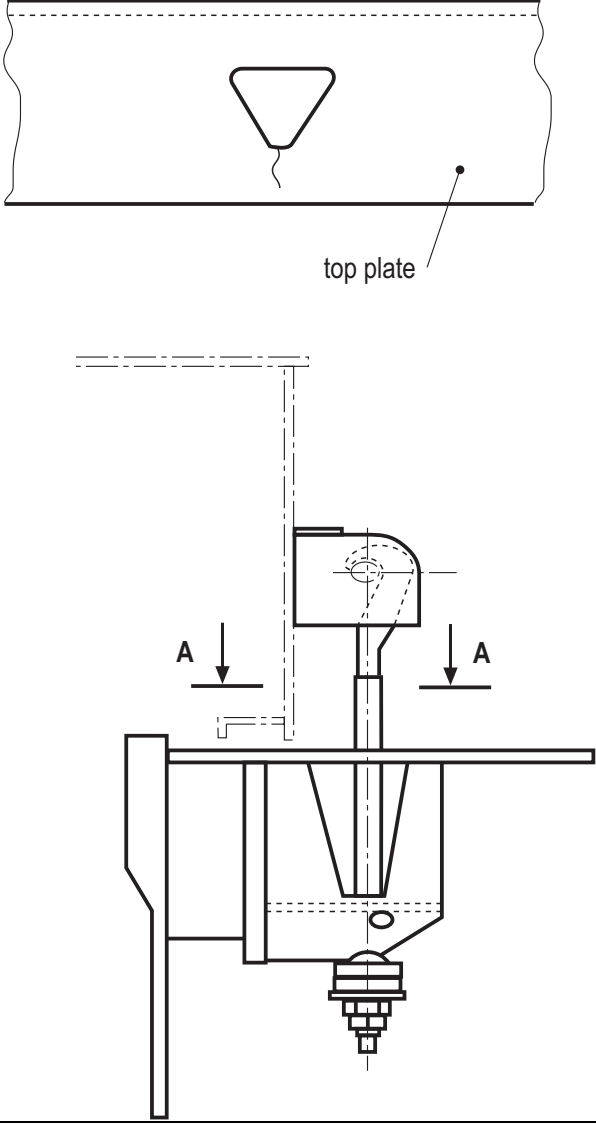
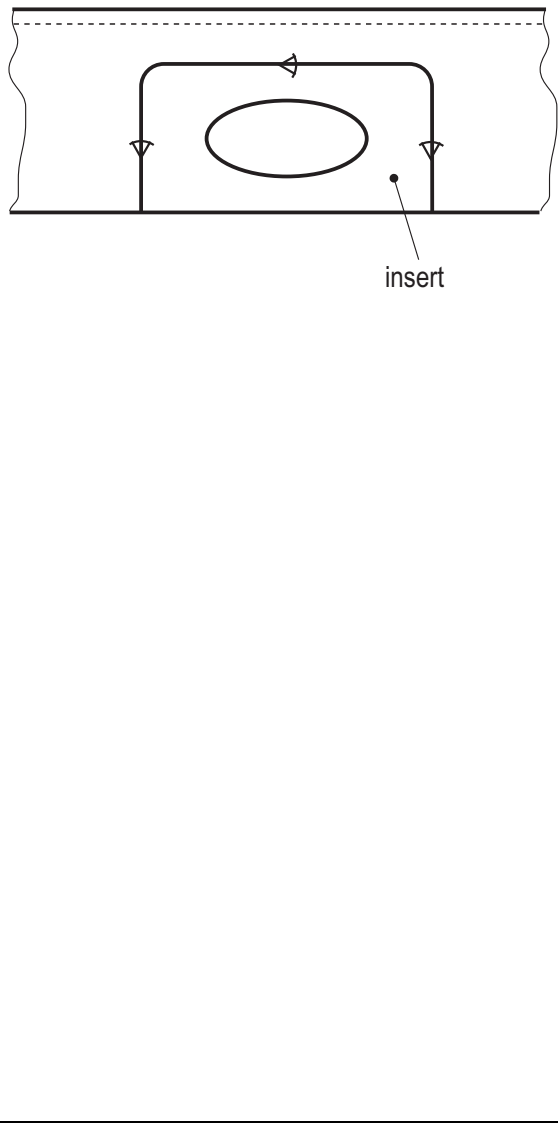
<b>Notes on possible cause of damage</b>		<b>Notes on repairs</b>	
<ol style="list-style-type: none"> <li>1. Stress concentration at hole</li> <li>2. Inadequate design</li> <li>3. Poor workmanship</li> </ol>		<ol style="list-style-type: none"> <li>1. Damaged area to be cropped and renewed.</li> <li>2. Elliptical hole to be provided for the quick acting cleat</li> </ol>

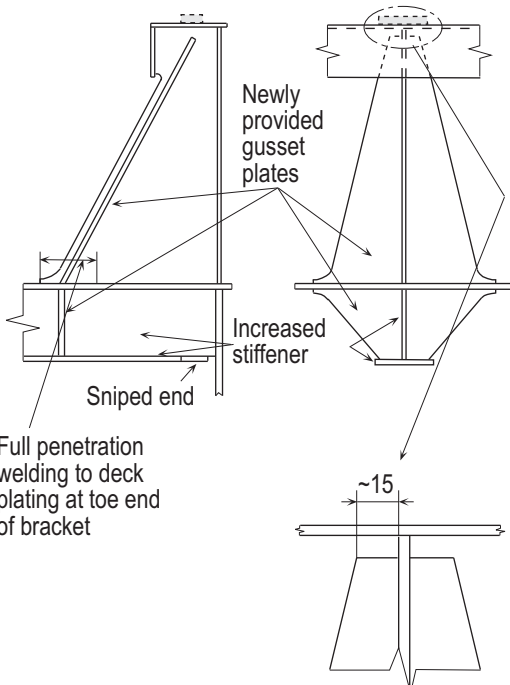
<b>Notes on possible cause of damage</b> <ol style="list-style-type: none"> <li>Insufficient consideration of the horizontal friction forces in way of the resting pads for hatch cover.</li> </ol>		<b>Notes on repairs</b> <ol style="list-style-type: none"> <li>Modification of the design of the hatch coaming stay.</li> <li>Full penetration welding between gusset plates and deck plating.</li> <li>Strengthening and continuation of the structure below the deck.</li> <li>Use pads with smaller coefficient of friction.</li> </ol>

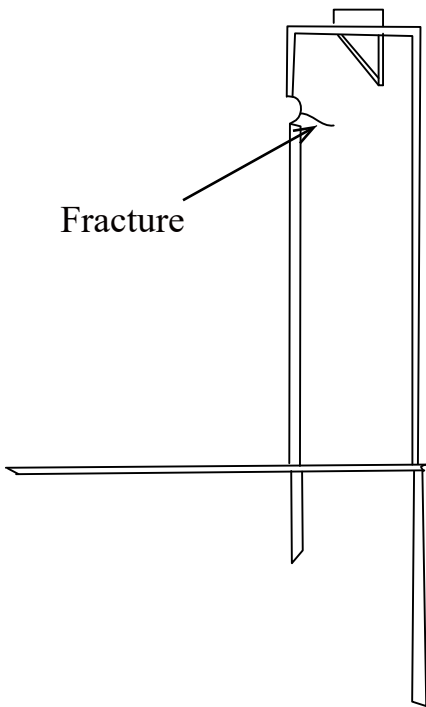
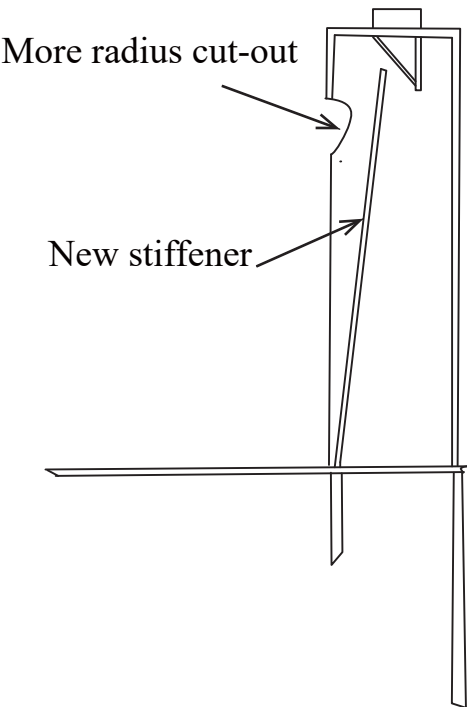
<b>Notes on possible cause of damage</b>		<b>Notes on repairs</b>	
<p>1. Insufficient consideration of the horizontal friction forces in way of the resting pads for hatch cover.</p>		<p>1. Expanded radius of the cut-out of the upper part of stay.</p> <p>2. Fixing a vertical stiffener as long as possible.</p> <p>3. Grinding of the radius cut-out.</p>

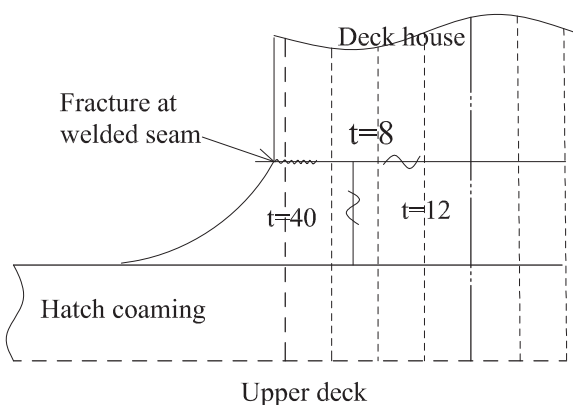
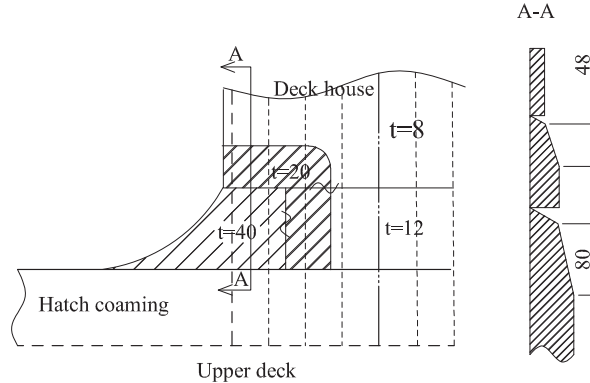
<p>Fracture at welded seam</p> <p>Deck house</p> <p>Hatch coaming</p> <p>Upper deck</p> <p><math>t=40</math></p> <p><math>t=8</math></p> <p><math>t=12</math></p>

<p>Deck house</p> <p>Hatch coaming</p> <p>Upper deck</p> <p><math>t=8</math></p> <p><math>t=20</math></p> <p><math>t=40</math></p> <p><math>t=12</math></p> <p>A-A</p> <p>48</p> <p>80</p>	
<b>Notes on possible cause of damage</b>		<b>Notes on repairs</b>	
<ol style="list-style-type: none"> <li>1. Stress concentration at the welding seam between plates with great differences of thickness.</li> </ol>		<ol style="list-style-type: none"> <li>1. Inserting plates with medium thickness between the plates with great differences of thickness.</li> <li>2. The plate to be tapered from thick plate to thin one</li> </ol>

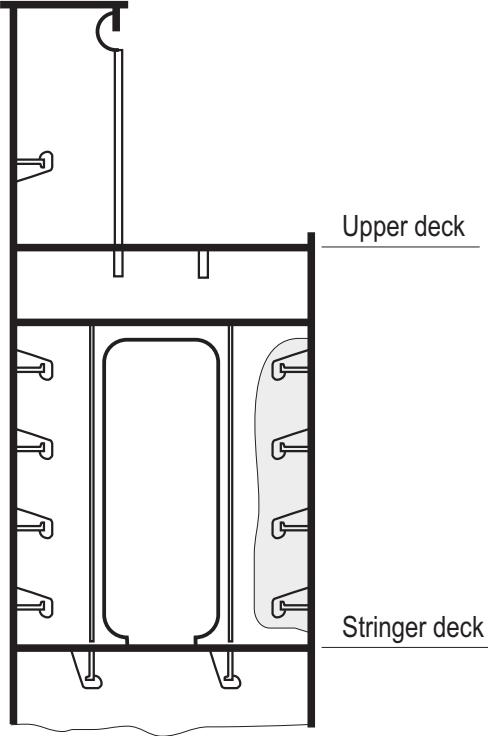
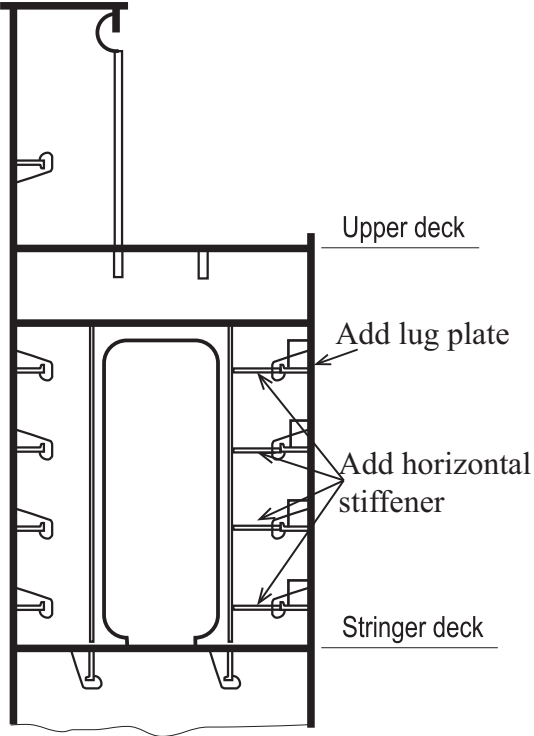
Notes on possible cause of damage	Notes on repairs		
<ol style="list-style-type: none"> <li>1. Deformation of web of transverse web frame and / or distortion of side longitudinals due to insufficient buckling strength.</li> <li>2. Insufficient strengthening of side structure in way of tug and / or fender area or misplacing of strengthened area, respectively.</li> </ol>	<ol style="list-style-type: none"> <li>1. Straightening or renewal (if necessary) of buckled web plate and distorted side longitudinals.</li> <li>2. Fitting of additional horizontal stiffeners on web plate in way of side longitudinals.</li> <li>3. Strengthening of tug or fender area or shifting of affected area to right position should be considered.</li> <li>4 Horizontal stiffeners may be connected to the vertical stiffeners or sniped in way of the vertical stiffener</li> </ol>

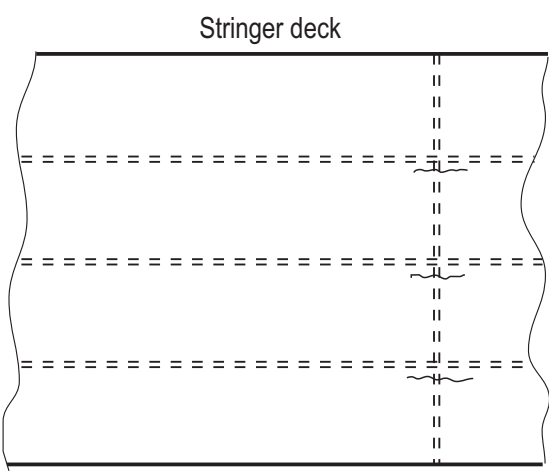
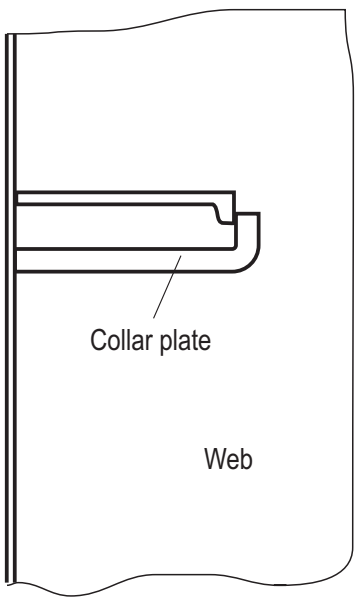
<b>Notes on possible cause of damage</b>		<b>Notes on repairs</b>	
<p>1. Damage can be caused by stress concentration leading to accelerated fatigue in this region.</p>		<p>1. Fractured side wall plating to be cropped and renewed by insert plate.</p> <p>2. Cut-outs for longitudinals to be closed by collar plates.</p>

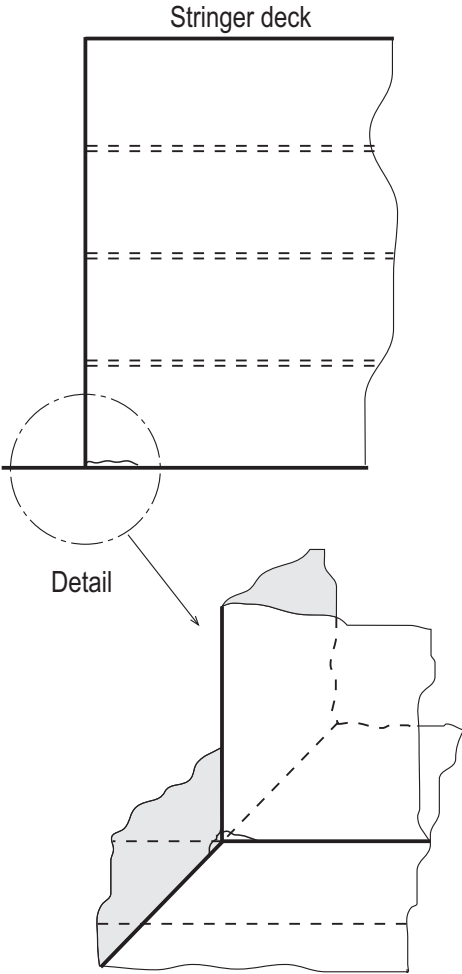
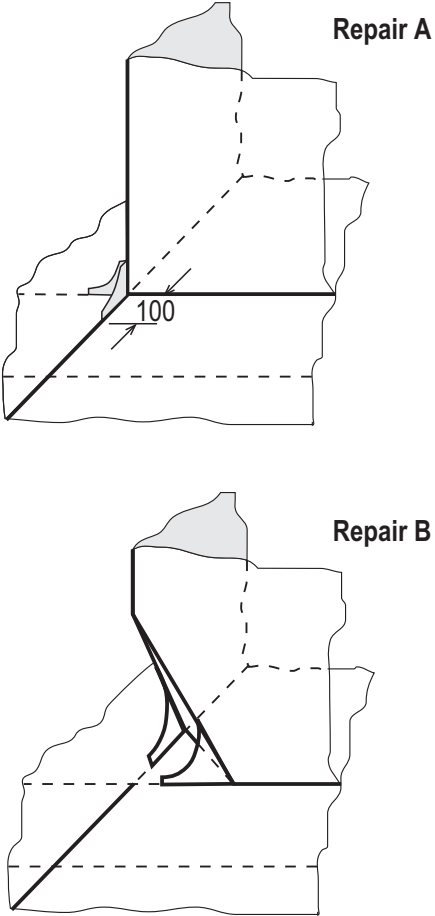
<p>Repair A shows a bracket with a 100 mm length. Repair B shows a modified design with a soft nose transition.</p>	
<b>Notes on possible cause of damage</b>		<b>Notes on repairs</b>	
<p>1. Damage can be caused by stress concentration leading to fatigue in this region.</p>		<p>1. Fracture in tank top plating to be cropped and renewed by insert.</p> <p>2. Repair A: Small brackets should be provided at the termination in longitudinal and / or transverse direction (proposed length about 100 mm)</p> <p>3. Repair B: Modification of the design with soft nose transition should be considered.</p>

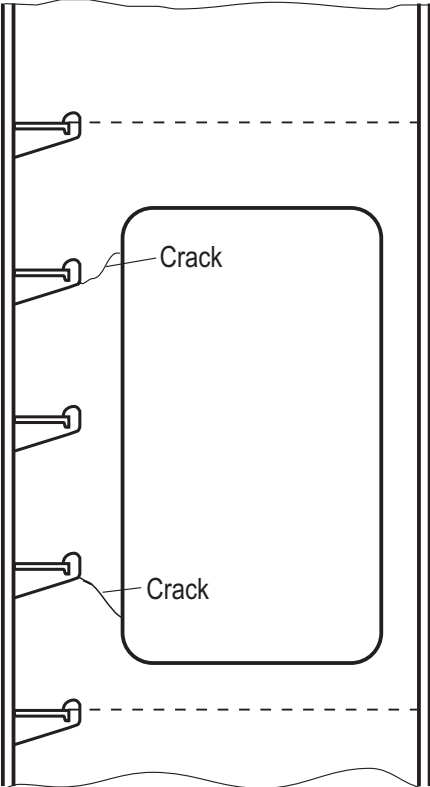
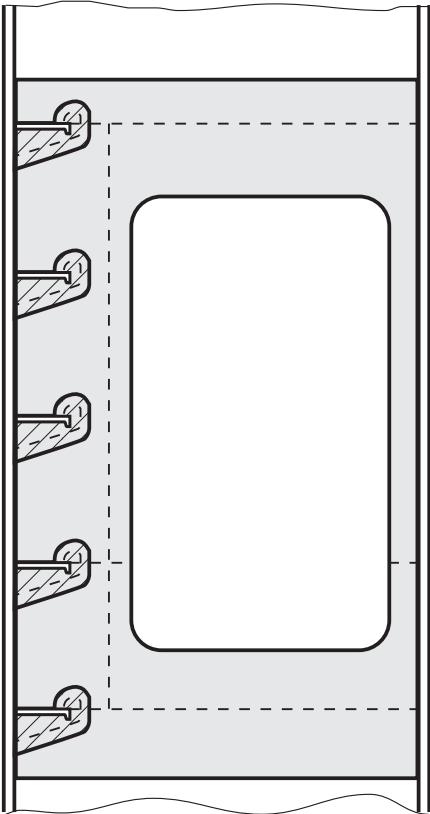
<b>Notes on possible cause of damage</b> 1. Damages caused by stress concentration leading to fatigue fractures.		<b>Notes on repairs</b> 1. Insertion of plating of increased thickness (chamfer 1:3 to 1:5). 2. Collar plates to cut-outs for vertical stiffeners are to be installed. 3. Additional stiffener adjacent to access opening to be fitted 4. Reduction in size of access hole to be considered

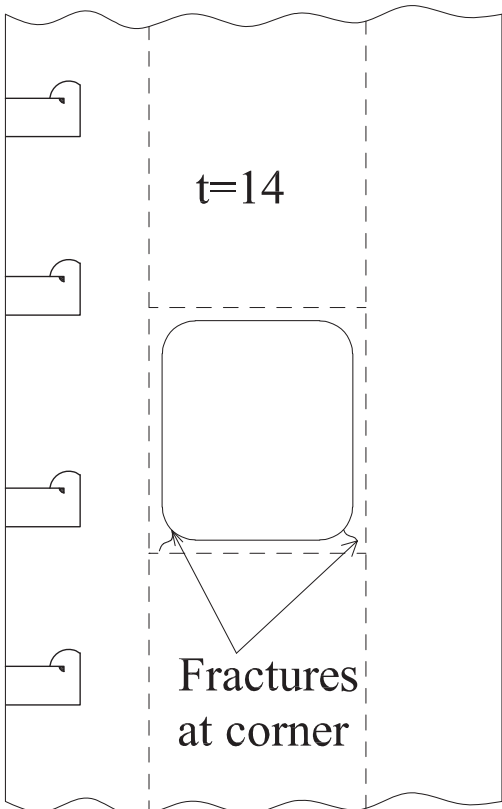
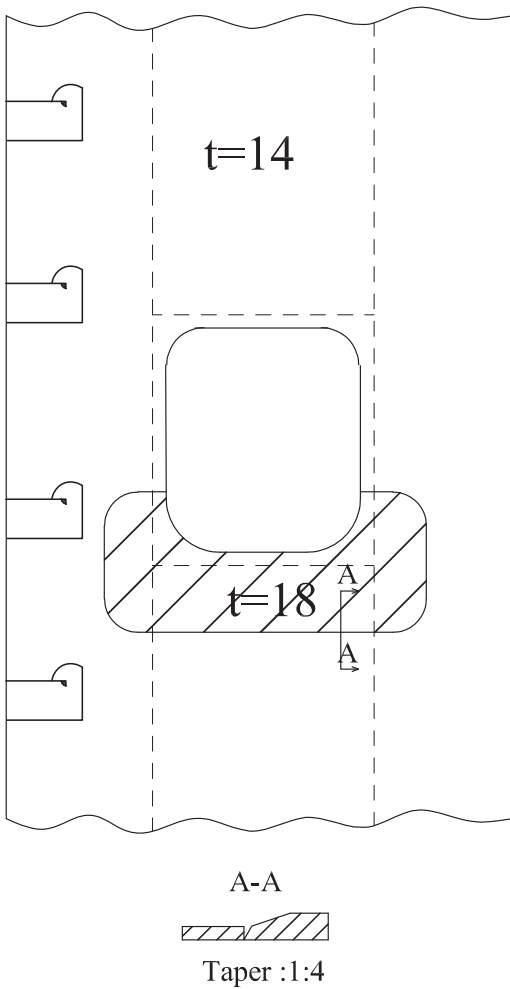
<p style="text-align: center;">A-A Taper :1:4</p>	
<p><b>Notes on possible cause of damage</b></p> <ol style="list-style-type: none"> <li>1 Too small corner radius and/or insufficient local plate thickness.</li> </ol>		<p><b>Notes on repairs</b></p> <ol style="list-style-type: none"> <li>1. Damaged plates are to be cropped and inserted with thicker plates.</li> <li>2. A larger corner radius is to be considered.</li> </ol>

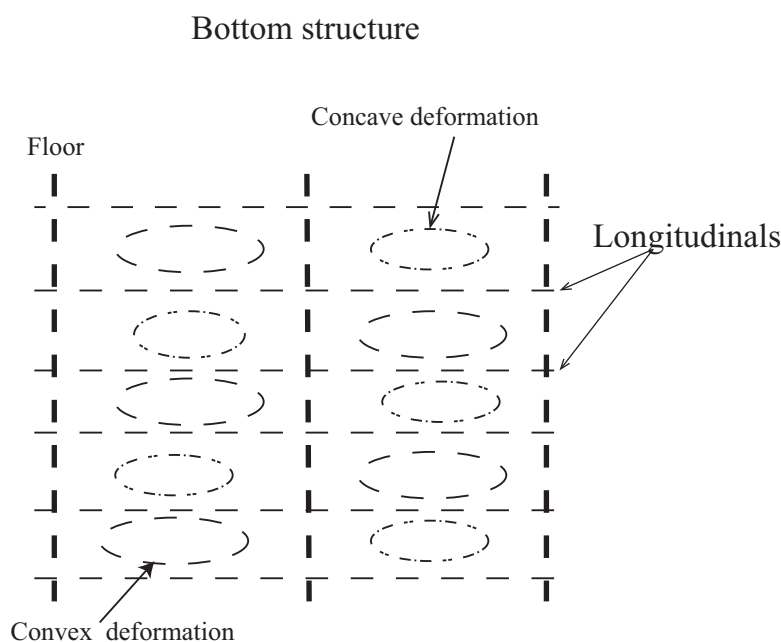
**Figure 1 – Buckling deformation observed in the bottom shell plating in way of cargo hold amidships**

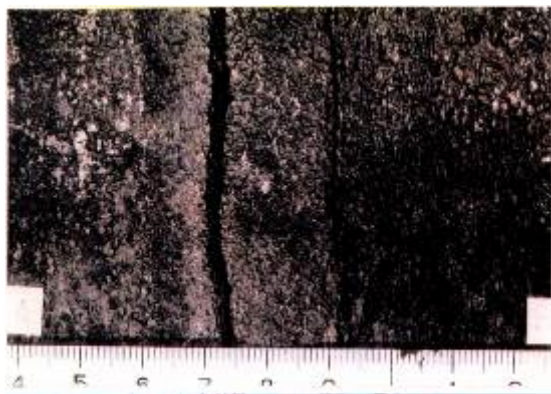
**4.1.3** Bottom or “docking” plugs should be carefully examined for excessive corrosion along the edge of the weld connecting the plug to the bottom plating.

**Figure 2**  
Grooving corrosion of welding of bottom plating

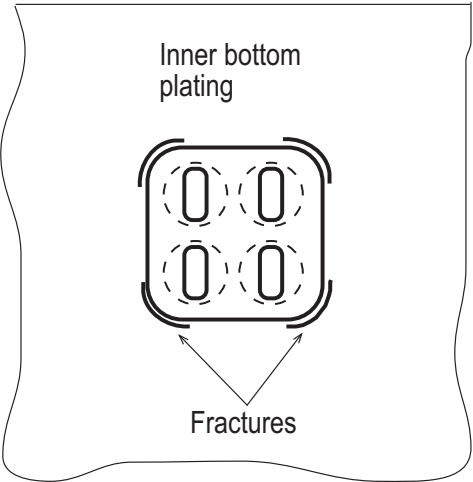
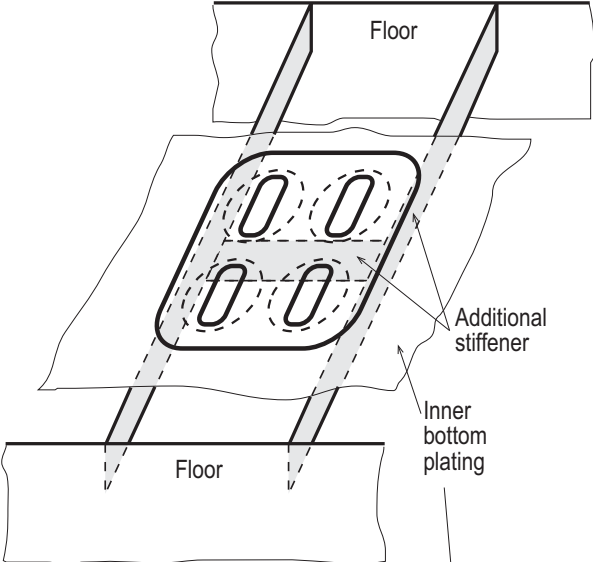
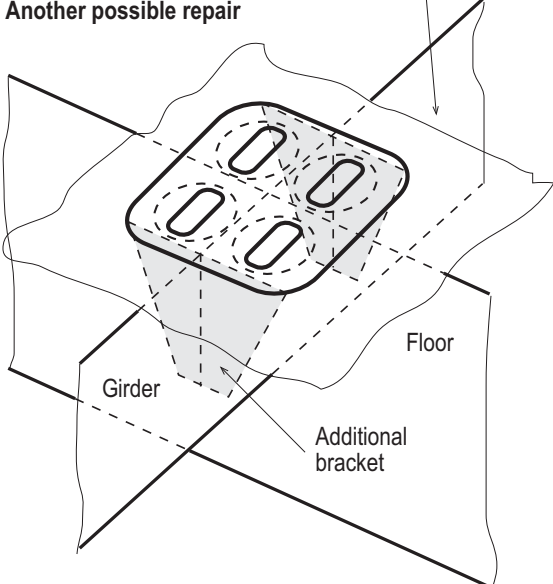
<b>Notes on possible cause of damage</b>		<b>Notes on repairs</b>	
<ol style="list-style-type: none"> <li>1. Pocket is not supported correctly by floor, longitudinal and/or stiffener.</li> </ol>		<ol style="list-style-type: none"> <li>1. Fractured plating should be cropped and part renewed.</li> <li>2. Adequate reinforcement should be considered.</li> </ol>

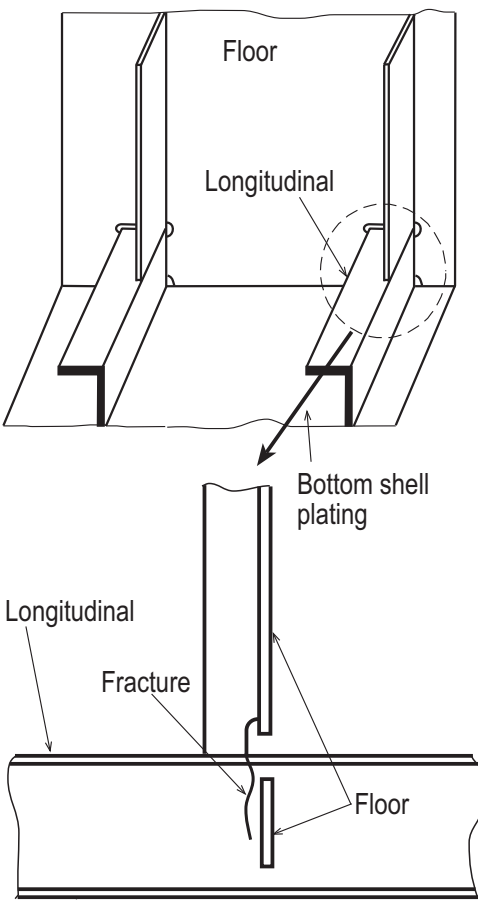
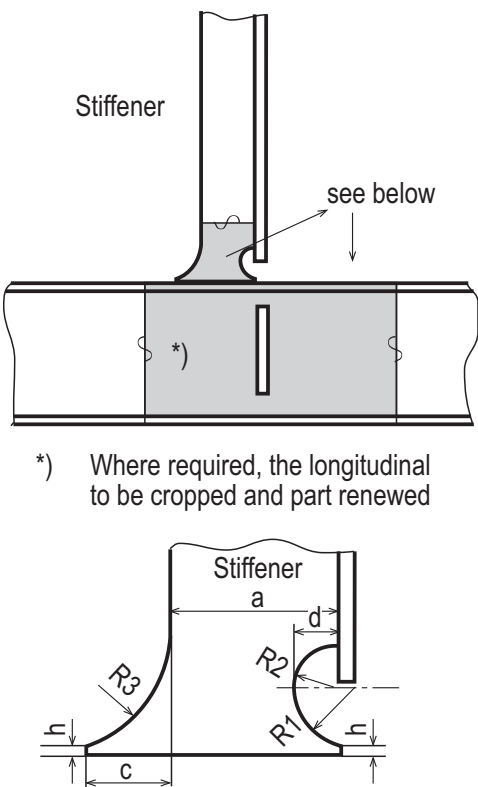
<p>Note: same damage max occur at similar connection to inner bottom plating</p>

<p>*) Where required, the longitudinal to be cropped and part renewed</p> <p>Various cut/out shapes have been developed. The following ist one example.</p> <ol style="list-style-type: none"> <li>1. Toe height as small as possible (h = 10 - 15 mm)</li> <li>2. Depth "d" of key hole notch as small a possible, max. 30 mm</li> <li>3. For a slope at toe max. 1 : 3</li> <li>4. <math>R1 = 1.5 d</math> <math>R2 = d</math> and <math>R3 = 1.5 c</math></li> </ol>	
<b>Notes on possible cause of damage</b>		<b>Notes on repairs</b>

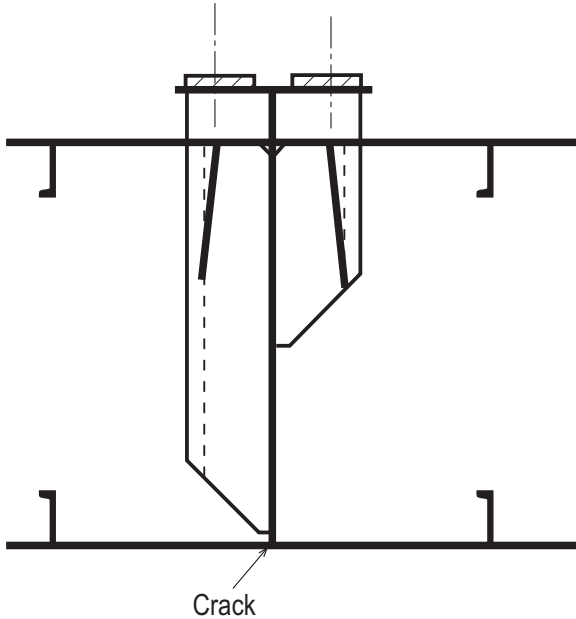
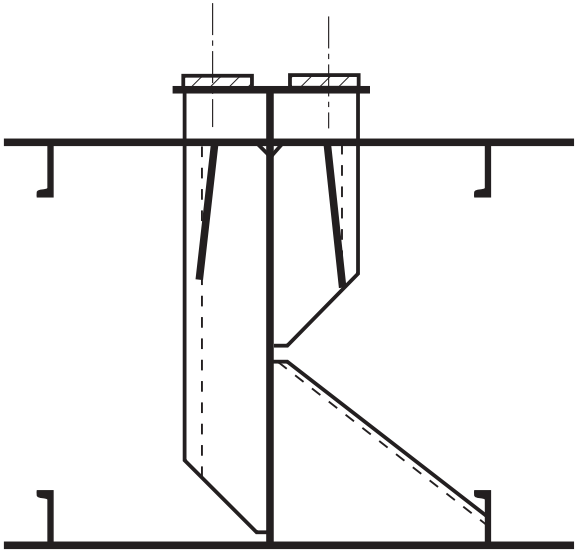
<b>Notes on possible cause of damage</b>		<b>Notes on repairs</b>	
<ol style="list-style-type: none"> <li>1. Damage can be caused by an insufficient strength of the longitudinal girder at the termination of the vertical stiffeners.</li> </ol> <p>The effect of a simultaneous occurrence of the tank pressure from one side and an asymmetrical load from the container sockets has not been taken into account.</p>		<ol style="list-style-type: none"> <li>1. Fractured part of the longitudinal girder has to be cropped and renewed by an insert.</li> <li>2. The lower part of the girder has to be supported by an additional transverse stiffener on the bottom shell plating.</li> </ol>

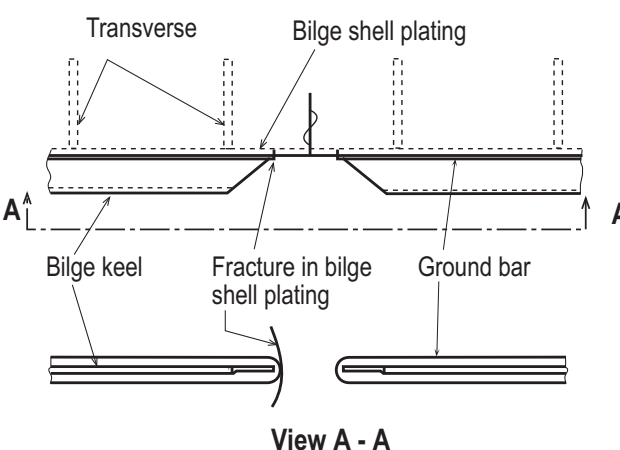
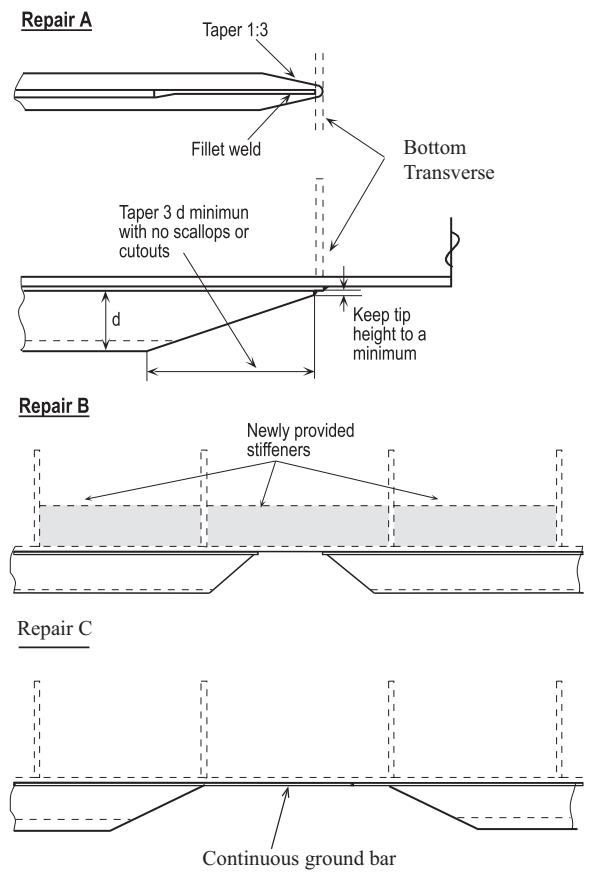
<b>Notes on possible cause of damage</b>		<b>Notes on repairs</b>	
<ol style="list-style-type: none"> <li>Poor design causing stress concentration.</li> </ol>		<ol style="list-style-type: none"> <li>Fractured plating is to be cropped and renewed.</li> <li>Reduction of stress concentration of the bilge keel end should be considered. <ul style="list-style-type: none"> <li><b>Repair A:</b> Modification of the detail of end</li> <li><b>Repair B:</b> New internal stiffeners</li> <li><b>Repair C:</b> Continuous ground bar (in connection with <b>Repair A</b>)</li> </ul> </li> <li>Instead of <b>Repair A</b> or <b>B</b> continuous ground bar should be considered, also the bilge keel should be terminated at transverses or brackets.</li> </ol>

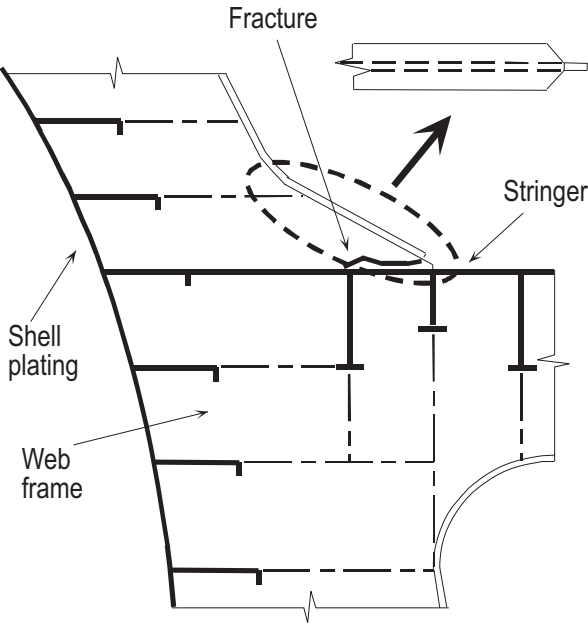
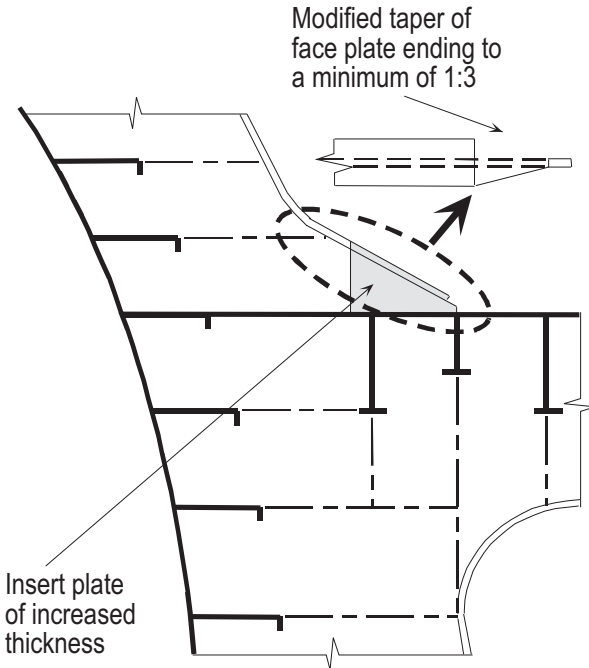
<b>Notes on possible cause of damage</b>		<b>Notes on repairs</b>	
<ol style="list-style-type: none"> <li>1. Inadequate bracket forming the web frame connection to the stringer.</li> <li>2. Localized material wastage in way of coating failure at bracket due to flexing of the structure.</li> <li>3. Dynamic seaway loading in way of bow flare.</li> </ol>		<ol style="list-style-type: none"> <li>1. Adequate soft nose bracket endings with a face plate taper of at least 1:3 to be provided.</li> </ol>

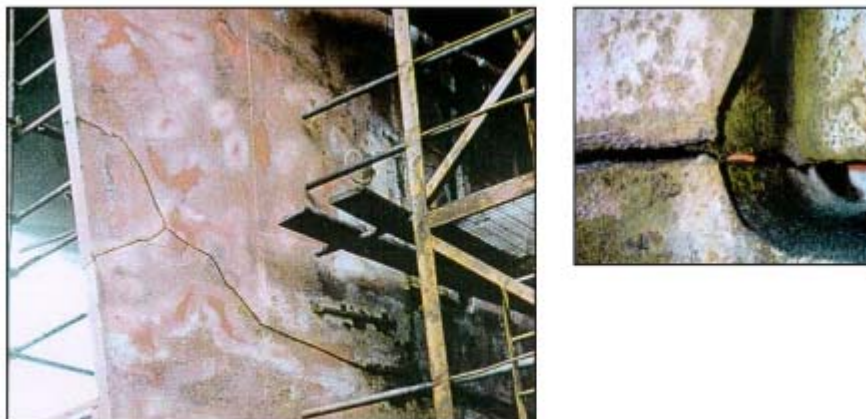
**Photograph 1 Fractured rudder**

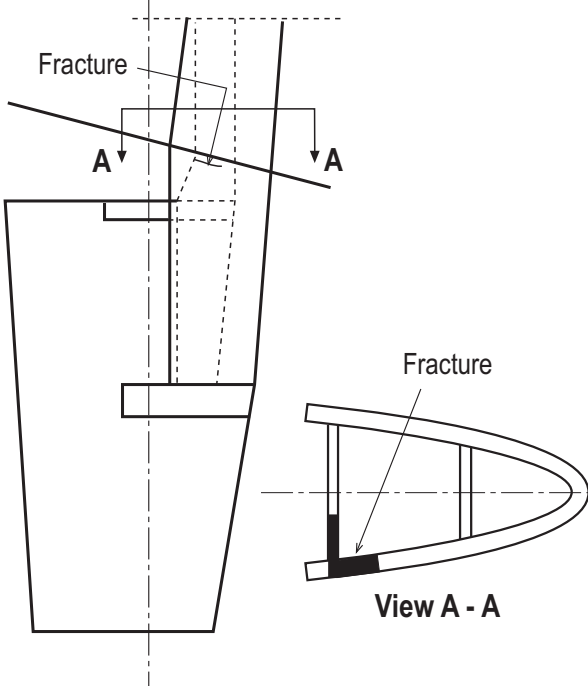
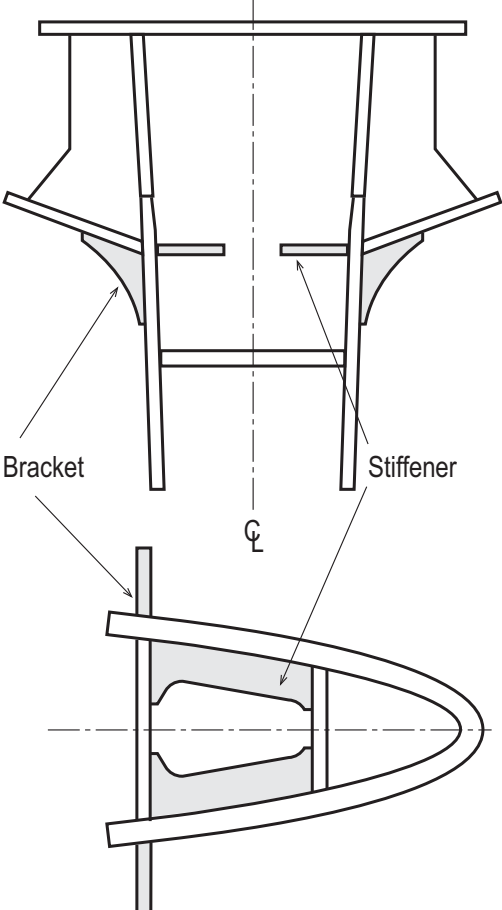
<b>Notes on possible cause of damage</b>		<b>Notes on repairs</b>	
<ol style="list-style-type: none"> <li>Insufficient strength due to poor design.</li> </ol>		<ol style="list-style-type: none"> <li>Fractured plating to be veed-out and rewelded.</li> <li>Fractured plating to be cropped and renewed if considered necessary.</li> <li>Reinforcement should be considered if considered necessary.</li> </ol>

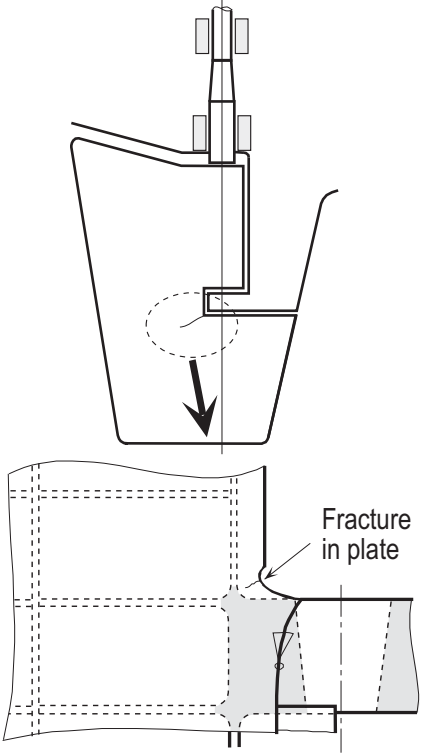
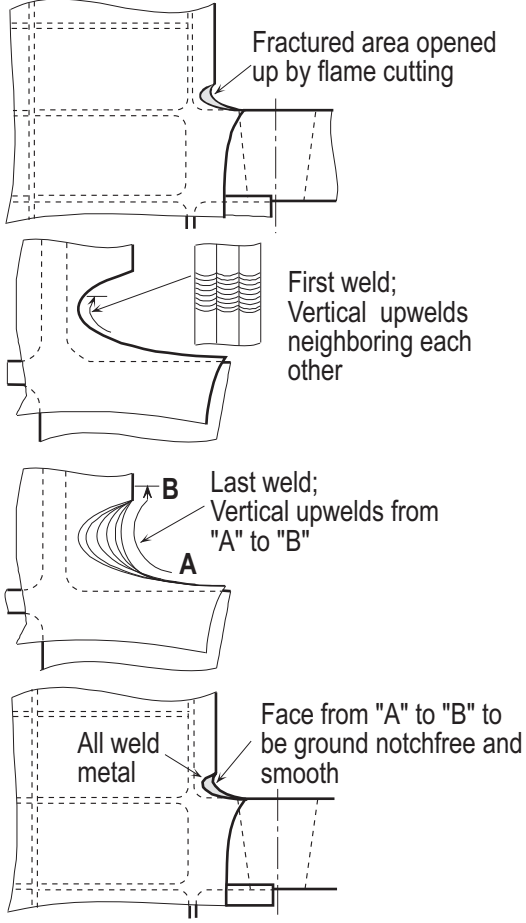
<p>Fracture in plate</p>

<p>Fractured area opened up by flame cutting</p> <p>First weld; Vertical upwelds neighboring each other</p> <p>Last weld; Vertical upwelds from "A" to "B"</p> <p>All weld metal</p> <p>Face from "A" to "B" to be ground notchfree and smooth</p>	
Notes on possible cause of damage		Notes on repairs	
<p>1. Stress concentration due to inadequate local design and/or fabrication notches in way of the butt weld between cast piece and plating.</p>		<p>1. Grooving-out and welding of the fracture is not always adequate (metallurgical notch in way of a high stressed area).</p> <p>2. In the proposed repair procedure the metallurgical notches are shifted into a zone exposed to lower stresses.</p> <p>3. After welding a modification of the radius according to the proposal in <b>Example 5</b> is to be carried out.</p> <p>4. In case of very small crack it can be ground off by increasing the radius.</p>

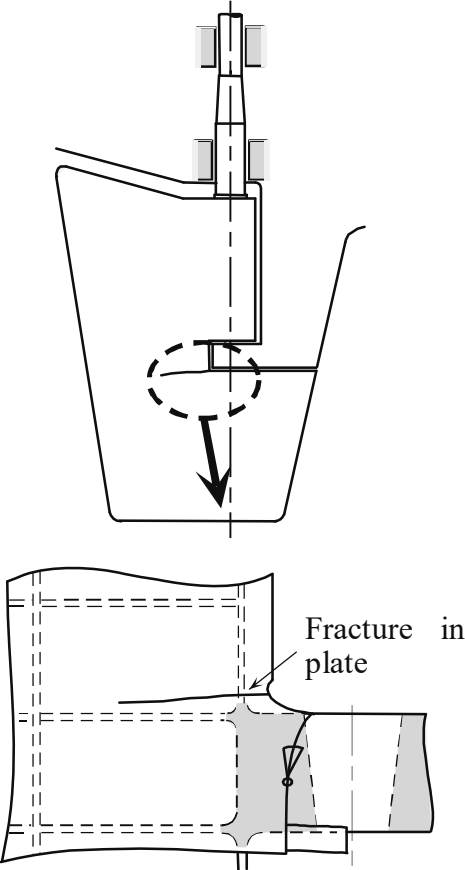
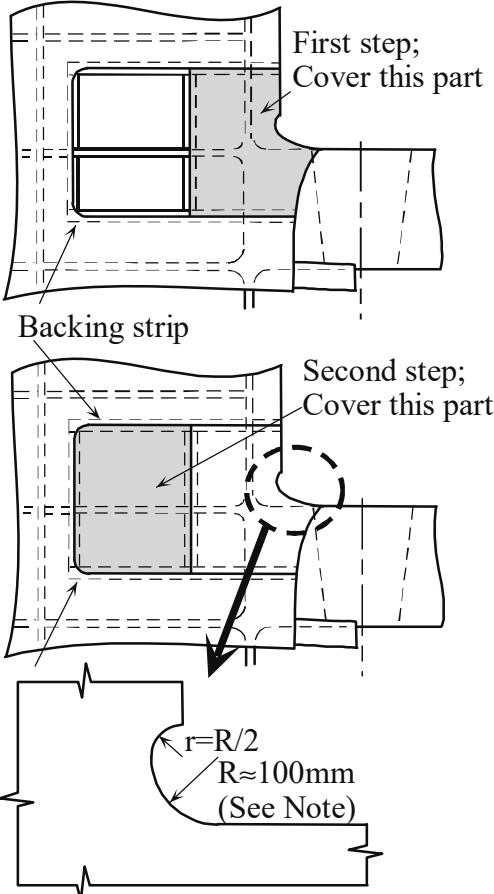
<p>Fracture in plate</p>

<p>First step; Cover this part</p> <p>Backing strip</p> <p>Second step; Cover this part</p> <p><math>r=R/2</math> <math>R\approx 100\text{mm}</math> (See Note)</p> <p>Note: R should be considered according to local detail</p>	
<b>Notes on possible cause of damage</b>		<b>Notes on repairs</b>	
<ol style="list-style-type: none"> <li>1. Stress concentration due to inadequate local design and/or fabrication notches in way of the butt weld between cast piece and plating.</li> </ol>		<ol style="list-style-type: none"> <li>1. Fractured plating is to be cut-out.</li> <li>2. Internal structures are to be checked.</li> <li>3. Cut-out is to be closed by an insert plating according to the sketch (welding only from one side is demonstrated).</li> <li>4. Modification of the radius.</li> <li>5. In case of a new cast piece, connection with the plating is to be shifted outside the high stress area.</li> </ol>

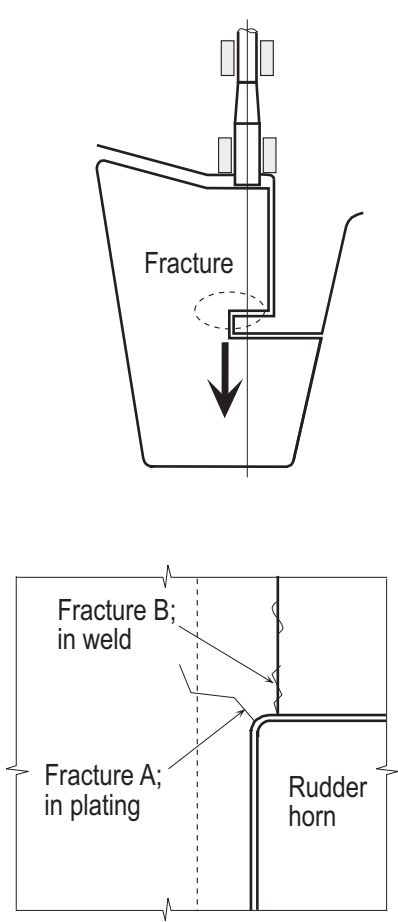
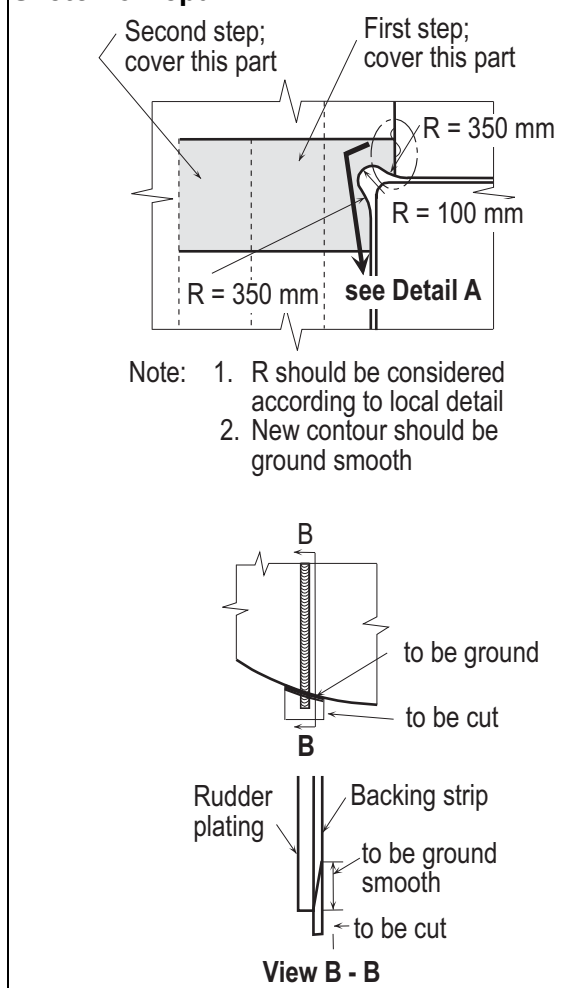
<p>The sketch shows a semi-spade rudder with a fracture in the plating. A detail view shows 'Fracture B; in weld' and 'Fracture A; in plating' near the 'Rudder horn'.</p>	<p><b>Sketch of repair</b></p>

<p>The repair sketch shows two steps: 'First step; cover this part' and 'Second step; cover this part'. It includes radii <math>R = 350\text{ mm}</math> and <math>R = 100\text{ mm}</math>. A note states: 'Note: 1. R should be considered according to local detail 2. New contour should be ground smooth'. A 'View B - B' shows 'Rudder plating', 'Backing strip', and areas 'to be ground' and 'to be cut'.</p>
