# No. 84 CONTAINER SHIPS

(2005)  
(Rev.1  
Nov 2017)

## Guidelines for Surveys, Assessment and Repair of Hull Structures

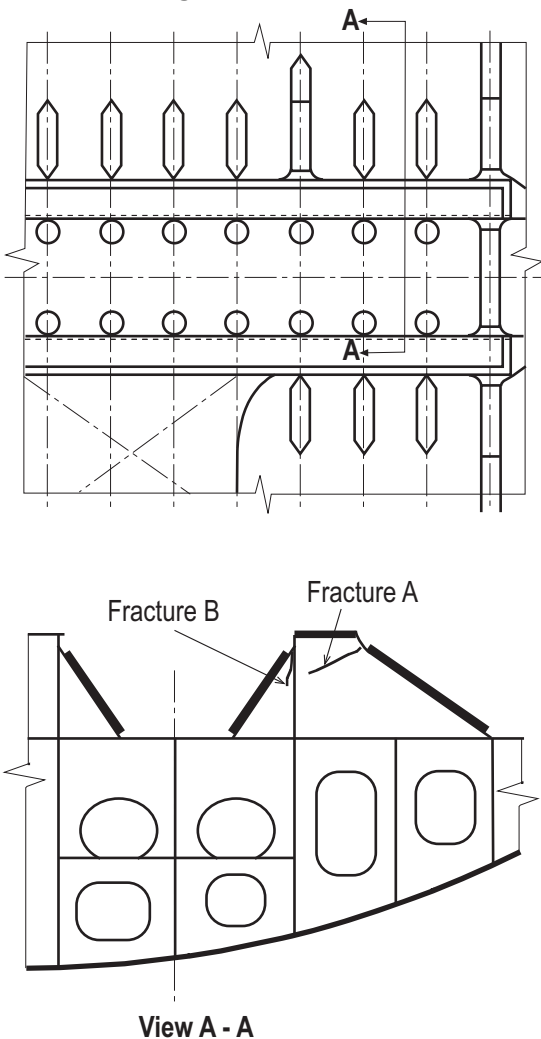
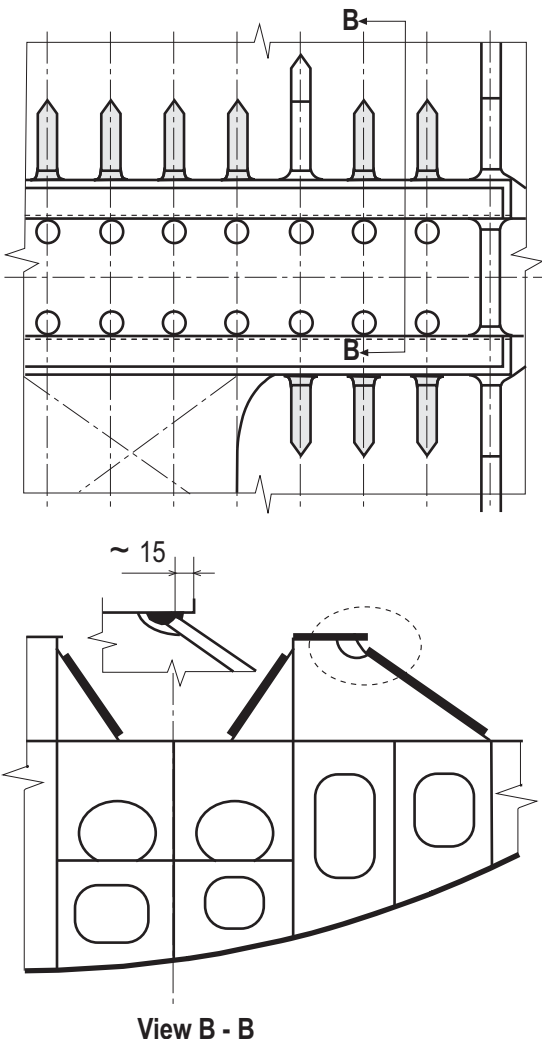
<p>View B - B</p>	
Notes on possible cause of damage		Notes on repairs	
<ol style="list-style-type: none"> <li>1. Vibration of main engine.</li> <li>2. Insufficient strength of brackets at main engine foundation.</li> <li>3. Insufficient pre-load bolts.</li> </ol>		<ol style="list-style-type: none"> <li>1. Fractures are to be veed-out and rewelded.</li> <li>2. New modified brackets at main engine foundation.</li> <li>3. Or insert pieces and additional flanges to increase section modulus of the brackets.</li> </ol>

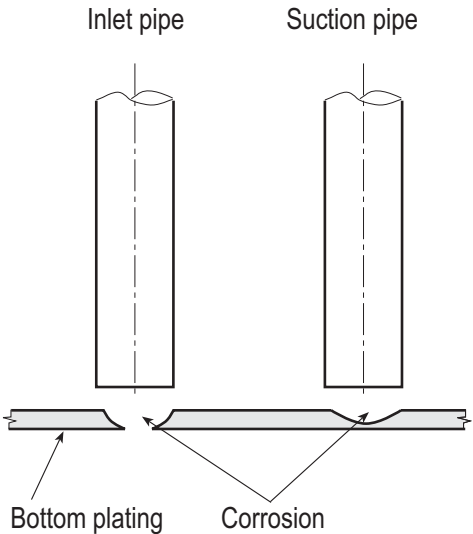
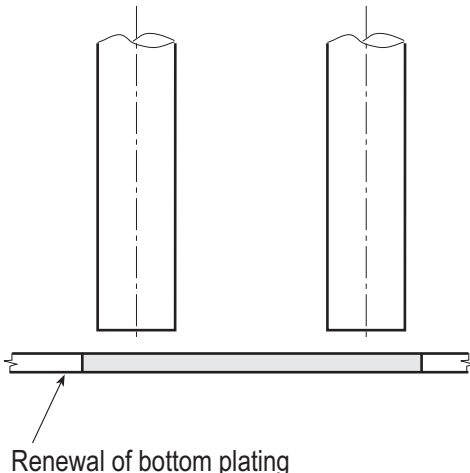
<b>Notes on possible cause of damage</b>		<b>Notes on repairs</b>	
<p>1. Heavy corrosion of bottom plating under the inlet/suction pipe.</p>		<p>1. Corroded bottom plating is to be cropped and part renewed. Thicker plate is preferable.</p> <p>2. Replacement of pipe end by enlarged conical opening (similar to suction head in ballast tank) is preferable.</p>

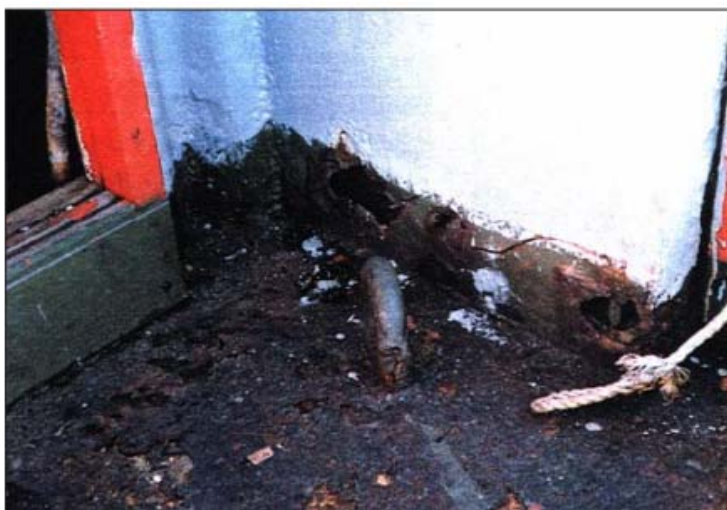
**Photograph 1 Corroded accommodation house side structure**
