Report on the investigation of
the cargo tank explosion and fire
on board the chemical tanker

Stolt Groenland

Ulsan, Republic of Korea

REPORT NO 9/2021

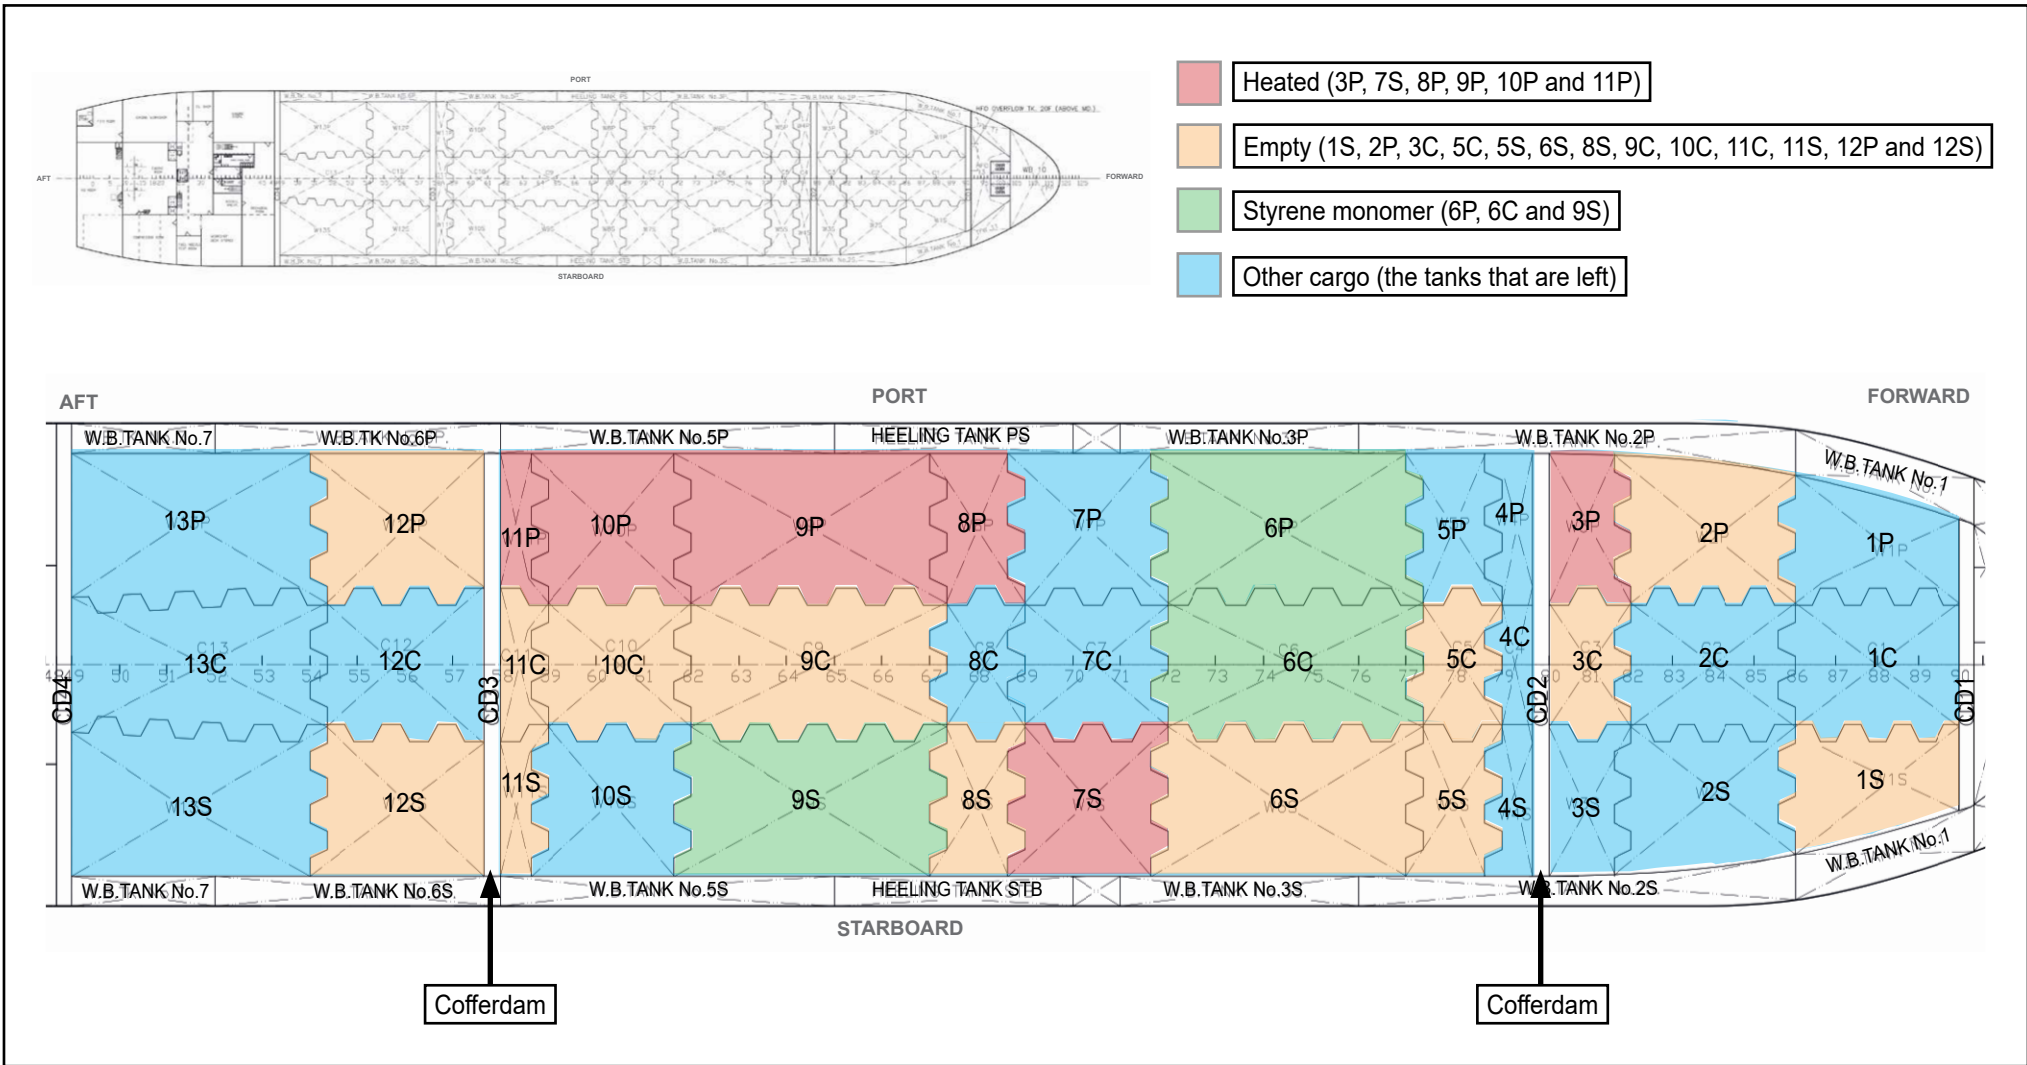
Figure 2: Cargoes remaining following discharge in Ulsan

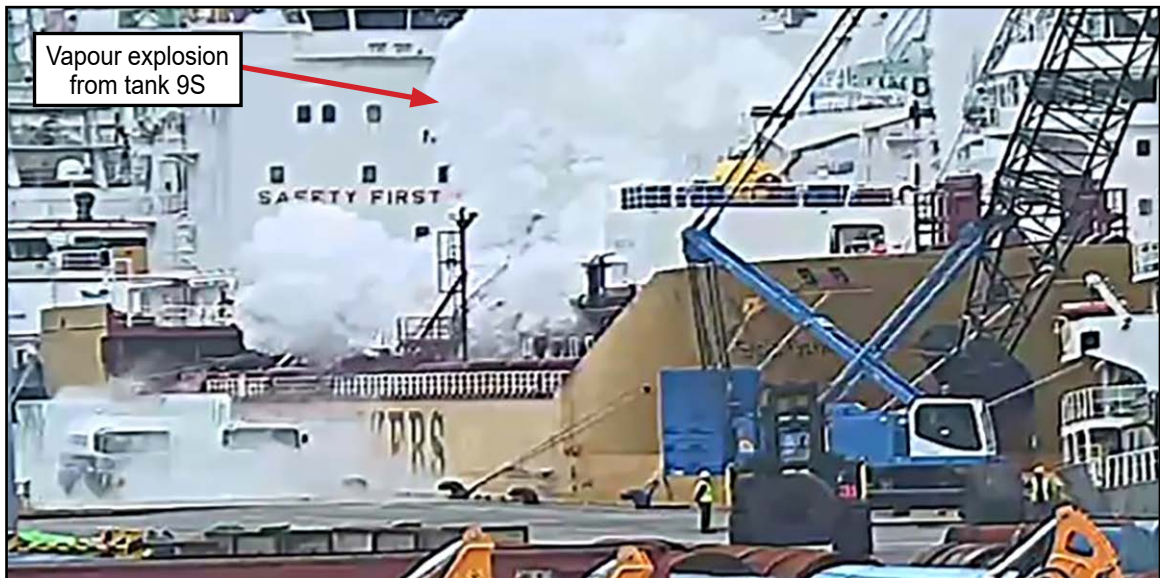
Figure 4: CCTV still showing tank rupture and vapour release

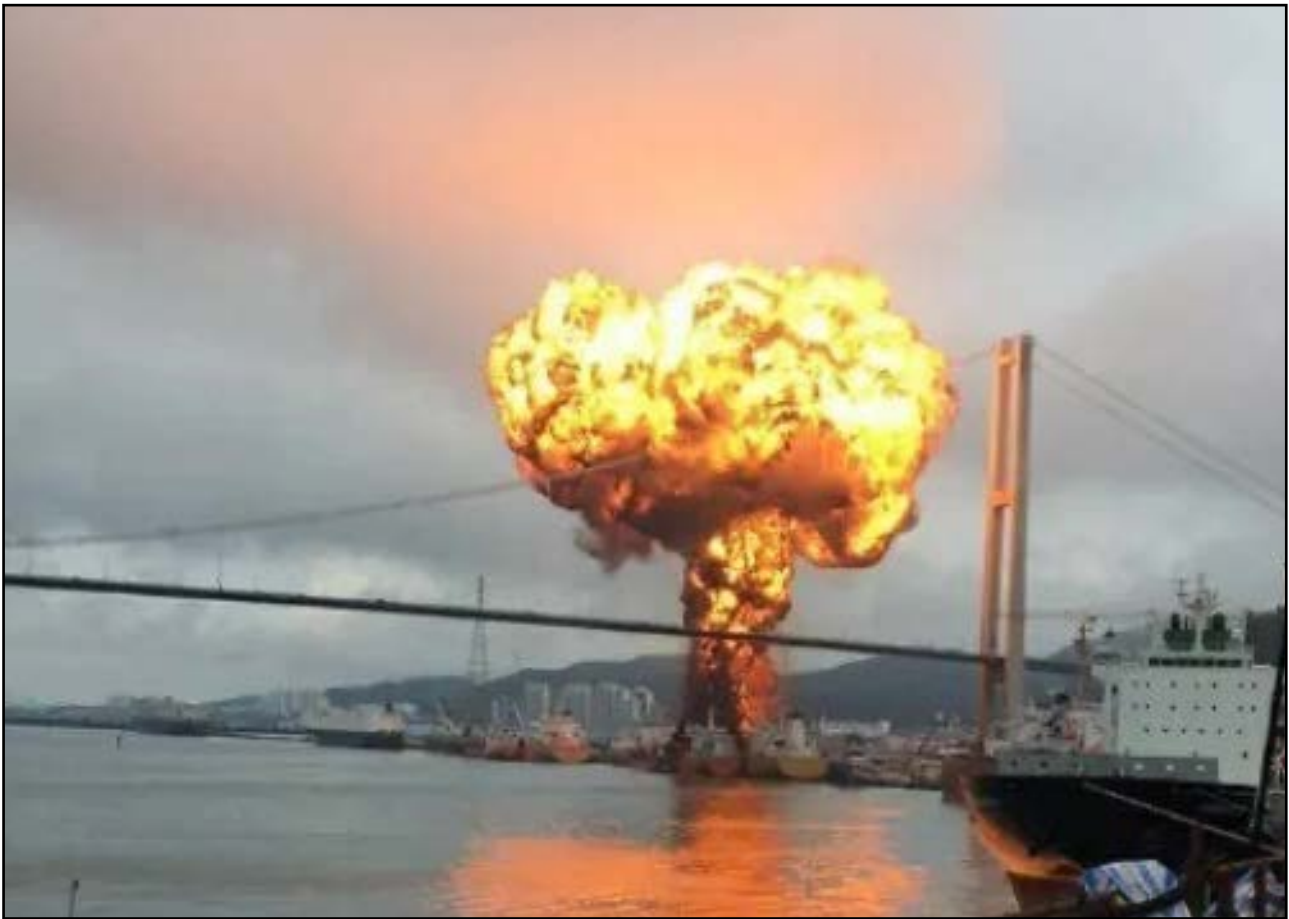
Figure 6: Fireball at Ulsan bridge

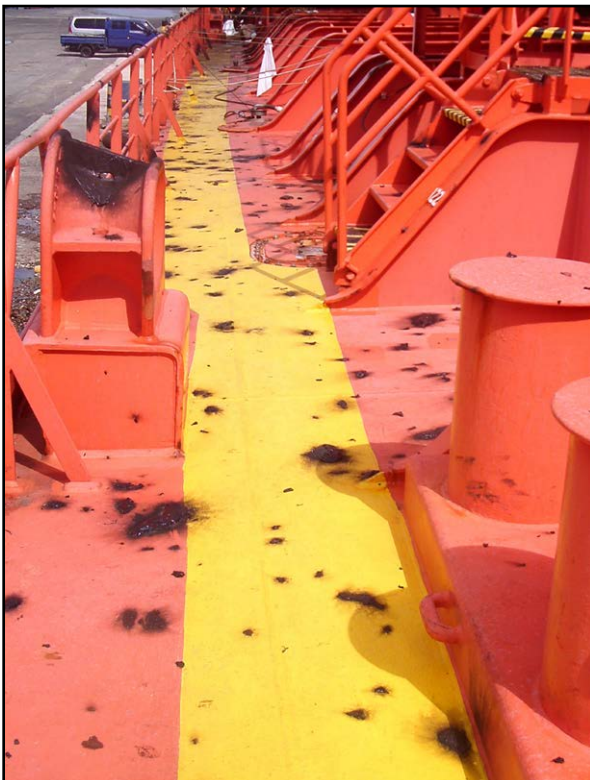
Figure 7: Bow *Dallian* main deck with burned styrene deposits

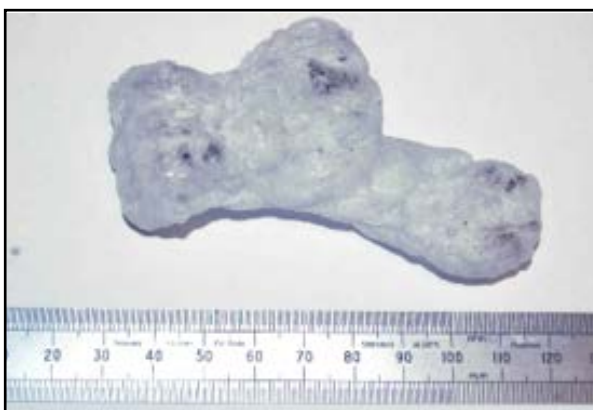
Figure 8: Styrene residue sample

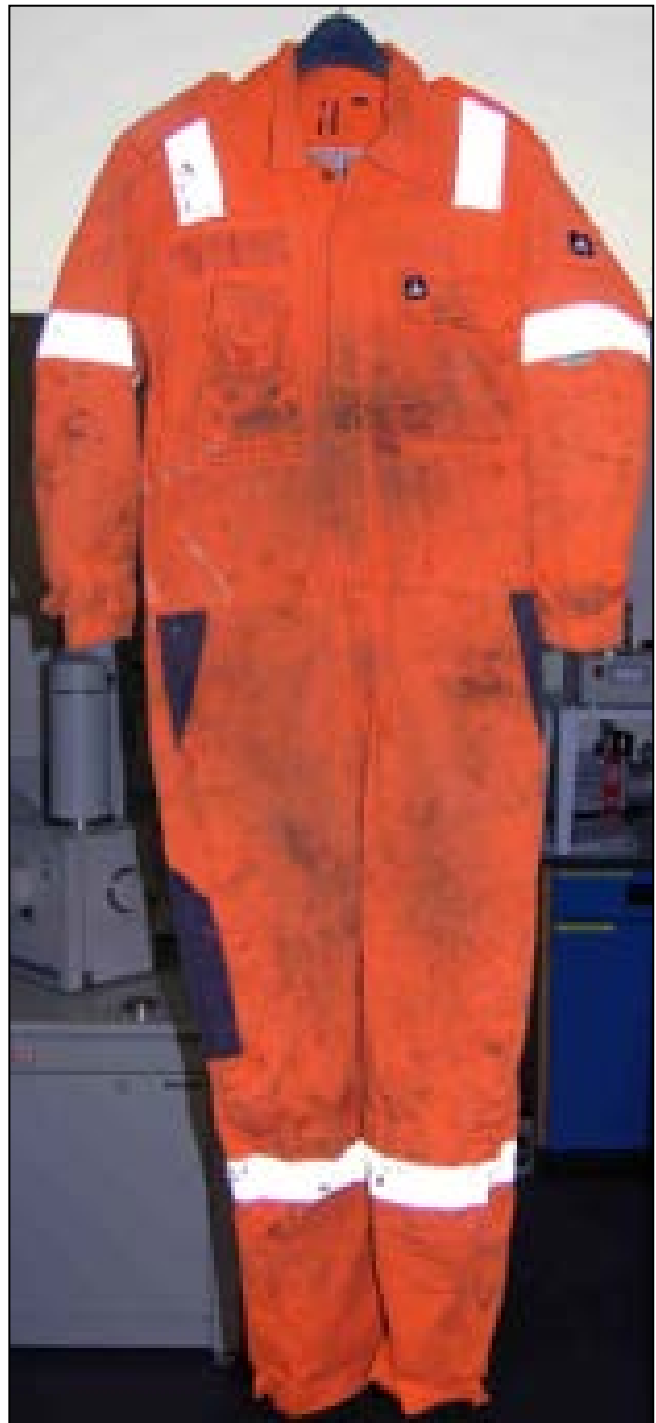
Figure 9: Overalls from *Bow Dallian* crewman

- *Styrene was identified on the overalls. This was observed in all areas but appeared more intense in areas of contamination.*
- *In high contamination areas (contaminated overalls) TBC was identified.*

- *If it is assumed that the styrene contamination of the overalls took place at the same time of the polymerization reaction and explosion was observed, then it can be stated that inhibitor was present, and detectable.*

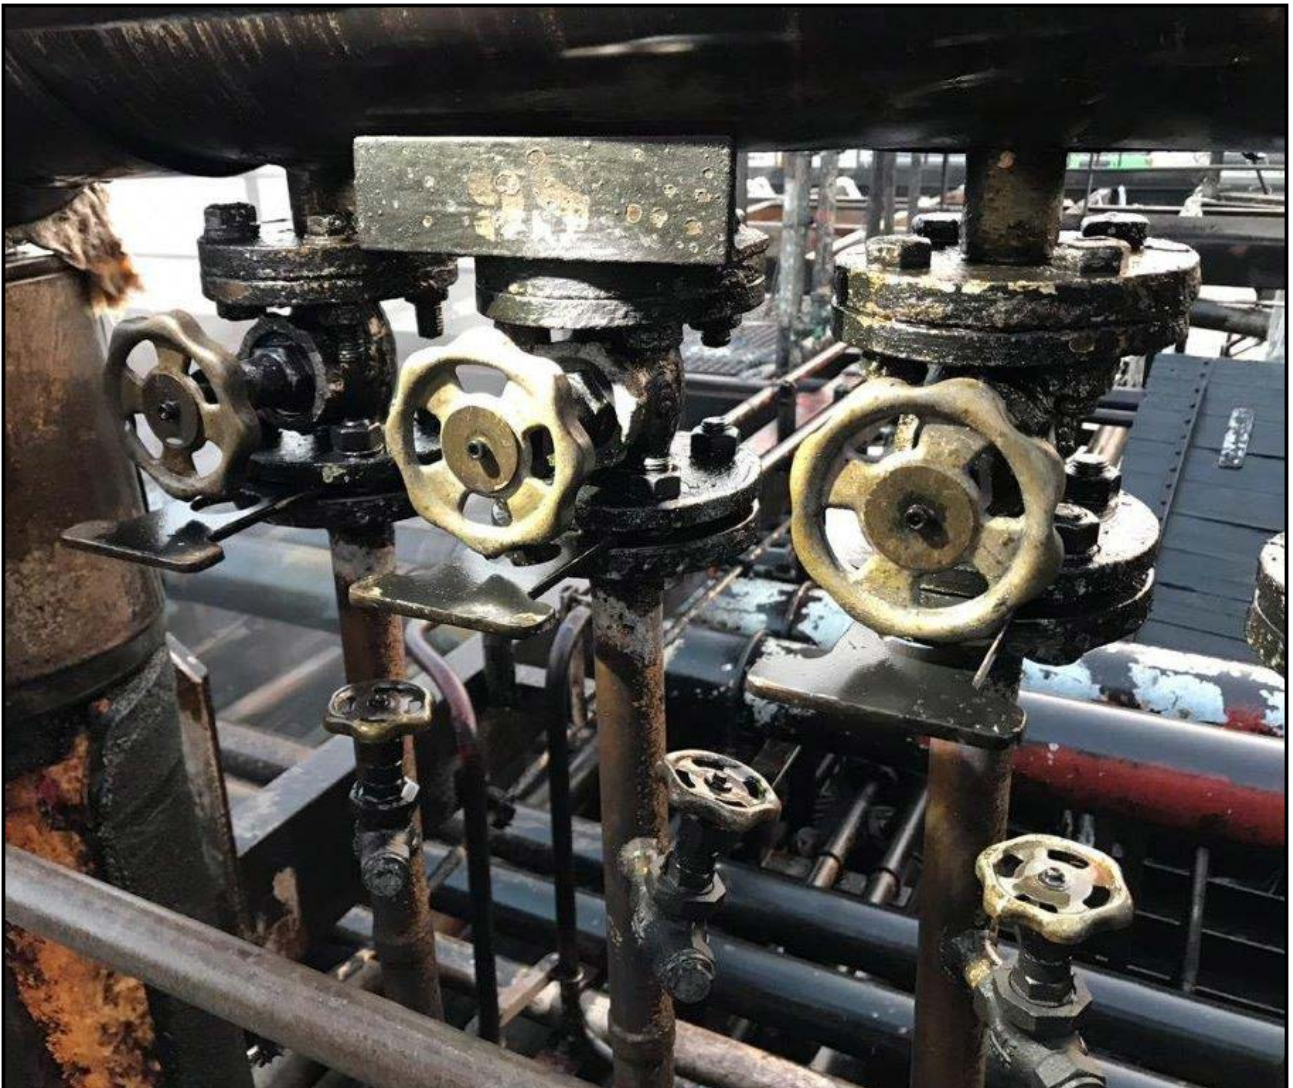
On 7 October, the analysis of samples of styrene monomer taken from *Stolt Groenland's* cargo tanks 6C and 6P indicated that the concentrations of the inhibitor 4-tert-Butylcatechol (TBC) were 8 parts per million (ppm) and 7ppm respectively. The following day, MAIB inspectors were allowed access to the vessel. However, the presence of hazardous chemicals and fire damage limited the inspection to the main deck primarily. A further inspection on 12 November was co-ordinated by the Korea Coast Guard and the KMST. These inspections, and inspections conducted by or on behalf of Stolt, confirmed that the heating coils in 9C and 9S were closed and blanked (**Figure 10**), and that vapours released from the p/v valves for 9S and 9C had ignited.

Figure 10: 9S heating control valves

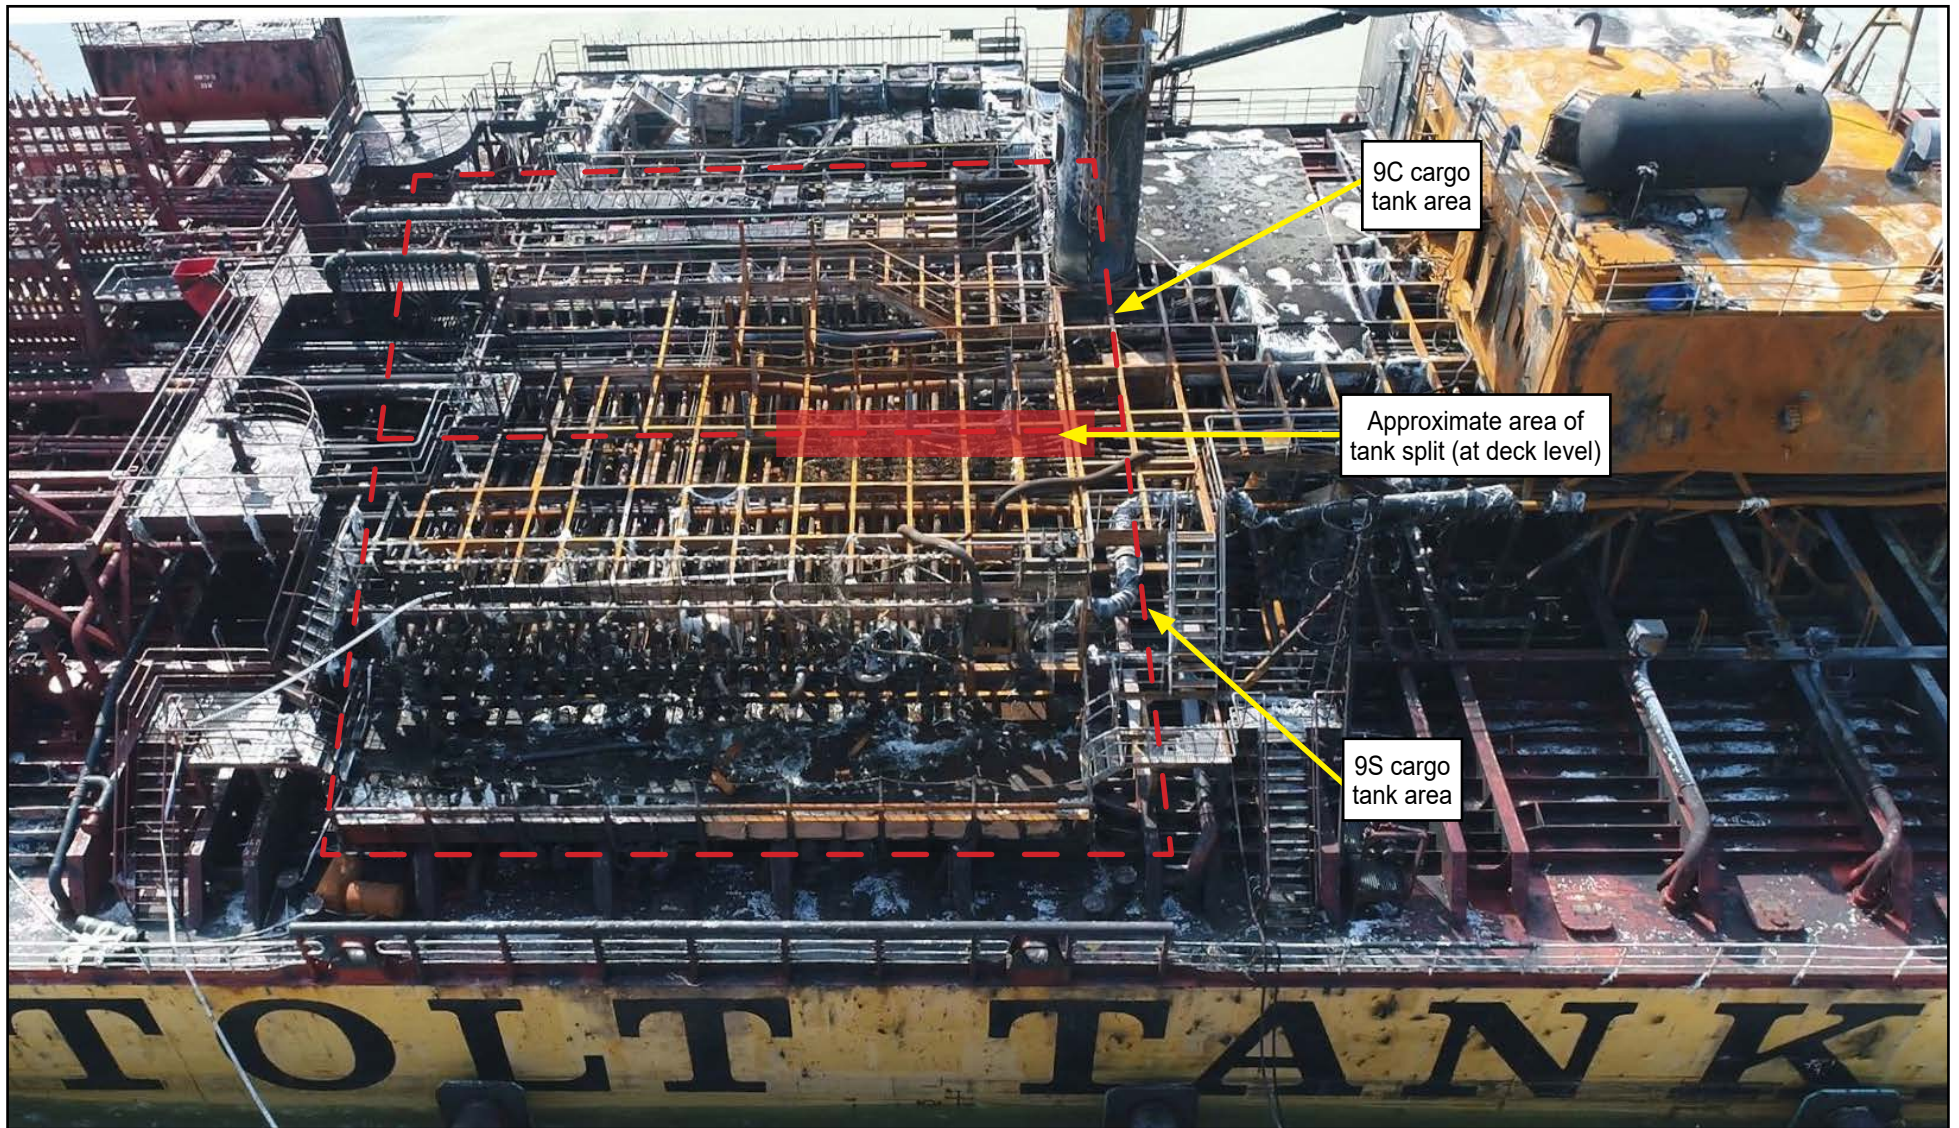
A large hole was found in *Stolt Groenland's* main deck in way of cargo tank 9S and its common bulkhead with cargo tank 9C (**Figures 11 and 12**). The access hatch cover to 9S had also been blown off (**Figure 13**). The manifold area was fire damaged to varying degrees, and the midships deckhouse was burned out (**Figure 14**).

Figure 11: Aerial view of main deck and location of 9S

The runaway polymerisation resulted in the rapid volumetric expansion of the styrene monomer, which increased the pressure within 9S at a rate that exceeded the venting capacity of the tank's p/v valve. As a result, the tank ruptured through the main deck and the common bulkhead with the empty cargo tank 9C (**Figures 11 and 12**).

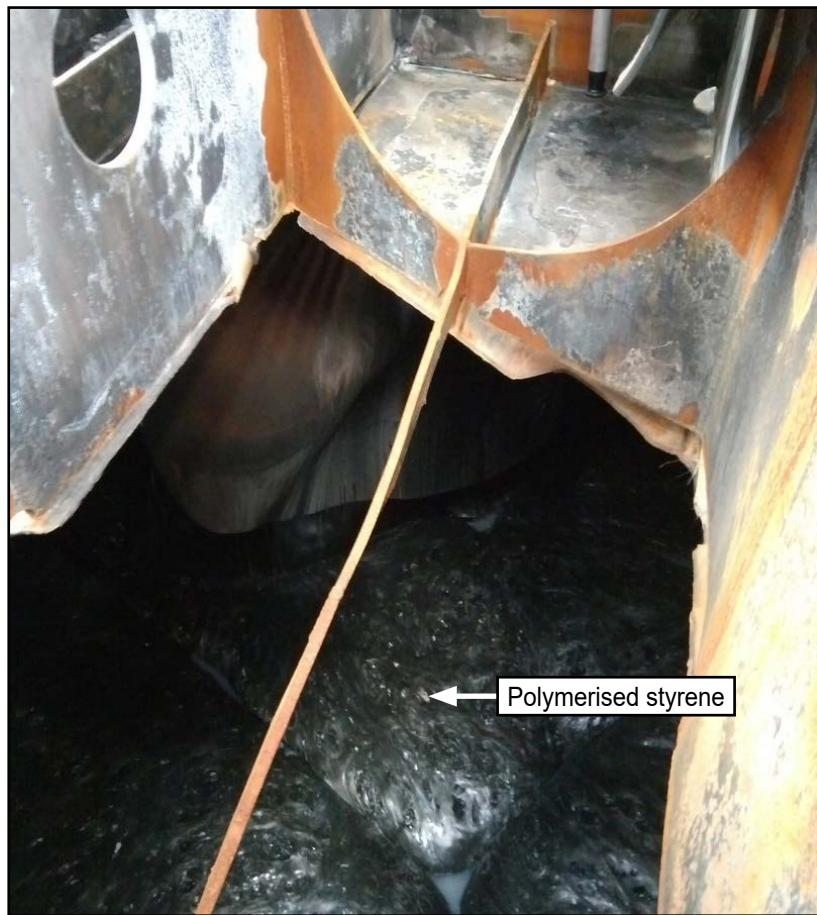
Figure 12: 9S tank rupture

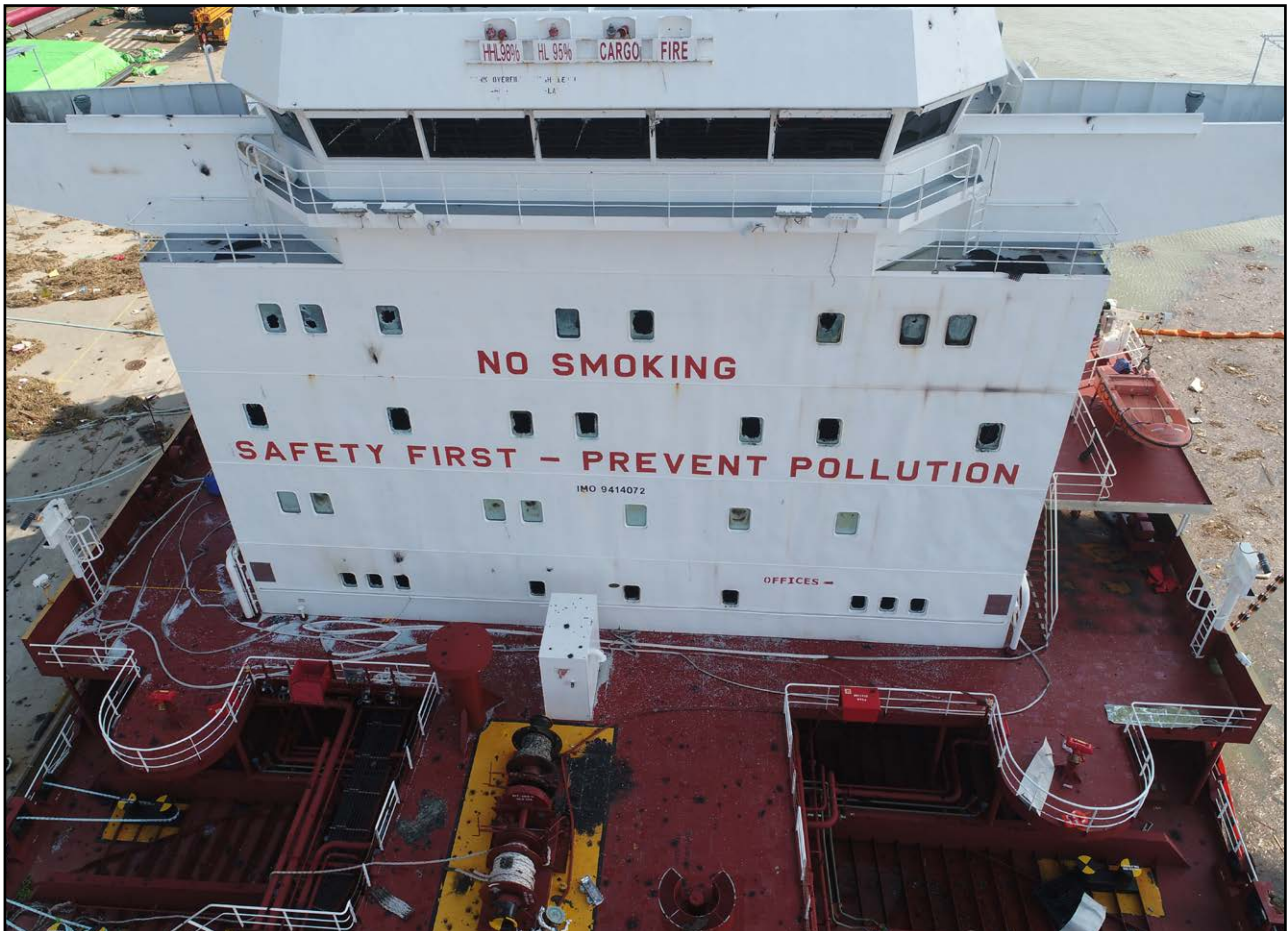
The tanker's accommodation block sustained extensive internal fire damage (**Figure 15**). The deck between the technical room and the CCR had collapsed, and both spaces were burned out. Heat and smoke had also penetrated the bridge and damaged much of its equipment. Other than broken windows, many of which were broken by firefighters during the emergency response, external damage to the front of the accommodation block was minimal (**Figure 16**).

Figure 16: Accommodation front

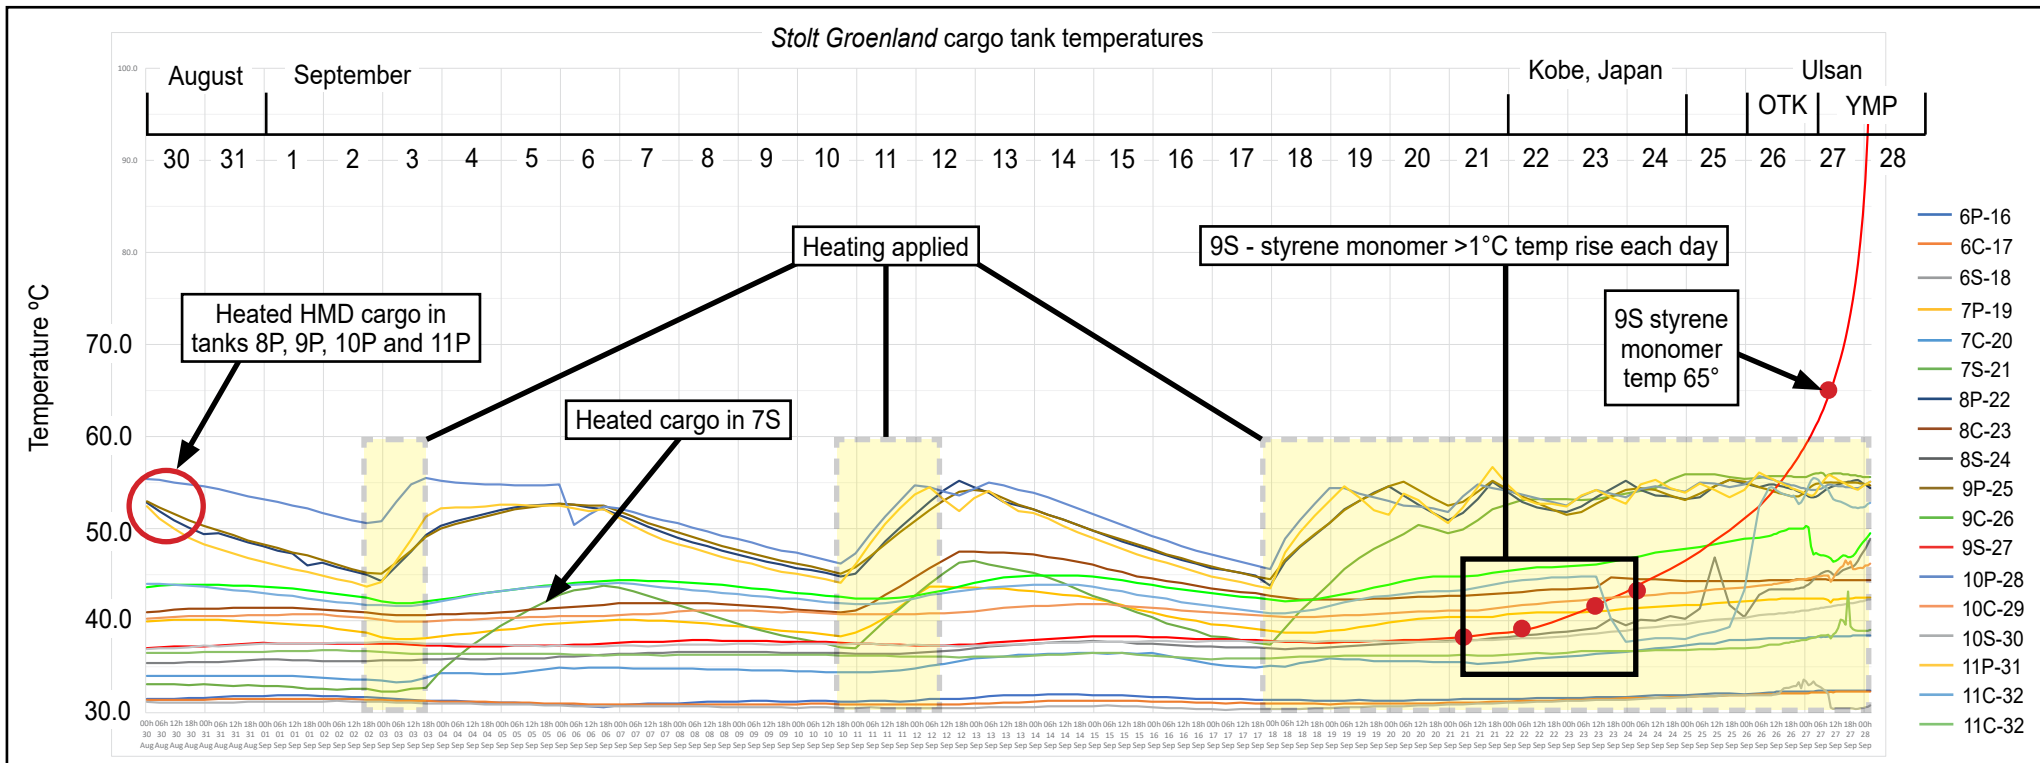
Figure 17: Cargo temperatures recorded on the VDR
