# No. 84 CONTAINER SHIPS

(2005)  
(Rev.1  
Nov 2017)

## Guidelines for Surveys, Assessment and Repair of Hull Structures

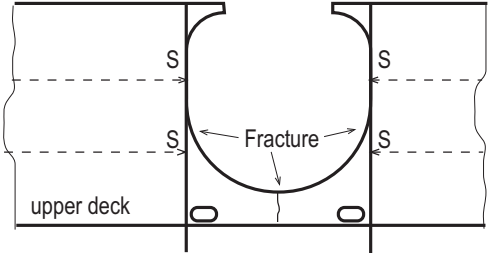
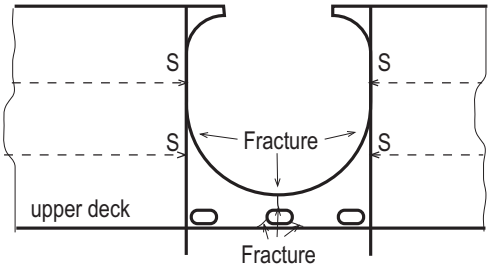
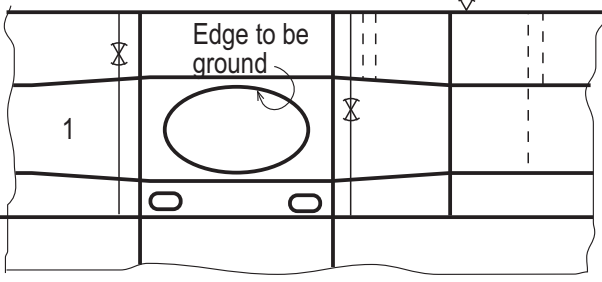
<b>Notes on possible cause of damage</b>		<b>Notes on repairs</b>	
<p>1. Coincidence of maximum of increased stress due to the reduction of the hatch coaming with the metallurgical notches due to the welding seams in web and flat bar located at the same position.</p>		<p>1. Hatch coaming to be continuous.                  2. Access opening to be provided.                  3. Drain holes to be elliptical and located above fillet weld to deck.                  4. Hatch coaming stiffeners of same material as coaming</p>

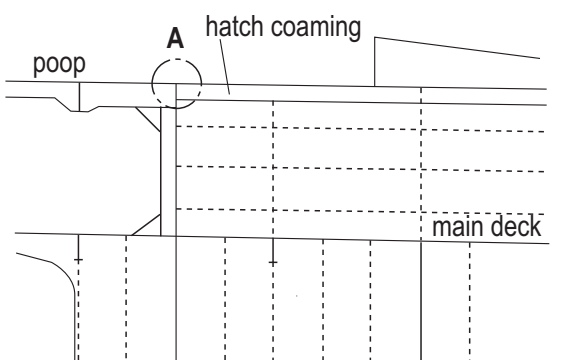
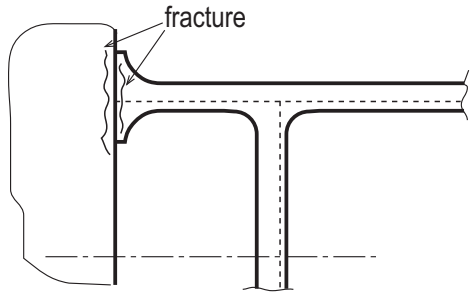
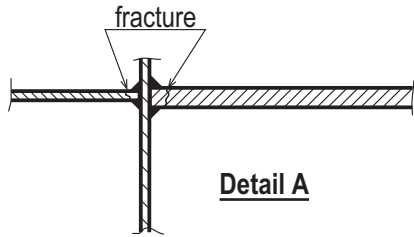
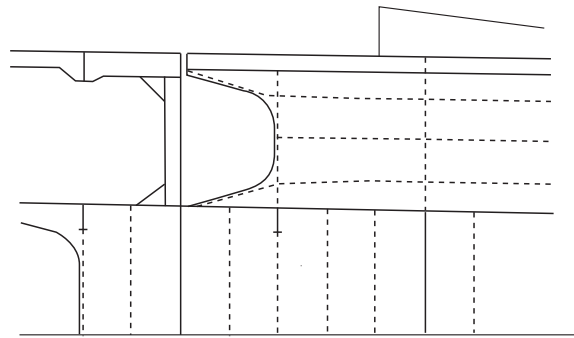
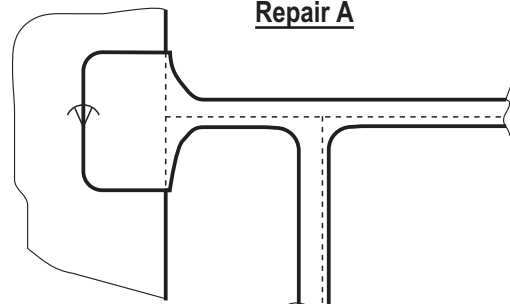
<p><b>Notes on possible cause of damage</b></p> <ol style="list-style-type: none"> <li>Insufficient transfer of forces from hatch coaming top plate into poop deck plating by cruciform connection.</li> </ol>		<p><b>Notes on repairs</b></p> <ol style="list-style-type: none"> <li>Continuation of hatch coaming top plate by inserting thick plate into the thin poop deck plating (chamfer 1:5) see Repair A.</li> <li>Cutting of the connection between longitudinal hatch coaming and poop in the case that the strength requirements are satisfactory (see Repair B).</li> </ol>

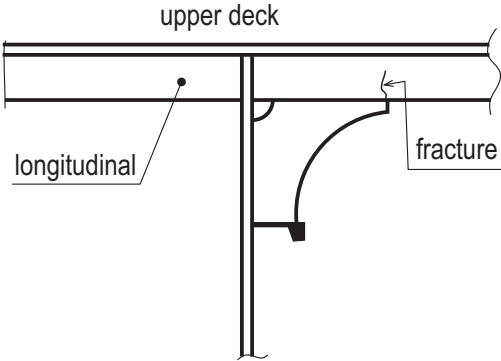
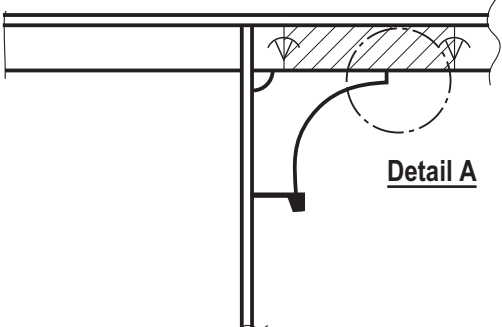
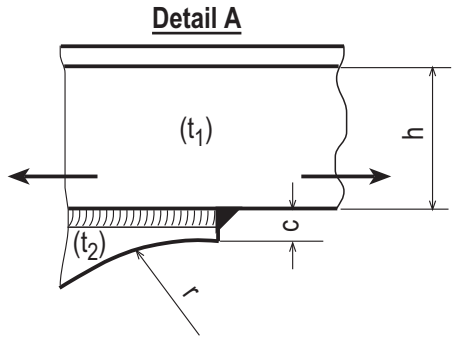
<p>upper deck longitudinal fracture</p>

<p><u>Detail A</u></p> <p>(t<sub>1</sub>) (t<sub>2</sub>) r c</p> <p><math>c \leq 2 t_2</math> max. 25 mm <math>r \geq 0,5 h</math></p>	
<b>Notes on possible cause of damage</b>		<b>Notes on repairs</b>	
<ol style="list-style-type: none"> <li>1. Stress concentration at bracket toe</li> <li>2. Bracket toe too high</li> <li>3. Poor workmanship</li> </ol>		<ol style="list-style-type: none"> <li>1. Damaged area to be cropped and renewed</li> <li>2. New bracket with soft toe to be added.</li> </ol>

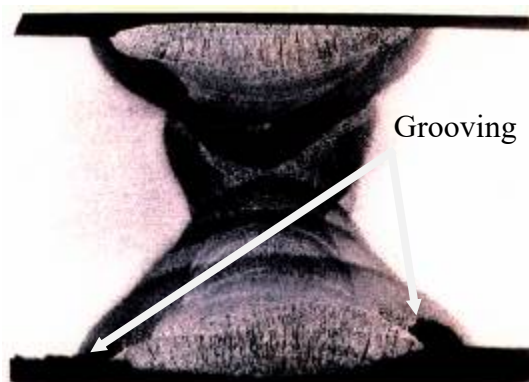
**Figure 3**  
Section of the grooving shown in Figure 2

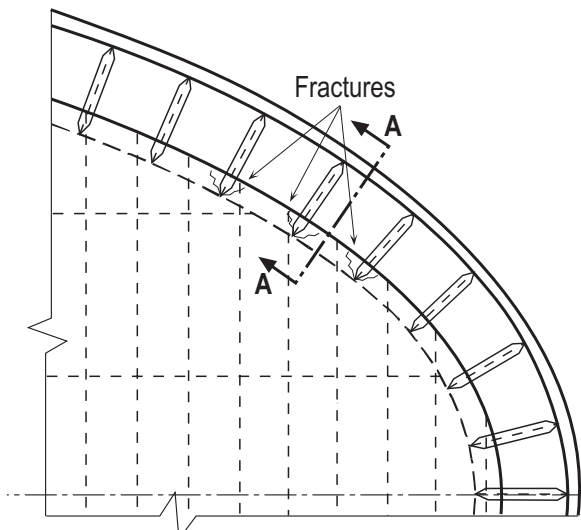
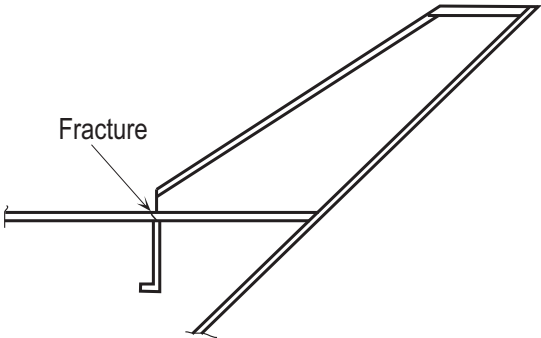
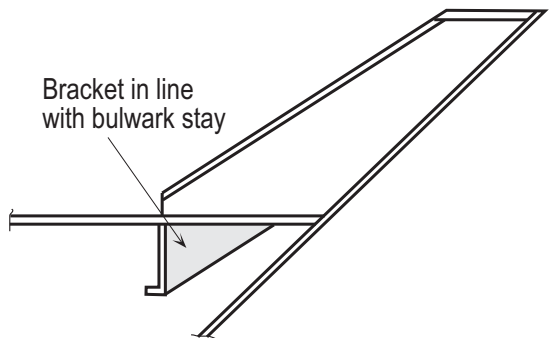
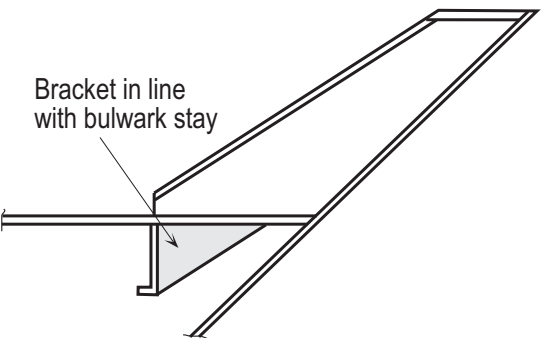
<p style="text-align: center;">View A - A</p>	
<b>Notes on possible cause of damage</b>		<b>Notes on repairs</b>	
<ol style="list-style-type: none"> <li>1. Bow flare effect in heavy weather.</li> <li>2. Stress concentration due to poor design.</li> </ol>		<ol style="list-style-type: none"> <li>1. Fractured deck plating should be cropped and renewed.</li> <li>2. Bracket in line with the bulwark stay to be fitted to reduce stress concentration.</li> </ol>

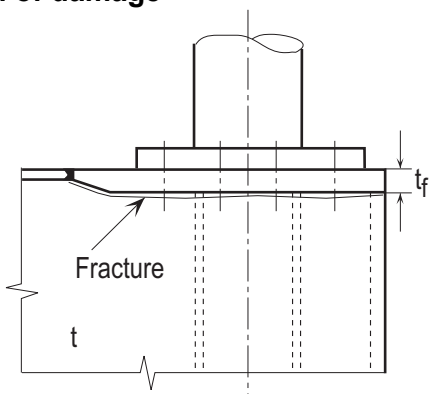
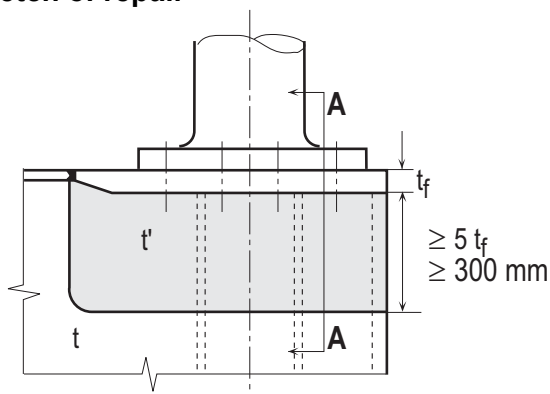
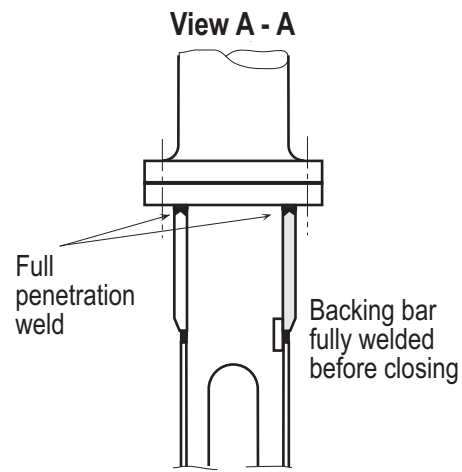
<p>1. Inadequate connection between horizontal coupling plate and rudder blade plating (insufficient plating thickness and/or insufficient fillet weld).</p>		<p>1. Modification of detail design of the connection by increasing the plate thickness and full penetration welding.</p>

<p>Full penetration weld</p> <p>Backing bar fully welded before closing</p> <p><math>t</math> = plate thickness [mm]  <math>t_f</math> = actual flange thickness [mm]  <math>t = \frac{t_f}{3} + 5</math> [mm], where <math>t_f \leq 50</math> mm  <math>t = \sqrt[3]{t_f}</math> [mm], where <math>t_f \leq 50</math> mm</p>	
<b>Notes on possible cause of damage</b>		<b>Notes on repairs</b>
