Annual Digest
Reports and Insight Articles

2020

Annual Digest of Reports and Insight Articles 2020

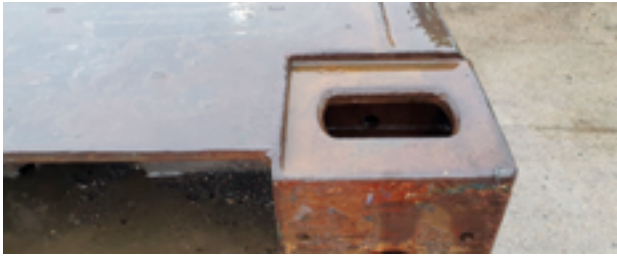
At ≈20mm the top plate thickness was 8mm thinner than more modern "flats" and the current industry standard, ≈28mm

Chamfer on the lifting socket can be clearly seen.

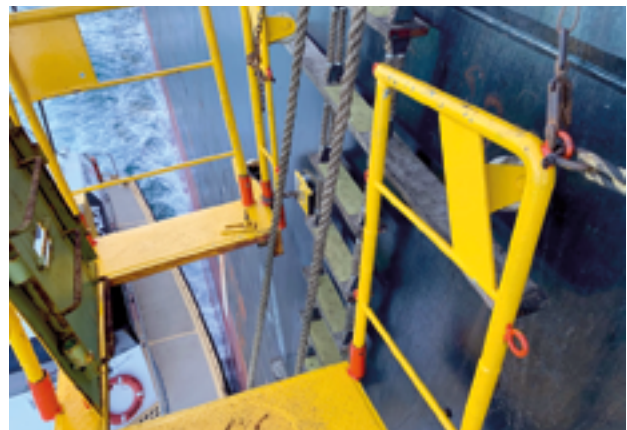
Example of a compliant combination PBA with trap door.

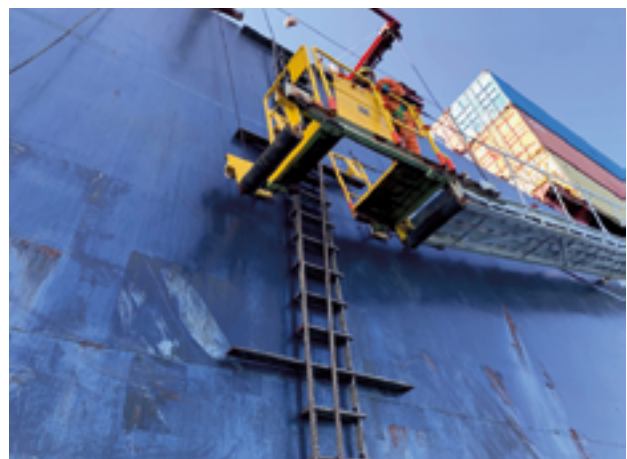
Compliant combination PBA with trap door – pilot ladder and man ropes extend up to and are made fast on vessel's deck

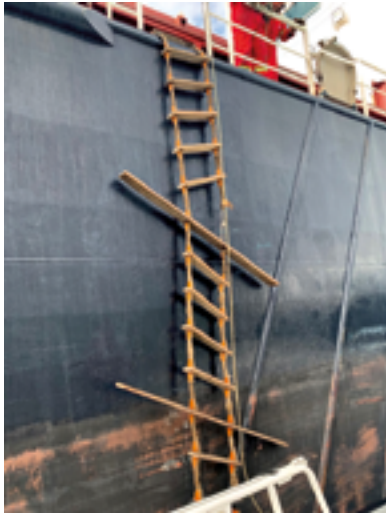
Parted ladder

While boarding the vessel at the pilot exchange station, one of the side ropes snapped. No other pilot ladders were available.

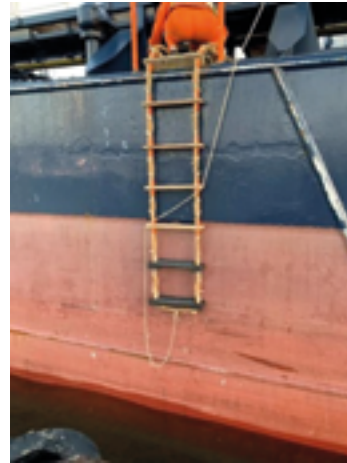
2 metres of ladder with at least 4 non-compliances.

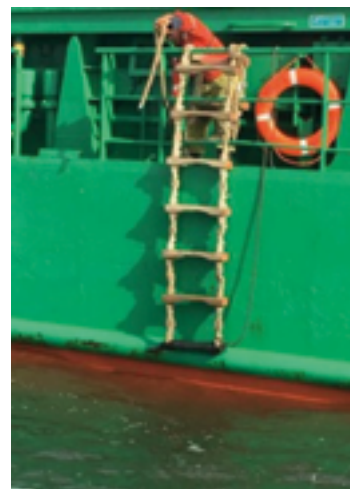
Notorious offender with bulwark setup. It's not even a pilot ladder (at least 6 non compliances).

IMO A.1045(27) states: The side ropes of the pilot ladder should consist of two uncovered ropes not less than 18mm in diameter on each side and should be continuous, with no joints and have a breaking strength of 24 Kilo Newtons per side rope (2.2.1).

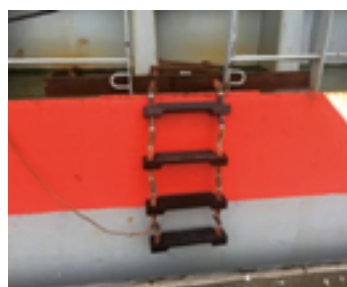
A spreader used for securing the ladder behind a very thin piece of railing.

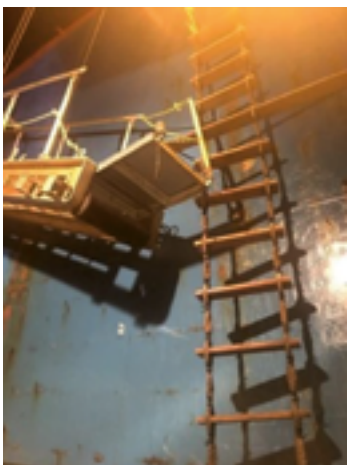
A non-compliant combination arrangement.

SOLAS V.23 clearly states (3.3.1): a pilot ladder requiring a climb of not less than 1.5m and not more than 9m above the surface of the water etc. etc.

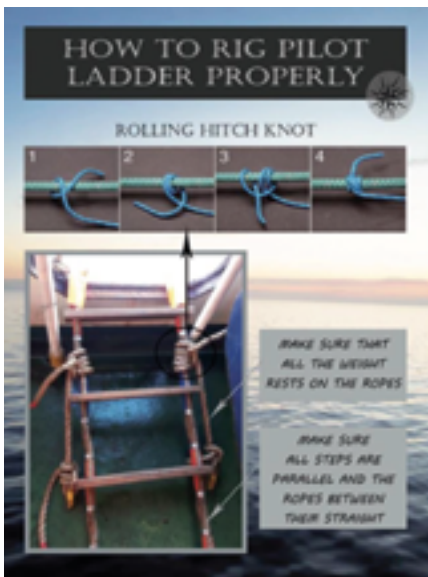
How to secure the pilot ladder correctly at deck level.

This is it... nothing to it, simple and safe!

The better ladder manufacturers supply securing ropes with every ladder they provide. Use these ropes. Don't use some random piece of rope you have found in the bosun's shop or strops or what else.

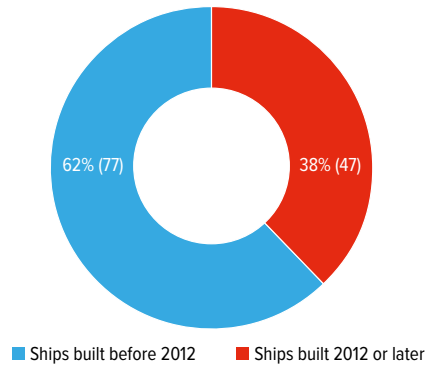
Figure 1 – Non-conforming ships by age.

It is perhaps no surprise that the greater number of non-conforming vessels were constructed prior to the advent of the current Regulations. Neither will there be any raised eyebrows with respect to the second chart – after all the larger sections of the pie chart are the larger ship registries. However, this is not the point. All vessels will have undergone a statutory five-year refit since the 2012 regulations came into force and have had ample opportunity to modify their arrangements in order to comply with SOLAS Chapter V. Yet this has not been done. CHIRP would query why this is so and refuses to accept that “We comply with pre-existing older regulations” is a satisfactory answer. The lives of maritime pilots are being endangered day in and day out, so it is incumbent upon shipping companies, classification societies, flag state administrations and indeed vessels’ crews to ensure that the arrangements are one hundred percent compliant.

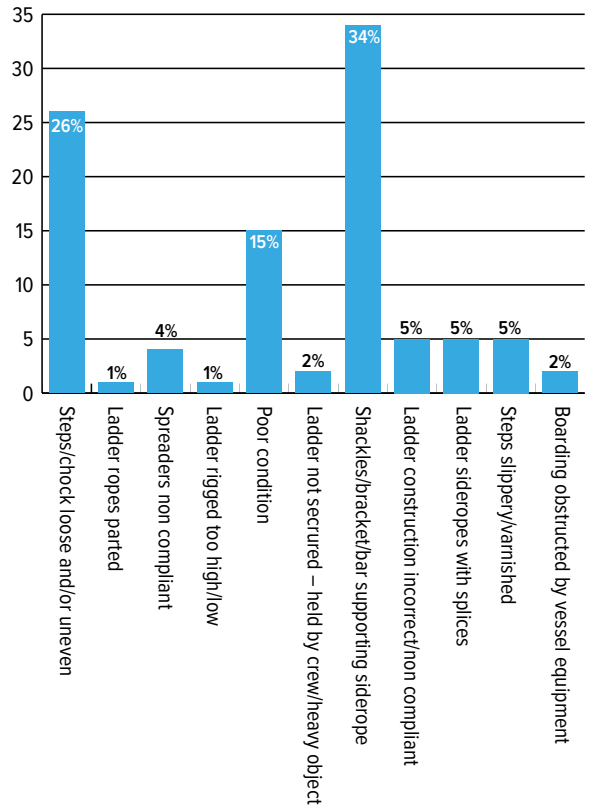
Figure 3 – Reports specific to pilot ladders.

The chart in Figure 3 shows deficiencies of pilot ladders, where a single ladder was utilised for pilot embarkation or disembarkation. CHIRP received 66 reports in this category, which detailed 99 specific deficiencies.

It is a damning indictment that 42% of the reports received highlight uneven steps, loose chocks, a ladder in poor condition or, in one case, the side ropes parting completely when weight was placed upon them prior to disembarkation. This highlights a deficient safety culture and woefully poor quality of seamanship as well as indicating a complete disregard for the safety of the pilot who has to use the ladder. It should be noted that a small percentage of the uneven steps/chocks were in fact ladders that were relatively new and manufactured ashore. CHIRP is aware that in some cases this has been followed up by the port or national administration who have contacted the manufacturer(s) in question. The same applies to some of the pilot ladders which have been manufactured ashore and have arrived varnished.

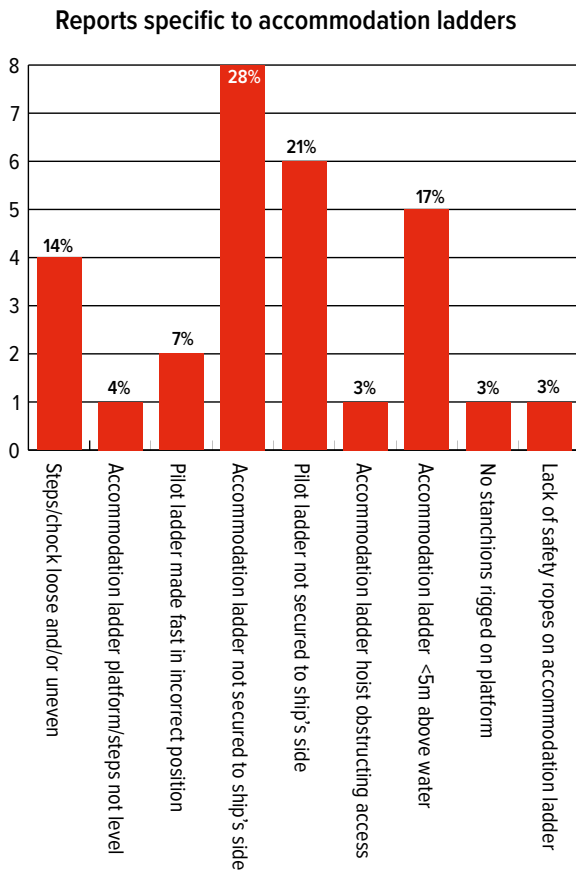
Figure 4 – Reports specific to accommodation ladders.

Figure 4 shows deficiencies related to accommodation ladders with 17 reports received and 29 separate deficiencies highlighted. Almost fifty percent of the reports relate to either the accommodation ladder itself and/or the pilot ladder, not being secured to the ships side as required by the 2012 SOLAS V regulations. Another significant slice of the pie describes the accommodation ladder itself being less than five metres above the waterline. Anything other than a light swell could cause damage to either the attending pilot vessel and/or the accommodation ladder itself.

The apparently repeated report of defective steps and chocks is explained by the fact that the reports highlighted this issue along with other deficiencies specific to accommodation ladders.

The smaller sections of the diagram deserve a mention since they are extremely dangerous – accommodation ladder steps not being level, a lack of safety ropes on the accommodation ladder and no stanchions rigged at the bottom of the ladder at the pilot access are all extremely dangerous. CHIRP Maritime would argue that there is no excuse for this – in dialogue with the reporters, we discovered the vessels concerned had confirmed that the arrangements were ready in all respects to effect a safe pilot transfer. Clearly this is not the case, and in no situation was the vessel being rushed to prepare the arrangement. This is safety culture and supervision in its poorest form.

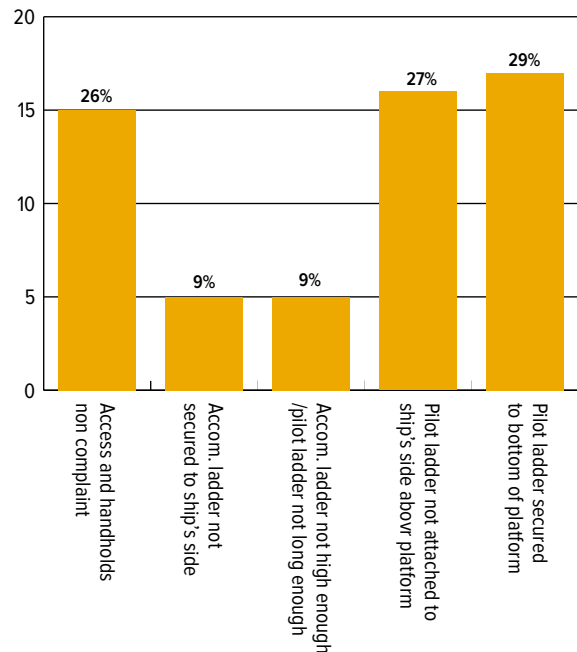
Figure 5 – Reports specific to “trap door” type combination rigs.

Figure 5 shows deficiencies with respect to “trap door” type combination rigs. CHIRP received 25 reports related to these arrangements and the analysis shows a high number of deficiencies, namely 58. The reason for this is not at all surprising. It is almost universally impossible to rig a trapdoor arrangement that is one hundred percent compliant with the 2012 SOLAS V regulations.

The largest areas of failing are the pilot ladder being secured to the bottom of the accommodation ladder, the pilot ladder (often another ladder) not being attached to the ships side 1.5m above the accommodation ladder platform, and access and handholds being non-compliant – this is causing repeated difficulties for the pilots to make the transition from pilot ladder to accommodation ladder.

CHIRP queries all of the above but specifically the pilot ladder being secured to the bottom of the accommodation ladder. Photographic evidence often shows modifications having been made to accommodation ladders, and that lugs have been welded to the base of the ladder to allow a pilot ladder to be shackled on. Despite the fact that this is non-compliant with the regulations, CHIRP asks the question, “Who authorised these arrangements?”

Fully compliant trap door arrangements such as three-sided trap door rigs are noted to be few and far between. The general view is that the sooner these arrangements are either modified to full compliance or are removed from service and banned altogether the better. CHIRP fully agrees with this sentiment but assesses that such a change will need to be mandated in clear language to avoid misinterpretation.

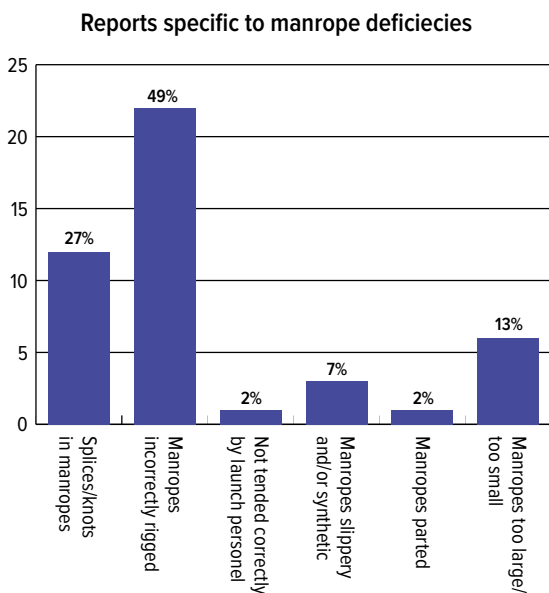
Figure 6 – Reports specific to manropes deficiencies.

CHIRP received 37 reports where manropes were specifically mentioned, and 45 deficiencies were highlighted. Almost half of the deficiencies related to the incorrect rigging of the manropes. Notwithstanding the nature of the other deficiencies reported, all of the failings came down to a basic lack of seamanship, supervision, safety culture and training. This is one area where any change to pilot ladder regulation is unnecessary – all of the deficiencies can be addressed on board to ensure that manropes are rigged correctly.

The whole chart demonstrates a lack of understanding as to what the manropes are used for, and this requires the urgent attention of vessels crews and their managers ashore in order to rectify the problem.

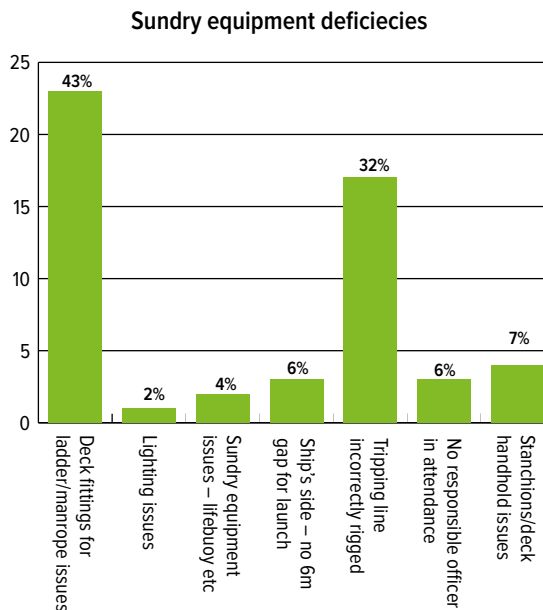
Figure 7 – Sundry equipment deficiencies.

The final chart in Figure 7 describes sundry deficiencies with the equipment. 47 reports were received, and 53 separate deficiencies were noted.

The largest area of failing were the deck fittings (or more correctly lack of) for side ropes and manropes. The deficiencies were noted for both pre 2012 and current SOLAS vessels. As noted earlier, all vessels have had ample time since the introduction of the current regulations to rectify any failings, so the question has to be asked why they have not done so? There is much more to be done by flag administrations, their recognised inspection organisations, port state control, and shipping companies in order to rectify this area.

Incorrect retrieval lines – often called tripping lines – accounted for almost one third of the reports, where the line was rigged in such a manner that it could become fouled upon the attending pilot launch or obstruct the safe access to the ladder for the pilot. The majority of failings were that the line led aft and not forward – also the line was rigged below the bottom spreader. All totally avoidable with a little care and attention.

Finally, the lighting issues and lifebuoy issues might charitably be attributed to carelessness, or it might be down to a poor safety culture. There is however absolutely no excuse for a responsible officer not being in attendance during the embarkation or disembarkation of a pilot. This highlights a disregard for the safety of any pilot boarding operation and/or exposes deficiencies in crew manning.
