**MAIB**

# **SAFETY DIGEST**

**Lessons from Marine  
Accident Reports  
2/2021**

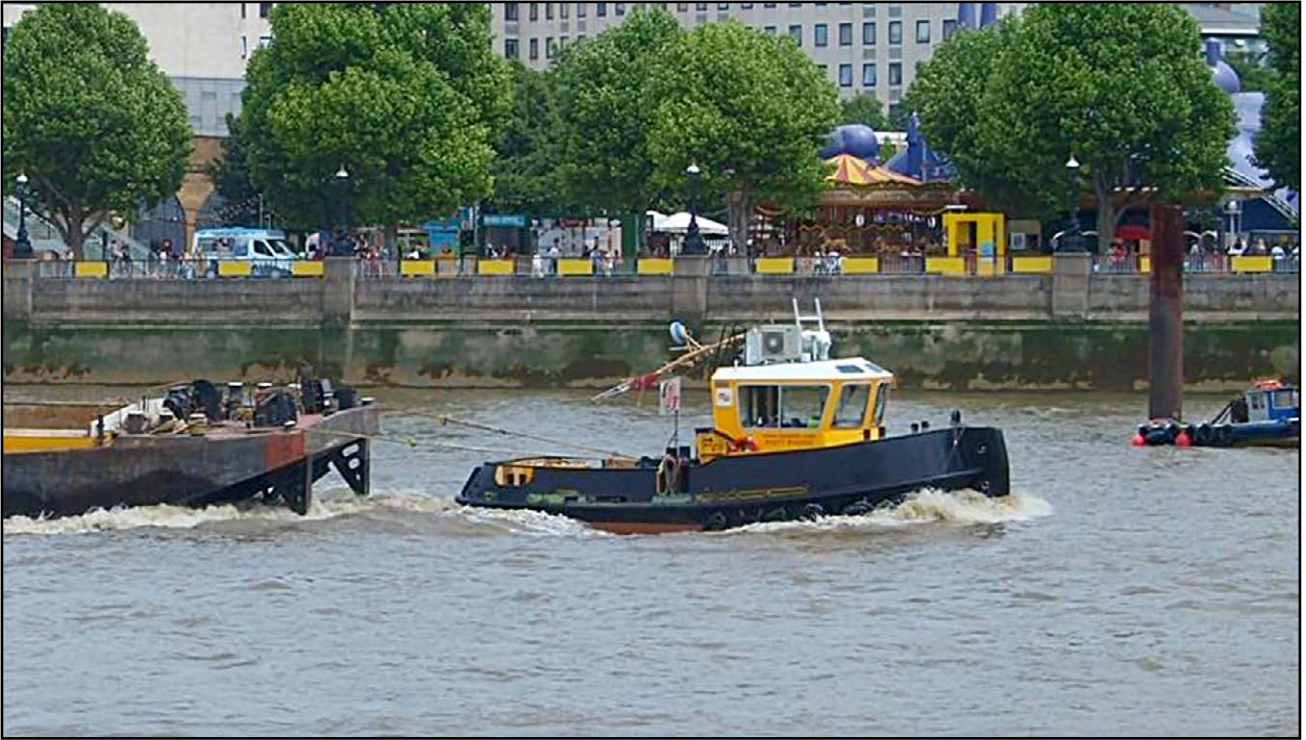
Figure 1: Tug towing the barge

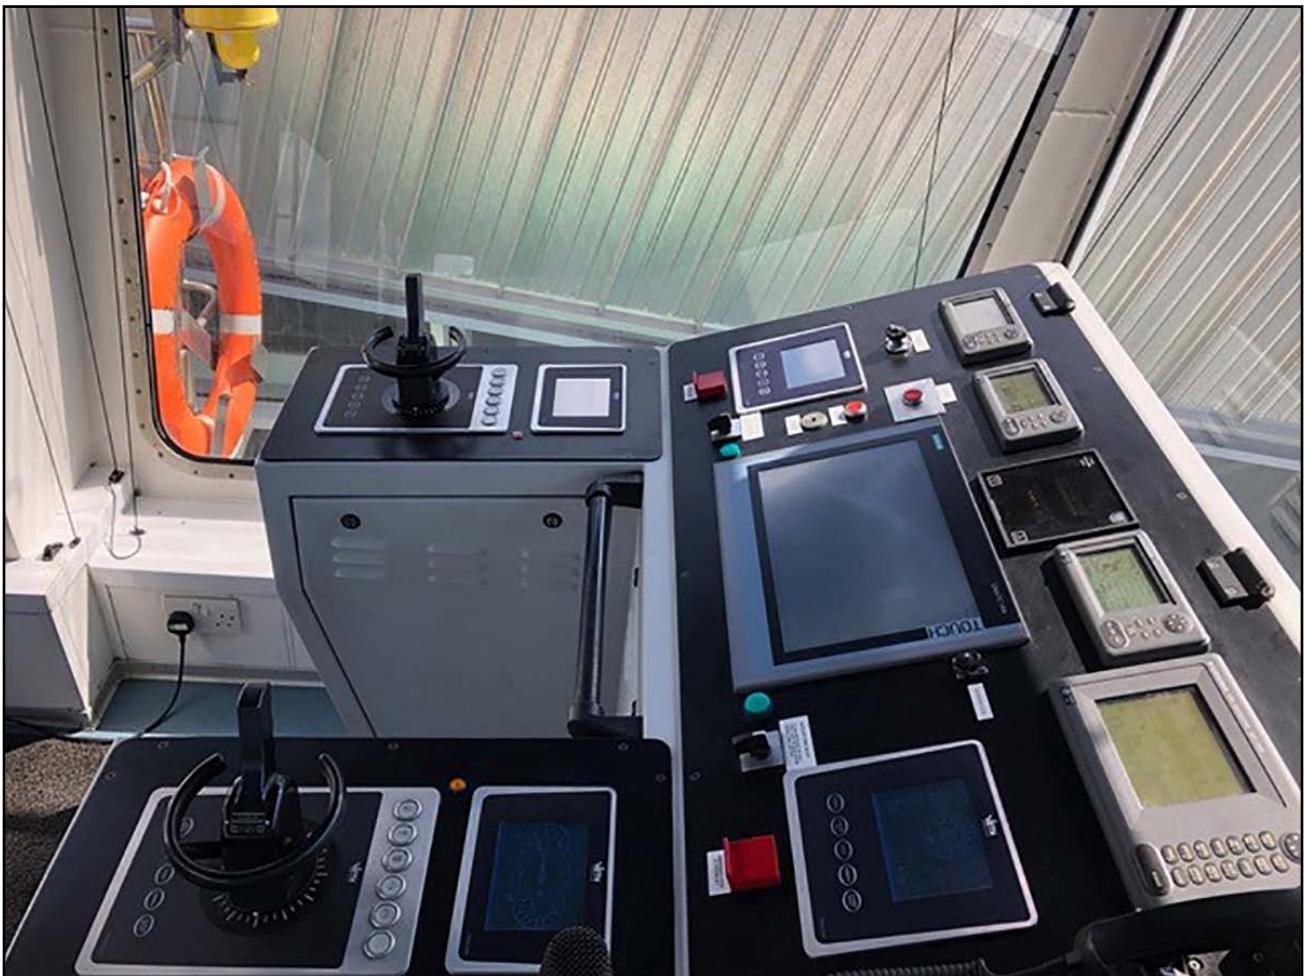
2. The bridge control panels were of a modern design with flat panel digital displays (Figure 2) and the ferry had excellent all-round visibility with full height bridge windows. However, this made the control panels vulnerable to light reflection, potentially making them difficult to read. This issue had been discussed by crews and the company, although no change to the design had been incorporated.

Figure 2: The bridge control panel, showing flat glass-style displays and tall bridge windows

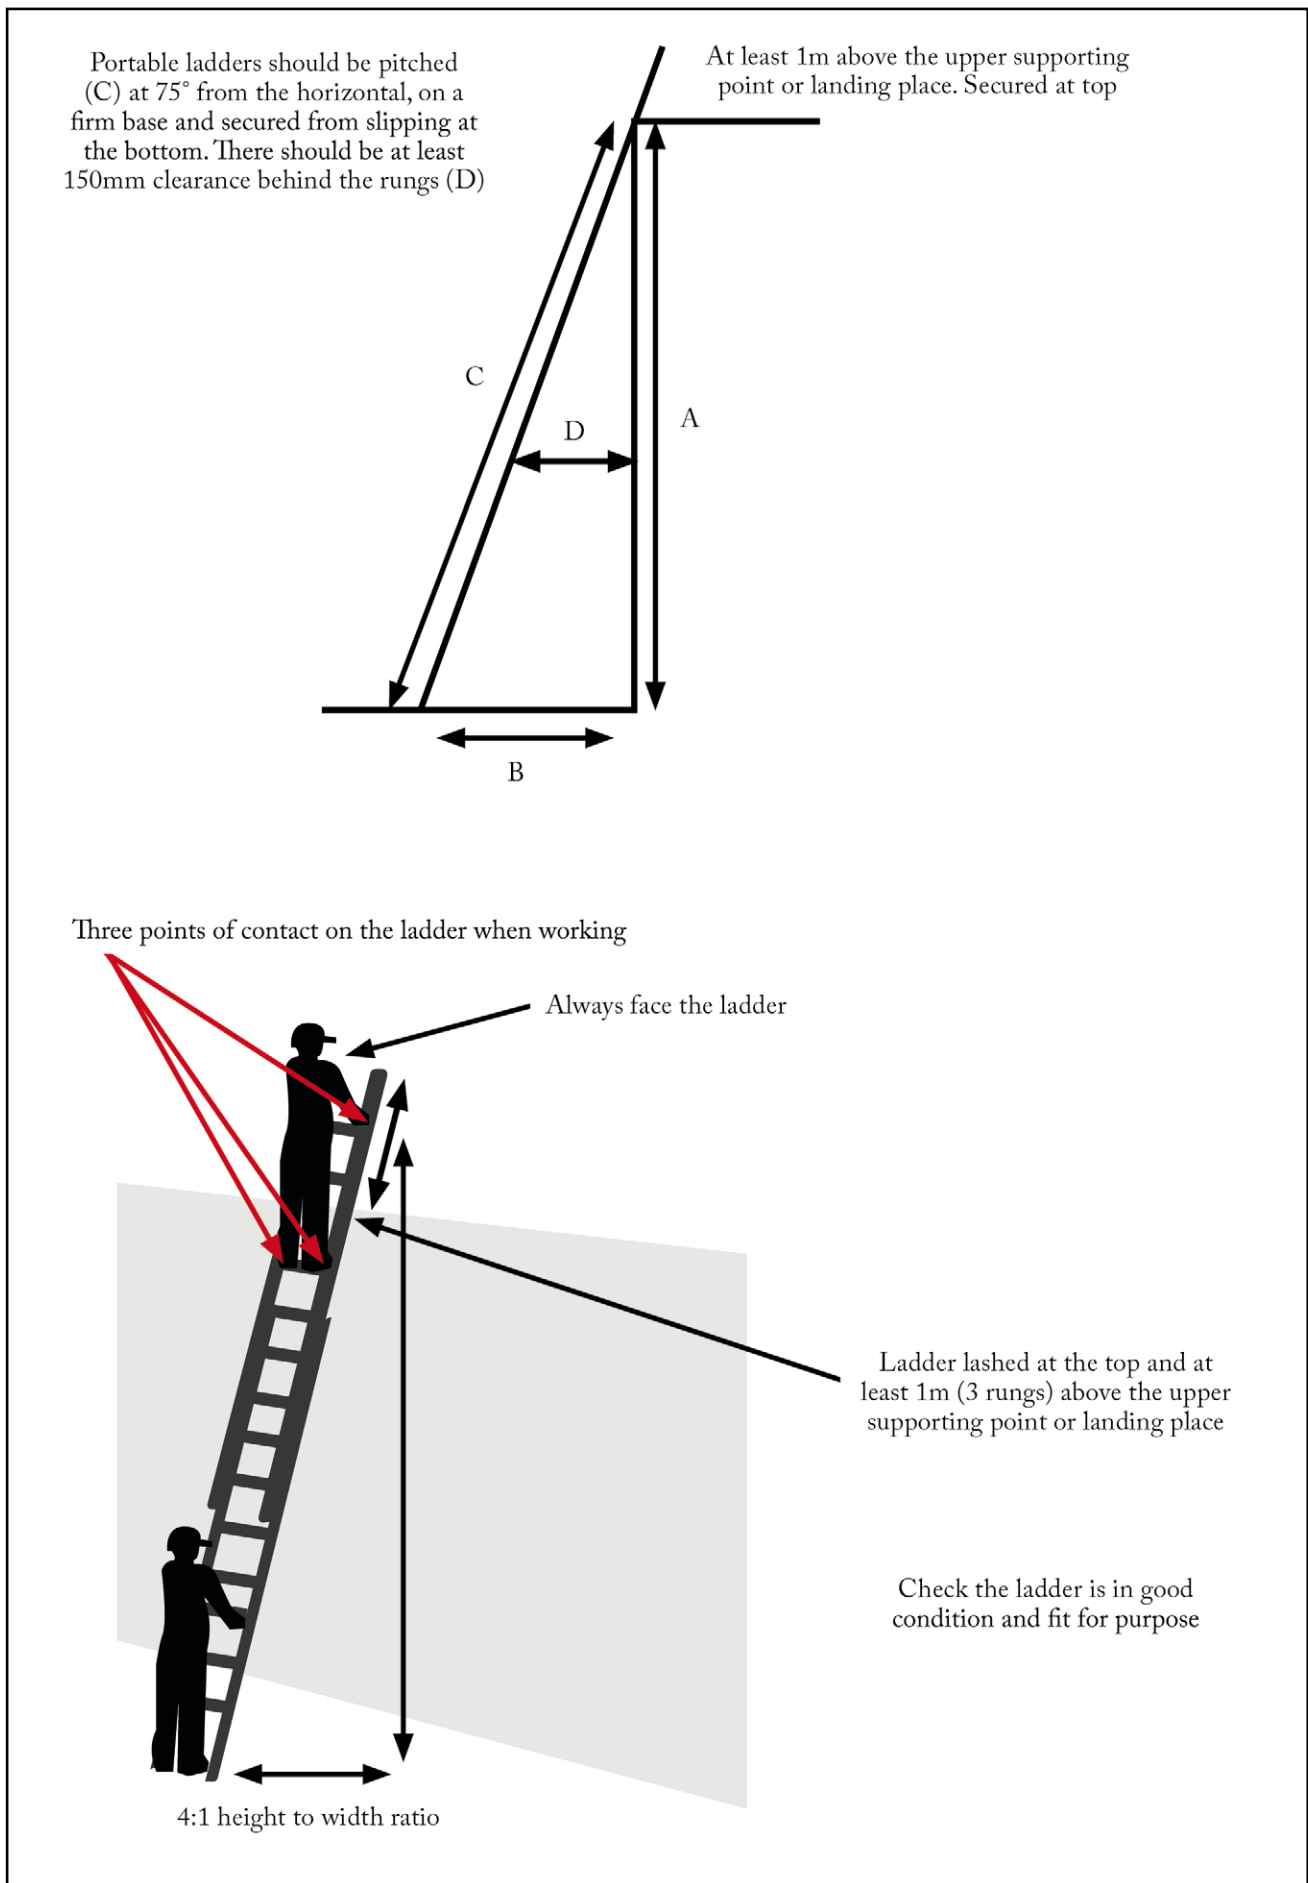
for rigging a portable ladder followed. COSWP's guidance goes on to advise that, where a portable ladder is to be used, it must be properly secured, pitched at 75° from the horizontal with a clearance of at least 150mm behind the rungs and extended at least 1m (3 rungs) above the landing place (Figure 2).

Figure 2: The correct way to rig and secure a portable ladder

1. The use of a portable ladder must be safely supervised and controlled. Advice in the Maritime and Coastguard Agency's *Code of Safe Working Practices for Merchant Seafarers* (COSWP) stated that a portable ladder should only be used as a last resort *where no safer means of access is reasonably practicable*. In this instance, either the approved means of access into the hold should have been unblocked, or guidance

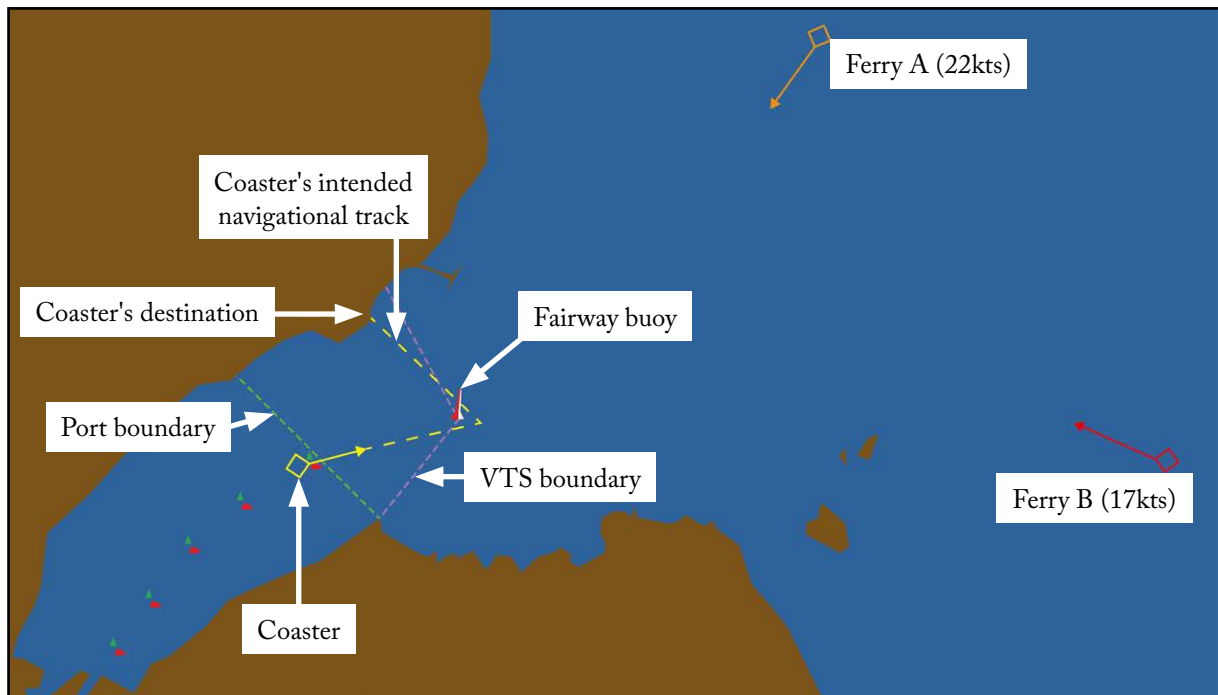
Figure 1: The coaster's master reports his intentions to VTS

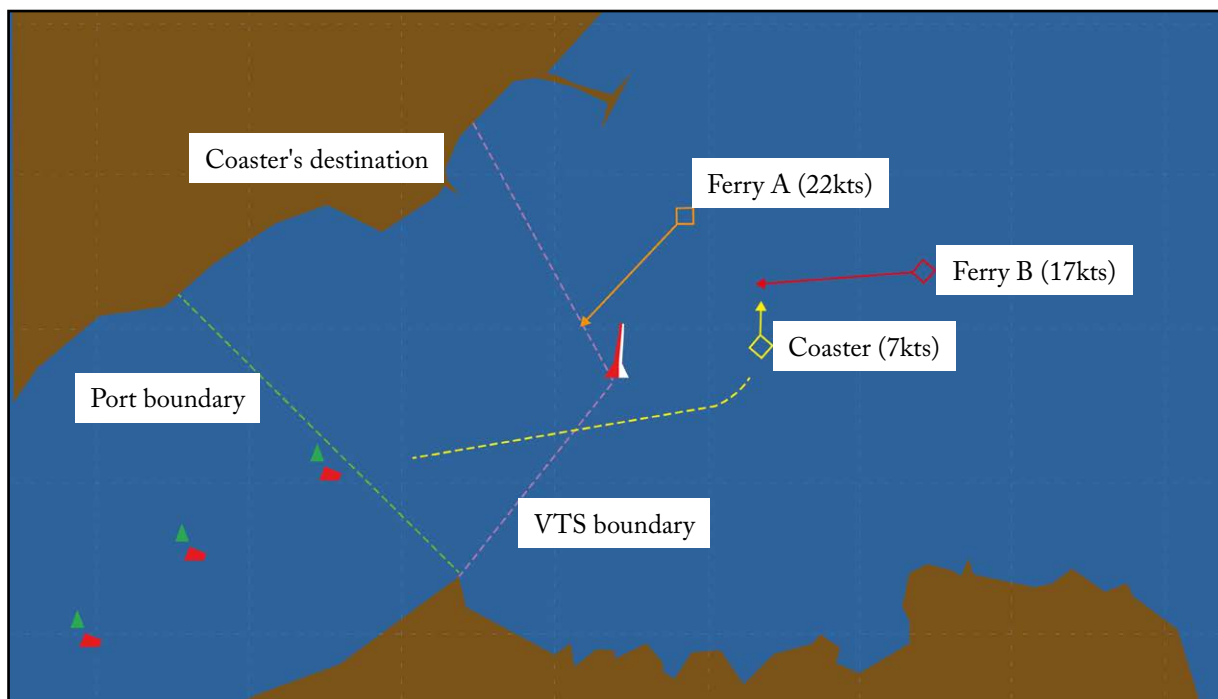
turn to port, following the stern of Ferry A and passing ahead of Ferry B. The master of the coaster then started to turn to port (Figure 2). As this happened, Ferry B's bridge team noted the rapidly reducing range and emerging risk of collision; the ferry's master took the con from the OOW and commenced a turn to starboard away from the coaster. Ferry B's OOW signalled a series of short flashes towards the coaster's bridge using an Aldis lamp.

Figure 2: The coaster's master commences a turn to port, following the stern of Ferry A and attempting to pass ahead of Ferry B

2. Conversely, Ferry B's bridge team had made an accurate assessment of the situation and had appreciated the potential for the coaster's turn to port. Collision avoidance decisions must be made on the actual rather than an anticipated situation; however, constantly reviewing the picture and doing the 'What if?' questions, particularly in pilotage waters, is good practice and, on this occasion, resulted in early and effective action to avoid collision as the situation deteriorated.

3. Sound signals should always be made when there is uncertainty as to the actions of another vessel and a risk of collision is apparent. Ferry B could have immediately alerted the coaster with five short blasts as soon as it was apparent that things were going wrong.
4. The purpose of a VTS is to contribute to safety of life at sea and efficiency of navigation. Although the incident occurred outside the harbour authority's VTS area, it would have been perfectly reasonable for the VTS to alert both ferries to the coaster's intentions.

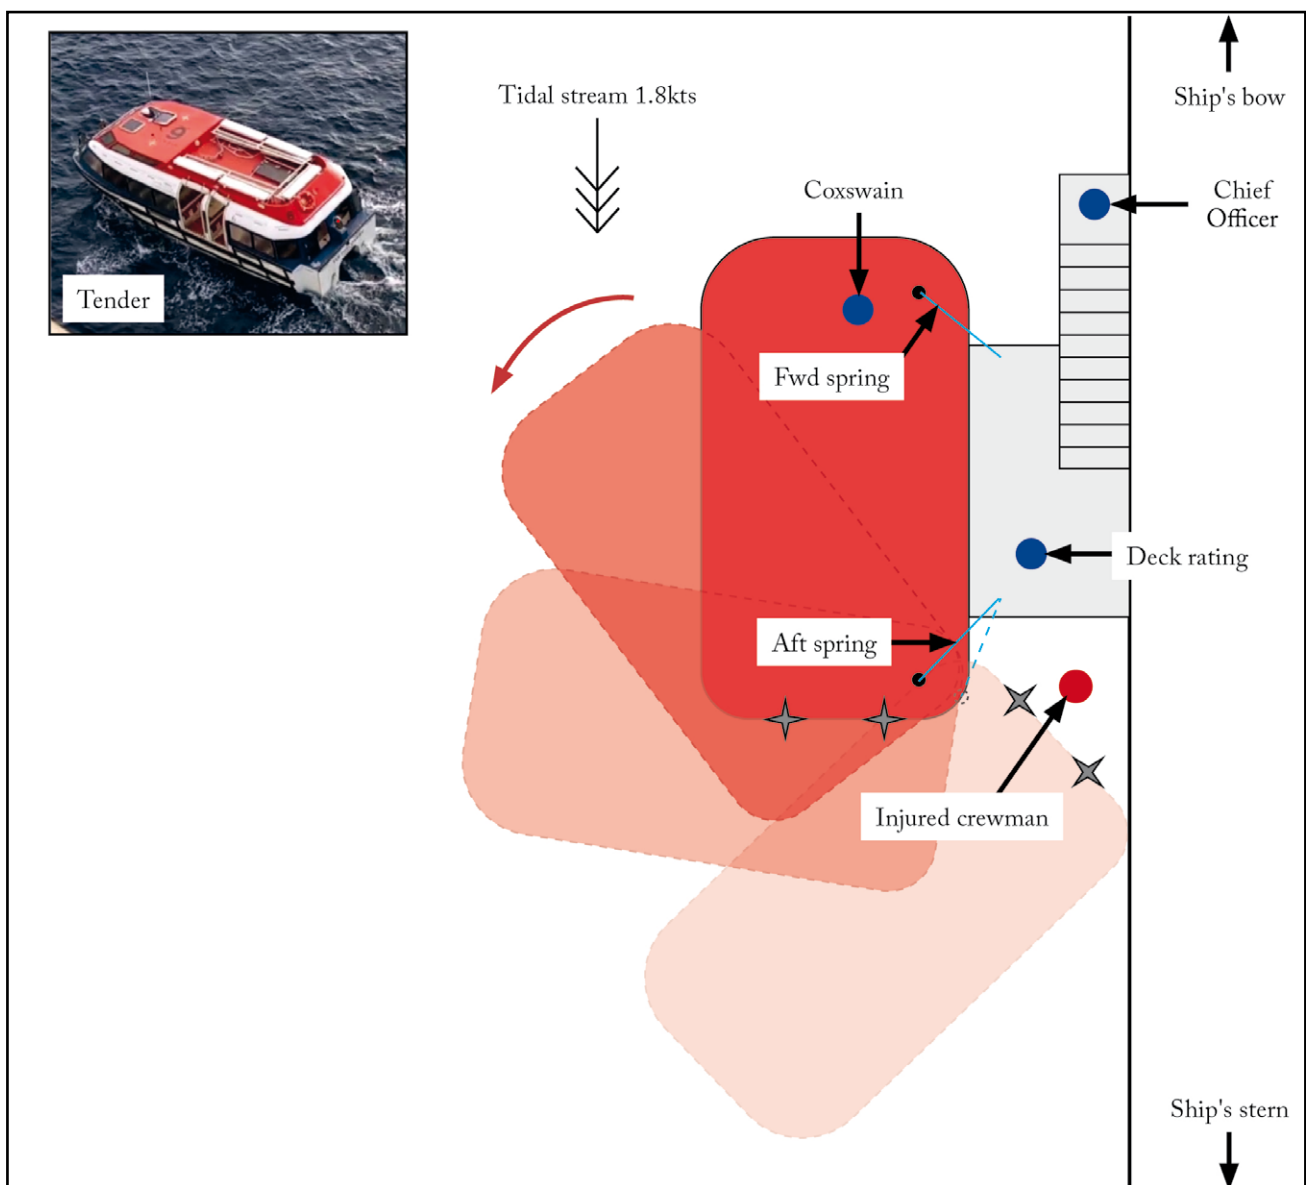
Figure: Tender's movement and contact with the ship's hull

As the parts were being transferred, the tender's forward mooring rope slipped off the cleat. The bow started to swing off the pontoon, with the stern held on by the aft line. As the bow swung away, the coxswain tried to control the situation using the engines, but he was unsuccessful against the strong tidal stream. He then instructed a crewman on the aft deck of the tender to let go of the aft mooring line, hoping to drive away from the pontoon. The attempt to let go the aft line was unsuccessful and the tender's port quarter made heavy contact with the ship's hull (see figure). The impact caused the crewman on the aft deck to lose his balance and fall overboard.

1. Tender operations are hazardous and require careful planning and a comprehensive brief so everyone knows the plan and their role. Planning for a transfer of this nature should, as a minimum, cover the operation, environmental conditions, role of each crewman and emergency procedures. In this case, the tidal stream was a significant factor and, when the bow line slipped off the cleat, a very hazardous situation emerged. Given the tidal stream, the plan could have included using a small amount of ahead propulsion when alongside to ease the tension on the lines.

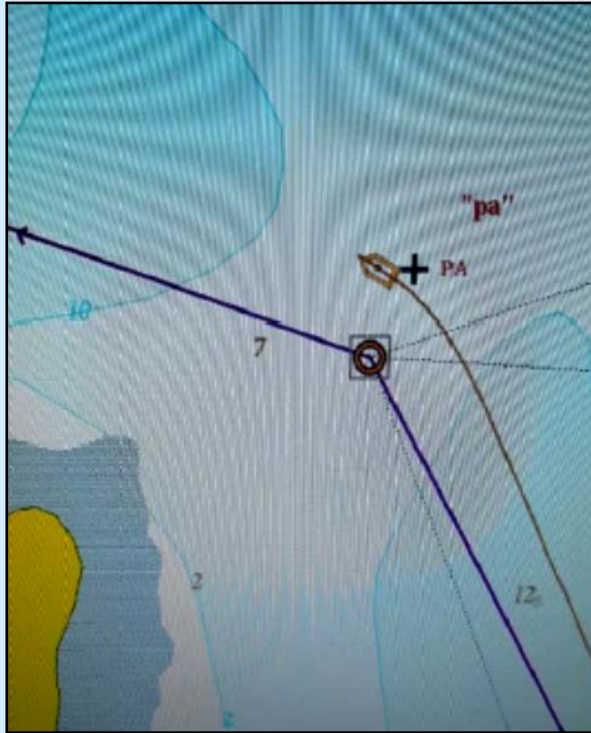
Figure 3: Planned route (blue), actual track (red) and rock (“+”). “PA” denotes position approximate

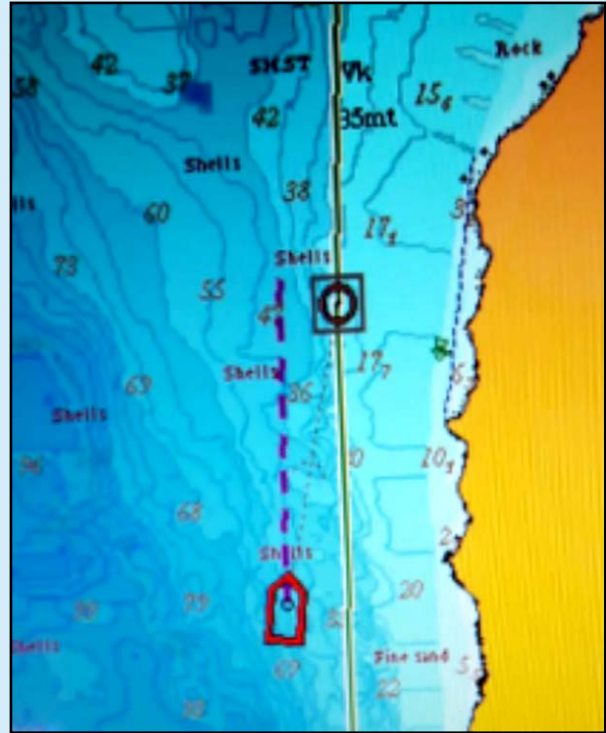
Figure 4: Zoomed out chart plotter view showing how the waypoint symbol (square) can obscure chart detail

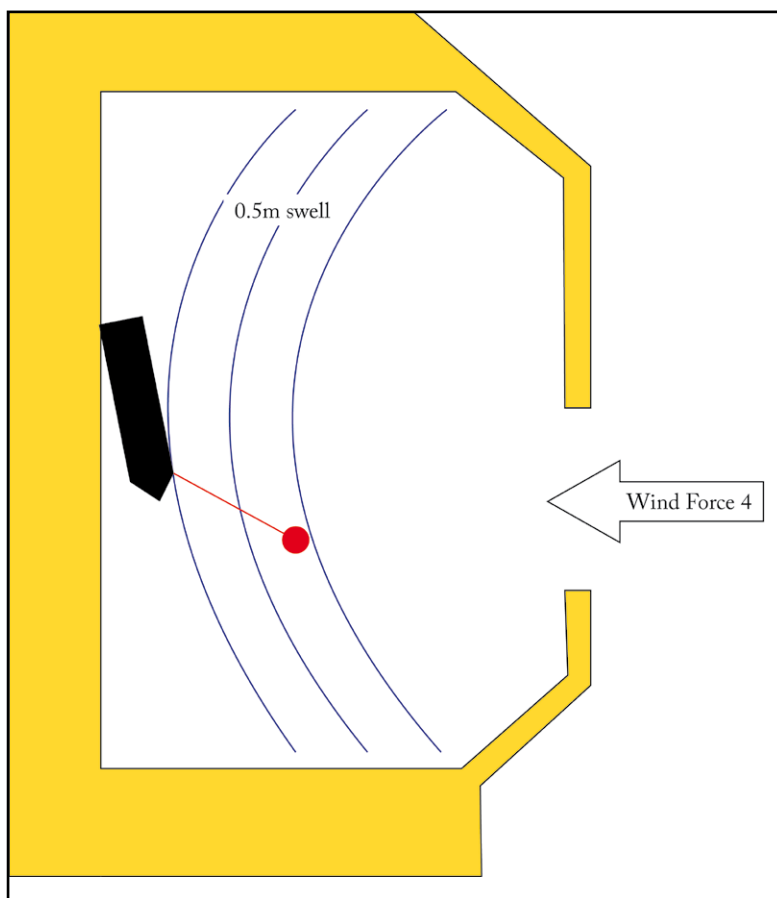
Having waited for the weather to ease, a pilot boarded an inbound coaster and discussed the arrival plan with the master; there was still a fresh onshore wind and no tugs were available. The vessel's bow thruster was defective, so the master and the pilot agreed that the port anchor would be dropped off the berth to control the bow, with the engine and rudder being used to control the stern (Figure 1).

Figure 1: The berthing manoeuvre

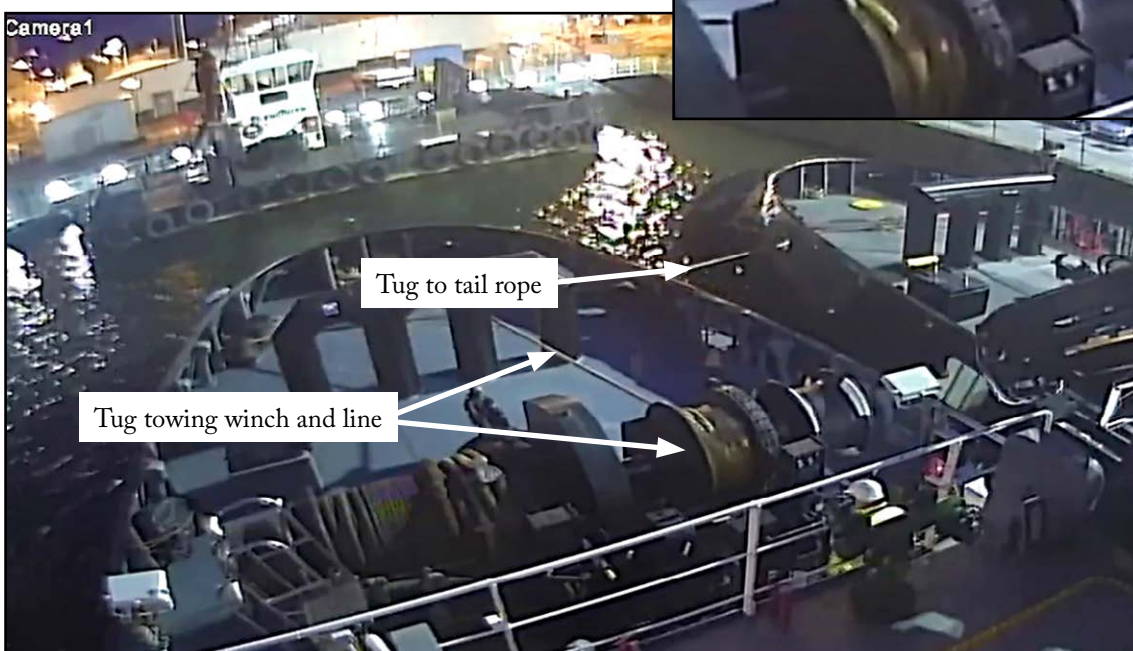
Figure 1: CCTV video still, showing the tugs moored together (inset: mate 'flicking' tail end of the rope over the bulwark)

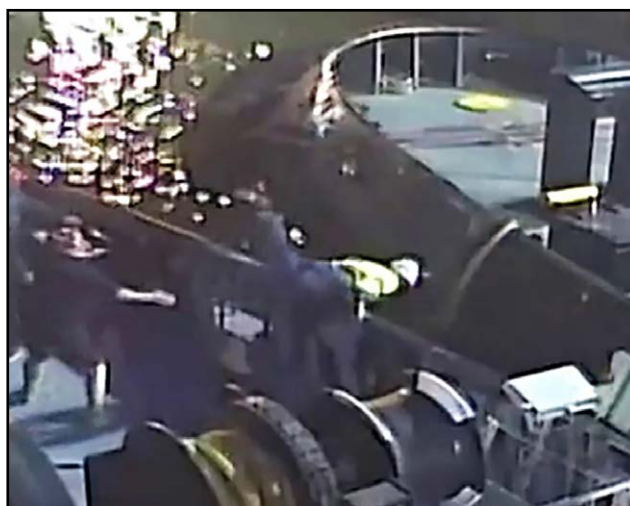
him and, despite the two deckhands trying to grab him, the mate, now over-extended, toppled over the bulwark, completing a 360° roll into the water (Figure 2). As he fell, his head hit the tug's rubbing strake and he banged his right knee.

Figure 2: CCTV video still, showing mate falling over the side of the tug

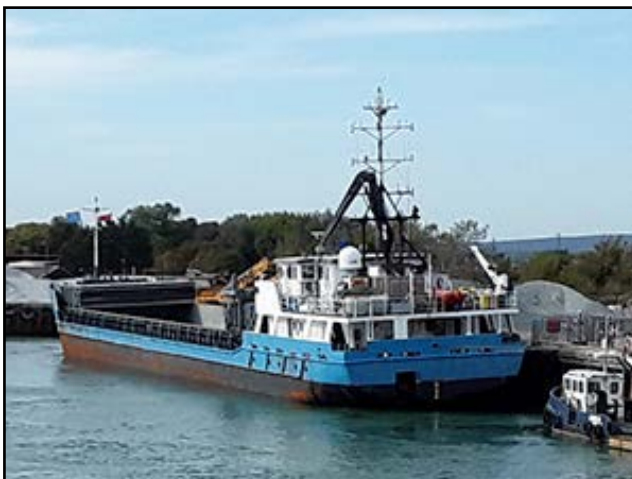
Several of the crew went ashore to buy provisions, leaving four crew members on board. Later that afternoon, as the tide ebbed, the stern settled into the mud, and the vessel took a slight list to port (Figure 1). A short

Figure 1: Vessel alongside as tide drops

2. The pilot had briefed the master on the need to tend lines as the vessel settled, and they had discussed the probability that the vessel would take a slight heel as the tide dropped. Mooring lines should be closely monitored on all berths; this is vitally important where there is a large range of tide, particularly on berths that dry out, as even on the flattest berths there is a chance a vessel will take the ground in one area before another, causing unequal loading on lines.

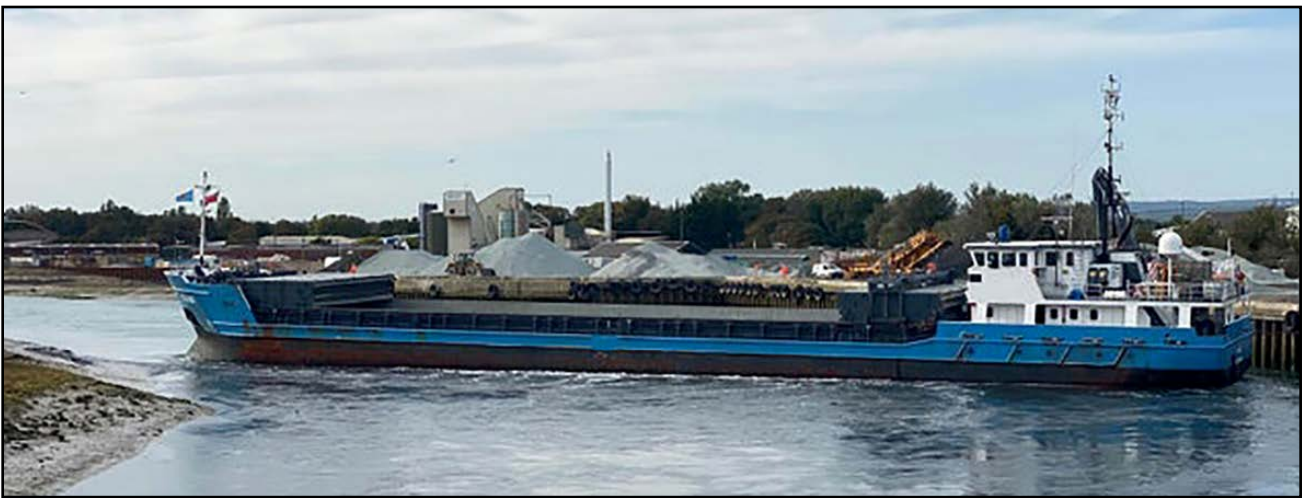
while later, the forward mooring lines parted one by one, and the bow started coming away from the jetty. Finally, the stern breast line parted and the bow crossed over to the other bank and came to rest with the vessel blocking the river (Figures 2 and 3).

Figure 2: Vessel across the river, aground at bow and stern

3. NAABSA berths, or non-declared berths where vessels regularly sit on the bottom, must be frequently checked to ensure they remain safe for use. This requires proactive engagement by berth owners, vessel agents and port authorities to ensure operations can be conducted safely. This is particularly important where berths are used less frequently, giving opportunities for sediment to build up and create slopes in the berth.

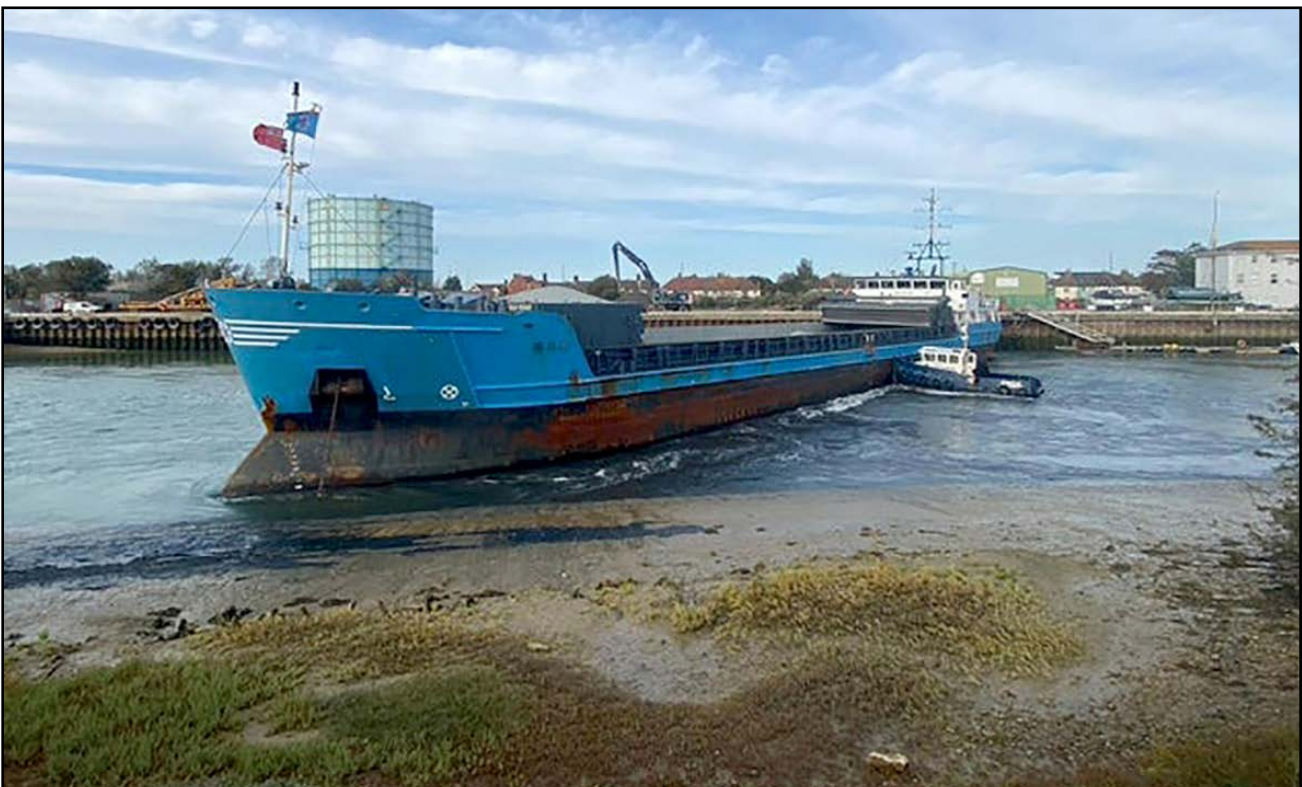
Figure 3: Tug amidships, stabilising vessel against the ebb tide

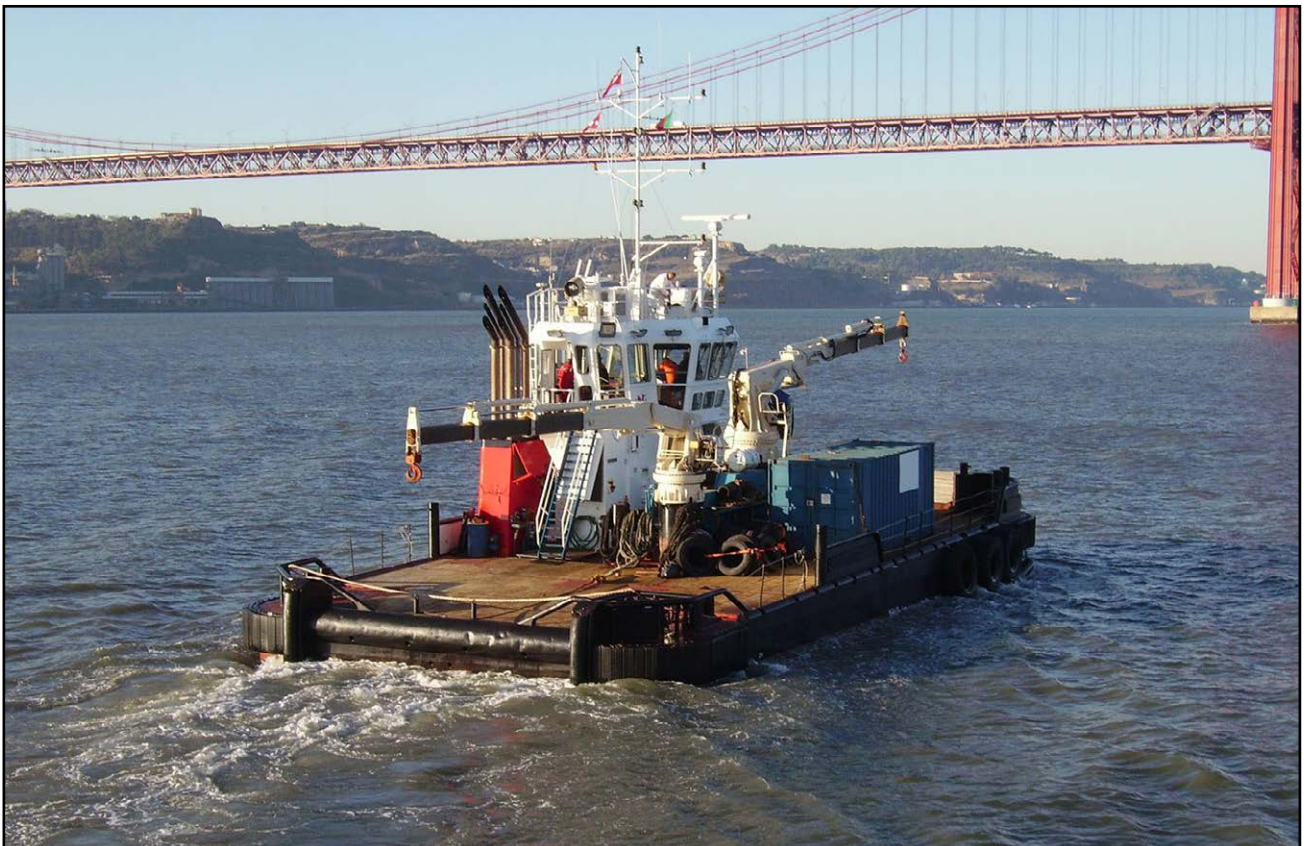
Figure 1: The workboat

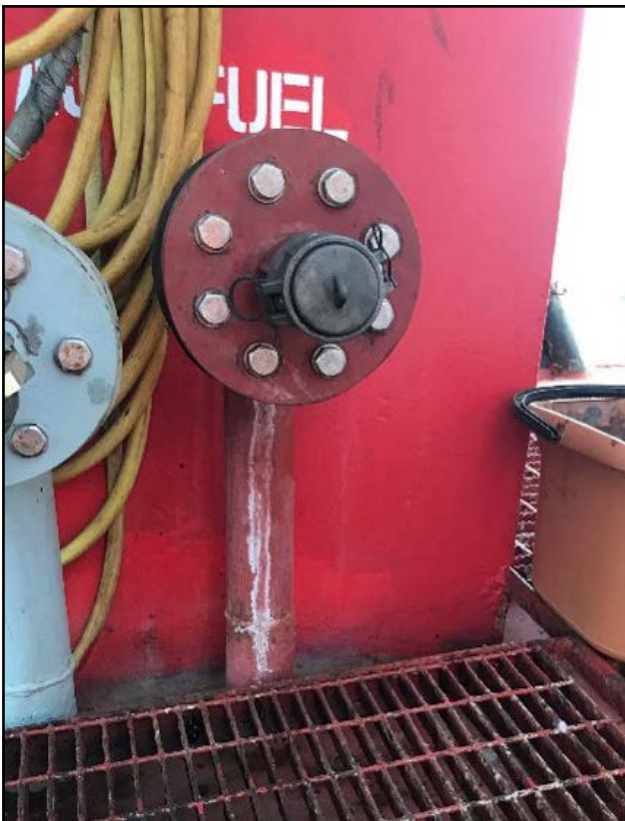
The crewman checked that the receiving vessel was ready then went below to the engine room, opened an isolating valve, and started the fuel transfer pump. Returning back on deck, the crewman realised that no fuel was being transferred because the hose had not been connected to the discharge manifold on the workboat's deck (Figure 2).

Figure 2: The workboat's fuel discharge manifold

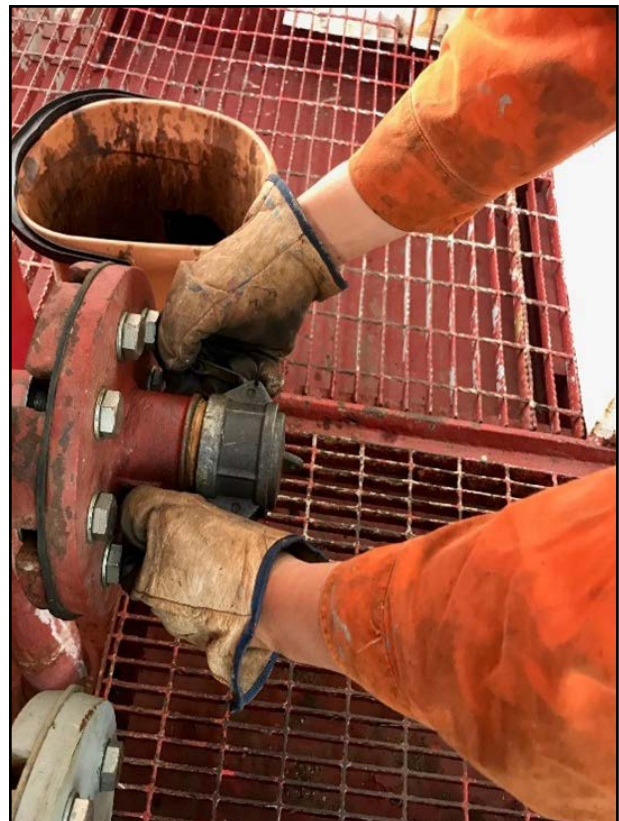
After stopping the fuel transfer pump, the crewman attempted to release the blanking cap on the discharge manifold in order to connect the fuel hose. As the two securing clips were released, the blanking cap flew off with an explosive force, striking the crewman on the leg. The crewman suffered lacerations, a fractured limb, and was off work for 6 weeks. Although the accident involved a pressurised fuel system, there was no pollution.

2. It is equally important to ensure that any residual pressure in a system has dissipated before opening up, and the workboat’s safety procedure also required this. Figure 3 is a reconstruction of the moment when the blanking plate was removed and the residual pressure in the system was released, causing the injury. Best practice on these occasions would be to check everything was safe and depressurised, have a toolbox talk so everyone knows the plan, and follow the procedures.

Figure 3: Reconstruction of the removal of the blanking plate when the system was pressurised

3. Lone working can introduce additional hazards when operating systems or undertaking potentially hazardous routines. In this case, a second crew member could have helped by supervising or double-checking the system or safety procedures.

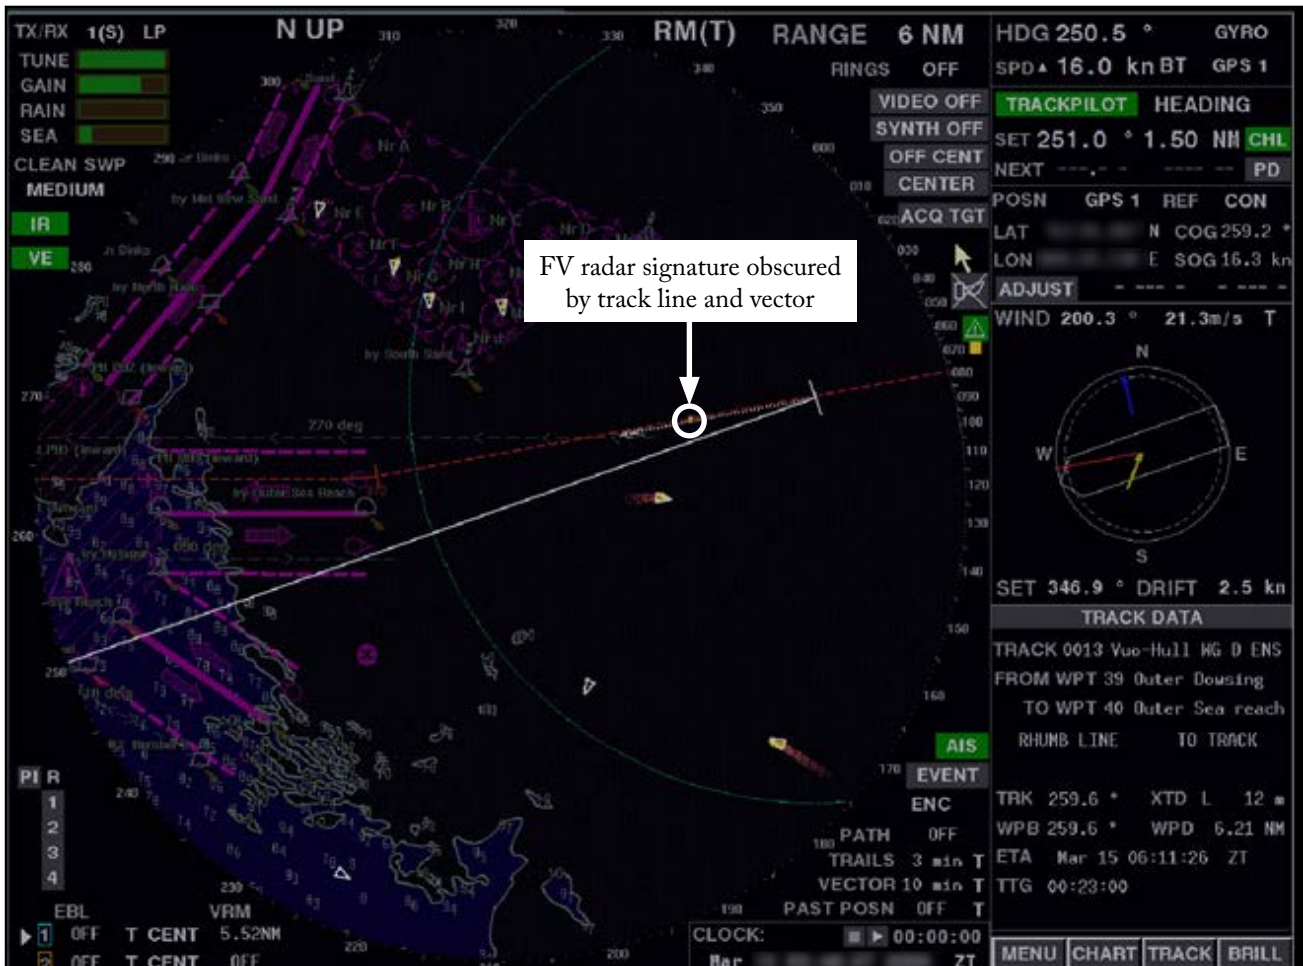
Figure: The fishing vessel's radar signature is visible, although obscured by the track line and vector

When searching for fishing gear in the vicinity of a TSS, skippers must recognise the increased risk of collision and sufficient crew must be present in the wheelhouse to keep an effective look out. As demonstrated in this accident, the search for fishing gear can be a significant distraction from navigation.

5. Even though contact by mobile phone was eventually made between the fishing vessel and ferry, the initial attempts to contact each other via VHF radio were unsuccessful. After the glancing blow, the ferry’s OOW and master made no assessment of the damage sustained on the fishing vessel and no attempt to slow down or return to the fishing vessel. Had the damage been catastrophic, the immediate deployment of search and rescue assets from the ferry could have been critical in the safe recovery of the fishing vessel’s crew.

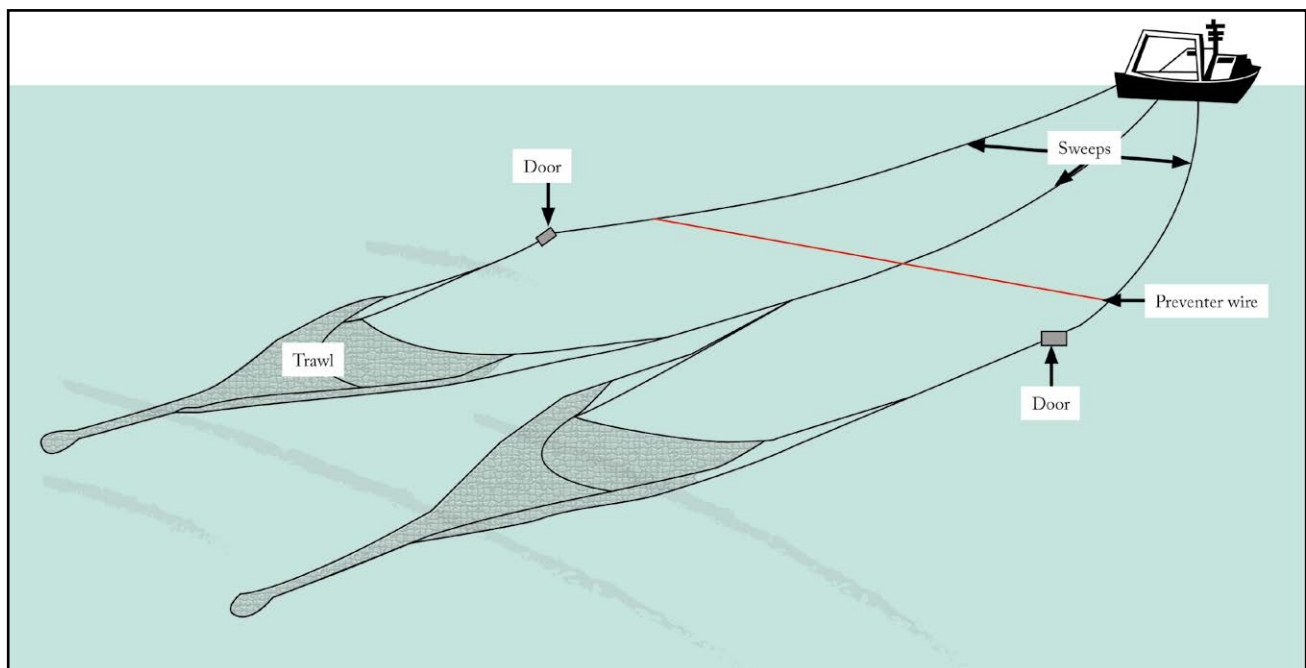
Figure 1: Net configuration

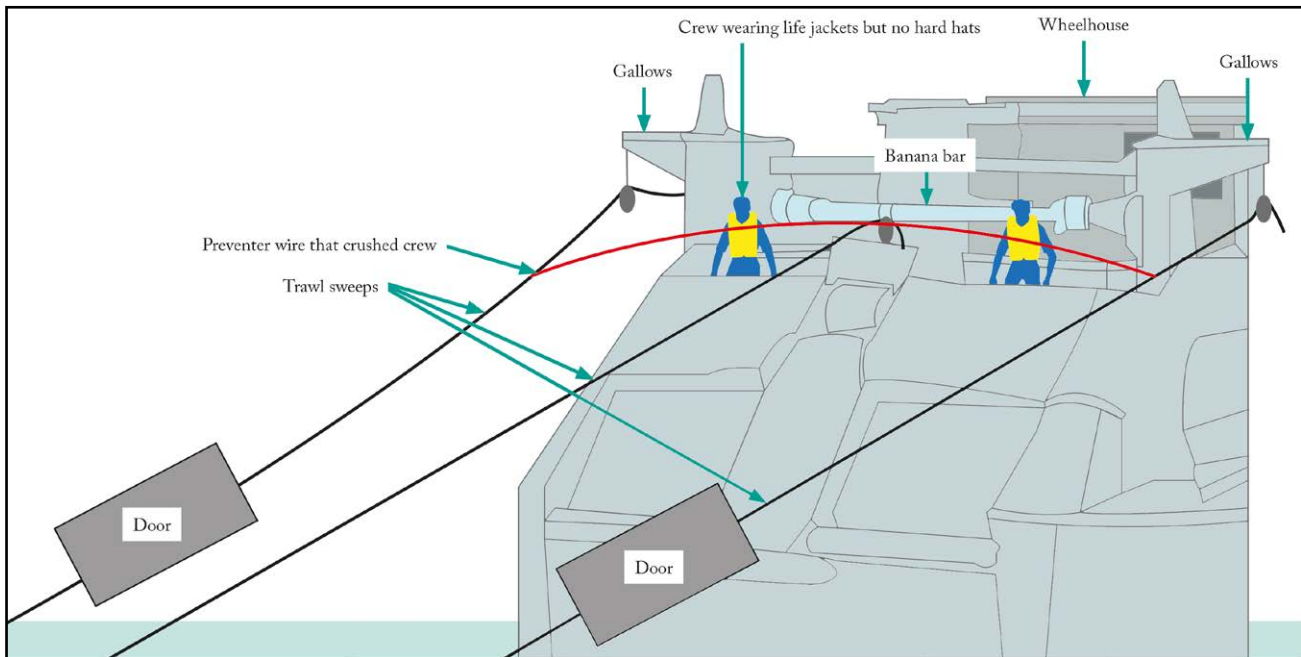
doors came clear of the water, the two crew on the upper deck moved aft, ducking under the banana bar, to reach the doors. Unfortunately, as the gear continued to be hauled in, the two crew members were pinned to the gallows by the preventer wire (Figure 2).

The skipper heard shouts and told the winch operator to pay out the trawl wires, freeing the two crewmen; however, both had suffered torso crush injuries. First aid was administered on board, and both injured crewmen were evacuated to hospital by coastguard helicopter where they were treated for their injuries. They were discharged home a few days later.

Figure 2: Preventer wire crushes two crew

1. Fishing is a hazardous business and it is critical that all members of the crew understand the risks associated with operating their boat. In this case, the crew were all inexperienced with this boat and not all activities had been properly risk assessed, with associated safe systems of work. It turned out that the crew did not need to go aft of the gallows to reach the trawl doors during hauling.

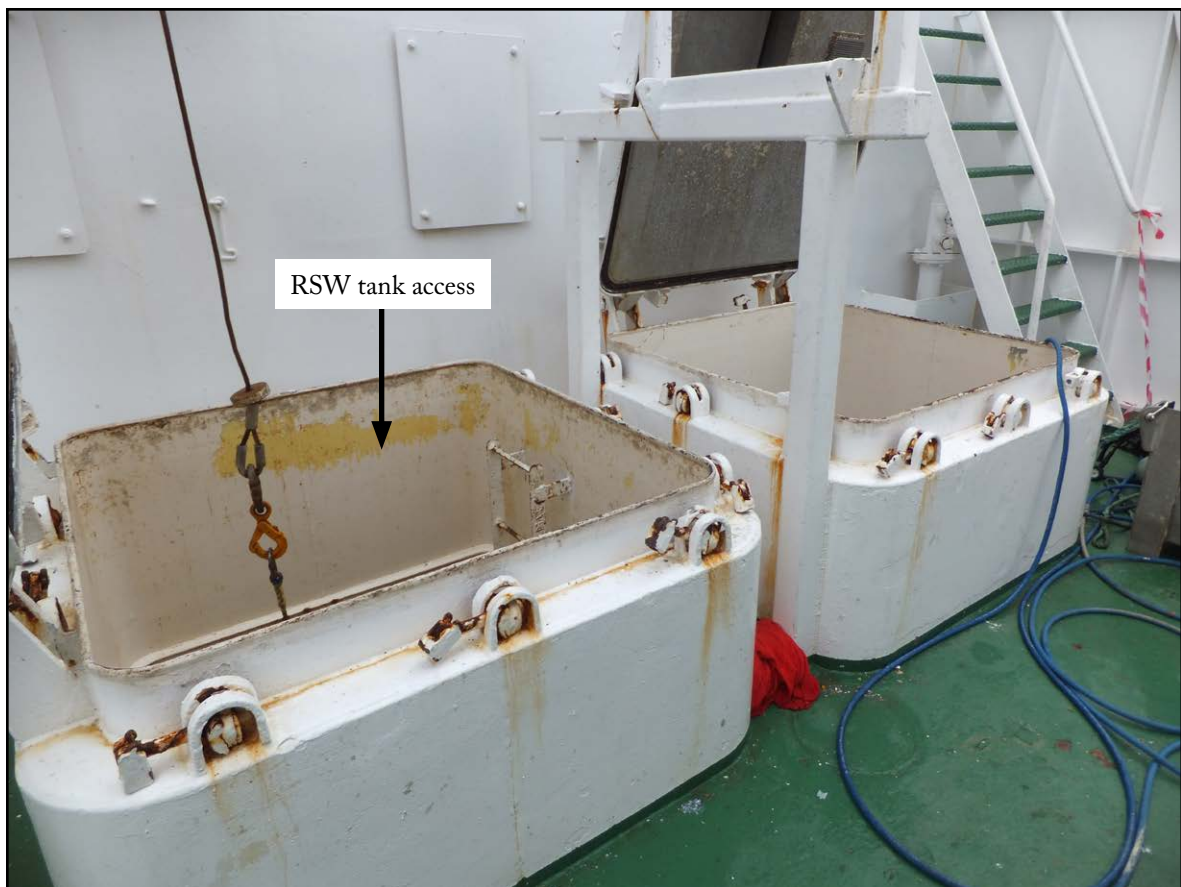
A technical analysis of the refrigeration system after the accident discovered that Freon gas had leaked into the RSW tank through corroded tubes in a heat exchanger. The heavy Freon gas had displaced the air, which meant that the atmosphere in the tank could not support life.

Figure 1: RSW tank access hatch

1. Freon was the hazard on this occasion, but there are many hazards associated with enclosed spaces, including exposure to: heat, flooding, flammable gasses, toxic gasses, or oxygen deprivation. The RSW tank in this accident met the internationally agreed definition of an enclosed space because it had limited openings, inadequate ventilation and was not intended for worker occupation. Safety precautions must be taken, including atmosphere testing, ventilation, emergency communications and an escape plan, to ensure crew safety when entering any enclosed spaces.
