**MAIB**

# **SAFETY DIGEST**

**Lessons from Marine  
Accident Reports  
2/2021**

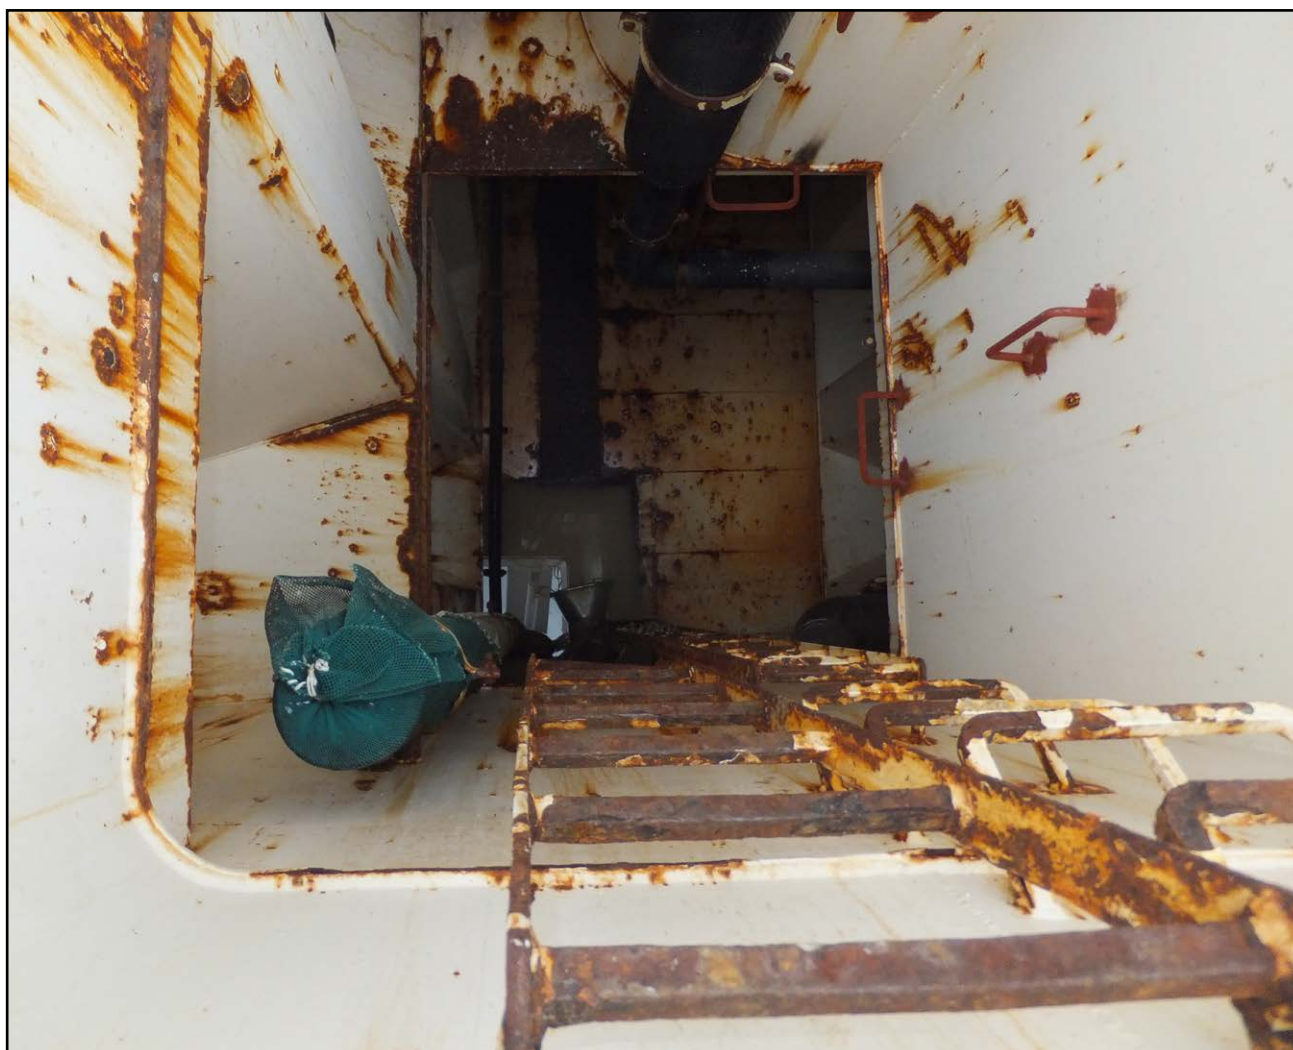
Figure 2: The view down through the access hatch into a pelagic fishing vessel's RSW tank

3. The view into an enclosed space (Figure 2) should cause concern and crew should ask themselves, “*Is this safe and are appropriate precautions in place?*”

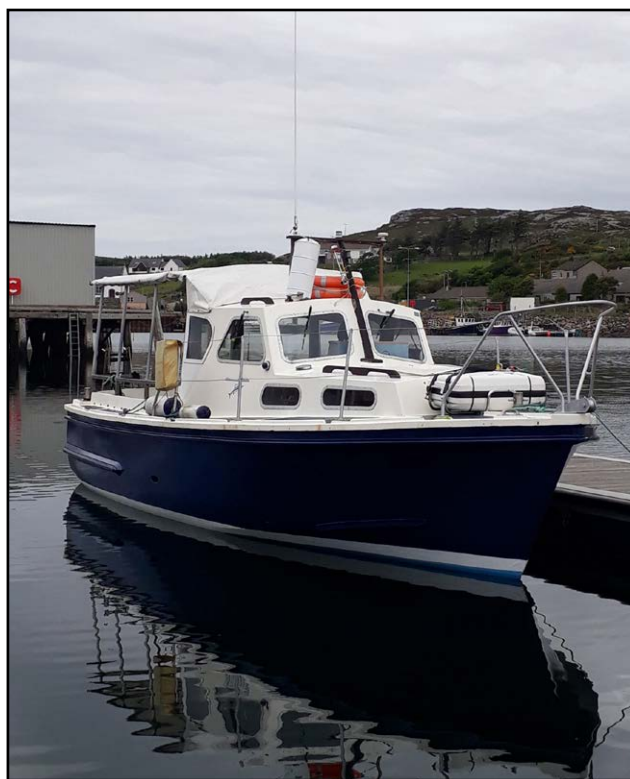
Figure: The fishing vessel before the accident, showing the liferaft on the foredeck – on the day of the accident, the liferaft was stowed inside

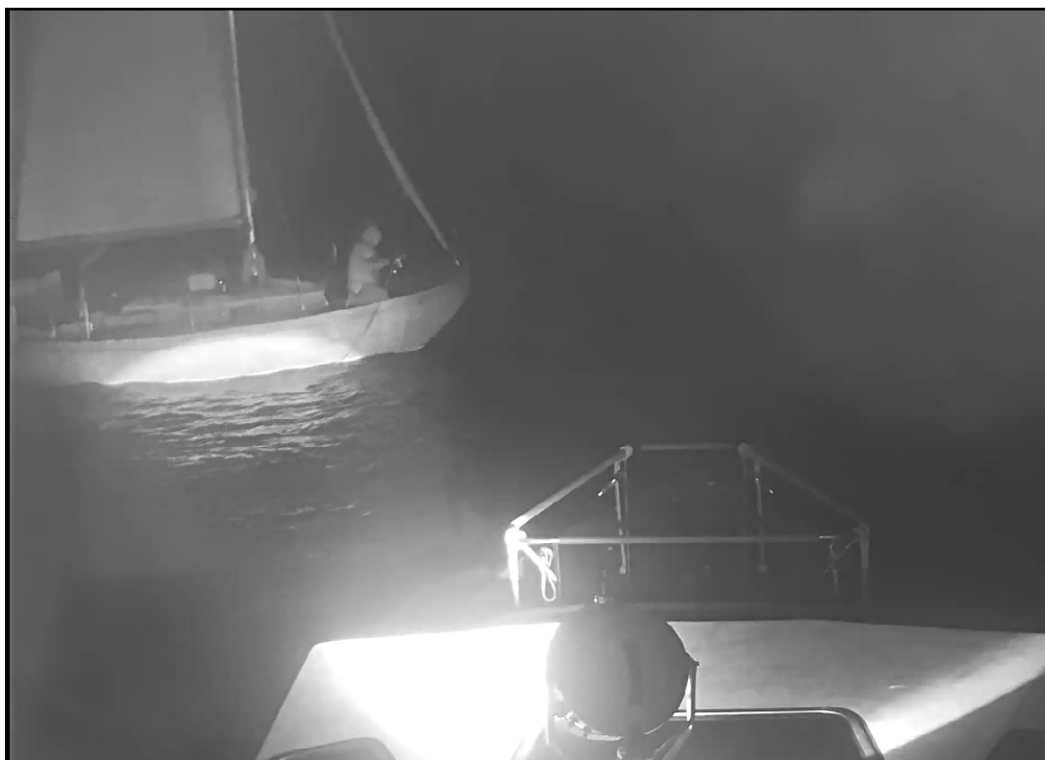
At the same time, a 38000 gross tonne chemical tanker was proceeding outbound at slow speed in the designated area, to disembark its pilot. When the pilot cutter was alongside the tanker, the coxswain saw the yacht's navigation lights close by. As soon as the pilot was safely on board the cutter, the coxswain manoeuvred clear of the tanker and approached the yacht. The cutter's horn was sounded and its searchlight was used to illuminate the yacht to alert the skipper to the risk of collision. The cutter's crew could also see that there was no-one in the yacht's cockpit. Soon after, the skipper emerged from the cabin and saw that a collision was imminent. He immediately put the yacht's engine astern but it was too late and the yacht collided heavily with the side of the tanker (Figure 1). The skipper was not injured and the cutter escorted the damaged yacht safely back to harbour (Figure 2).

Figure 1: A still image from the pilot cutter's external CCTV camera, showing the yacht with the skipper at the bow assessing the damage just after collision
