# Final Report

***Marine inquiry MO-2020-202***

***Bulk log carrier Funing***

***Loss of manoeuvrability while leaving port***

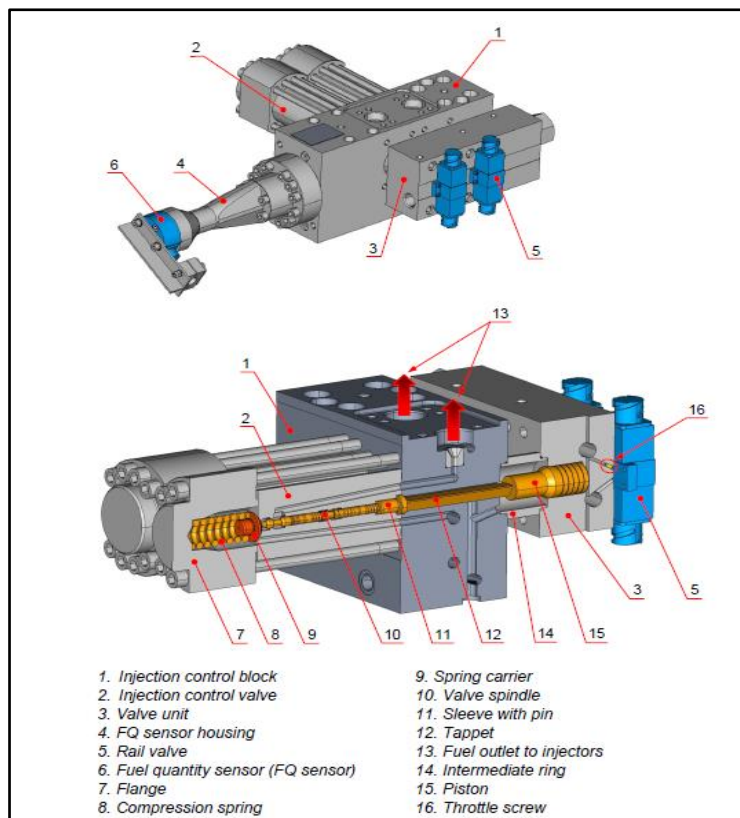
**Figure 6: Fuel injection control unit  
(Credit: Wärtsilä technical bulletin)**

- 2.36 The ICU was a key component of the RT-Flex engine. Figure 5 shows a photograph of the ICU removed from the *Funing* after the accident, and Figure 6 shows a labelled image.

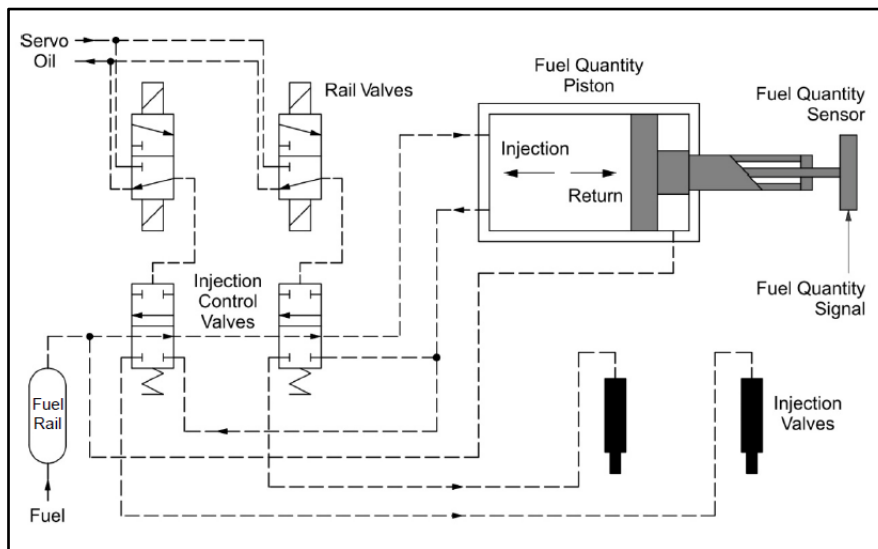
**Figure 7: Schematic showing the working principle of the ICU (image taken from a Wärtsilä technical bulletin)**

- 2.38 The WECS controlled the functions of the main engine. For each combustion cycle of each cylinder, the WECS sent an 'injection command' to the FCM-20, which was relayed to the electro-hydraulic rail valves on the ICU (Figure 7).
