MAERSK ESSEN

Marine accident report on loss of cargo

16 JANUARY 2021

**MARINE ACCIDENT REPORT ON MAERSK ESSEN'S
LOSS OF CARGO ON 16 JANUARY 2021**

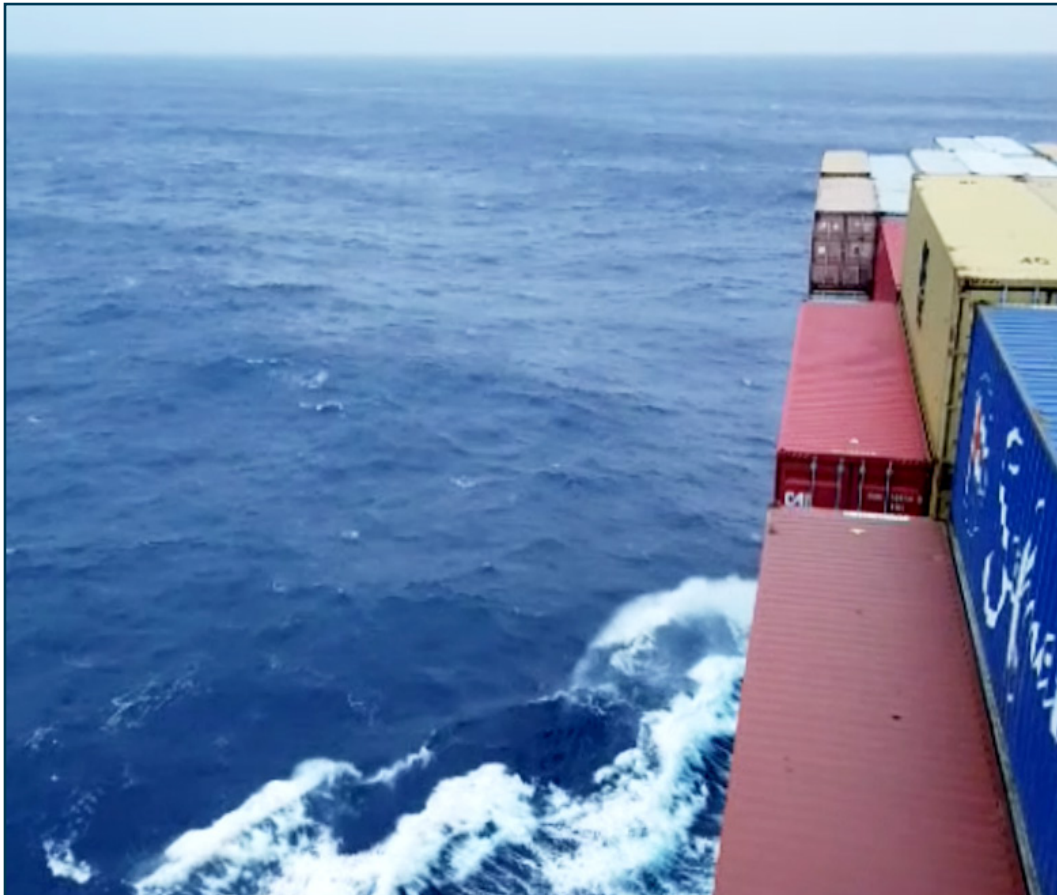
At approximately 0600, some of the crew were woken by the sound of cups and laptops sliding and falling off tables in their cabins as the ship took a few heavy, slow rolls. On the bridge, the chief officer saw from the inclinometer that the ship had rolled 15° to each side. The rolls stopped as quickly, as they had started. The chief officer observed nothing unusual out of the windows, and the sea state seemed not to have changed (Figure 5).

*Figure 5: Sea state in the morning on 16 January 2021
Source: Private photo*

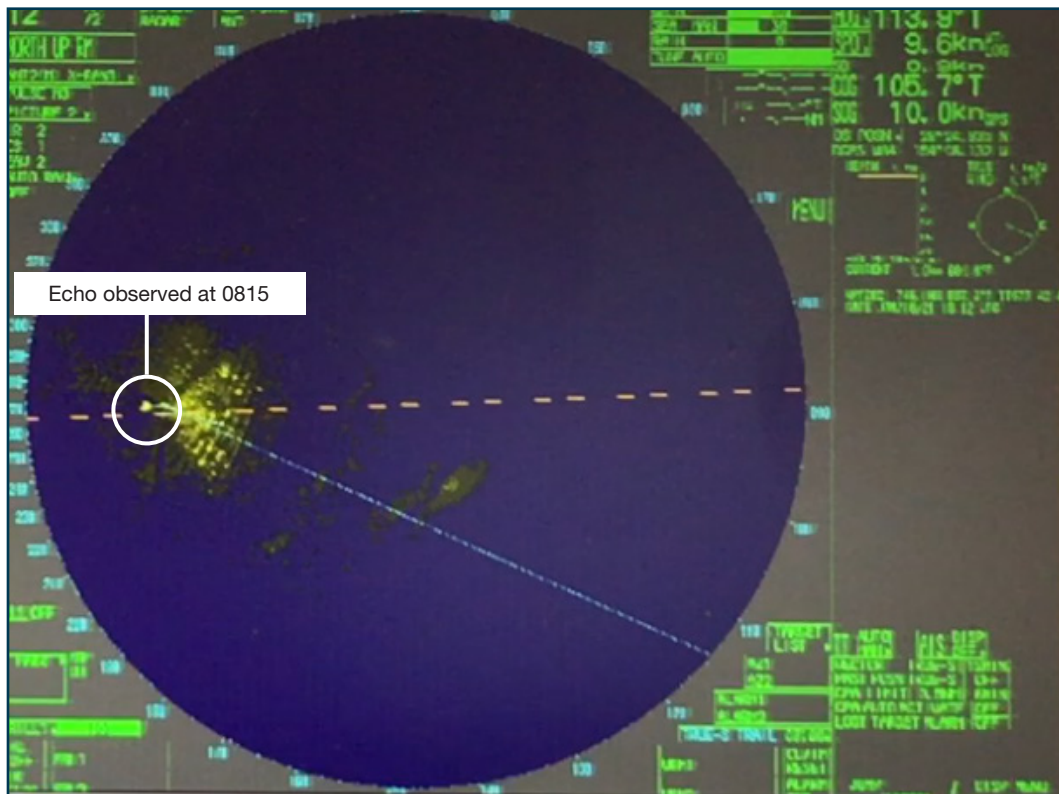
At 0815, the master detected an echo on the radar close astern of the ship (Figure 6).

Figure 6: Echo observed on the radar at 0815
Source: Maersk A/S

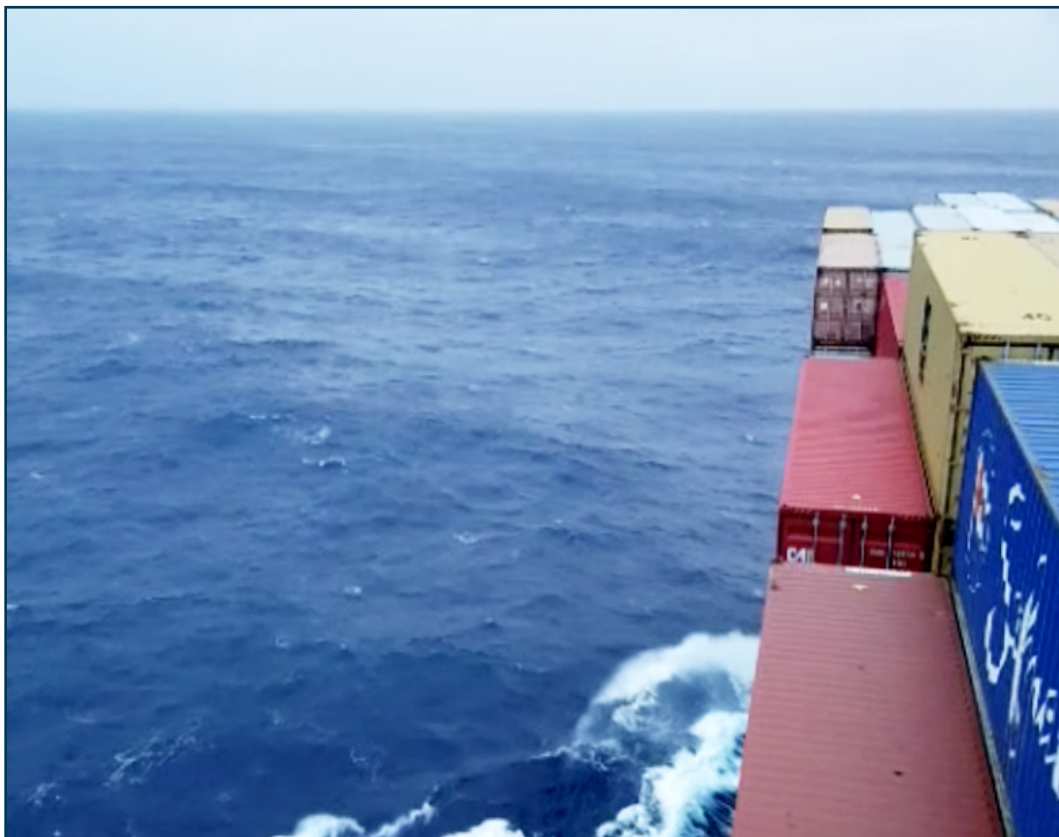
During the hours prior to the heavy rolling episodes, observations of north-north-easterly (NNE) wind of Beaufort force 6 were recorded in the bridge logbook. This corresponded to a strong breeze of 10-14 m/s and moderate wind seas of approximately 2m. The Beaufort scale only refers to wind and wave, not swell. Hence, swell height was not recorded in the logbook. According to crew statements, the swell was about 5m with a long period coming on the ship's port quarter. Photographs taken 45 minutes before and 8 minutes after the loss of containers corresponds with the crew's observations (Figures 16 and 17).

Figure 16: Sea state 45 minutes prior to the accident. Photo taken from the bridge wing.
Source: Maersk A/S

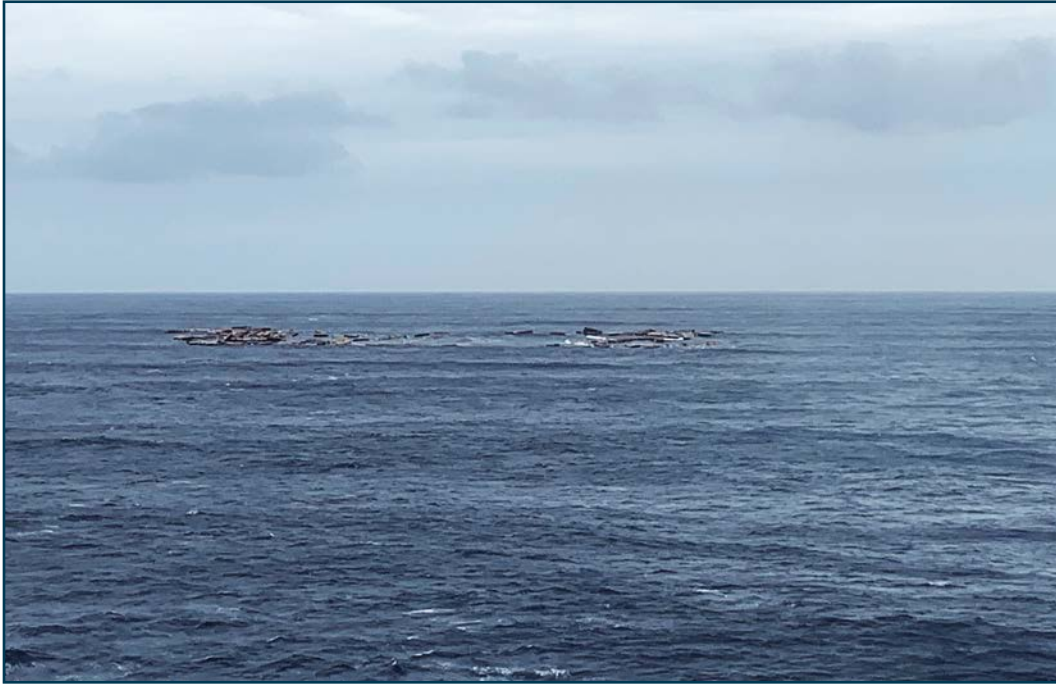
Figure 17: Sea state 8 minutes after the accident
Source: Maersk A/S

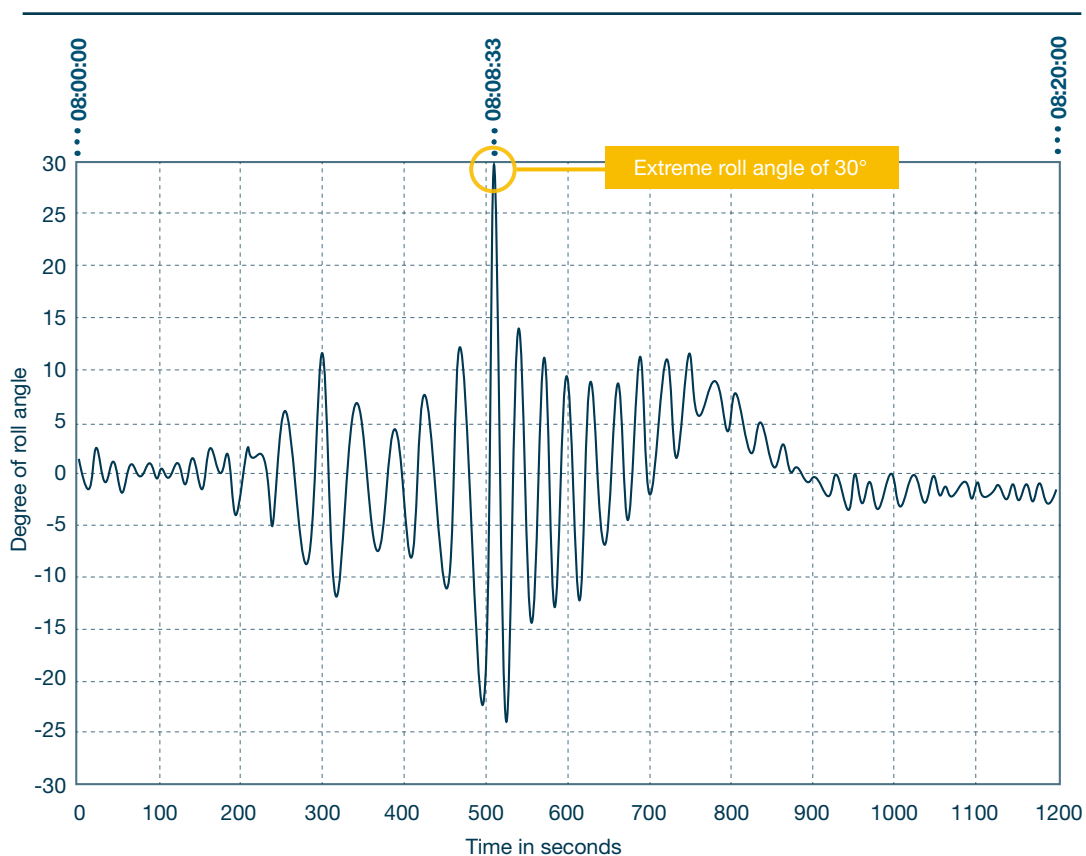
On request from Maersk A/S, an investigation into MAERSK ESSEN's cargo loss was carried out by the Institute of Ship Design and Ship Safety at Technische Universität Hamburg (TUHH). By retrieving data from the VDR on the ship's course over ground and the ship's GPS antenna location, TUHH calculated the rolling angles experienced by MAERSK ESSEN between 08:00-08:12. The calculations concluded that the ship experienced roll angles up to 30° (Figure 20). As the inclinometer reading gives a lower value than the TUHH calculations, it suggests that it was not influenced by acceleration forces resulting in higher roll angle readings.

Figure 20: Graph of TUHH's roll angle calculations, modified by DMAIB
Source: Maersk A/S

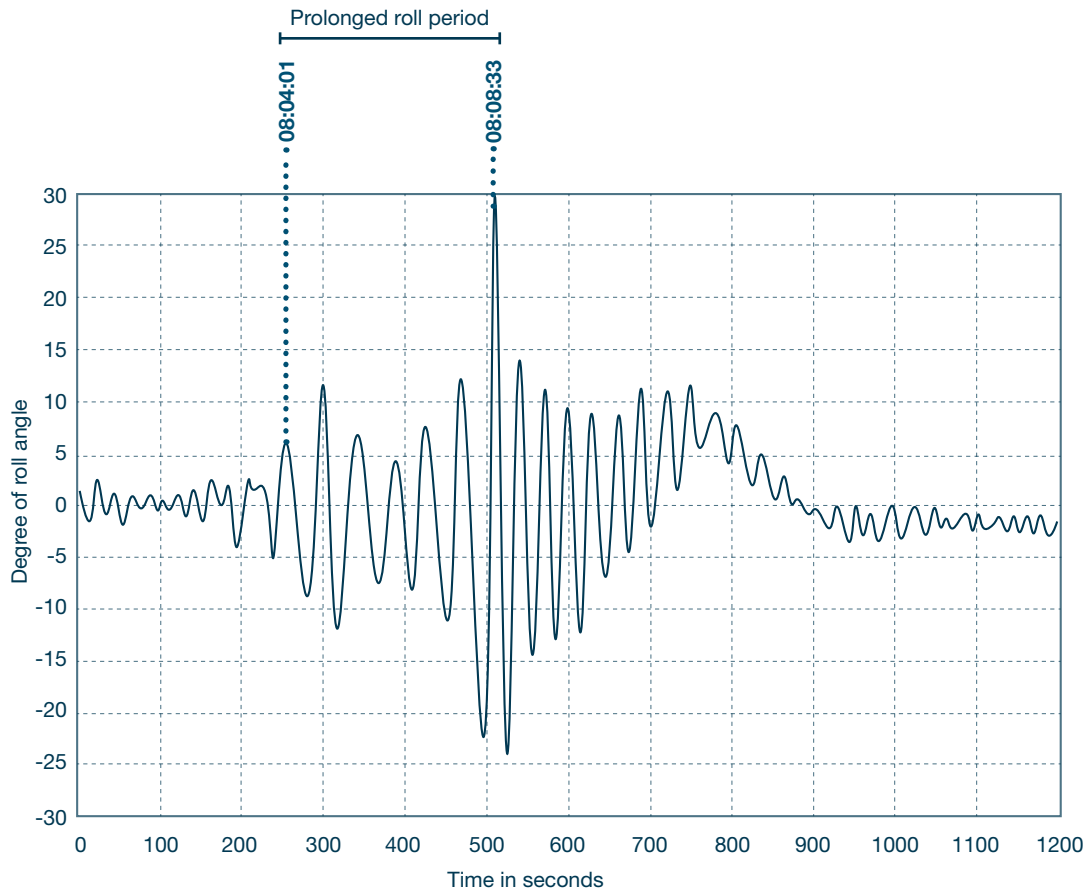
Figure 21 shows TUHH's calculations of MAERSK ESSEN's roll cycles between 08:00 and 08:20. It can be seen that the roll angles before and after the episodes of heavy rolling were between 2-3° to each side, and that the stable period experienced by the 3rd officer was not a complete return to the ship's normal roll period and angle.

Figure 21: Graph of TUHH's roll angle calculations, modified by DMAIB
Source: Maersk A/S

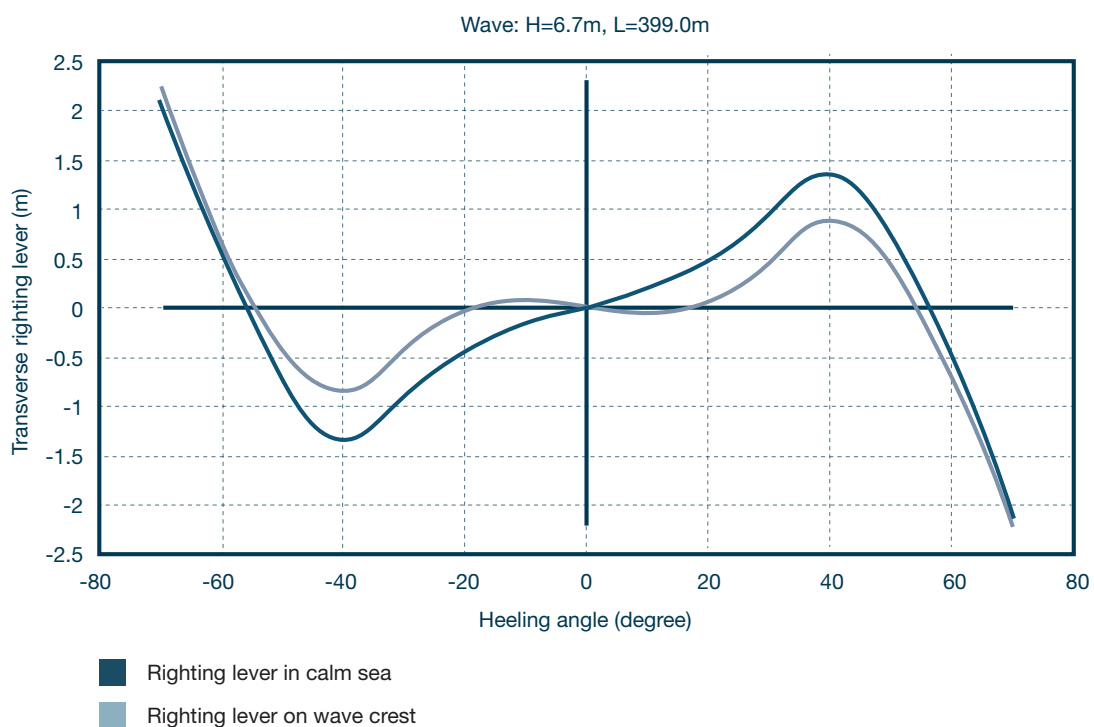
The stability calculation indicates that while the GZ curve for calm sea was positive until a heeling angle of 55°, the initial stability was negative on a wave crest and would not find a stable equilibrium until an 18° heeling angle was reached. Based on this calculation, TUHH concludes that MAERSK ESSEN was exposed to a pure loss of stability which could potentially cause the ship to capsize. However, TUHH also concludes that this scenario would not be plausible for a container vessel, as the cargo will fall overboard and improve the stability.

As highlighted in the section on sea conditions on the day of the accident, there were discrepancies in the wave height and wave period values provided by the different weather information suppliers, and the forecast values did not necessarily reflect the actual swell influencing the ship's motions at the time of the accident. Therefore, TUHH's calculations do not with certainty prove that MAERSK ESSEN suffered a pure loss of stability in connection with the heavy rolling episodes on 16 January 2021. However, as the TUHH calculations are based on a wave height that lies within the spectrum of wave heights identified in the hindcasts, the risk of pure loss of stability was most likely to have been present.

Figure 22: Stability graph for MAERSK ESSEN prepared by TUHH, modified by DMAIB
Source: Maersk A/S

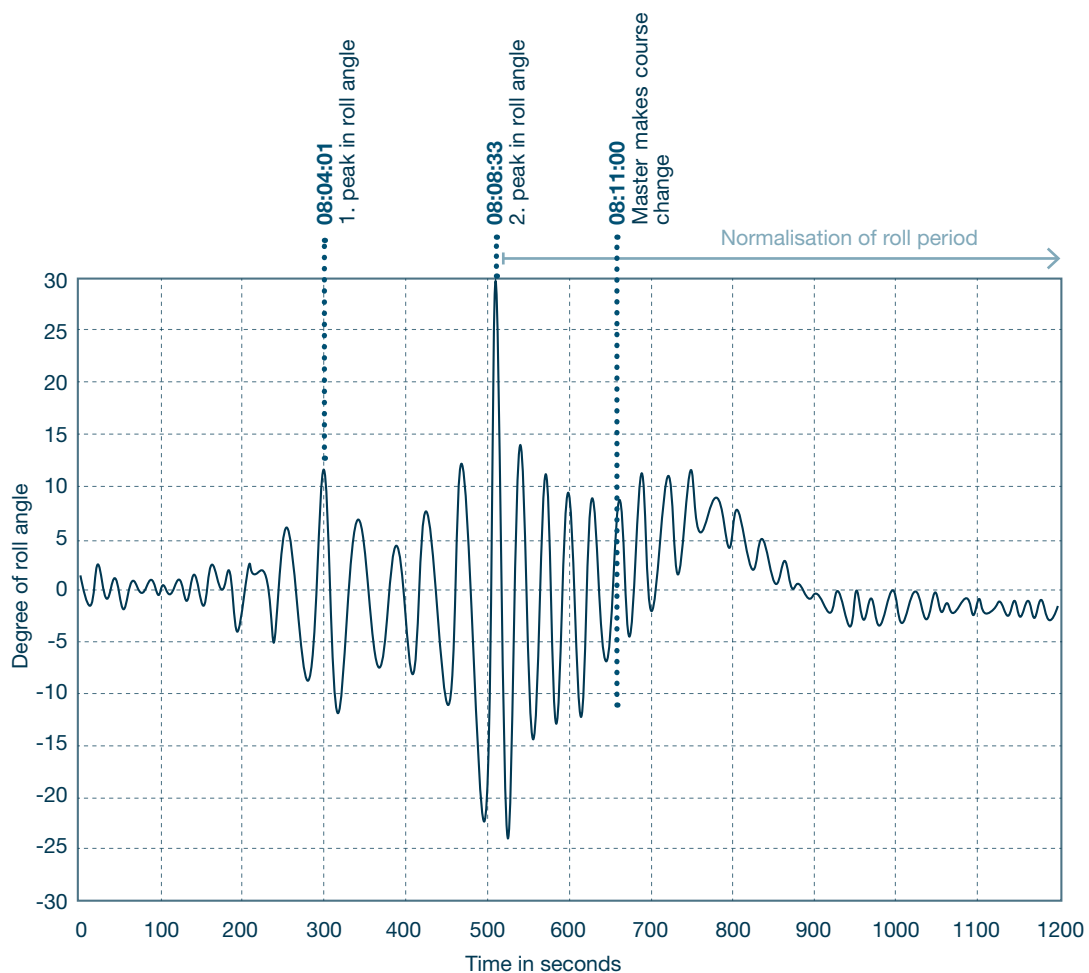
The roll angle graph prepared by TUHH for the time of the container losses reflects parametric resonance. It can be seen that there are two episodes of increasing roll angles. After the first peak in roll angle, the roll angle starts to decrease while the roll period continues to be prolonged. This indicates that the resonance conditions diminished momentarily. This might have been due to alterations in frequency coupling linked to speed or wave period. However, the resonance effect swiftly returned. After the second extreme peak in roll angle, the roll angles decreased, and the roll period normalised (Figure 26). These episodes occurred without any observed changes in the sea conditions.

During these oscillations, the ship lost containers overboard resulting in significant change in GM. Information from the ship's stability calculation software indicated that the GM increased from 0.95 m to 2.44 m, which altered the ship's natural roll period so that the frequency coupling with the wave encounter ceased.

DMAIB finds it plausible that the heavy rolling motion on the day of the accident was a result of parametric resonance, because MAERSK ESSEN was situated in conditions equal or close to the trigger conditions described for this phenomenon, and because the roll angle graph shows the characteristics of parametric roll resonance.

Figure 26: Graph MAERSK ESSEN's roll angles at time of the accident.
Source: TUHH, modified by DMAIB

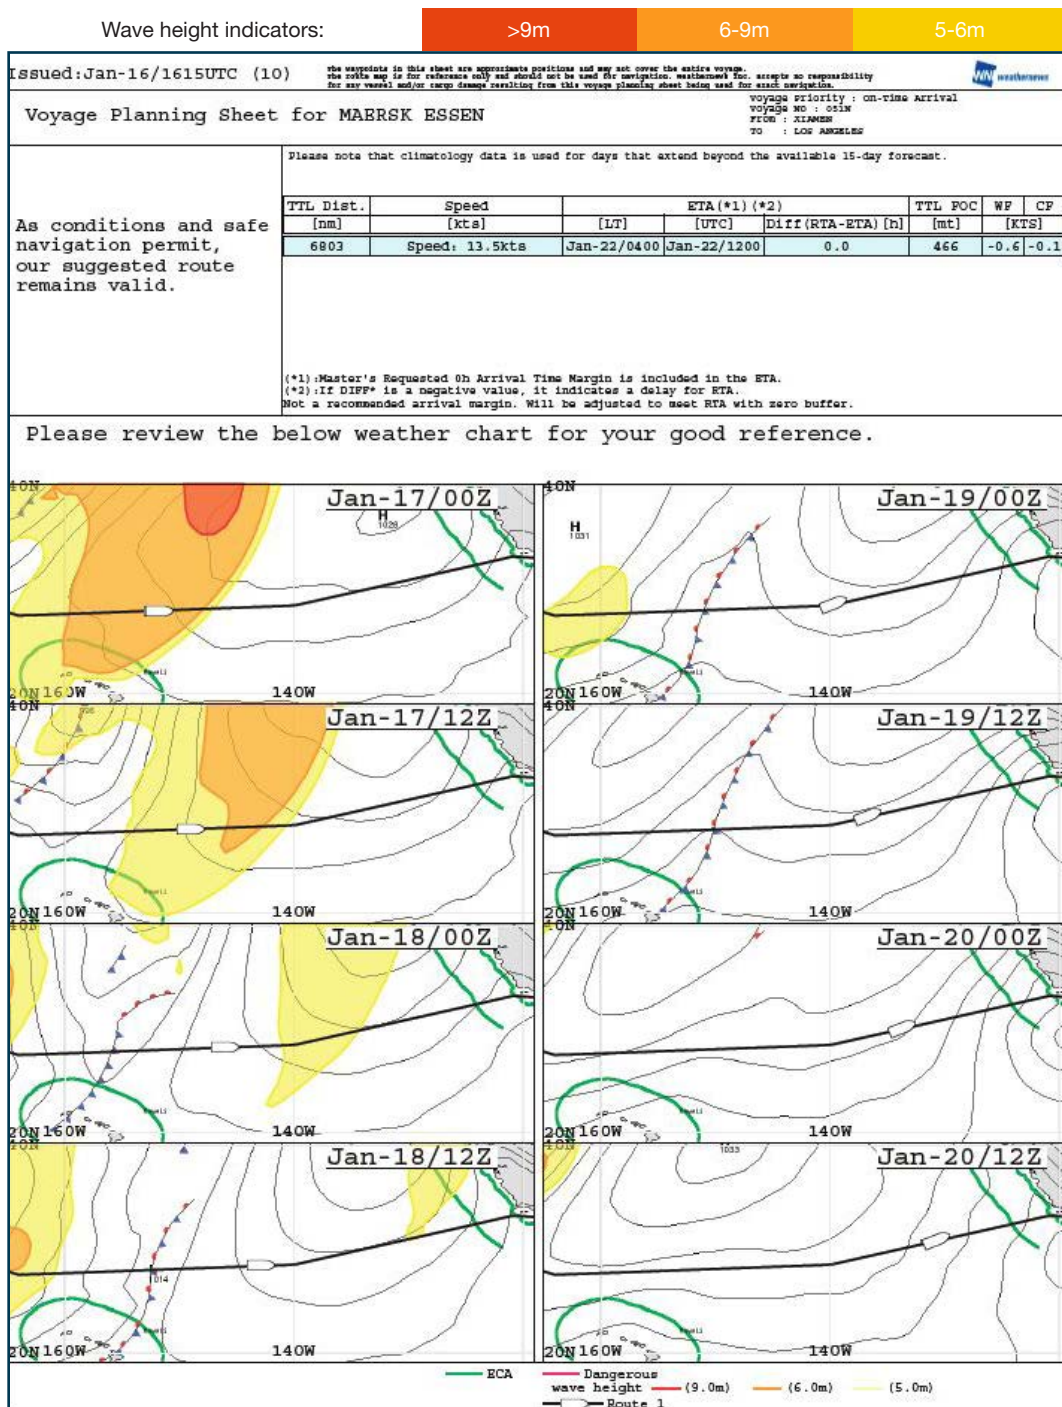
WNI's voyage planning sheet contained a four-day forecast described in eight surface pressure charts starting at 16 January at 14:00 (Jan-17/00Z) (Figure 28) which indicated improving conditions with the ship clearing an area with significant wave heights between 6-9 m on 17 January at 02:00 ship time (Jan-17/12Z). The graph of forecasted wind, sea and swell heights combined indicated significant wave heights of 7.5 m on 16 January 14:00 LT (00 Zulu) and that the wave height was reducing (Figure 29).

Figure 28: Voyage planning sheet issued on 16 January 2021
Source: WNI, modified by DMAIB

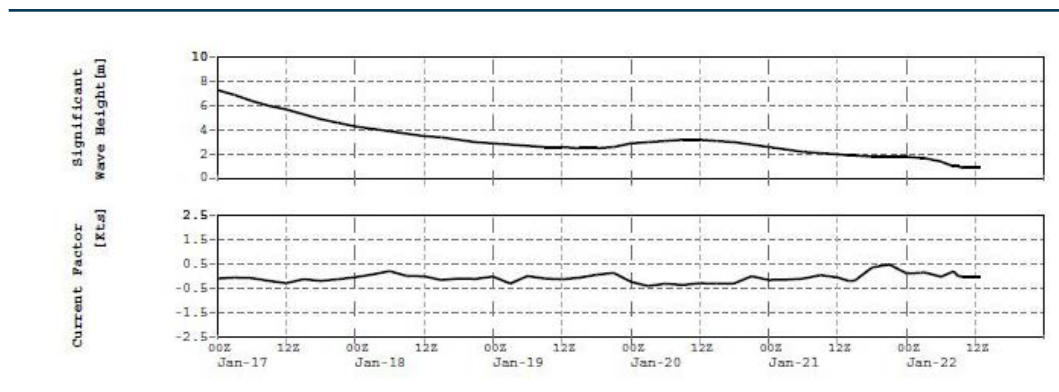
Figure 29: Voyage planning sheet issued on 16 January 2021
Source: WNI

The gradient of the significant wave height in the damage mitigation message indicates that the wave height was improving from 17 17 Jan/00Z (Figure 29). Arguably, when the message was received at 06:45 (ship's time), it could be extrapolated from the graph that the ship was already encountering worse sea conditions than those forecast in the damage mitigation message. In these circumstances, the message was not seen to be urgent which led to the chief officer's decision not to inform the master about the message until 08:00 at the operational meeting. In addition, as the damage mitigation message did not mention parametric rolling, it did not prompt the association of the heavy rolling at 06:00 with this phenomenon. It is noted that the heavy rolling that resulted in the loss of containers occurred at 08:00 on 16 January 2021, six hours earlier than the start of the period covered by the damage mitigation message from WNI.

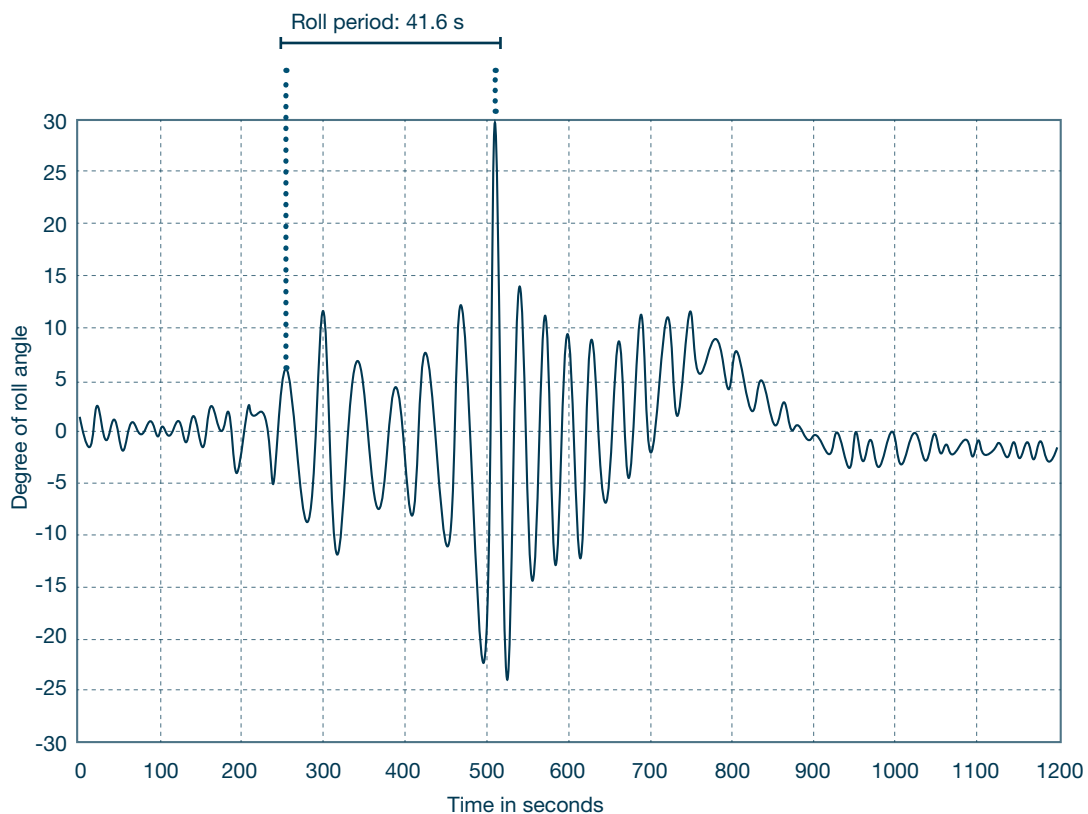
Figure 30: Graph MAERSK ESSEN’s roll angles at time of the accident.
Source: TUHH, modified by DMAIB

“Close to” is not defined by a spectrum or threshold and is hence left to masters’ discretion. Guidance is provided on how to obtain the values needed to determine the encounter period and ship’s roll period with a ship’s natural roll period being estimated by observing the rolling motion in calm sea. In practise, this is not possible as the ship will not roll in calm seas, and measuring the rolling motions in rough seas will not reflect a ship’s natural rolling motions. The variability of a ship’s roll period is demonstrated by the TUHH calculations which show that, in the case of MAERSK ESSEN, the roll period in waves before the heavy rolling episodes was considerably shorter than the natural roll period calculated by TUHH, while the roll period in waves during the parametric rolling motions is close to the calculated natural roll period (Figure 30).

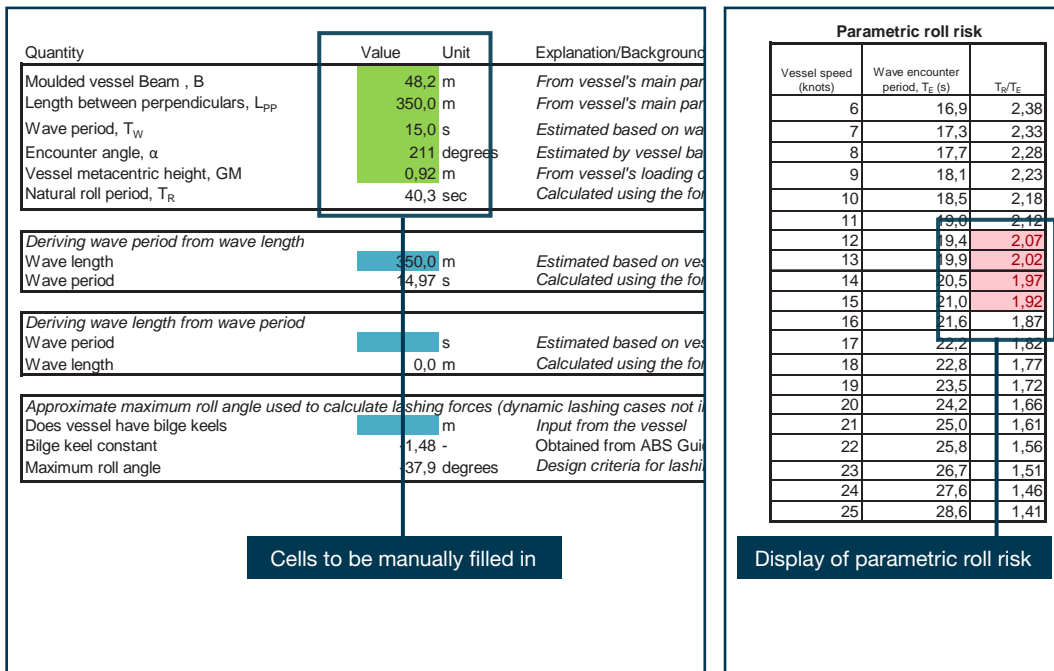
Figure 32: On board parametric roll calculator
 Source: Maersk A/S

The onboard calculator is easy to use, as it only requires the crew to fill in five cells in the Excel document with values that are readily available on the loading computer and SPOS. The result of the calculation is displayed by highlighting a range of vessel speeds where the relation between roll period and encounter period will be close to 1:1 or 1:2 (Figure 32).

The calculator defines “close” to be within a margin of 10%. This means that the risk calculator is sensitive to variation and inaccuracies, which is a problem when calculations are based on forecast data, which are already prone to uncertainty and variation. A variation of one second to the wave period alters significantly the speeds identified with having risk.

While the onboard calculator operationalises the knowledge from the IMO MSC.1 Circ. 1228 and makes it easy to use for the crew, it still requires the crew to manually insert values into the calculator and is not suitable for monitoring the risk continuously in real time. The combination of the calculator's sensitivity, the generic calculation of natural roll period and the dependency of forecast data means that the risk calculation is a rough estimate. However, the numerical values and the sensitivity of the calculator give the impression of accuracy, which can be misleading to the crew.

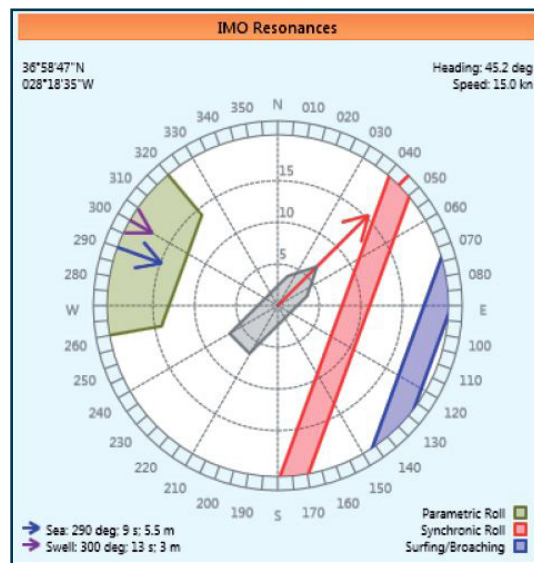
Figure 33: Example of polar diagram in SPOS Seakeeping module
Source: SPOS

The seakeeping module is fully integrated in the voyage planning and weather routing programme, which means that the risk of parametric rolling is automatically calculated based on forecast data and vessel information, and is readily available to the crew when planning the voyage and monitoring forecasted weather and sea conditions. The module can, inter alia, advise on safe speed for the given time, location and direction of travel, and displays real-time and predicted risk of resonance in a polar diagram (Figure 33). Furthermore, the module can automatically optimise the route according to motion limits.

To make use of the Seakeeping module, the software needs to be configured with ship particulars and roll damping parameters. This makes the calculation of parametric resonance more accurate than those provided by the onboard parametric roll calculator. However, the calculation is based on the same forecast data with the same uncertainty. Some of the navigational officers had experience from other ships with tools with similar functionalities as SPOS Seakeeping, and they found them to be useful tools for weather routing. However, the navigational officers on MAERSK ESSEN expressed concerns towards the tool's ability to foresee parametric rolling due to the differences between forecasted and observed wavelengths and wave periods.

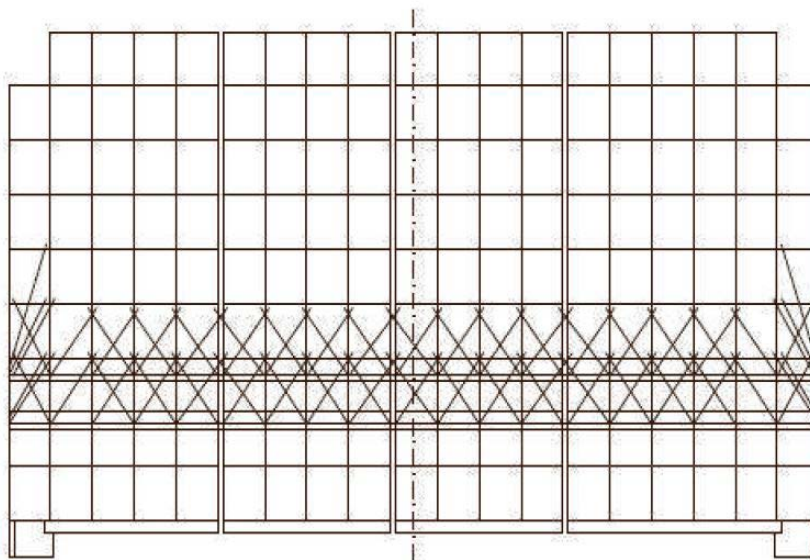
Figure 38: Lashing pattern for a nine high stack on MAERSK ESSEN
Source: Maersk A/S

Containers stowed on deck were secured with a lashing system comprising ISO container sockets fixed on hatch covers, base locks, semi-automatic twistlocks, knob lashing rods and turnbuckles. The lashing system consisted of various lashing patterns to be used on certain bays and container sizes. The dominant lashing pattern in use on MAERSK ESSEN was:

- Inboard stacks were secured with external lashings to the 2nd and 3rd tiers of the lashing bridges.
- The outboard stacks were secured to the 2nd and 3rd tier of the lashing bridge with internal lashings and one long windlash from 3rd tier.
- The containers on tiers five to ten were secured by semi-automatic twistlocks only, except the outermost rows where containers in tier 6 was lashed in one corner (Figure 38).

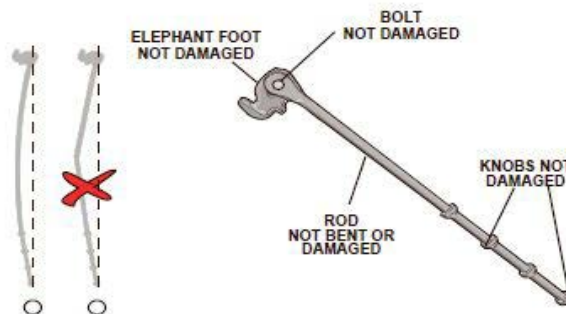
Figure 40: Inspection guide on lashing bar in CSM
Source: Maersk A/S

According to the CSM, the portable and fixed lashing systems had to be visually inspected once a year and a function test must be carried out. The manual described what the visual inspection should focus on and how to test the equipment. Whether equipment was in a satisfactory condition was up to the crewmembers' assessments and subjective opinion, e.g. whether minor dents or bends on lashing rods were acceptable or not (Figure 40).

No maintenance records were kept on the individual lashing gear, so while the equipment might visually seem in working order, years of exposure to tension as well as general wear might have resulted in metal fatigue and reduced holding capacity to some degree. Furthermore, the crew did not perceive it to be possible to routinely assess the state of the ISO sockets fixed on the hatches and pedestals as they were in constant use, apart from when the ship was in dock. According to the company, some ISO sockets were renewed in dry-dock in February 2020.

Inspect for any pittings or cracks which may weaken the lashing bar

A slight bend of the lashing rod is acceptable(1).
Sharply bent lashing rods must be discarded (2)

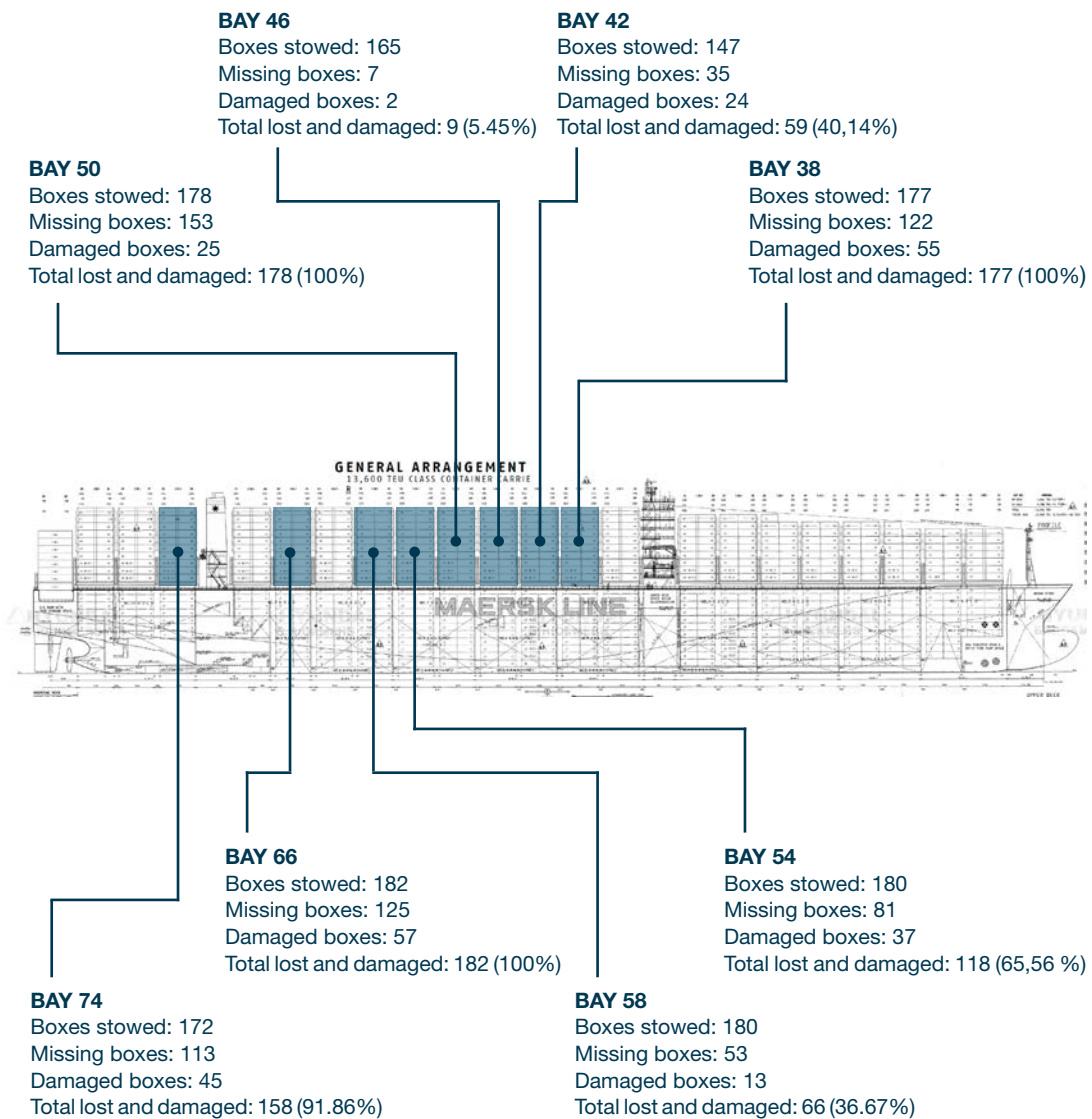
Figure 42: Overview damaged and lost containers based on Maersk info (DMAIB)
Source: MAERSK A/S / DMAIB

After all the containers on board had been accounted for, Maersk A/S informed DMAIB that 689 containers were lost and 258 were damaged. Eight bays aft of the accommodation were affected: Bays 38, 42, 46, 50, 54, 58, 66 and 74. In Figures 42 and 43, the location and number of missing and damaged containers on the affected bays are highlighted:

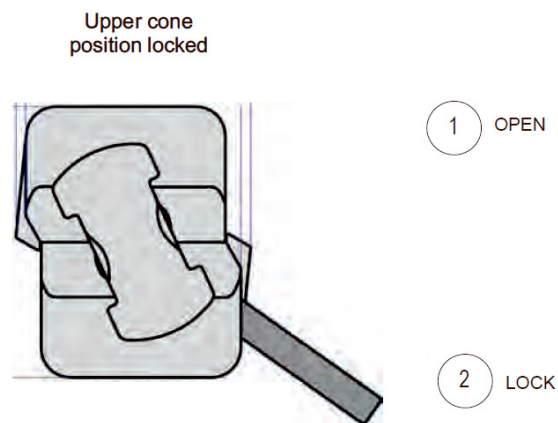
Figure 52: Base lock mechanism from CSM
Source: Maersk A/S

Both damaged and undamaged base locks were found in the sockets on the affected bays. In some cases, the locking pins seemed to be in the open position, but damages to container corner castings and twistlocks indicate they had been locked, but that the locking pins had been forced open when the container stacks toppled (Figure 51 and 52).

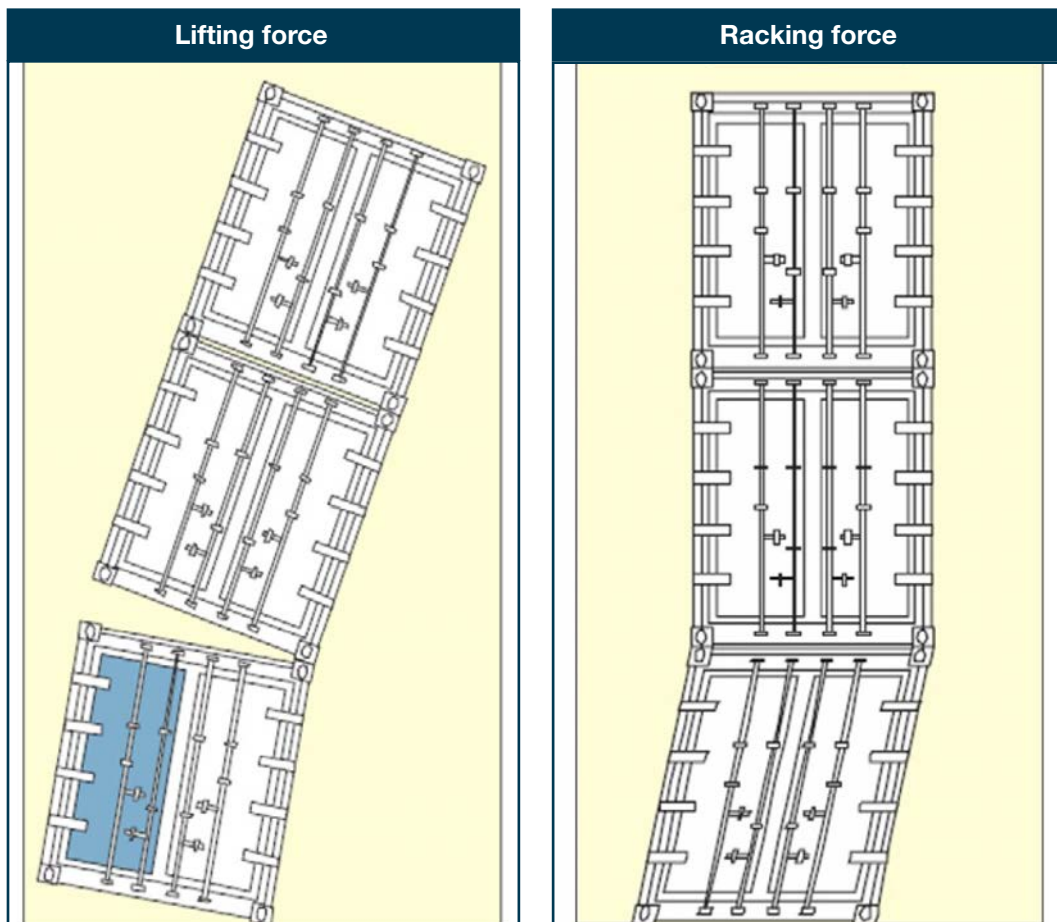
Figures 53 and 54: Racking and lifting force
Source: UK P&I Club, modified by DMAIB

The ISO sockets, which had the lowest holding capacity, were damaged on most of the affected bays. Fractures on sockets, corner castings and base-locks often related to overload caused by lifting and separation forces induced by heavy rolling, which resulted in a tipping moment (Figure 53). However, the corner post load or lifting force might also have resulted from other dynamics within the individual stack, such as acceleration forces at the top leading to racking forces towards the middle of the stack, which then results in lifting/compression in the bottom of the stack (Figure 54). This type of dynamic will increase with stack height, especially for stacks with the tiers above the lashing bridge connected by twistlocks only. Furthermore, impact from collapsing adjacent stacks can also induce a tipping moment.
