Final Report

FIRE ON BOARD MAERSK HONAM AT ARABIAN SEA ON 6 MARCH 2018

MIB/MAI/CAS.035

Transport Safety Investigation Bureau
Ministry of Transport
Singapore

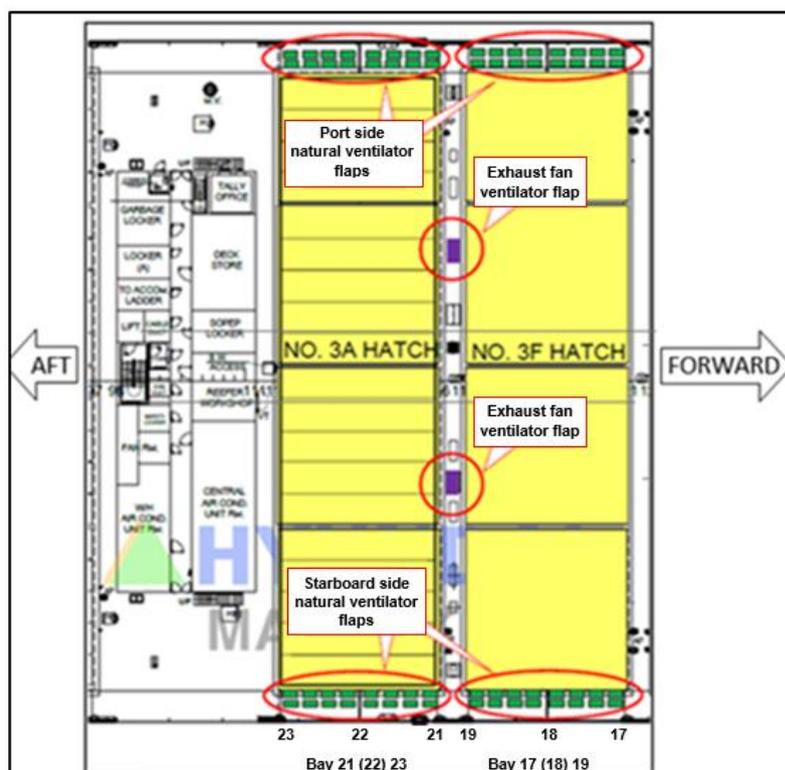
Figure 4 - Plan view showing locations of the natural ventilator flaps and exhaust fan ventilator flaps for no.3 cargo hold (for reference only, annotated by TSIB)

1.2.8 The CM instructed the AT-1 to shut the natural⁶⁰ ventilator flaps⁶¹ for no.3 cargo hold on the leeward side i.e. the port side, while the CM took some crew⁶² to shut the natural ventilator flaps on the windward side i.e. the starboard side (see **figure 4** showing locations of the ventilator flaps at no.3 cargo hold). It was planned that on completion of these tasks, both teams would then meet at bay 19/ 21 cross-deck to close the two exhaust ventilator flaps for the mechanical⁶³ fan.

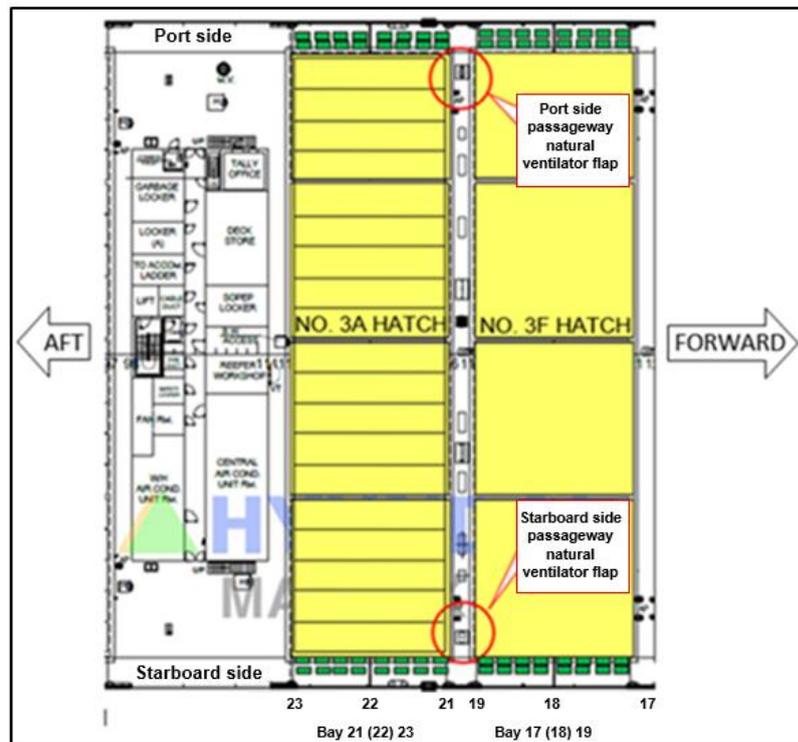
Figure 5 - Plan view showing locations of the natural ventilator flaps for the passageway as marked by the red circle (port and starboard side) annotated by TSIB

- 1.2.11 Overhearing the conversation, the 3E-1 responded and advised the 2E over the walkie-talkie to use the starboard passageway which was clear of smoke at the time the 3E-1 was going to the ECR. The 2E followed the 3E-1's advice and did not encounter any smoke or unusual smell on the way to the FCS (see **figure 5** showing the locations of the port and starboard natural ventilator flaps⁶⁴ for the passageway).

⁶⁴ These flaps were open at the time of the occurrence allowing for a flow of air within the passageway.

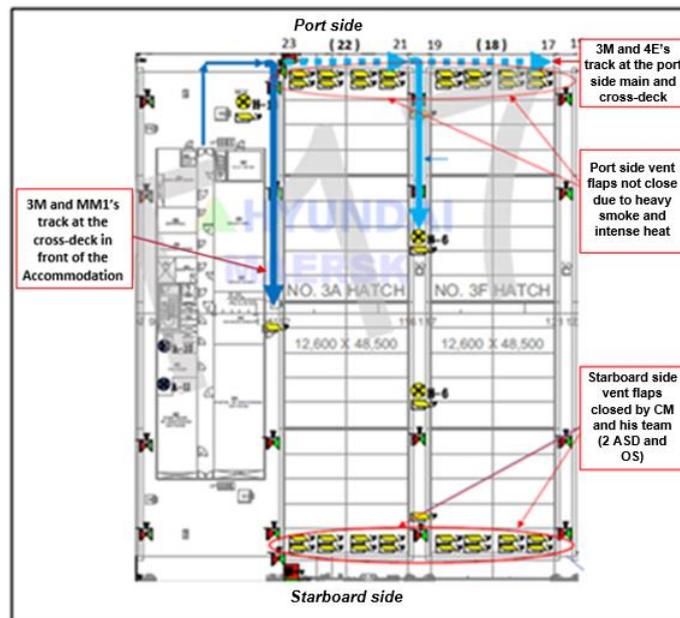
Figure 8 - AT-1's track for closing the ventilator flaps

1.2.26 The CM also instructed the crew doing boundary cooling at the port side main deck to provide a water curtain for aiding the 3M, and later the 4E, to minimise the effects of heat and smoke. Although the 3M reported a slight improvement in the visibility, the area near the port side natural ventilator flaps was still inaccessible due to the intense heat and huge amount of smoke. Unable to close the natural ventilator flaps at the side of the hatch cover, the 3M walked further forward and ascended the second vertical ladder leading to the cross-deck, identified later as bay 19/ 21. The 3M located and successfully closed the no.3 cargo hold exhaust ventilator flap at the port side cross-deck. (See **figure 8** - showing AT-1's track for locating the port side flaps).

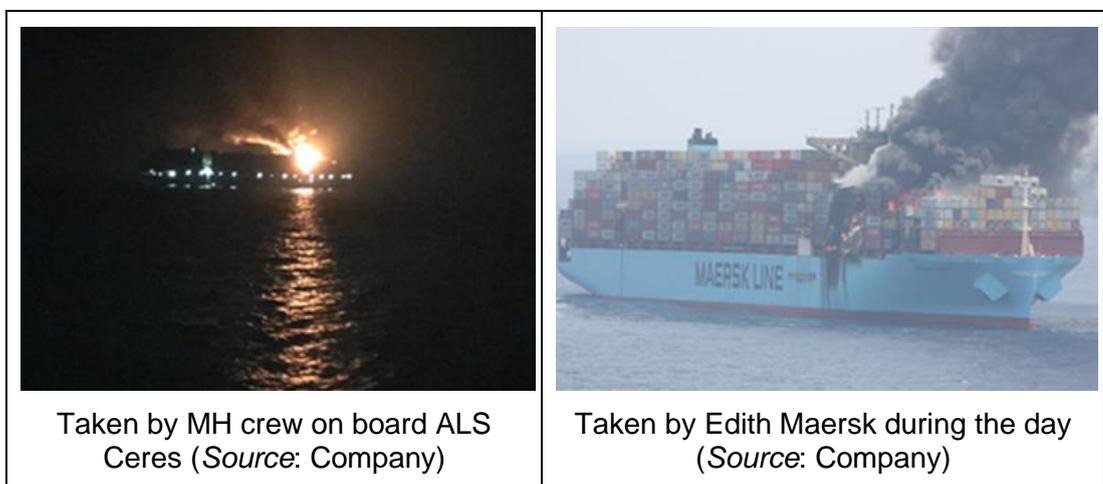
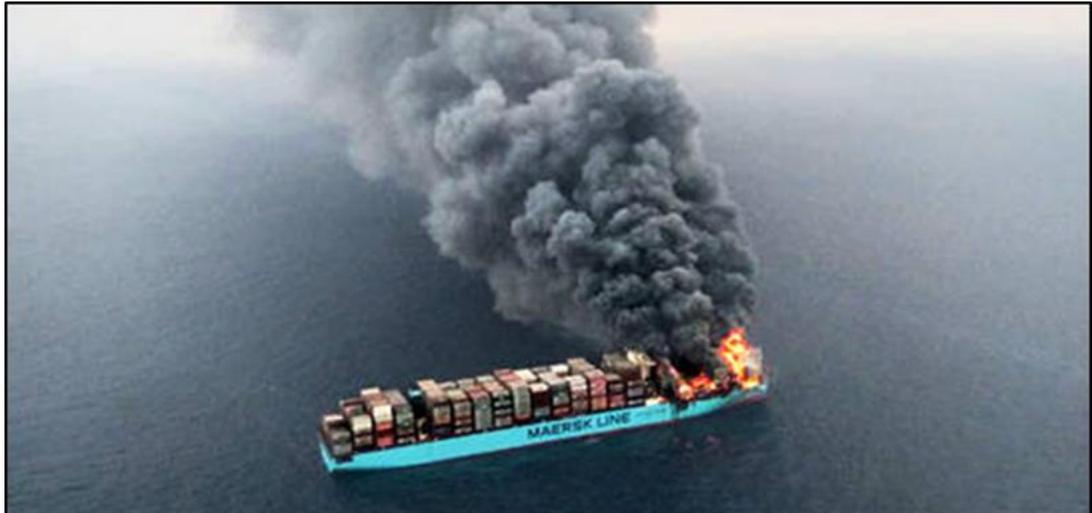
- 1.5.3 By about 2230H, ALS arrived on scene and updated MRCC Mumbai.
- 1.5.4 Subsequently, the Master of ALS updated MRCC Mumbai that on 7 March 2018 at about 0130H, 23 crew members from MH had been recovered on board ALS and that four persons were unaccounted for. SAR operations of the nearby sea area to look out for the four missing persons continued with the assistance of several vessels. See **figures 13 and 14** - fire on board MH.

Figure 13 - Fire onboard the MH

Figure 14 - Aerial view of MH during the day (Source - Tradewinds)

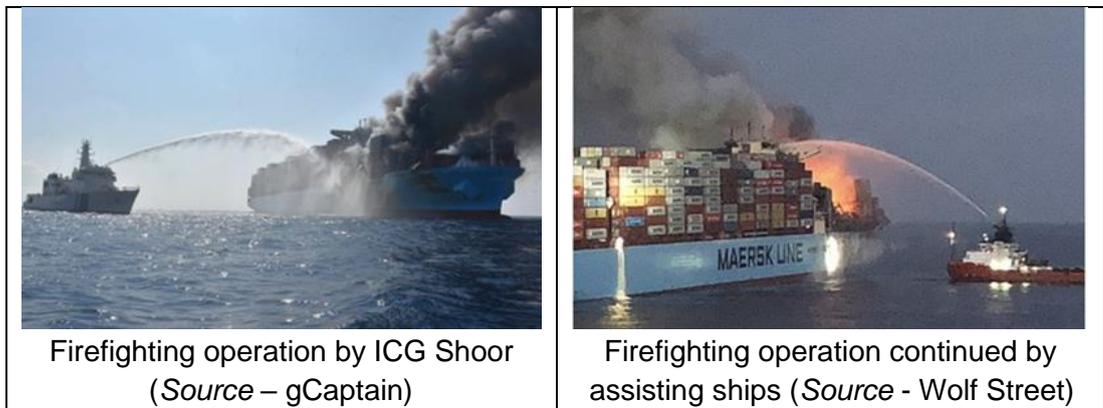
Figure 15 - Firefighting operation

- 1.5.9 On 8 March 2018, the ICG's ship (Shoor) commenced firefighting operations. Thereafter, the ICG Shoor was joined by other ships engaged by the Company for the firefighting operations. See **figure 15** - firefighting operation.

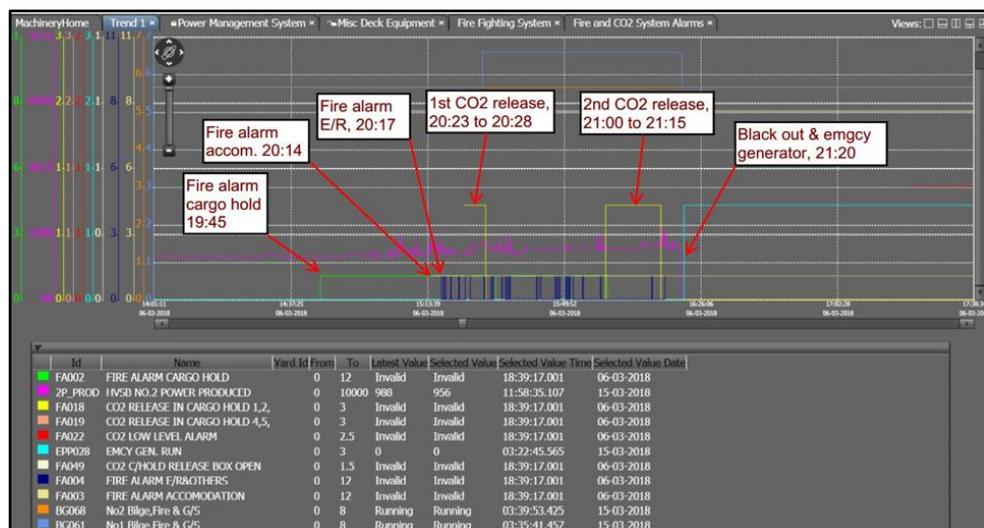
Figure 17 - CAMS data showing the alarms and events during the incident (Source – Annotated by the Fire Forensic Expert)

- 1.6.1 A screen shot of the CAMS console (see **figure 17**) showing the graphical representation of some of the key alarms that occurred during the incident indicating the onset of the smoke alarm, the release of CO₂ and the blackout.

- b. Electrical source - Correlating the sequence of events (see **figure 17 and table 2**) and the examination and tests carried out on the electrical remnants by the Fire Forensic Expert, seems to suggest that an electrical

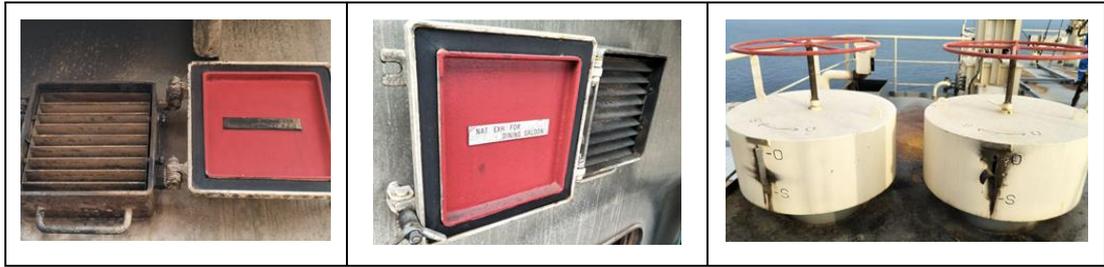
Figure 20 - Ventilation covers and mushroom ventilators for the accommodation

- 1.8.7 In addition to the fire dampers, the accommodation block was also fitted with a total of 27 manually operated ventilation closing appliance¹¹⁷ (hereinafter referred to as exterior ventilation vents). These exterior ventilation vents were meant for exchanging of fresh air with exterior environment when opened and for preventing entry of smoke or gases into the accommodation when closed.
- 1.8.8 The investigation team was able to access and check the condition of the exterior ventilation vents for the accommodation. Most of these were found¹¹⁸ in an open position (see **figure 20** on ventilation closing appliance of cover type and mushroom type).

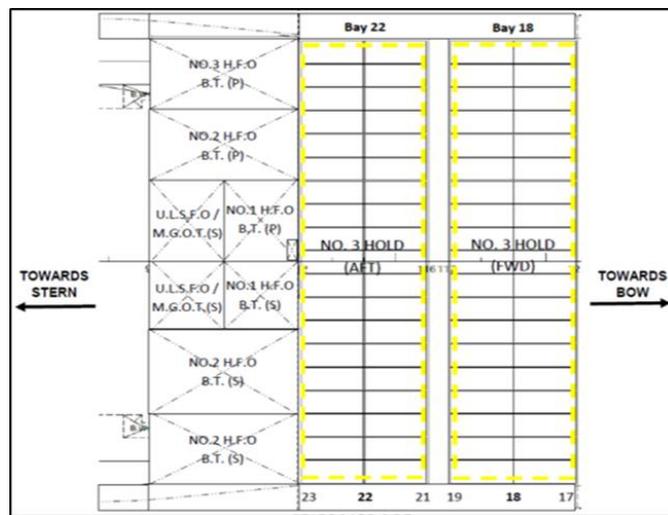
Figure 21 - Position of bunker tanks (adjacent to and aft of no.3 cargo hold)

1.8.9 The ship had six HFO bunker tanks (namely 1, 2, and 3 port and starboard) located immediately aft of no.3 cargo hold (see **figure 21**).

1.8.10 Typically, as per normal practice, before consuming the fuel from the bunker tanks, the HFO in the tanks would be pre-heated by steam coils (about 40°C) from the exhaust gas boiler. The high-temperature alarm was set at 45°C. At the time of the incident, bunker tank no.1 starboard was in use and according to the 3E-1, the last temperature of the tank checked was about 43°C.

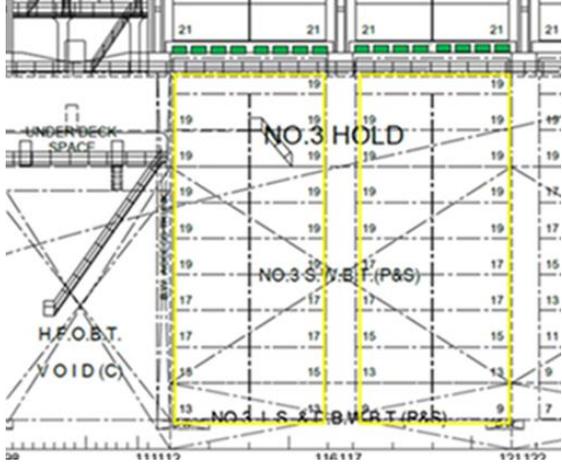
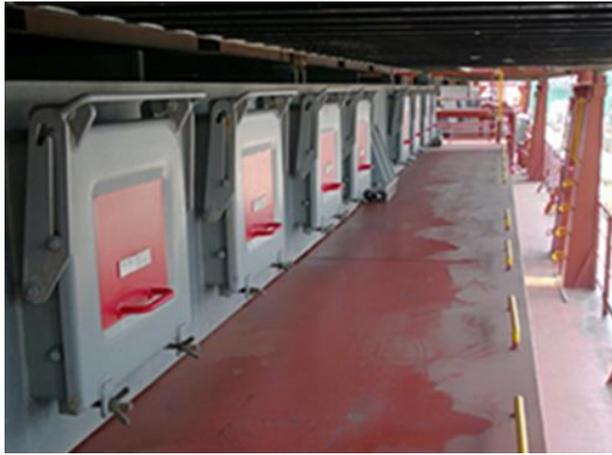
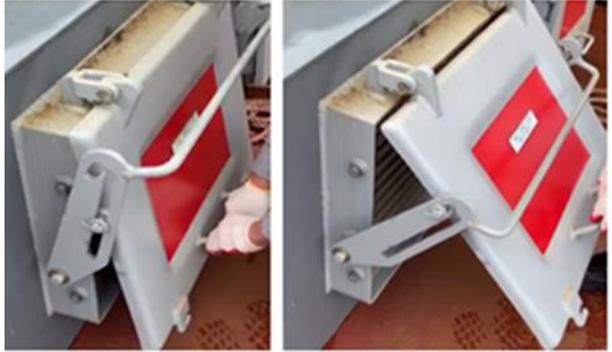
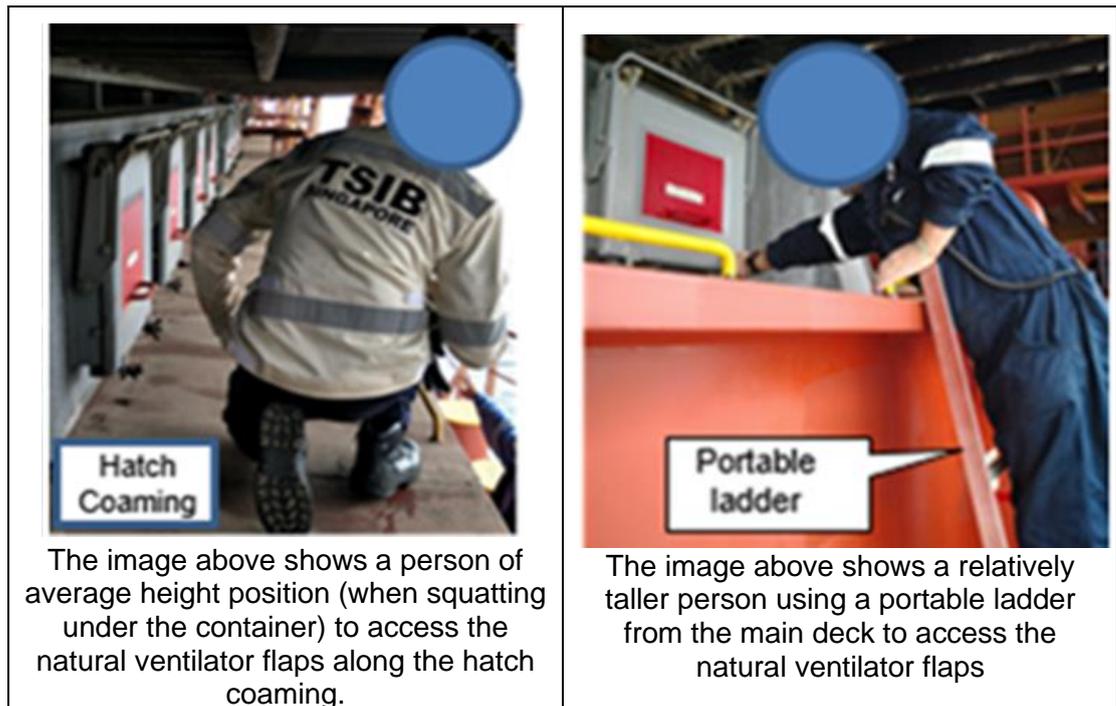
Figure 25 – Natural ventilator flaps

<ul style="list-style-type: none"> • Side view of no.3 cargo hold (forward and aft part) indicated by yellow markings. • The illustration shows the location of the 16 natural ventilator flaps, annotated by TSIB in green, on the hatch cover (in this case the starboard side is depicted)

<ul style="list-style-type: none"> • The image shows the natural ventilator flaps of a sister ship in close position, located on the side of the hatch cover panel. • These flaps are located at a height of about 1.95m above the main deck. To access these flaps, the crew must either use a portable ladder on the main deck to reach the flaps or climb on to the hatch coaming and squat under the container.

<ul style="list-style-type: none"> • The image shows the flap in the process of being opened (with two hands) and then hooked in an open position. • To close the flap, it must be first lifted in the upward direction to release the “locking hook” before closing and securing with a wing nut

¹³¹ It was noted that the natural ventilator flaps for no.3 cargo hold (total 32nos.) were in open position.

1.8.21 The investigation team was able to confirm the account of the crew by an inspection of the ship post-incident, that the starboard side natural ventilator flaps were closed while those on the port side were open (see **figure 26**).

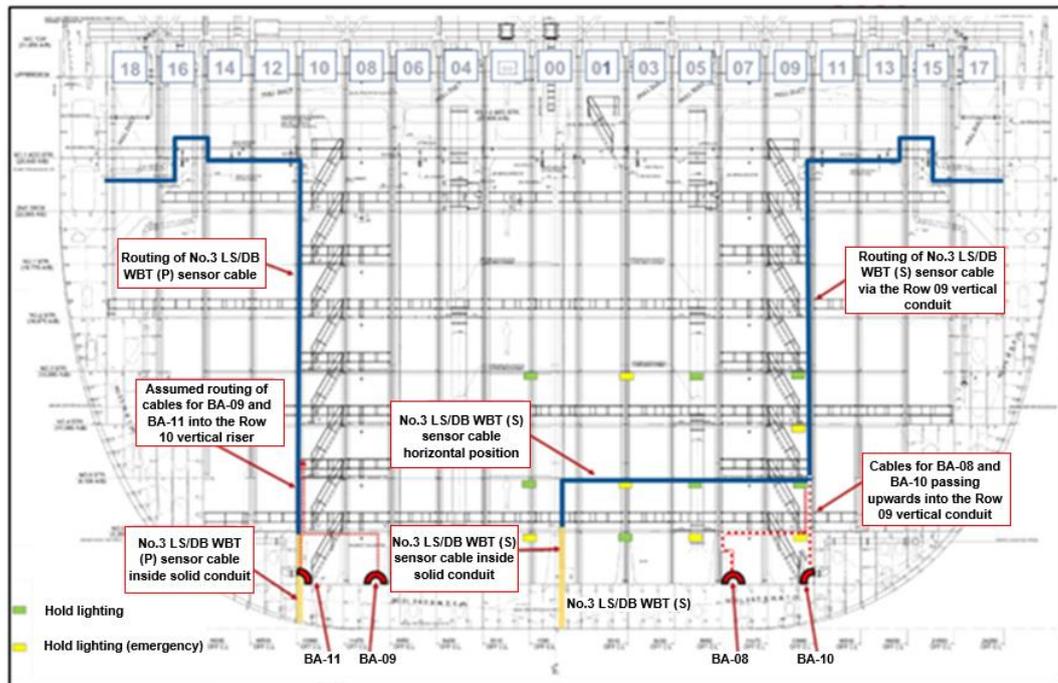
Figure 27 - Layout of no.3 cargo hold and the intermediate gallery at frame 116 ~ 117

1.9.1 No.3 cargo hold comprised two 40' bays, i.e. bay 17(18)19 in the forward section, and bay 21(22)23 in the aft, which were separated by a non-watertight bulkhead (hereinafter referred to as the intermediate gallery), at frames 116 and 117 (see **figure 27**). The hold was enclosed at the forward and aft, by watertight bulkheads (at frames 121 and 112 respectively).

1.9.8 The port side hydrostatic sensor was mounted in line with row 10¹³⁴ and the cable for this sensor passed vertically from where it exited the tank-top directly into the vertical conduit, before passing horizontally at no.1 additional stringer level into the port side passageway. The solid steel conduit in which the tank sensors were housed are shown with the yellow lines in **figure 27**.

¹³⁴ An error by the Fire Forensic Expert mis-identified No.3 LS/ DBT WBT (P) as No.3 LS/ DBT WBT (S) has been amended to read correctly in figure 27.

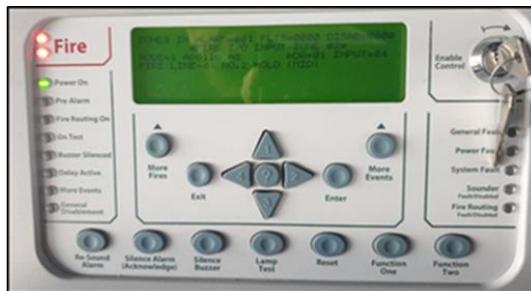
Figure 28 - Cargo hold smoke detection repeater panel on the bridge

1.11.2 At about 1945H, the bridge team was alerted by the smoke alarm on the bridge repeater panel indicating smoke being detected in the mid-section of no.3 cargo hold. See **figure 28** showing the repeater panel.

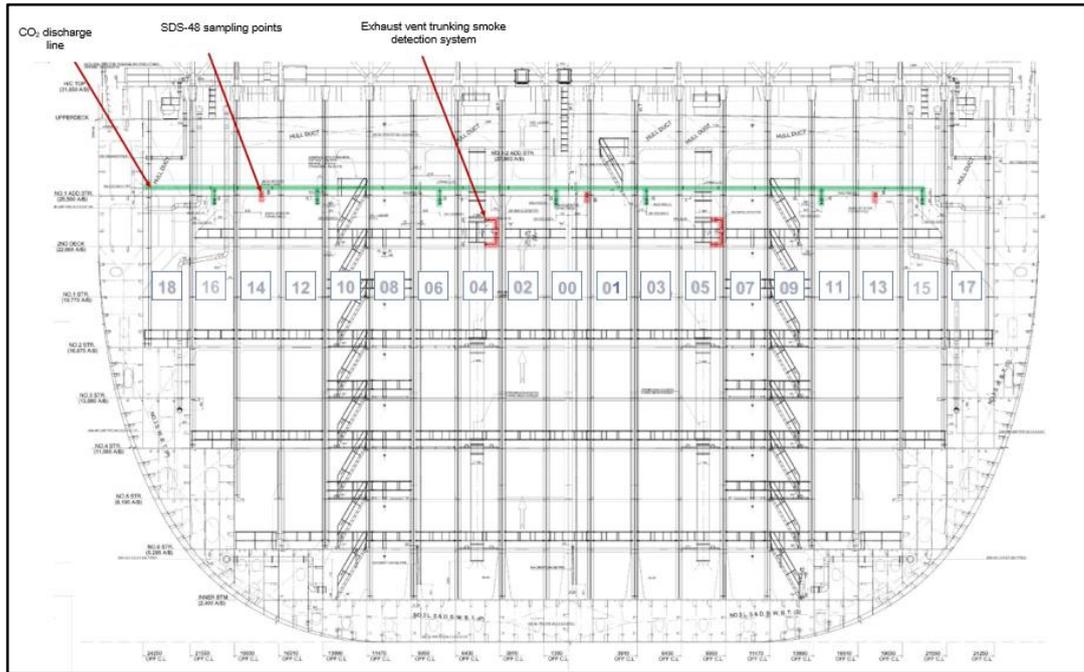
Figure 29 - Showing intermediate bay of no.3 cargo hold at frames 116-117¹⁴⁵

1.11.3 The smoke detection system for MH's cargo holds consisted of the 'Smoke Detection System' (SDS-48) with 'Addressable Fire Detection System' (Synchro ASM¹⁴⁴) provided by "Safetec". Each cargo hold had sample lines connected to sensors in a detector unit housed in the CO₂ room. A fan unit would draw air from the cargo hold through the system while the detector monitored the air. Each cargo holds exhaust ventilation ducts were also fitted with individual smoke detectors. See **figure 29** – showing intermediate bay of no.3 cargo hold at frames 116 -117.

1.12.3 Each cargo hold on board MH was protected by CO₂ fire suppression system by means of multiple discharge heads located at high level across the intermediate gallery of each hold (also shown on **figure 29**). As CO₂ enters¹⁵¹ the space and mixes with the atmosphere, the percentage of oxygen in the atmosphere is reduced (space is inert) and results in extinguishing the fire. The enclosed space must be sealed as reasonably tight as possible to maintain the concentration of CO₂ and the reduction in oxygen. Spaces must be kept filled with CO₂ until it has been established that the fire has been extinguished and reduction of hot spots is verified.

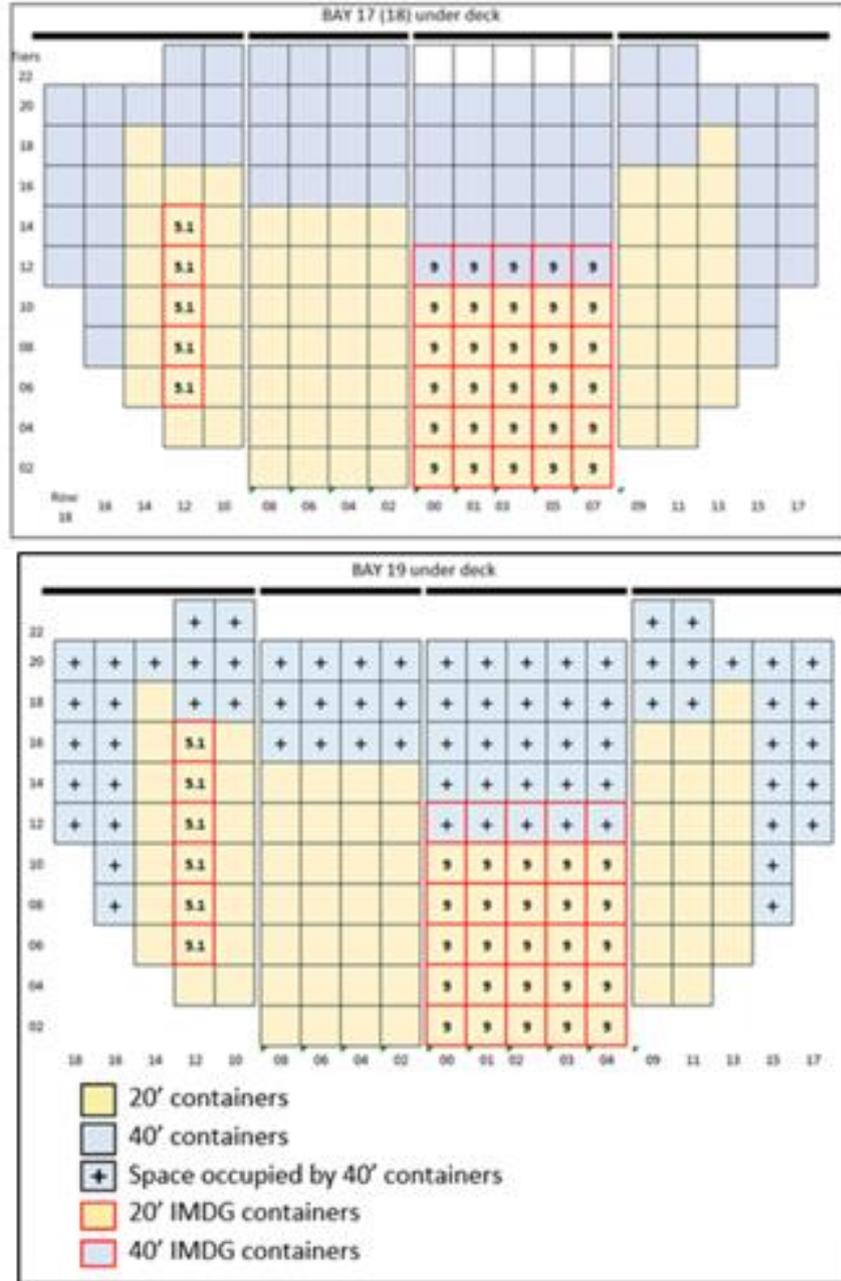
Figure 34 – Showing containers at bay 17 (18) 19

- 1.15.11 As per the cargo spotting plan, there were 269 containers inside no.3 cargo hold (Forward) in-way of bay 17 (18) 19. The breakup of numbers and type of containers stowed as a block stowage¹⁶⁶ (see **figure 34**) were as follows:

¹⁶⁷ Consisted of nine containers of Potassium Nitrate (UN No. 1486) and two containers of Sodium Carbonate Peroxyhydrate (UN No.3378).

¹⁶⁸ These containers were declared to be Sodium Dichloroisocyanurate Dihydrate (SDID) (UN No.3077).

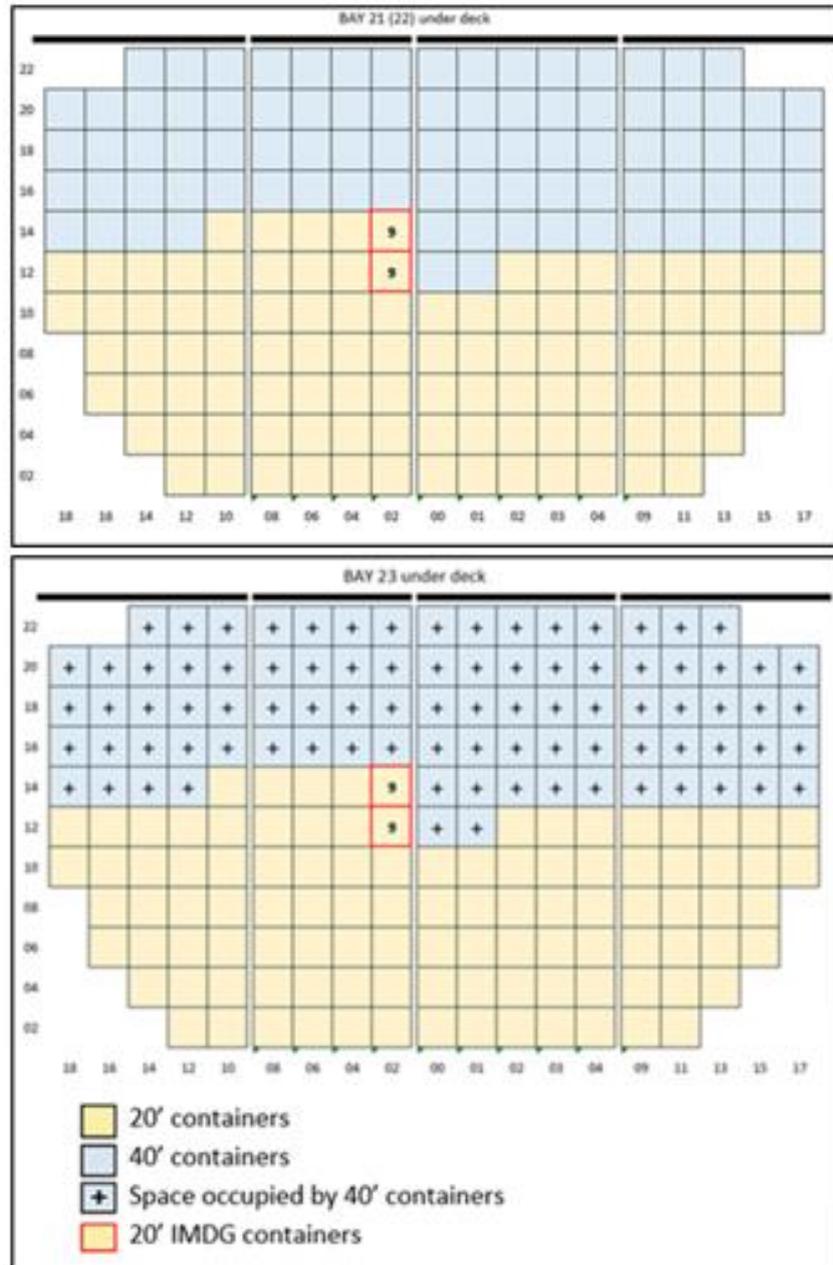
Figure 35 - Showing containers at bay 21 (22) 23 – annotated by TSIB

1.15.12 Similarly, there were 294 containers inside no.3 cargo hold (Aft) in-way of bay 21 (22) 23. The breakup of the numbers and type of containers (see **figure 35**) were as follows:

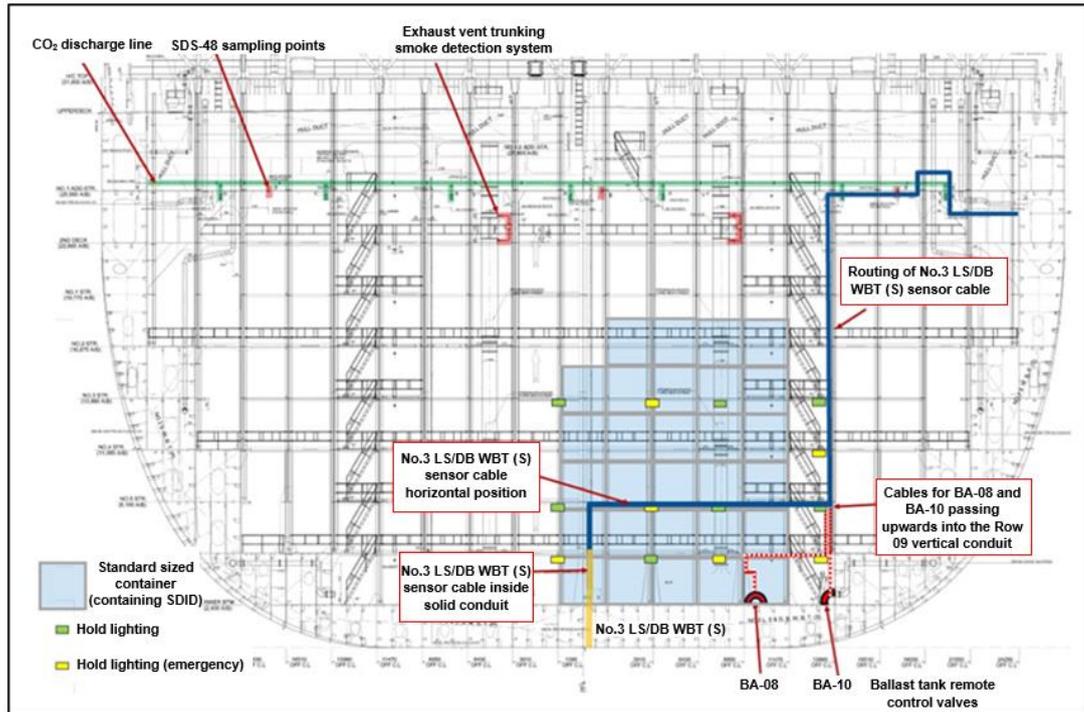
Figure 36 - Cross-section of no.3 cargo hold showing the routing of water ballast tank hydrostatic sensor cabling, the position of lighting, and the approximate outline of the 54-container block stow of SDID – Source: The Fire Forensic Expert

1.15.13 Section view of no.3 cargo hold superimposed with the routing of water ballast tank hydrostatic sensor cabling, the position of lighting, and the approximate outline of the 54-container block stow of SDID in **figure 36**.

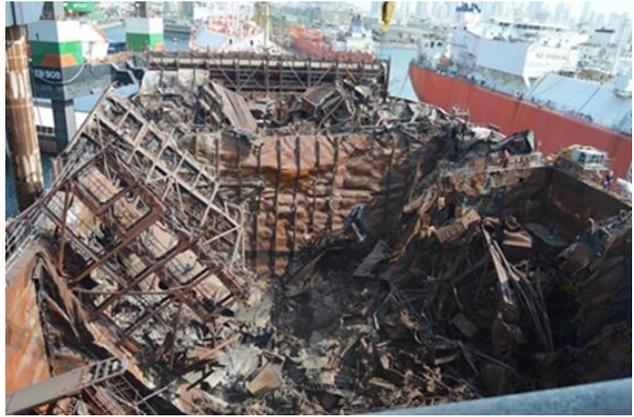
Figure 37 – Condition during excavation

Highlighting the SDID block in no.3 cargo hold at bay 17 (18) 19 as viewed from different angles.
