NATIONAL TRANSPORTATION SAFETY BOARD

2021

SAFER SEAS Digest

Lessons Learned from
Marine Investigations

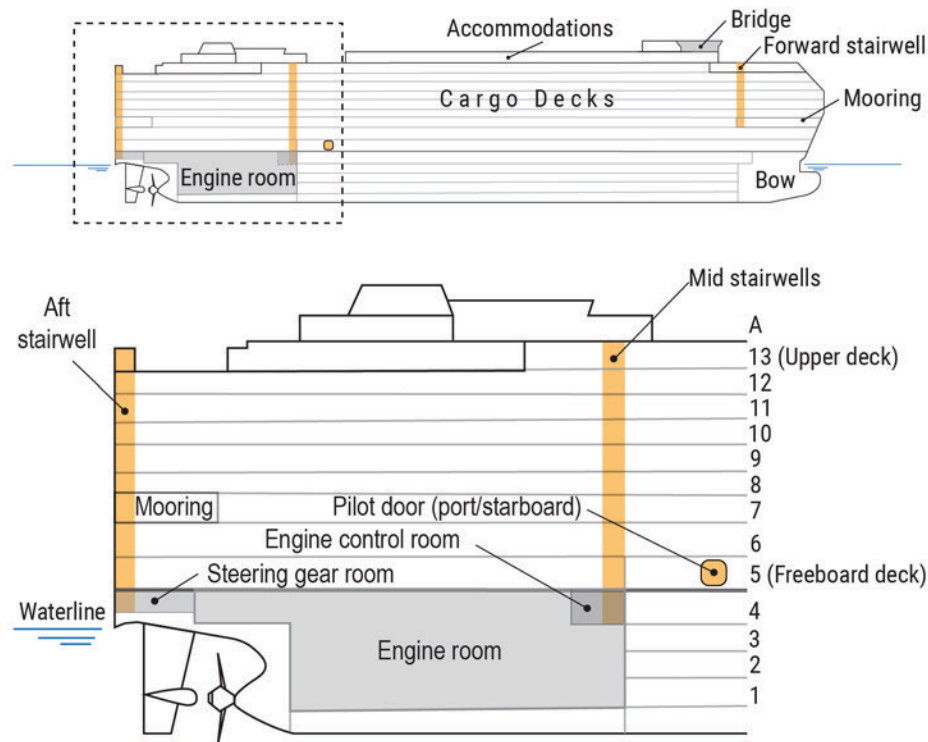
Figure 6. Simplified profile of the *Golden Ray* and 3-D diagram showing a portion of the engine room and engine control room. Exit doors shaded gray.

The NTSB also found that the open watertight doors on deck 5 of the *Golden Ray* allowed flooding into the vessel and blocked the primary egress from the engine room, thus trapping engineering personnel. Watertight integrity is critical to the safety of a vessel and its crew, so the NTSB recommended that G-Marine revise its SMS audit process to verify crew adherence to the company's Arrival/Departure Checklist regarding the closure of watertight doors.

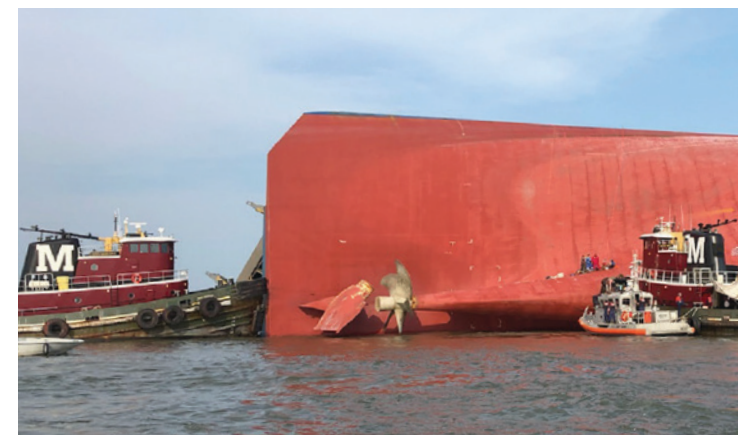
Figure 9. Emergency responders work to rescue the trapped engineers and cadet. SOURCE: COAST GUARD

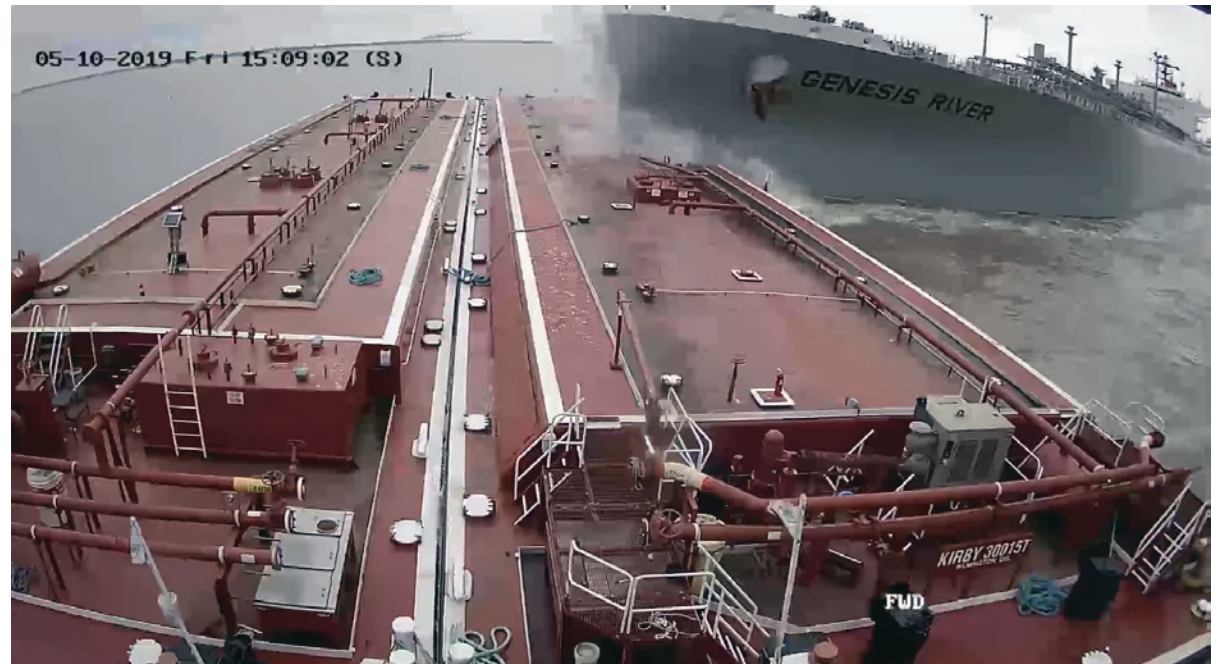
Figure 32. Screen capture from wheelhouse video on board the *Voyager* at the moment that the *Genesis River* struck the *Voyager* tow. SOURCE: KIRBY INLAND MARINE, LP

At 1516:09, the *Genesis River's* bow struck the starboard barge midship on the starboard side, penetrating through the double hull and breaching the no. 2 starboard cargo tank (causing reformat to leak) and capsizing the port barge. The Houston Ship Channel was closed to navigation for two days during response operations and did not fully open for navigation until May 15. The total cost of damages to the *Genesis River* and the barges was estimated at \$3.2 million. The cost of reformat containment and cleanup operations totaled \$12.3 million. There were no injuries reported.

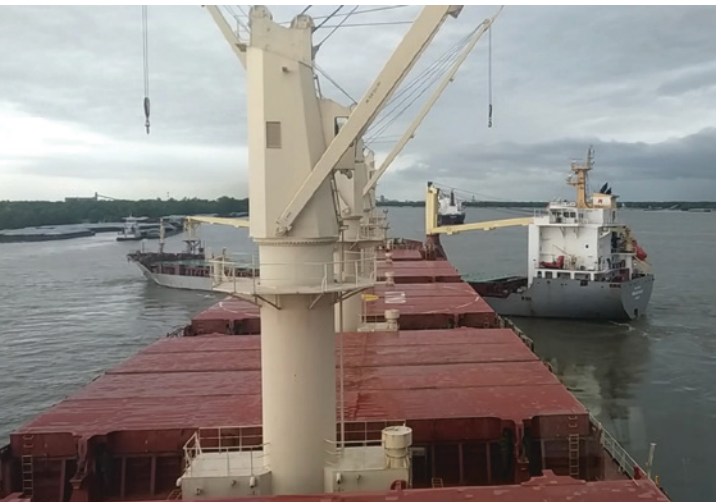
Figure 40. Image from video taken at 1701 from the bridge of the *Atlantic Venus* with the *Nomadic Milde* lying against its bow. SOURCE: ATLANTIC VENUS CREWMEMBER

At 1655, the port side of the *Nomadic Milde* collided with the bulbous bow and anchor chains of the *Atlantic Venus*. With the *Nomadic Milde* broadside to the current and pushing on the bow of the *Atlantic Venus*, both vessels moved towards the right descending bank and closed on a nearby chemical dock about 650 feet away. During efforts to assist the vessels, the *Nomadic Milde* struck the dock before grounding on the right descending bank.

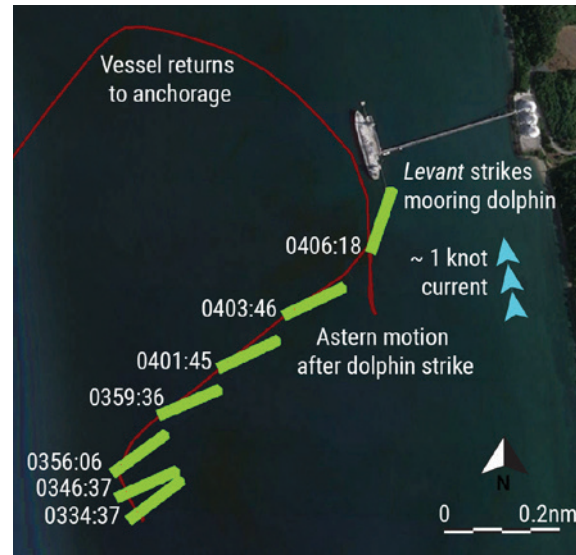
The probable cause of the contact of the liquid petroleum gas carrier *Levant* with a mooring dolphin at the Petrogas Ferndale Wharf was the pilot's approach with excessive speed and at too steep an angle, resulting from the pilot's and bridge team's poor bridge resource management.

Figure 70. The *Levant's* positions as it moved from the anchorage to the Petrogas Wharf, based on AIS data. Vessel scale approximate; vessel at pier was not present at the time of the accident.

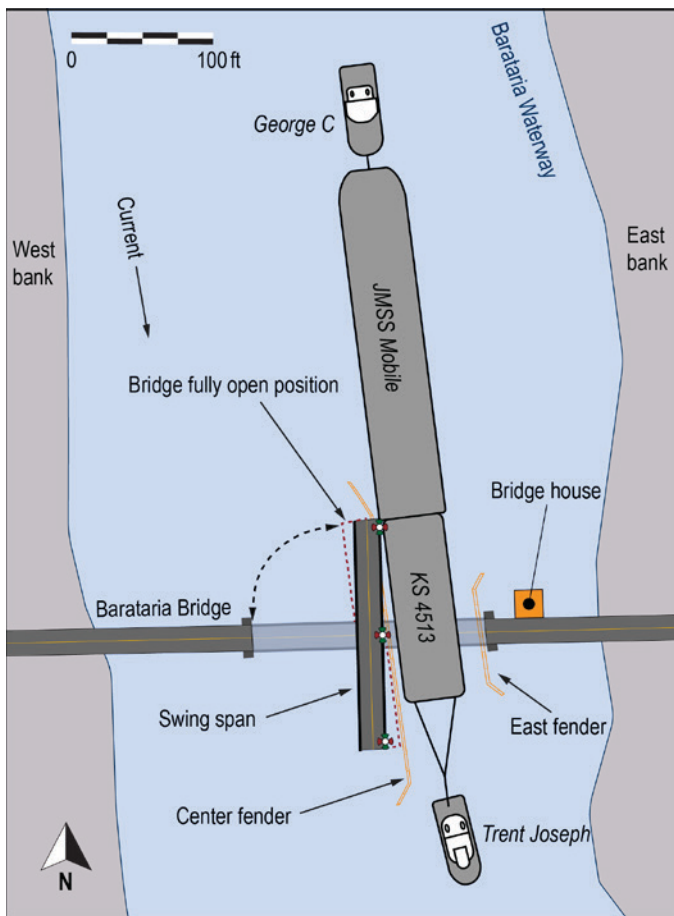
Figure 83. Estimated position of the *Trent Joseph* tow as it passed through the Barataria Bridge and approximation of the contact of barge *JMSS Mobile* with the northeast corner of the swing span. (Navigation lights not to scale.)

Photos taken at the scene and a postaccident survey report confirmed that the swing span's beam was struck by the aft port corner of the aft barge. By design, the protective fender was in place to shield the swing span from being struck when rotated to the open position. As such, if the swing span had been behind the fender as it should have been, the tow would have contacted the fender instead of striking the swing span. Although the fendering system contained previous damage, if the tow had contacted the fender, damage (if any) to the fendering would have been minimal due to the tow's low speed.

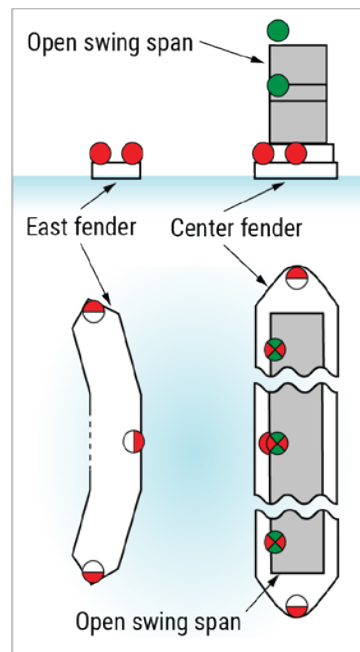
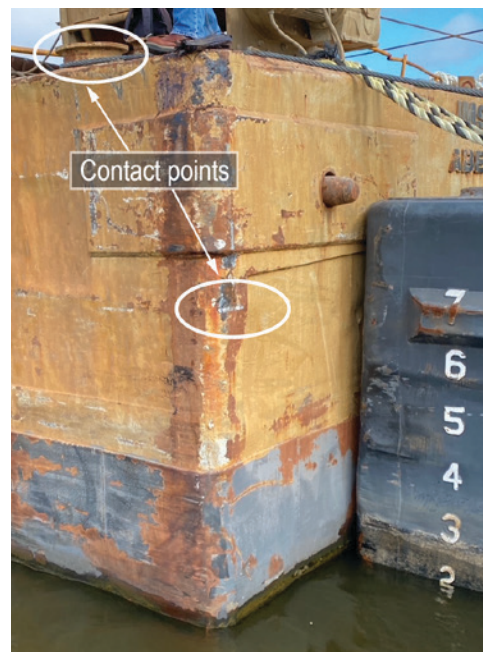
The probable cause of the contact of the tow of the *Trent Joseph* with the Barataria Bridge was a corner of the bridge's swing span protruding outside of its protective fendering into the navigable channel after recently attempted repairs to the limit switch system that controlled the swing span's rotation limit.

Figure 84. Left: Simple representation of fendering and swing span lighting; profile (top) and plan (bottom) views. BACKGROUND SOURCE: COAST GUARD. Middle and Right: Postaccident damage to the corner of barge *JMSS Mobile*, with damage markings and scrapes about 6 feet above the waterline, and to the northeast corner of the Barataria Bridge, with points of contact with the barge *JMSS Mobile* indicated. SOURCE: ANONYMOUS.

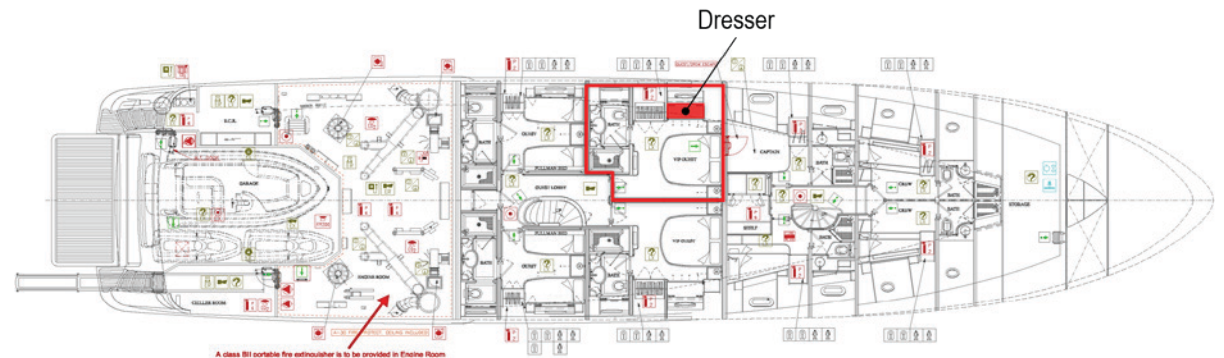
Figure 87. Plan view of the lower deck showing the dresser in the port VIP suite where the candles were lit. SOURCE: BENETTI FIRE & SAFETY PLAN

The postaccident fire report revealed the fire originated in the port VIP suite. As the *Andiamo*’s flag state warned, “leaving open flames such as...candles unattended” poses a fire risk. The candles also had not been secured on candle holders or any other type of secondary containment to ensure they would remain stationary, a precaution particularly important on a vessel likely to sway even within its berth. As the open flames burned, the curtains hanging above the dresser nearby likely provided the combustible material that started the fire. The vessel’s interior spaces were framed in wood with veneer, as well as outfitted and furnished with wood and other flammable materials, allowing the fire to spread upward.

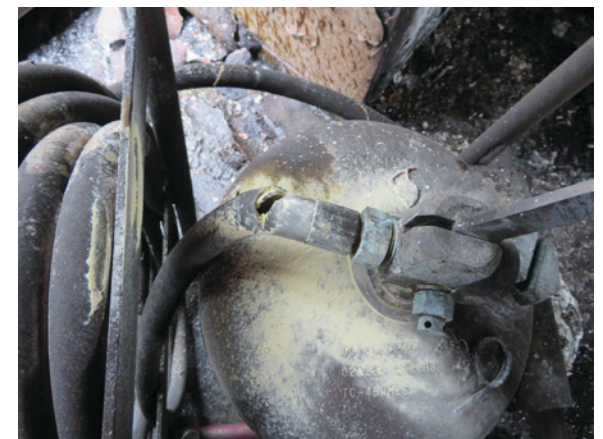
The doors from the weather deck to the engine room were closed since the vessel was under way, but the exterior windows were open for engine room ventilation. The crew was unable to close them due to heat and smoke from the fire. The steel door between the rudder room and the upper engine room was open, and fire spread aft to that space. The two semi-portable extinguishers, stowed on each side of the upper engine room, were the only means for the crew to fight the conflagration. However, the portside extinguisher was inaccessible due to the flames, and the hose on the starboard extinguisher failed proximate to the extinguisher.

Figure 91. Semi-portable extinguisher in starboard engine room following the fire.

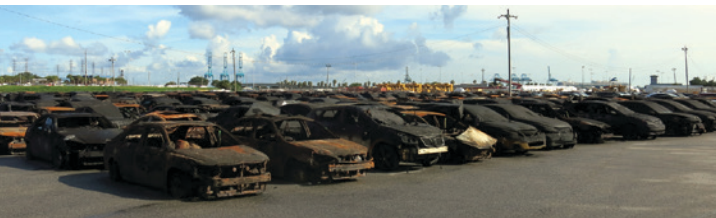
Figure 95. Thermally damaged vehicles after removal from the *Höegh Xiamen*, Blount Island, Jacksonville, Florida, July 23, 2020.

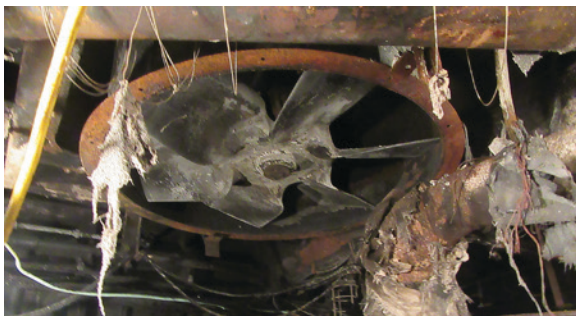
Figure 105. Starboard exhaust trunk fan (post-fire) located above the No. 1 generator. SOURCE: COAST GUARD

number one generator was directly under the starboard exhaust fan (which was secured) and had a fire cloth over it for protection from falling sparks that could come down the exhaust trunk. The shipyard foreman examined the generator room at approximately 0930 and determined that the space was safe, since there was no indication of fire or smoke.

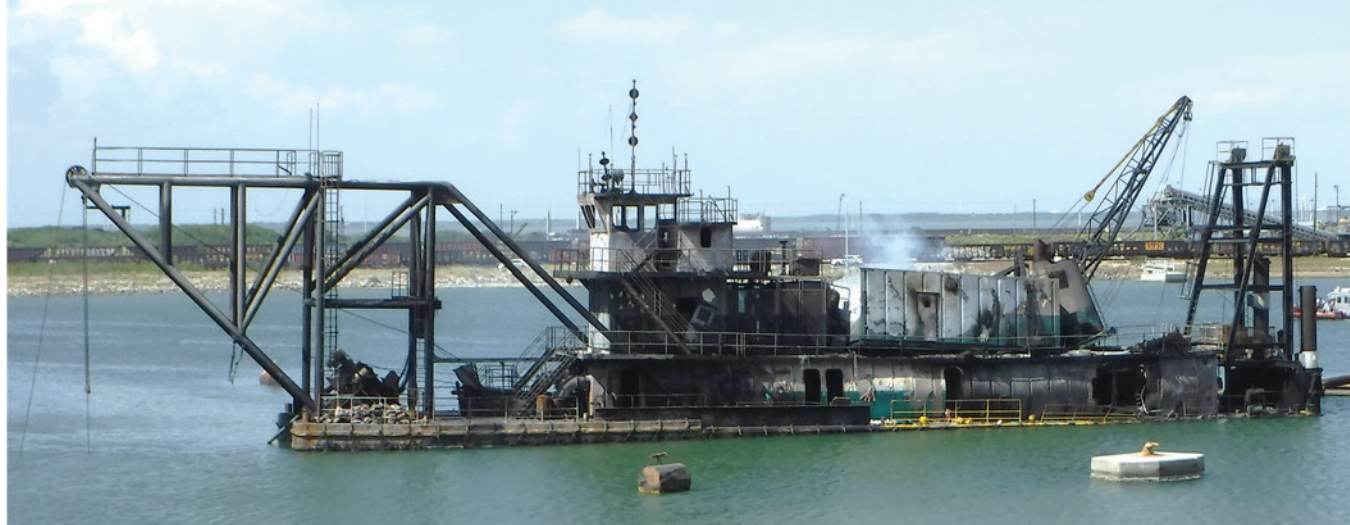
Figure 125. Post-fire photo of the *Waymon Boyd*, before sinking. SOURCE: COAST GUARD

On August 21, 2020, about 0802 central daylight time, the US-flagged dredge *Waymon Boyd* struck a submerged 16-inch liquid propane pipeline during dredging operations in Corpus Christi, Texas. A geyser of propane gas and water erupted adjacent to the vessel. Shortly thereafter, propane gas engulfed the vessel, and an explosion occurred. Fire damaged the vessel and surrounding shoreline. A total of 18 personnel employed by Orion Marine Group were working or resting on the dredge and assist boats (tender boats, anchor barges, booster barges, and a supply barge) on the day of the accident. Three crewmembers aboard the *Waymon Boyd* and one on an adjacent anchor barge died in the explosion and fire. Six crewmembers aboard the dredge were injured, one of whom later died from his injuries. The *Waymon Boyd*, valued at \$9.48 million, was a total loss. The cost of pipeline damage was \$2.09 million. The cost of physical damage to the EPIC facility was \$120,000.

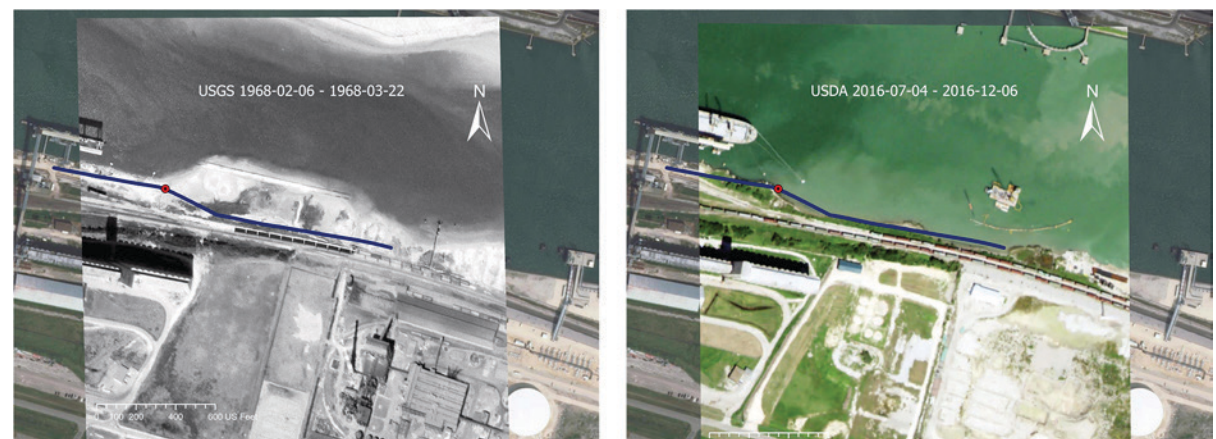
Figure 128. EPIC dock project area, 1968 and 2016, showing the extent of land loss. The blue line indicates the TX219 location, and the red circle is the approximate accident location. SOURCES: US DEPARTMENT OF AGRICULTURE [LEFT]; US GEOLOGICAL SURVEY [RIGHT]; PHOTOS GEOREFERENCED AND OVERLAID ON A MAXAR TECHNOLOGIES IMAGE.

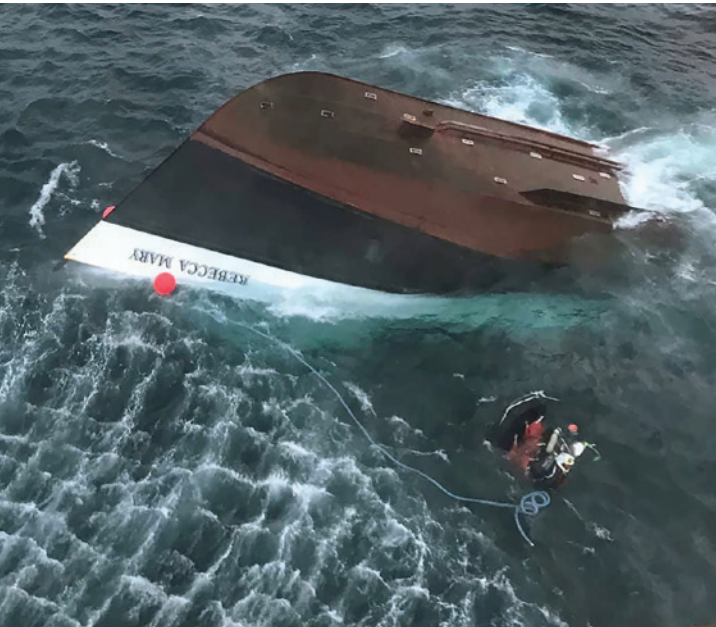
Figure 145. Inverted and mostly submerged *Rebecca Mary* during rescue operations on the morning of the sinking. SOURCE: COAST GUARD

The probable cause of the flooding and sinking of the fishing vessel *Rebecca Mary* was undetected flooding of the lazarette, likely through a non-watertight raised hatch.

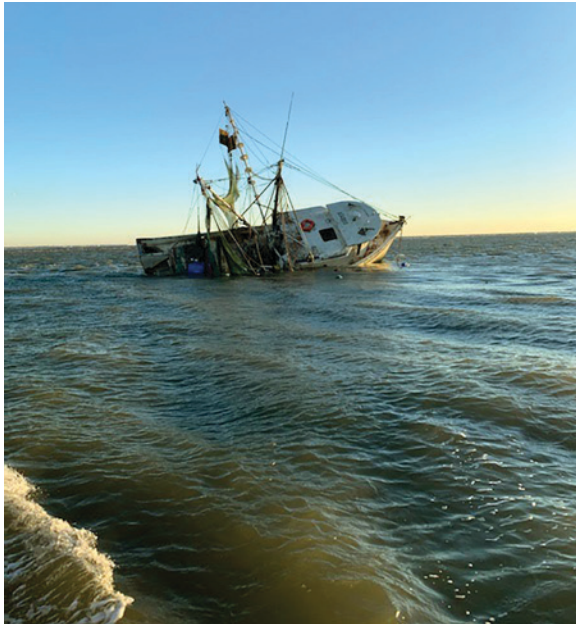
Figure 147. *Miss Annie* shortly after all three crew were rescued. SOURCE: COAST GUARD

The probable cause of the *Miss Annie* stranding and subsequent loss was the vessel striking an unmarked wreck, whose position had shifted from its previous known position and was yet to be charted or announced in the notice to mariners.
