# IIMS 2022 Safety & Loss Prevention Briefings Compendium

EDITION II

A COLLECTION OF WORLDWIDE MARINE INCIDENT AND  
ACCIDENT REPORTS, LOSS PREVENTION BRIEFINGS  
AND CASE STUDIES PUBLISHED IN 2022

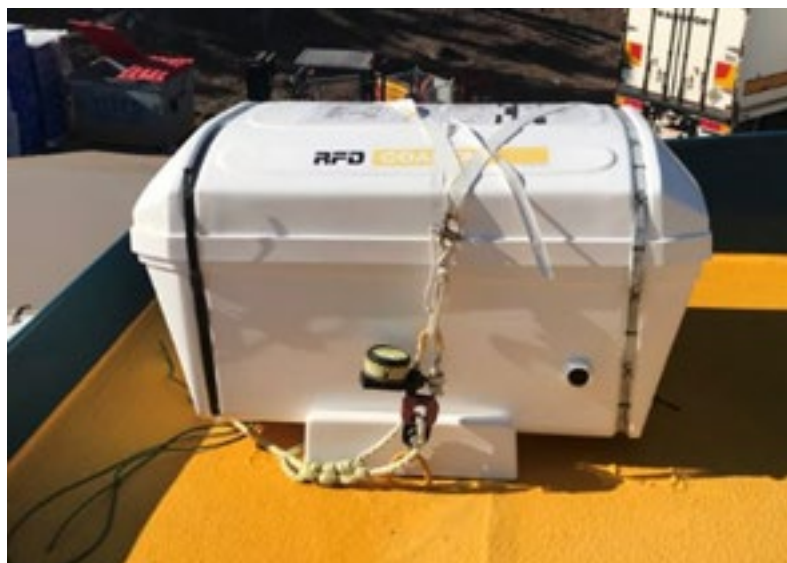
*Correctly fitted HRU on a life raft*

The HRU on a float-free EPIRB should be checked to ensure it is installed correctly. No additional lashings should be used on the EPIRB housing – this can prevent the housing cover from releasing when the HRU activates, stopping the EPIRB from floating free.

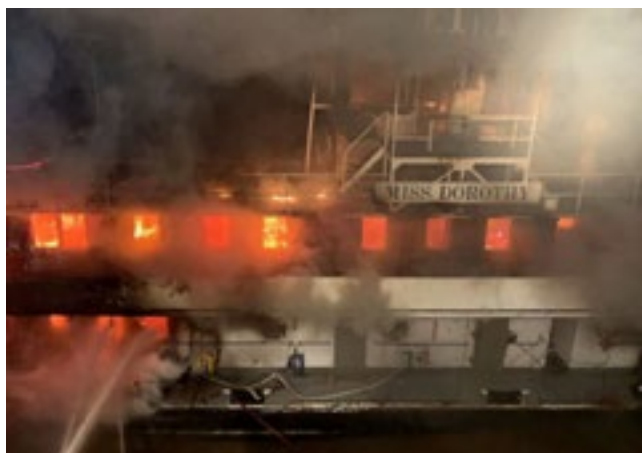
An engine room fire aboard a towing vessel started when diesel fuel spray hit an uninsulated section of the engine's exhaust system, the National Transportation Safety Board (NTSB) report has revealed.

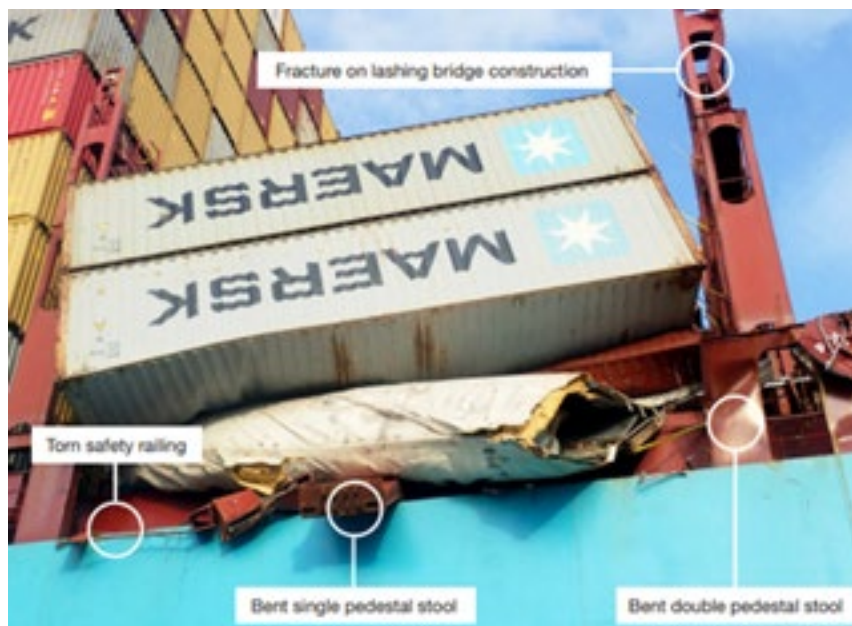
- [2] Lessons learned: Detecting the risk of parametric resonance rolling based on forecast sea conditions can be problematic as they are encumbered by uncertainty. No matter how automatised and detailed the onboard tools for monitoring parametric resonance are, they are prone to the uncertainty of the forecasts which makes them unreliable as tools, unless a broad risk margin is applied.

*Parametric rolling is the suspected cause of the loss of containers from Maersk Essen. Photo credit: DMAIB*

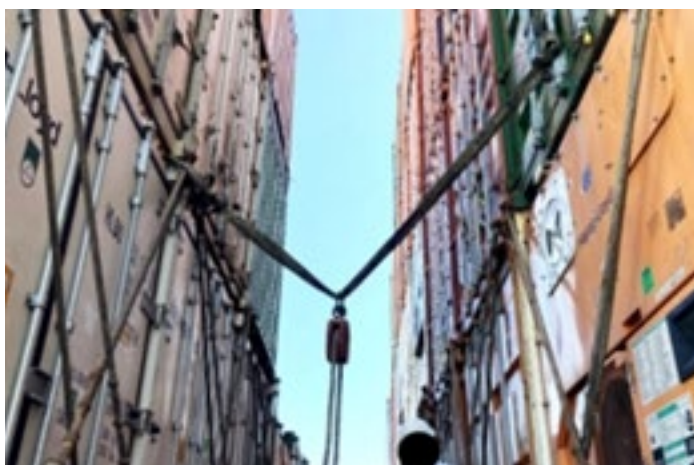
*Sling construction for evacuation via the access hatch (simulated on 19/10/2021). Photo credit: BSU*

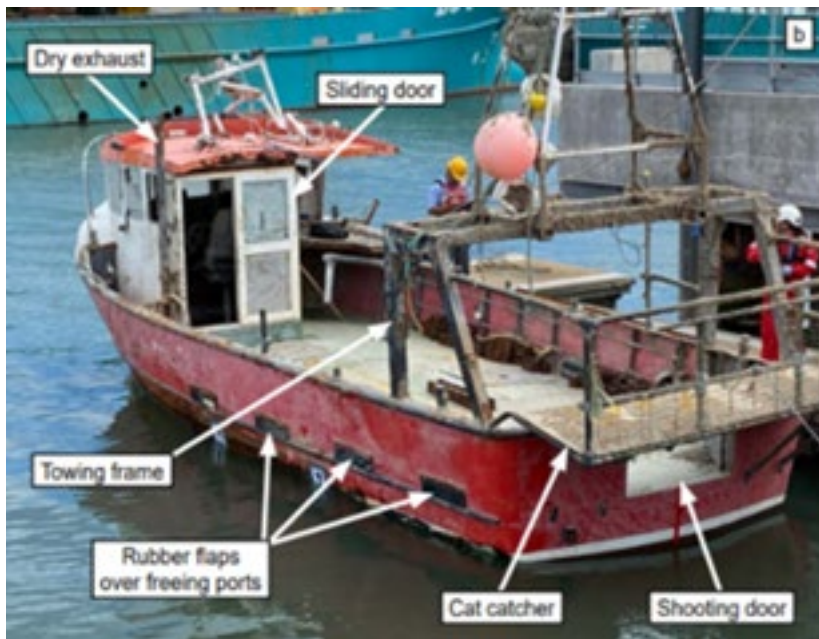
On 27 January 2021, the whelk potter Nicola Faith capsized and sank 1.9 miles north of Rhos-on-Sea, North Wales with the loss of its three crew members. The vessel had been extensively modified during its life which had significantly reduced its margin of positive stability. On the day of the accident the Nicola Faith had been loaded with catch and retrieved strings of pots to the point of instability, which resulted in the capsize and subsequently sinking of the vessel. Nicola Faith had not been fitted with a mandatory emergency beacon to alert to the capsize, and it was not reported as overdue until 1000 the next day. Following its salvage by the MAIB, a thorough inspection of the vessel was carried out to determine possible modes of capsize and a full assessment of its stability was undertaken.

*Whelk potter Nicola Faith*

- Nicola Faith was operated in an unsafe manner and was loaded with a combination of catch and retrieved fishing gear to the point of instability
- a mandatory Emergency Position Indicating Radio Beacon (EPIRB) was not fitted to the vessel and the crew were not equipped with personal locator beacons
- Nicola Faith was found to have been extensively modified; these modifications had eroded its margin of positive stability
- Maritime and Coastguard Agency surveyors had noted some of the modifications, however, the guidance concerning modifications that would have triggered a stability assessment was not sufficiently clear

Recommendations have been made to the Maritime and Coastguard Agency to (2022/125) amend the Code of Practice for the Safety of Small Fishing Vessels of less than 15m Length Overall, to revise the wording and refer to a load limit rather than a catch limit, and to (2022/126) review and enhance the guidance to surveyors to clarify what level of modification should trigger further investigation into a vessel's stability.

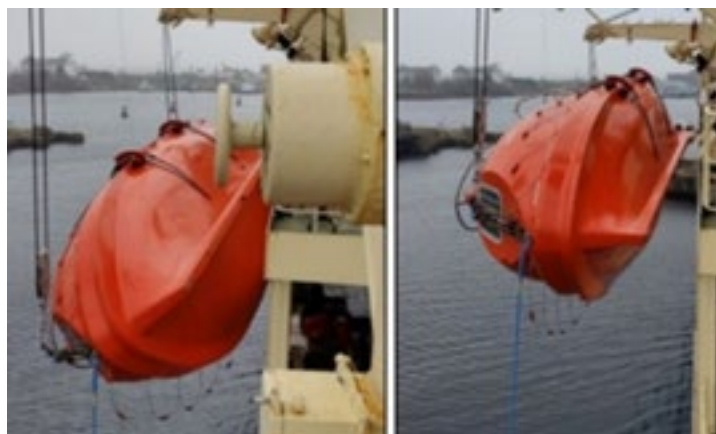
In fact, during a recent U.S. deep draft container ship inspection, a vessel's crew was lowering the lifeboat when the remote control wire arrangement caused two separate failures:

- The first occurred when the remote control wire parted as the lifeboat was being lowered to the waterline with crew on board. Causal factors included poor winch spooling potentially hidden under the outer spools, which led to a wire kink and winding on itself, creating enough force to part the wire.

- The second occurred a day later after the replacement remote control wire was hand spooled from extra wire found on board. While testing with crew on board using the remote control wire to lift the brake, an unexpected payout of wire led to the winch brake prematurely engaging, which made the lifeboat stop lowering and swing erratically above the embarkation deck. Seconds later, the movement caused the wire to regain tension, which lifted the winch brake arm and caused the lifeboat to lower again. While lowering in a swinging motion, the skeg of the lifeboat caught on the knife-edge of the ship's deck, causing the lifeboat to list more than 90 degrees. Without the quick action of a crewmember who activated the winch brake lever from the deck, the lifeboat could have inverted further and led to catastrophic outcomes.

USCG strongly recommends that ship's crew are visually inspecting lifeboat launching systems and test lowering thoroughly prior to operation with crew on board, paying special attention to the following inspection points:

- Verify the proper spooling of the remote control wire, expand inspection as necessary.
- Verify the proper position of the remote control wire weight. If the weight is very close to the top of the lifeboat, this may indicate the remote control wire is too long.
- Verify material condition of the shackle that connects the pull cable to the remote control wire within the lifeboat. These steel shackles can corrode in the elements and maybe overlooked during weekly/monthly/annual inspections.

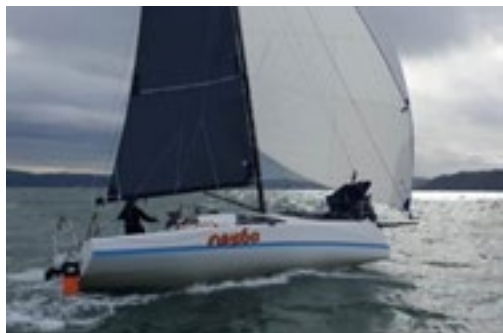
The crew of the first Farr X2 have been rescued after the boat lost its keel on an overnight offshore qualifier. Nexba Racing, a new 30ft grand prix racer aimed at the short-handed market, was sailing in a 100nm qualifier off the coast of New South Wales, Australia in a light to moderate breeze and 1-2m seas when the keel attachment failed resulting in the boat capsizing. The two female crew were rescued after spending 15 hours drifting. The 9.2-metre boat is the latest project from Farr Yacht Design. She was built in Singapore by XSP and launched in May.

"We take the safety of all the crews who sail on boats of our design very seriously and our design team is working with the builders, component suppliers and the composite structural engineers of to identify the root cause and to implement any necessary design, material or build process changes required to insure this cannot happen again," said Farr in a statement.

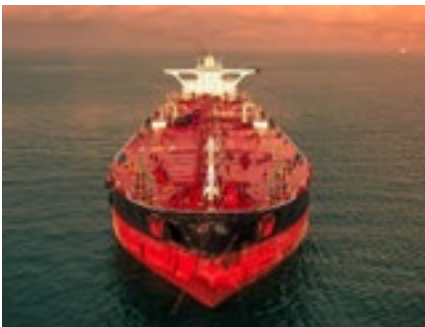
## Cargo claims from damage due to water originating from cargo hold bilge systems

The American Club has warned operators to be vigilant in light of a number of recent claims arising from damage caused by water originating from cargo hold bilge systems. Specifically, the American Club says:

- Debris lodges in the non-return valves fitted in the hold bilge pumping systems, preventing them from operating as designed to ensure that water cannot flow back via the bilge line, into the hold bilge wells and thereafter into the cargo hold;
- Manually operated valves in the interconnected bilge, ballast and fire lines are left open following completion of operations, allowing water to enter the bilge line and into the bilge wells/cargo hold in the event of non-return valve failure.

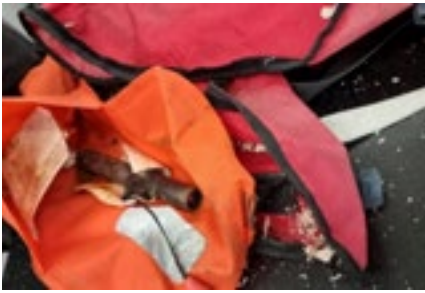
## RNLI Fowey finds over 50% of flotation devices faulty or condemned at a recent lifejacket clinic

A recent lifejacket clinic organised by Fowey RNLI found an astonishing 50% were faulty or condemned. The lifejacket clinic invited a team from Ocean Safety Ltd in Plymouth to carry out vital safety checks on a total of 169 lifejackets.

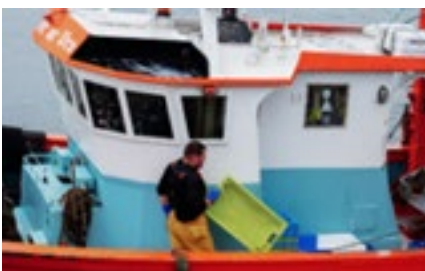
## USCG safety alert issues about dangerous gas build-up in fish holds

Following an incident, the US Coast Guard (USCG) had released a Safety Alert which addresses the importance of verifying atmospheric conditions in fish holds on commercial fishing vessels, that can lead to a dangerous build-up of gases.

Four crew members onboard a commercial fishing vessel noticed an unusual odor coming from the fish hold while conducting shrimping operations. While under the assumption that the odor was due to a leaking refrigerant line, the crew hauled in their nets and began transiting back to port to have their system inspected by a service technician.

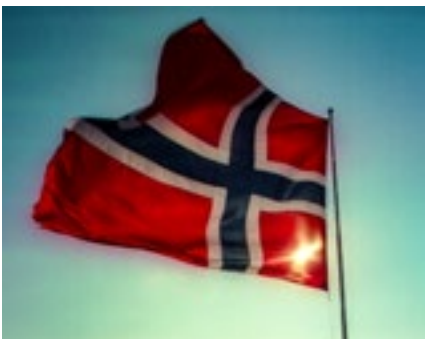
## Norway inspects vessels with battery installations with low IP rating

As a consequence of the Brim accident on 11 March 2021 and a preliminary report from the Norwegian Safety Investigation Authority, the Norwegian Maritime Authority is carrying out inspections on vessels with battery installations with a low IP rating of less than IP-44. These inspections are ongoing, with surveyors having detected salt in several battery rooms as a result of humid air or water intrusion.

The Norwegian Maritime Authority has received a report from a battery supplier pointing out that there is a significant risk of incidents involving systems that have a low IP rating and where the barrier system cannot prevent the intrusion of moisture, salt and possibly seawater into the battery room.

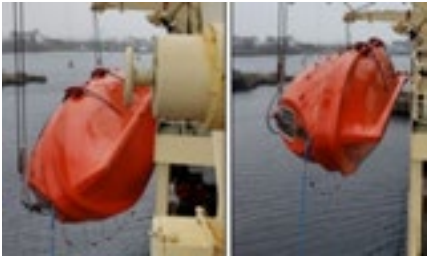
## Visually inspecting lifeboat prior to testing crucial

The US Coast Guard (USCG) has published a safety alert addressing the importance of visually inspecting lifeboat and davit installations prior to testing with crewmembers onboard and ensuring crew familiarity with company policy related to lifesaving equipment testing. As USCG said, the remote-control wire may be overlooked, yet weaknesses within the linkages or poor spooling of the wire itself can lead to catastrophic failures in the lifeboat launching systems.

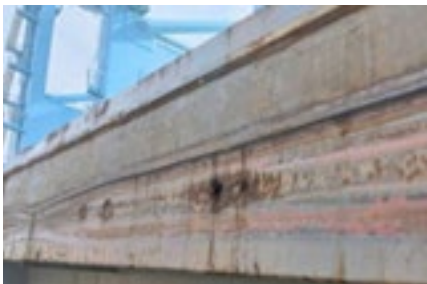
## Corrosion causes holes to ship's hatch covers

A vessel carrying containers was found to have several holes in its hatch covers as a result of corrosion. When the vessel arrived, it was discovered that one cargo hold had 12-14 inches (30-35 cm) of water at the aft end of the hold. Sixteen containers had water ingress. The cargo was not damaged in 4 of the containers, but in the other 12 containers, the cargo was declared a total loss. Several of those containers were loaded with consumer electronics. Several others had automotive spare parts. One had designer leather shoes.

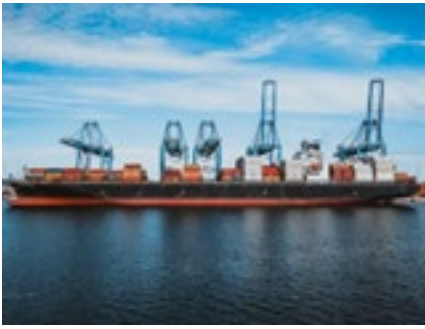
## Excessive container and cargo weight putting stress on containerships

According to Peter Peltenburg, CEO of Dutch-based Cargo Care Solutions, the weight of extra containers and cargo is placing massive amounts of stress on ships' hatch covers and lashing gear. Containership owners are placing more emphasis on the repair and maintenance of their hatch covers and container lashing equipment as the full loading caused by strong market conditions impacts the condition of their ships.

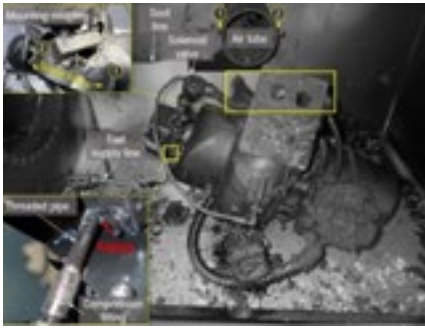
## Repeated removal and reinstallation of furnace's burner causes engine room fire

The NTSB determines that the probable cause of the engine room fire aboard the bulk carrier Roger Blough was likely the repeated removal and reinstallation of the furnace's burner that led to the failure of its mounting coupling, resulting in the operating burner dropping to the bottom of its enclosure and fracturing its fuel supply line, which allowed diesel fuel to ignite.

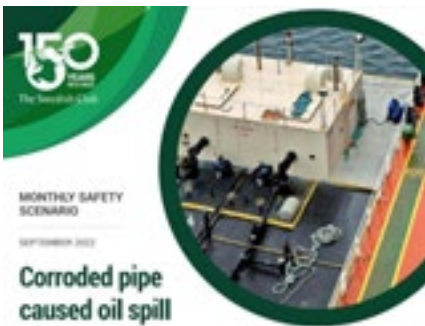
## Corroded pipe led to oil spill

In its latest safety bulletin, The Swedish Club has highlighted and analysed an incident involving a corroded pipe that caused an oil spill.

The 15 year-old bulk carrier was in dry dock completing its third special survey. As usual there were also many other maintenance tasks being carried out at the same time, including the replacement of a section of a de-aeration pipe in the cargo hold. The Chief Officer had discovered during a cargo hold inspection a month earlier that the de-aeration pipe appeared to be corroded. This pipe led from the sea chest, passing through the cargo hold, then through a heavy fuel oil (HFO) tank and finally out through the vessel's shell plate.

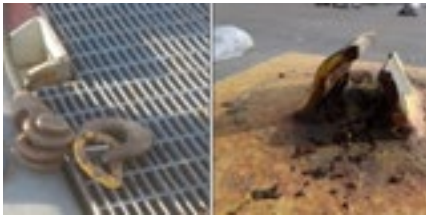
## Hidden corrosion can cause dangerous failures

The US Coast Guard has shared lessons learned from a marine casualty that resulted in a severe injury to a crewmember onboard a cargo vessel. The incident brought to light a dangerous and potentially fatal situation involving hidden corrosion on D-ring lifting points.

While positioning a removable hatch cover on the vessel, three of the four D-ring securing straps failed, causing an uncontrolled snap-back of the lifting sling assembly that struck the crewmember in the head. The three fractured securing straps showed similar failures with a significant amount of corrosion beneath the paint and on the underside of the straps. It is likely that just one D-ring failed initially, which would have instantly doubled the load on the two adjacent corner D-rings, both of which were apparently weakened and subsequently failed. Without proper and periodic inspection and replacement, corrosion and stress can eventually lead to deck fitting failures.

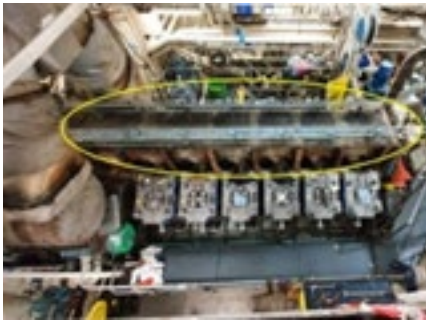
## Insulation panels contaminated with oil caused fire

Belgium's Federal Bureau for the Investigation of Maritime Accidents (FEBIMA) has released its investigation report into the fire that broke out on board TSHD UILENSPIEGEL resulting in damage to the engine room.

The fire was caused because insulation panels contaminated with oil were installed during the re-assembly of the main engine. In addition, insufficient control measures were in place to verify the condition of the insulation before installation. According to the report the oil ignited when the temperature in the exhaust line increased during the running in of the engine. In fact, the contamination with oil happened when the insulation was stored unprotected under a thermal oil line.

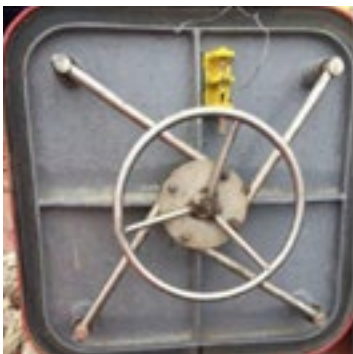
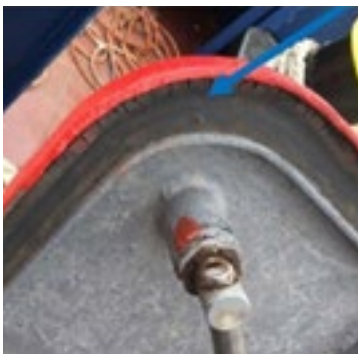
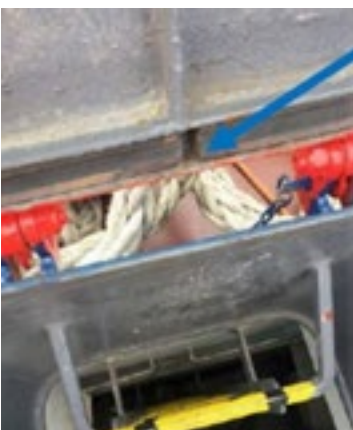
## Deteriorated seals on emergency hatch

During an inspection of a vessel as a part of the 5-yearly docking, deteriorated seals were found on a number of hatches. Preliminary investigation was conducted and after crew feedback, it was revealed that the crew had observed this unsafe condition some while ago, ordered and received new seals, but had continued to operate with no action, waiting for docking in order to replace deteriorated seals etc.

Hatch seals perform a vital role in a wide variety of marine applications. The hatch seal ensures that no liquid or gas is able to enter the vessel. After a period of use seals can deteriorate and become worn which reduces potential sealing properties. In this case, there was the risk of potential seawater leakage to the engine room had no action been taken.

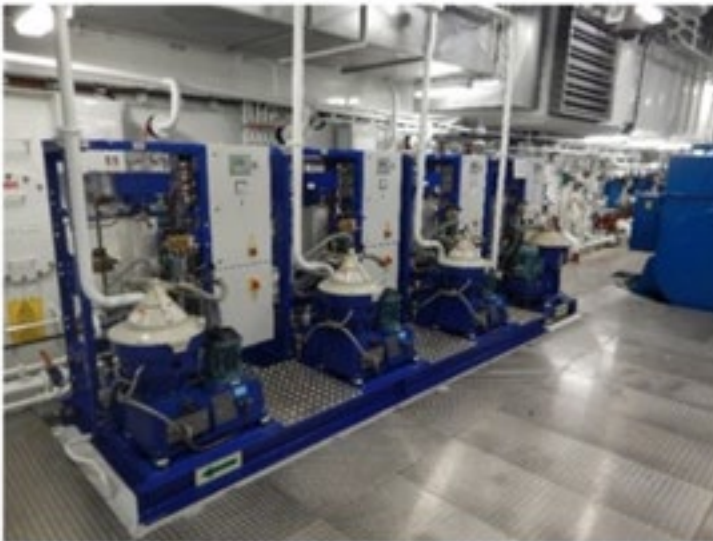
LO separator – MDO purifier rack

An engineer suffered a minor electrical shock while troubleshooting a faulty 690V electric motor. The engineer checked the drive belt and then proceeded to measure the phases. Measuring the phases was not in his initial plan when he prepared the troubleshooting. The incident occurred when he was measuring the phases.

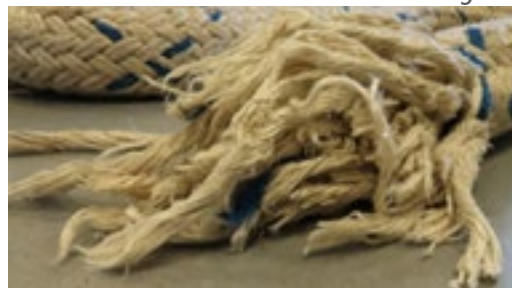
*A parted mooring line*

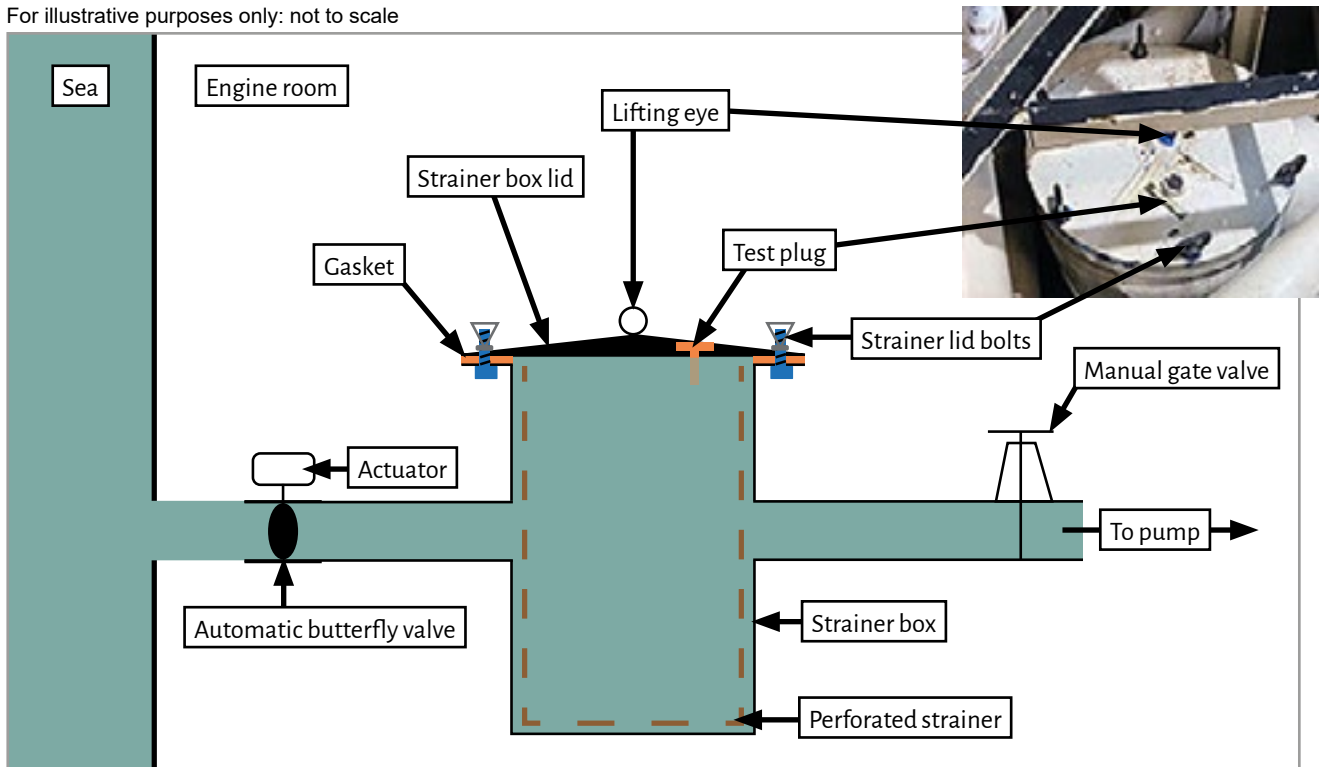
Figure 1: Ballast water valve and strainer arrangements

1. **Procedure** → The strainer lid was fitted with a test plug (Figure 1), provided to make sure the system was not still under pressure before the lid was removed. However, the engineers involved in this accident neither followed an approved procedure for the strainer clean nor opened the test plug and so were unaware of the faulty hull valve that meant the system was still open to sea pressure. Additionally, when they tried to remove the lid with a screwdriver, the absence of any leakage underpinned their assessment that the system was isolated.

After the accident, a technical investigation identified that the automatic butterfly hull valve was defective, and had remained partially open when indicated as shut on the ballast control panel. This investigation also found that the strainer was clean but that a ballast pump defect had caused the slow ballasting operations. The company has provided a revised safe system of work for strainer cleaning.

2. **Check** → Given that the hull valve indicated shut on the ballast control panel, it was reasonable of the engineers to assume this was correct. However, where there is doubt or, for instance, when reducing a system to single valve isolation to sea, it is good practice to visually inspect the valve's mechanical position indicator as well as checking its remote indication. A further precaution is to loosen the nuts, then use wedges to crack the lid open; if water floods out, the retaining nuts can be retightened to seal the strainer lid.

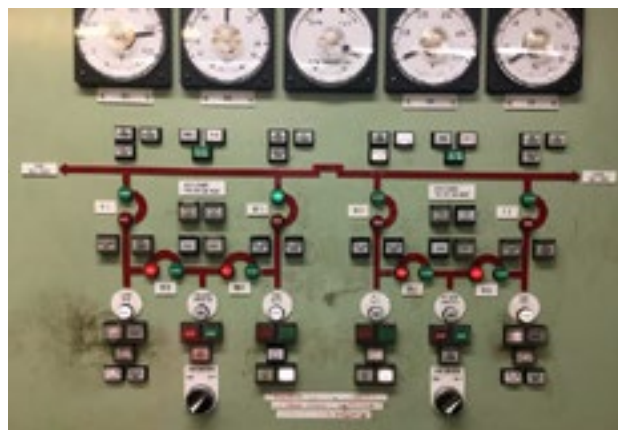
Figure 1: Main switchboard

the switchboard and manually disconnect the shaft alternator (Figure 1). During this operation, the first diesel generator engine tripped on low lubricating oil pressure and the vessel lost electrical power. The main engines continued to run for a few minutes before they stopped due to a lack of fuel pressure.

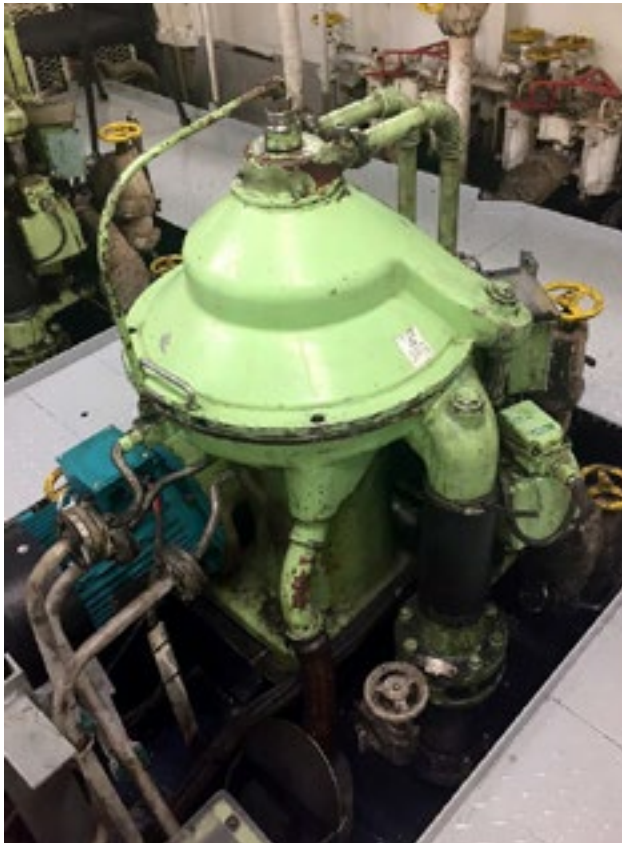
Figure 2: Lubricating oil purifier

3. **Maintain** → Conduct rounds. The low oil level in the generator was caused by a fault with the lubricating oil purifier cleaning the engine's oil. The purifier had started to dump the oil to a waste tank (Figure 3). Regular and comprehensive machinery rounds may have picked this up before the situation became critical.
4. **Qualified** → Check the system. The vessel's monitoring and alarm system had recently been upgraded but, due to incorrect wiring, a generator's low oil pressure alarm was indicated as the stabiliser room bilge alarm. Critical system warnings and alarms must be tested and verified as operating correctly on completion of monitoring and alarm system modification work.

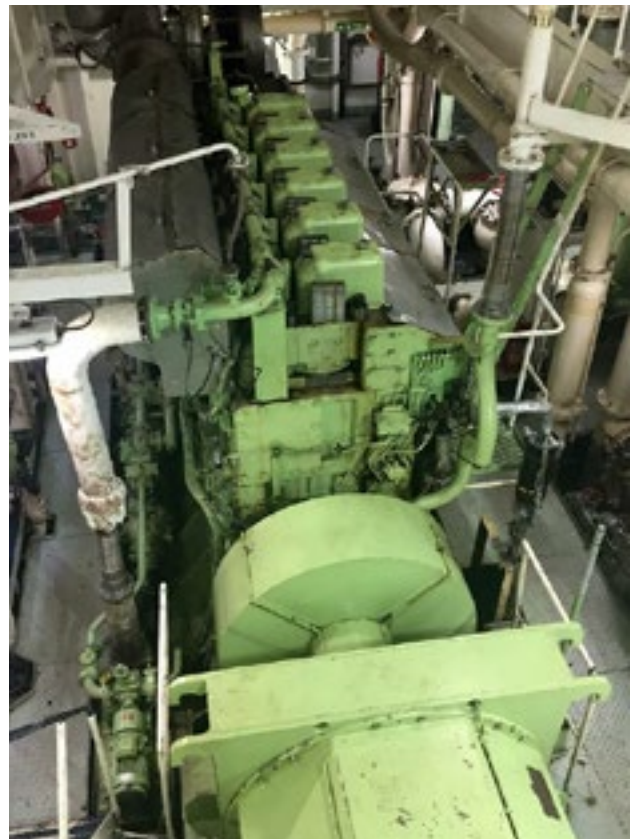
Figure 3: Diesel generator

oil level check may have indicated that there was a problem. The failure to start was associated with the low oil level in the sump; it is good practice to check running machinery before standby to ensure that potential critical failures are identified.

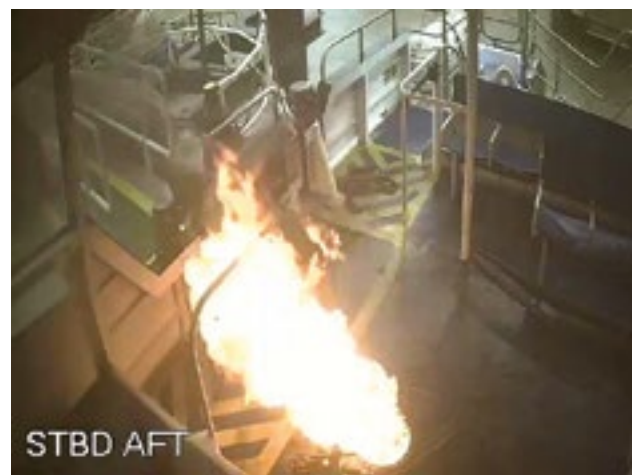
Figure 2: Flames emanating from the engine compartment hatch after reignition

Once the ferry was berthed, the local fire and rescue service boarded the vessel to take charge of the situation. Without liaising with the crew, one of the fire officers opened the access hatch to the starboard engine, causing rapid reignition of the fire with significant flames and smoke emanating from the compartment (Figure 2). This forced the fire and rescue team to retreat to gather their firefighting equipment and the fire was eventually extinguished by completely flooding the compartment with water. The reignition of the fire caused severe damage (Figure 3) to the engine and the starboard engine compartment, requiring extensive repairs.

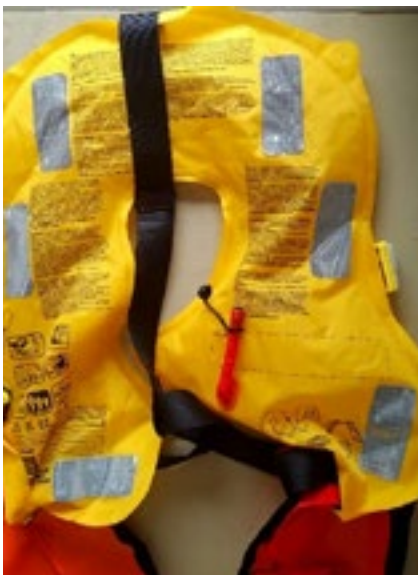
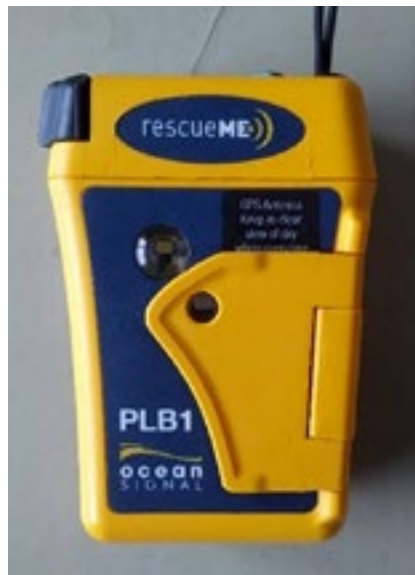
Figure: PFD and PLB used by the crew member

1. **Equipment** → PFDs save lives. The crewman was in the water for about 80 minutes before being rescued, which is a significant period of time to survive in seawater without lifesaving equipment. The PFD was absolutely crucial in keeping the crewman afloat, with his head out of the water; because there was no need for him to tread water to continue breathing, he could save his energy while awaiting rescue.

2. **Communicate** → PLBs also save lives. Because the crewman carried and activated a PLB, the coastguard was alerted to the emergency almost immediately and able to send rescue assets quickly. It is impossible to know the delay that would have been incurred had the alarm not been raised until the skipper realised he was alone; however, it is likely to have been significant. Importantly, a PLB transmits the distressed individual's position to the coastguard, which is vital for both a swift and effective search and the survival of the person in the water. A PLB is smaller than a mobile phone and a relatively inexpensive item of safety equipment that, in this case, undoubtedly contributed to the successful outcome of this rescue.

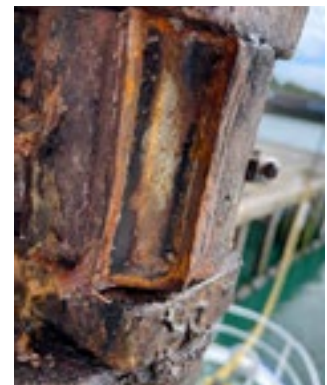
Figure 2: The failed weld on the gooseneck joint

The company investigation identified that the derrick had been inadvertently over-topped, resulting in too much force being applied to the topping wire. On examination of the fallen gear, it became clear that the force had caused the

welds on the port derrick lifting lug to fail (Figures 2 and 3). The lug had been supporting the weight of the derrick and the suspended gear so, when the weld gave way, the block, derrick, beam and fishing gear had come crashing down.

3. **Revise** → In this case, it would have been easy to just weld the lug back on and think nothing more of the accident. By more thoroughly examining what happened, the owner has produced a new lug arrangement that includes a preventer, fitted strain gauges and refined the lifting plan. Clear markings on the topping lift wire also indicate the safe working range. There is a lot to learn from every accident and near miss – taking the time and effort to do so pays dividends.

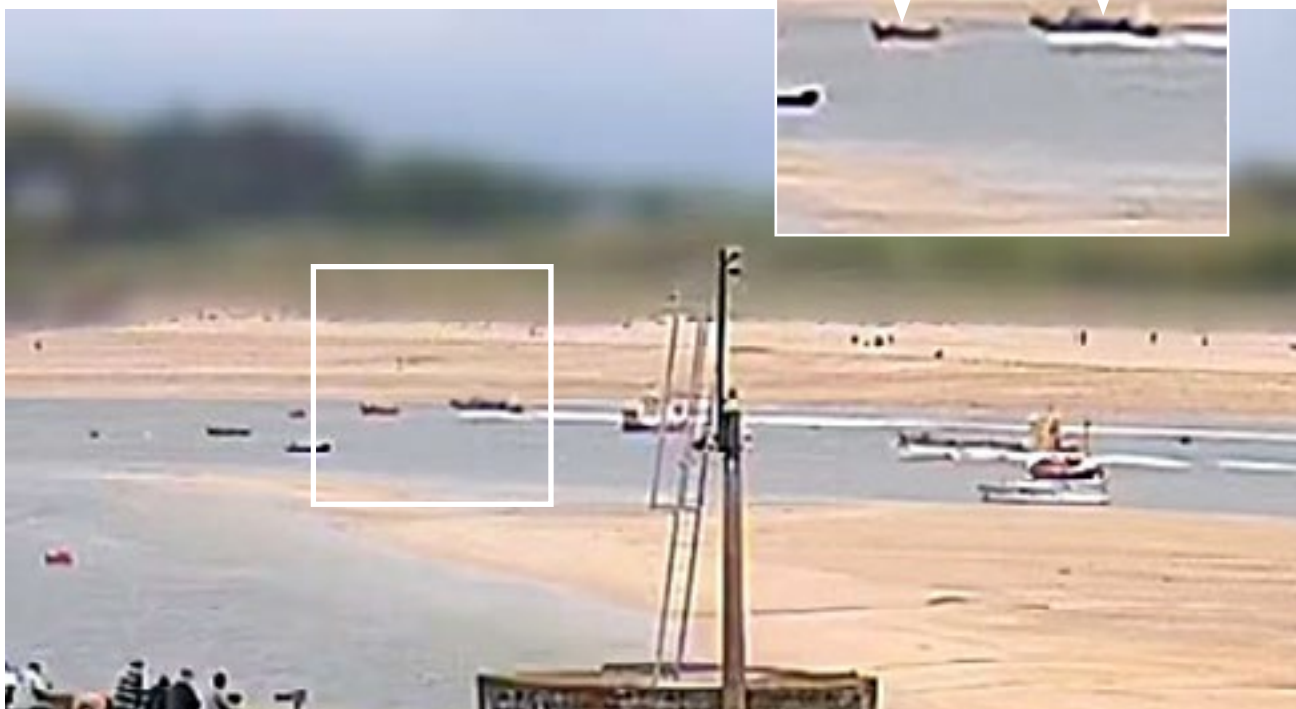
Figure 1: CCTV image just prior to the collision

ahead, the skipper put the outboard engines into neutral. However, this action came too late to prevent a collision with a small, unmanned tender tied to a nearby mooring (Figure 1). The tender was badly damaged (Figure 2) but there were no injuries to anyone on board the RIB.

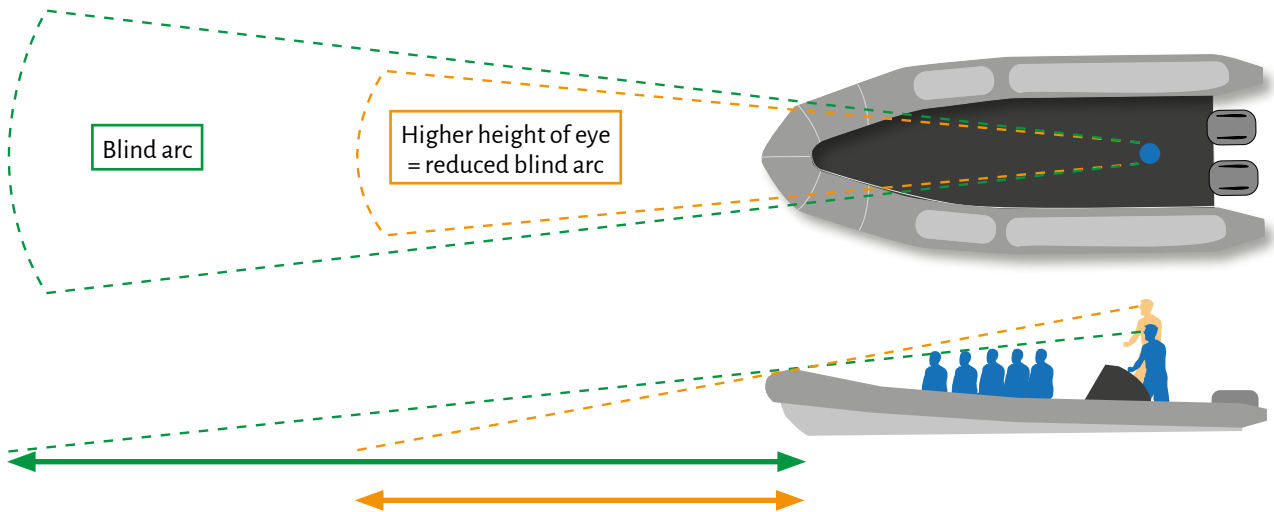
Figure 3: The effect on blind arc by raising the driver's height of eye

- Observe** → Integral to operating at a safe speed is keeping an effective lookout. RIBs, particularly those with the driving pedestal aft, may have a blind arc immediately ahead whose size will depend on several factors, including the boat's bow up attitude and the skipper's height of eye. Figure 3 illustrates the potential impact of raising and lowering the driver's height of eye, which RIB skippers should understand and manage. The company modified the RIB after this accident, raising the deck at the driver's position to improve visibility immediately ahead.

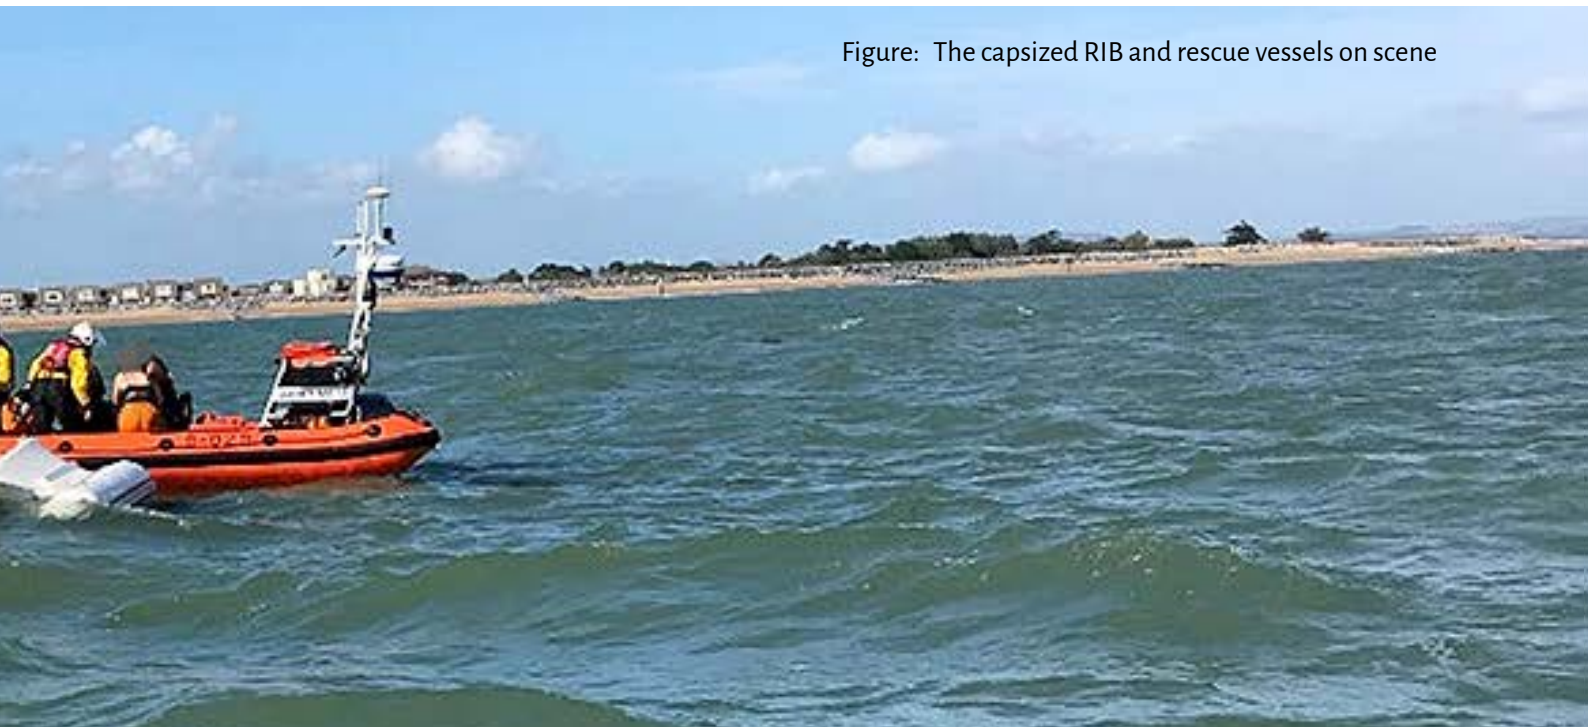
The skipper of a nearby yacht witnessed the capsize and called "Mayday" on VHF channel 16. The yacht stood by until rescue craft arrived but could not make an approach because of the shallow water and hazardous seas around the RIB. All members of the RIB group were recovered by a local rescue craft and taken ashore by the lifeboat for medical observation (see figure). Fortunately, although shocked, none of them were injured. The upturned RIB was towed back into the harbour and recovered.

Figure: The capsized RIB and rescue vessels on scene

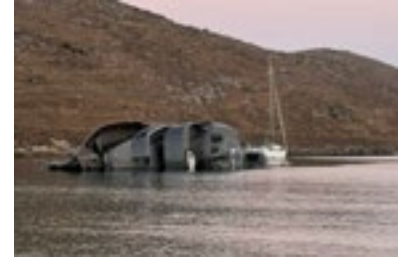
A 49m superyacht, named 007, capsized and is now semi-submerged in Greece, 15 metres off shore, awaiting recovery. According to the Hellenic Coast Guard, five passengers were rescued and no one was hurt. The incident took place at Kolona Bay, Kythnos. Media reports suggest that the superyacht ran aground, causing an inflow of water that gradually tilted the vessel.

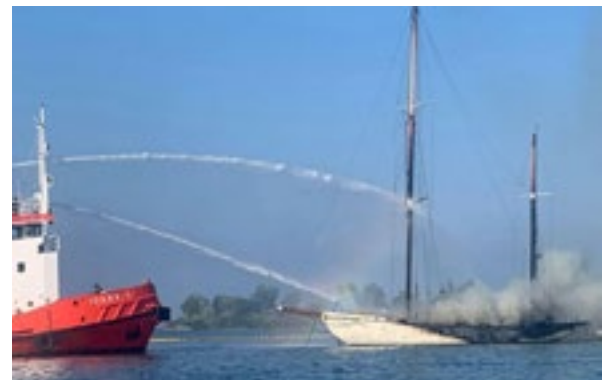
## 29m classic yacht catches fire in Corfu

A 29 metre (95ft) classic yacht known as Halcyon caught fire in Marina Gouvia, Corfu. No injuries were reported. According to local reports, the fire broke out on a 20m (65ft) sailing yacht and continued to spread to several other yachts in the vicinity. Other yachts involved in the fire included a sailing catamaran and a speedboat.

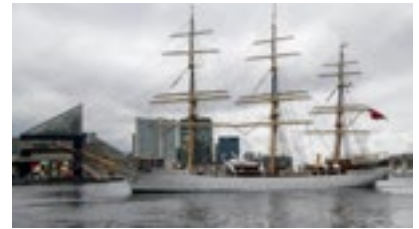
A Danish sail training ship sustained minor damage in an allision with the littoral combat ship USS Minneapolis-Saint Paul at a pier in Baltimore, Maryland. According to local media, the Danish training ship Danmark was under tow by two tugs when she struck some pilings alongside the pier. The Danmark then carried on and made contact with the hull of the Minneapolis-Saint Paul.

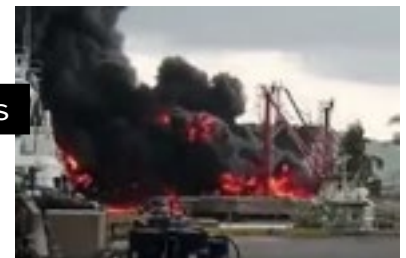
A Venezuelan oil terminal experienced fire after a loading hose broke while a tanker was being loaded. The incident took place at the Guaraguao facility in Puerto La Cruz. According to press agency Reuters, the product carrier Larko was being supplied with oil at the time, and it was also affected by the incident.

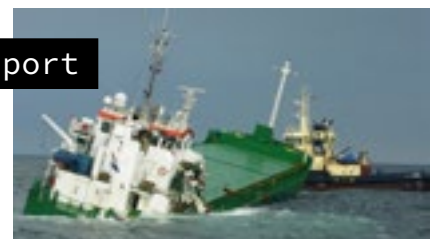
Denmark's Marine Home Guard was able to salvage the general cargo ship that was involved in a North Sea collision and tow the vessel to port. The 5,000-dwt general cargo ship Helge had initially been feared lost after the collision with its crew abandoning ship to be rescued by the Danish Navy. When the Marine Home Guard reached the Helge they found the vessel had remained afloat despite the original expectations that it was sinking. They reported that weather conditions had improved dramatically since the morning when the vessel collided. The Danish tug Sigyn arrived and together they completed a survey of the vessel and were joined by a salvage team airlifted out to board the vessel.

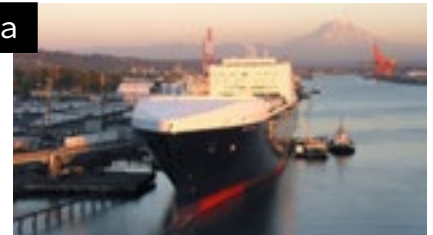
A fire broke out on the upper deck of the TOTE ro/ro *Midnight Sun* at her homeport of Tacoma, Washington. At about 1920 hours, local authorities received notice of a fire aboard the vessel. By the time fireboats and fire engines arrived on scene, the ship's crew had extinguished the fire using the fixed firefighting system. No injuries or pollution were reported.

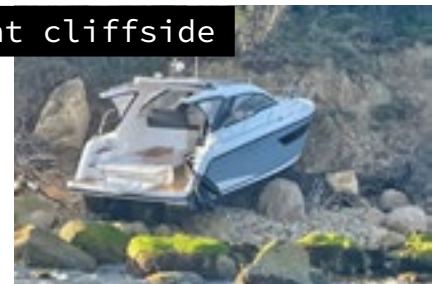
Police said enquires are ongoing to determine the exact circumstances surrounding a boat ploughing into the cliffs at Totland Bay, Isle of Wight. According to Yarmouth RNLI, the 30ft motorboat had hit the rocks west of Totland bay with casualties sustaining multiple injuries. The RNLI's casualty care crew landed on the beach where the crew assessed the injured casualties onboard. There were found to be four walking wounded and two more serious injuries within the group.

The four-walking wounded were transferred to the ALB and taken to safety. The Coastguard Rescue helicopter flew the other two to the mainland for treatment. On return, the ALB crew secured the casualty boat as the boat had sustained considerable damage and checked for any pollution/debris in the surrounding area of the beach and water.

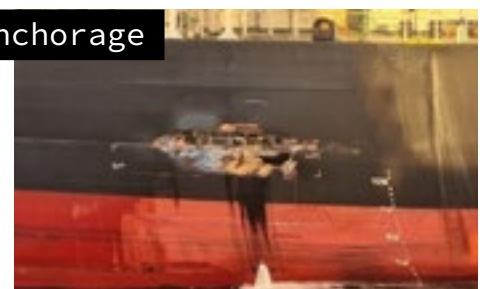
The Netherlands Coastguard and the Maritime Police attended at the scene of an allision that took place in the busy IJmuiden anchorage off the coast of the Netherlands. The authorities reported that a small oil leak from the tanker has been stopped while they continued to investigate. The product tanker *Golden Daisy*, which was at anchor, reported that it had been struck by a vessel which was later identified as a fishing vessel the *ARM 18 Joris Senior*. No casualties were reported.

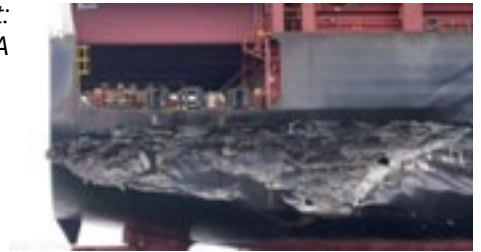
Two ships, a tanker and a containership, collided along the Malacca Strait with reports of serious damage to both vessels. The Zephyr 1 Aframax tanker rammed into the rear of the 7,455 teu GSL Grania boxship between Malaysia and Singapore. According to local reports both ships require extensive repairs.

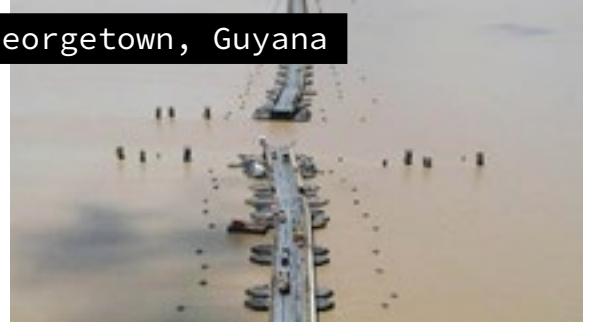
The bridge across the Demerara River near Georgetown, Guyana has been damaged in an allision, the bridge operator said. The product tanker Tradewind Passion was transiting the river when it collided with the open bridge. AIS data suggest that the vessel passed the bridge at about 0200 local time, then continued upriver. She reversed course and returned to a fuel pier near the bridge.

Multiple spans of the floating bridge were pushed about three feet out of position when the tanker struck, and an engineering team was working 24 hours a day to bring them back into the proper position. Nicholas Henry, a structural engineer with the Demerara Harbour Bridge Corporation, told Guyana's public information bureau that his team hoped to have the bridge reopened for light traffic within three days.

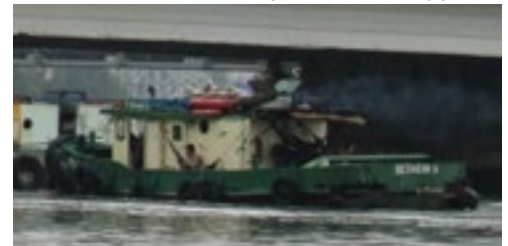
Local good Samaritans rescued the eight-man crew of the tug *Betheva 2* after it sank off Golo Island, about 70 nm to the southwest of Manila. As the *Betheva 2* was transiting past Golo on a trip from Manila to Palawan, the tug took a large wave over the stern. The water flooded the engine room, according to her captain, and the vessel quickly sank. All crewmembers managed to abandon ship.

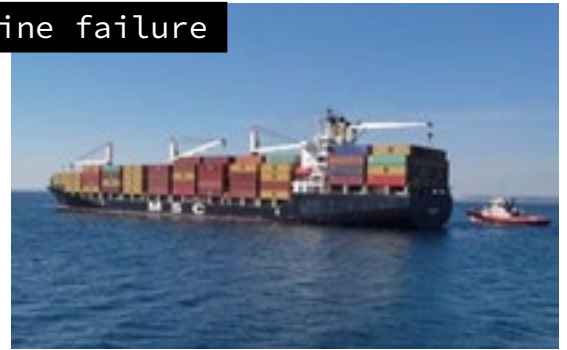
MSC containership Malena experienced an engine failure in front of Canakkale in the Turkish Dardanelles Strait. The incident took place while the 2,503 TEU vessel was heading to Italy from Tekirdağ, Turkey. Upon being notified of the incident, the Canakkale Ship Traffic Services Centre launched rescue efforts with two tugboats. The ship was safely anchored in Dark Harbor, Gulf of Erenköy's midpoint in southern Dardanelles.

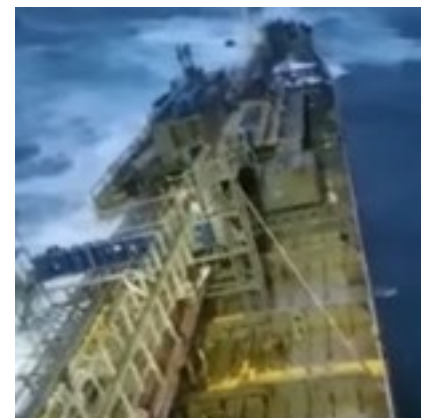
One seaman died on a South Korean Flag vessel KELSEY 2 after it sank in Taiwan. 10 others were rescued. The ship was en route from Hong Kong to the port of Gunsan, Korea, sailing at a speed of 7.1 knots. Tanker with GT of 5,328 was considered to be in loaded condition, carrying a cargo of oil and chemicals. According to preliminary reports, the crew reported water ingress in the aft section area in the engine room the evening before the ship sank.

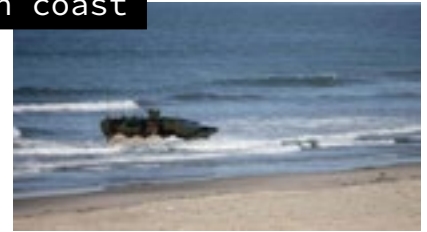
A new U.S. Marine Corps Amphibious Combat Vehicle (ACV) flipped over in surf during an exercise at Camp Pendleton, California, adding to the list of recent incidents with the service's amphibious vehicles. Due to a "reported mechanical malfunction," the ACV tipped over in the surf zone during a beach landing. The three crewmembers inside were not harmed, but to prevent further incidents, the service has temporarily suspended ocean beach landing and launch operations. Training will continue on land and on sheltered waters.

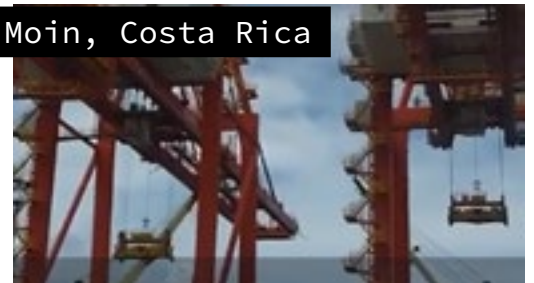
A geared bulker struck an STS gantry crane at Puerto Moin, Costa Rica. The bulker Irma arrived at Puerto Moin and berthed at a breakbulk terminal on the port's small commercial quay. AIS data provided by Pole Star shows that she remained there until 1100 hours when she got under way to the south as though planning to shift berths.

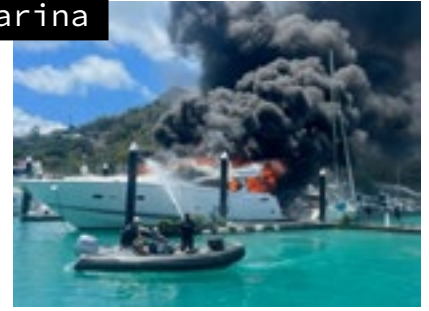
Dramatic images show a Sunseeker 82 yacht engulfed in plumes of thick black smoke at Hamilton Island marina in Queensland, Australia. The 25-metre luxury yacht was understood to be named Time Out.

Queensland Ambulance reports that paramedics rushed to the scene shortly after. Police say that nobody was on board at the time the fire broke out. A man in his 40s and a man in his 60s have been assessed for smoke inhalation, according to broadcaster ABC, with no other injuries reported.

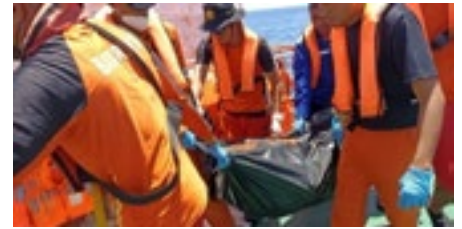
The ferry "Express Cantika 77" caught fire in the waters off southwest Timor, near Batek island, Indonesia. The ferry was carrying 177 people on board while en route from Kupang to Kalabahi, Indonesia. The ship was quickly engulfed in flames, while the search and rescue agency of East Nusa Tenggara deployed inflatable boats and more than 50 rescuers to evacuate 167 passengers and 10 crew. A total of 17 people have been confirmed as dead.

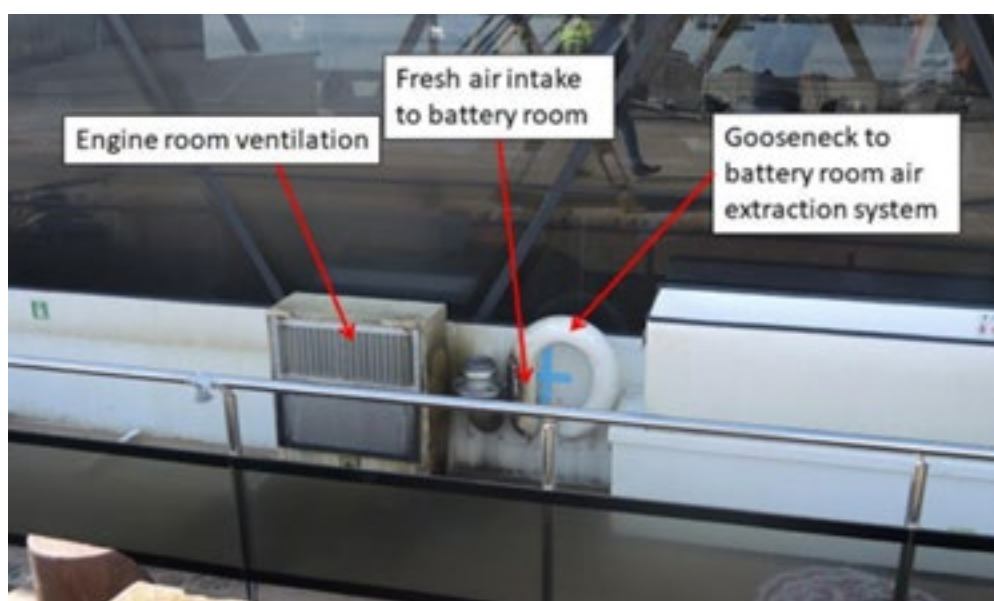
*'There was no camera surveillance of the battery room. The presence of a camera might have helped the crew to dispel the incorrect perception that it was the engine room that was on fire. The DNV's updated classification rules from 2021 recommend camera surveillance of battery rooms to improve the crew's situational awareness, in addition to gas monitoring for early detection of gases before they develop into smoke.'*

Ventilation for engine room and battery room on starboard side of 'Brim'. Photo: NSIA
