# IIMS 2022 Safety & Loss Prevention Briefings Compendium

EDITION II

A COLLECTION OF WORLDWIDE MARINE INCIDENT AND  
ACCIDENT REPORTS, LOSS PREVENTION BRIEFINGS  
AND CASE STUDIES PUBLISHED IN 2022

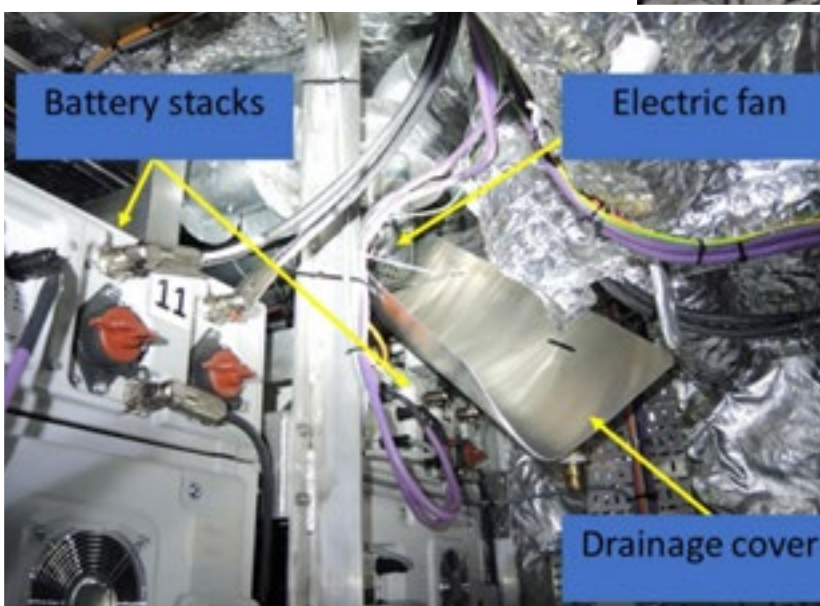
Electric fan above battery stack 12 with temporary drainage cover installed in port battery room to lead water away from the battery system. Photo: NSIA

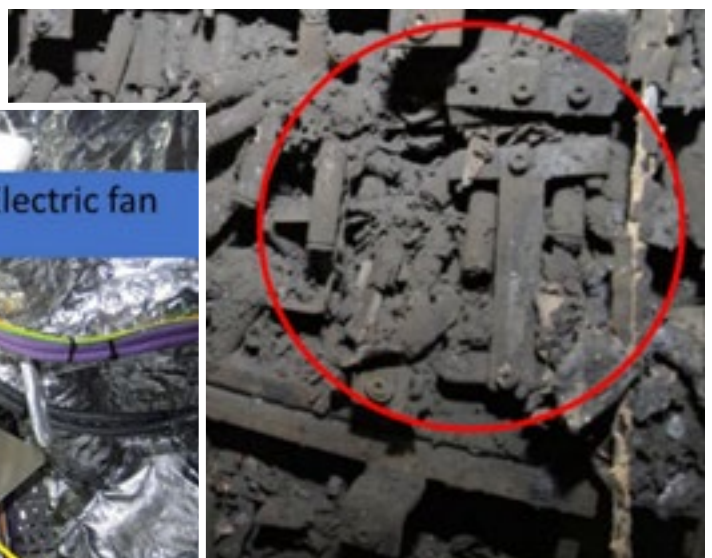
Remnants of battery module 2 in battery stack 6, with the copper strip encircled in red. Photo: Kripos

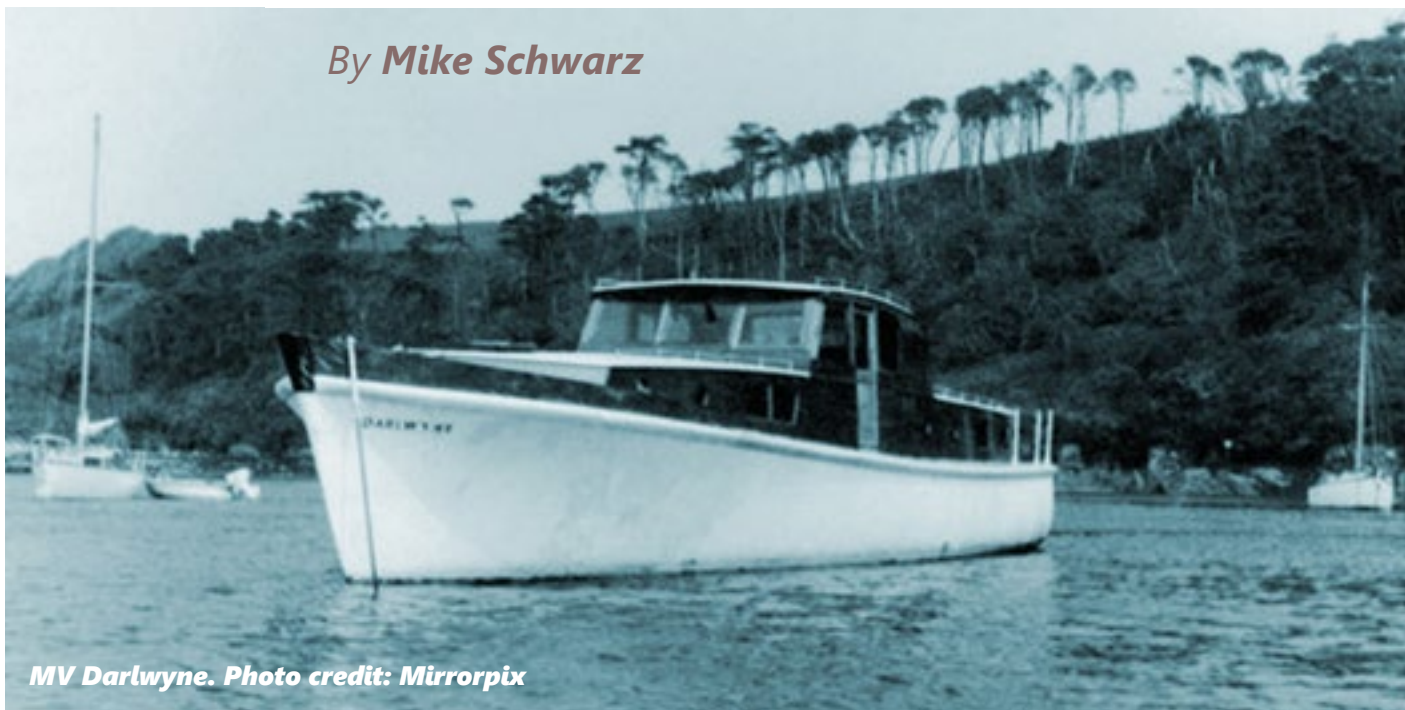
*MV Darlwyne. Photo credit: Mirrorpix*

On 20 July 1966, at the request of Barratt's daughter, Darlwyne was again examined by marine surveyor George Corke, who found the boat in generally poor condition. Among the faults he listed were dry rot, a weakening of the hull caused by the removal of various supporting frames, and signs that the hull had been "pushed in" below the waterline. Corke's report reiterated his earlier view that Darlwyne was presently unfit for work in the open sea. This report was sent not to Barratt but to the family's solicitors, where in the days that followed it lay unread; there is no indication that Barratt was aware of its contents before 31 July.

Evidence of Darlwyne's history confirmed Barratt as its legal owner. The court noted the general state of the vessel and the various alterations that had been carried out, affecting its seaworthiness. In particular, the cockpit floor was not watertight and had inadequate scuppers, so that water entering the cockpit drained into the lower hull rather than back into the sea. Lacking watertight bulkheads, the hull would easily flood with any rapid ingress of water. The hull itself showed evidence of dry rot and other external damage. Poor communication between the various parties concerned with the vessel in the preceding months meant that these various shortcomings had been overlooked or ignored. Furthermore, the overloading of the vessel with 31 people meant that it lay low in the water, so that a modest heel of 30 degrees would allow water into the open cockpit.

In determining responsibility for Darlwyne's loss, the court was "satisfied that the major cause of the disaster was the Darlwyne going on a voyage to sea when she was physically unfit to withstand the normal perils which she might expect to meet". Culpability was shared between Bown and Barratt, the former for taking passengers to sea in an unfit boat, the latter for failing to warn his "agent or servant" of the vessel's unfit state. Barratt was severely censured by the court and ordered to pay £500 towards the cost of the enquiry. Barratt considered the court's findings as related to him were "rather unfair", while Bown's widow defended her late husband as a competent and experienced skipper.
