THE SWEDISH CLUB CASEBOOK

Contents & Introduction

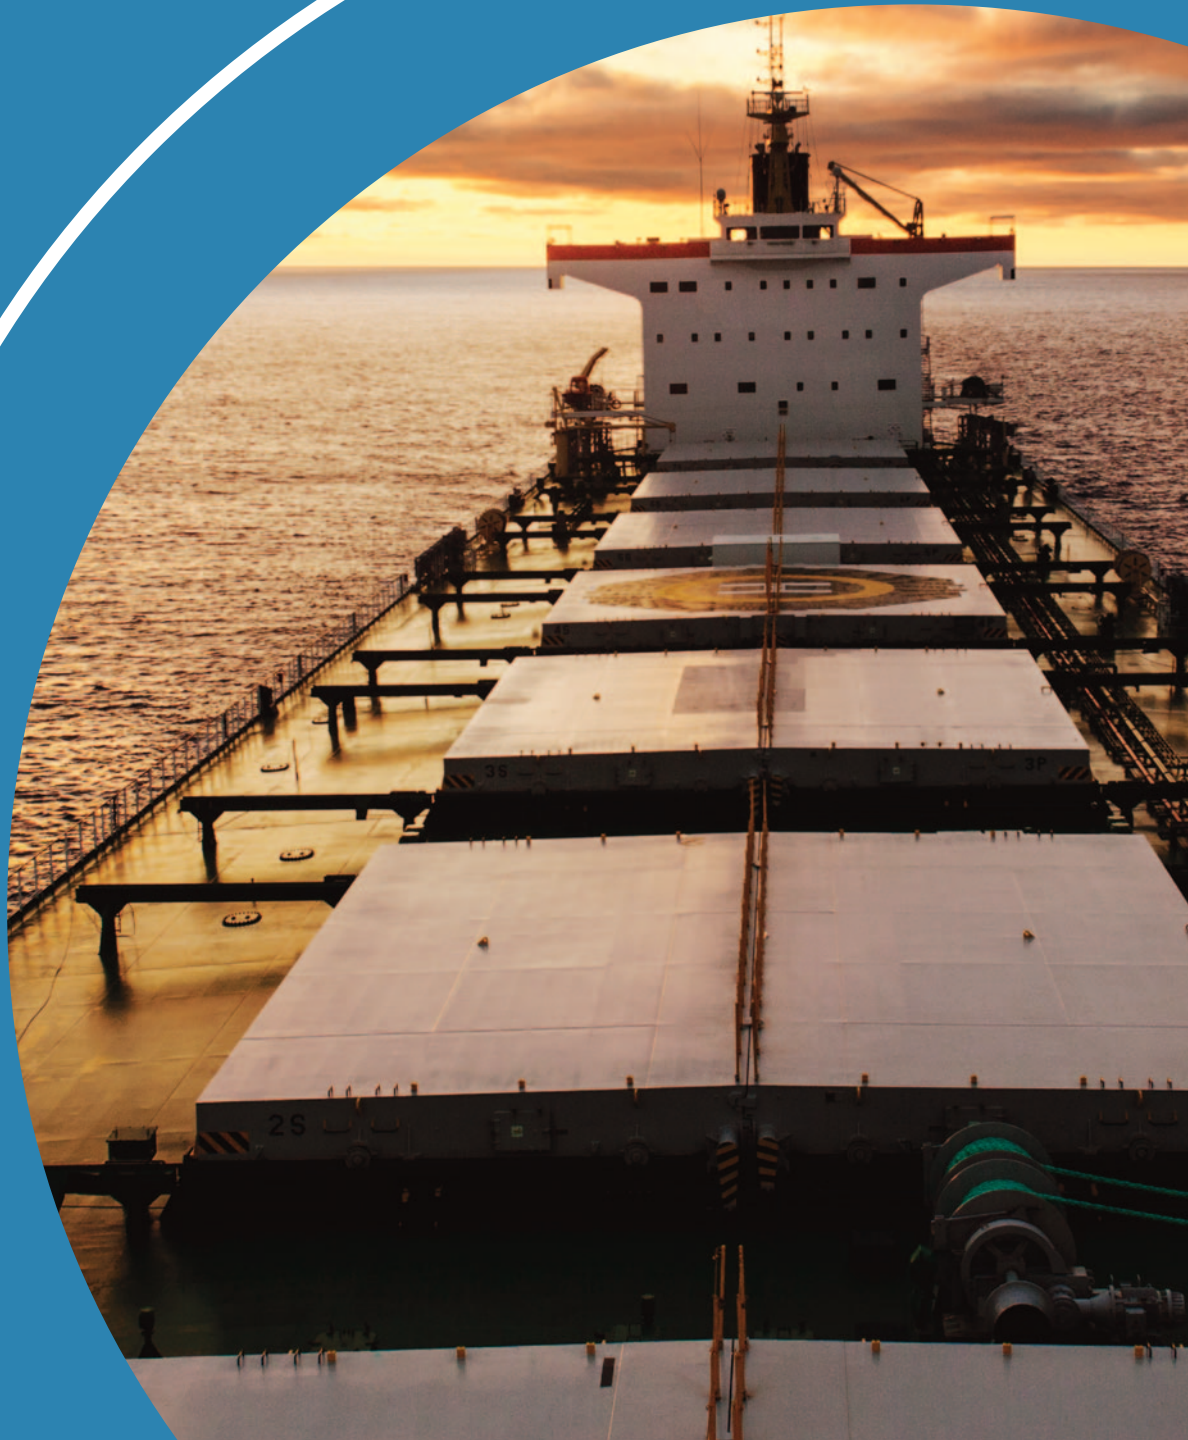
1.1 Leaking cargo hatch covers caused cargo damage

A bulk carrier had been fully loaded with grains. The vessel had side rolling cargo hatch covers. For six days, the vessel encountered heavy weather at Beaufort scale 9 which caused it to pitch and roll heavily. During the voyage the cargo hatch covers were washed over by seawater.

Whilst opening the cargo hatch covers it was found that cargo in a number of holds had been damaged by water. Most of the water-damaged cargo was below the middle cross joint of the hatch covers and below the aft hatch coaming's corners.

According to the Master there had not been any ventilation to the cargo holds during the voyage. A surveyor carried out an inspection and found the following hatch cover parts to be in poor condition:

The survey indicated that seawater had leaked through the middle cross joint drain channel and through the corner of the hatch coamings.

- Before loading, completion of loading and after discharge, the crew should inspect the hatch covers to ensure they are in a weathertight condition. It is essential that cargo hatch covers are inspected and tested at regular intervals to ensure that the weathertight integrity is maintained, and that the vessel is in a cargo worthy and seaworthy condition.

- Ensure that gaskets and coamings are in good condition.
- It is important that records are kept about what maintenance and service has been completed in the PMS.

- Inspection of cargo hatches and coamings, including securing devices, is part of both the annual load line survey and safety construction survey normally carried out by the vessel's classification society. The main purpose of these inspections is to ensure that the vessel is in a seaworthy condition, and not necessarily to confirm that the vessel is in a 'cargo worthy' condition. A few tons of water in the cargo hold will not jeopardise the seaworthiness, but it might completely destroy the cargo.

- Carry out a weathertightness test at least annually and always after repairing or replacing components in the cargo hatch system. When carrying water-sensitive cargo such as grain, soyabeans, paper, etc. it is recommended that weathertightness is tested before each loaded voyage. The most effective method is to use an ultrasonic device, which can pinpoint the area which is leaking, and if the compression of the gasket is sufficient. The advantages of using this type of equipment are evident, since ultrasonic tests can be carried out during any stage of the loading without risking cargo damage. The test can also be completed in sub-zero temperatures.

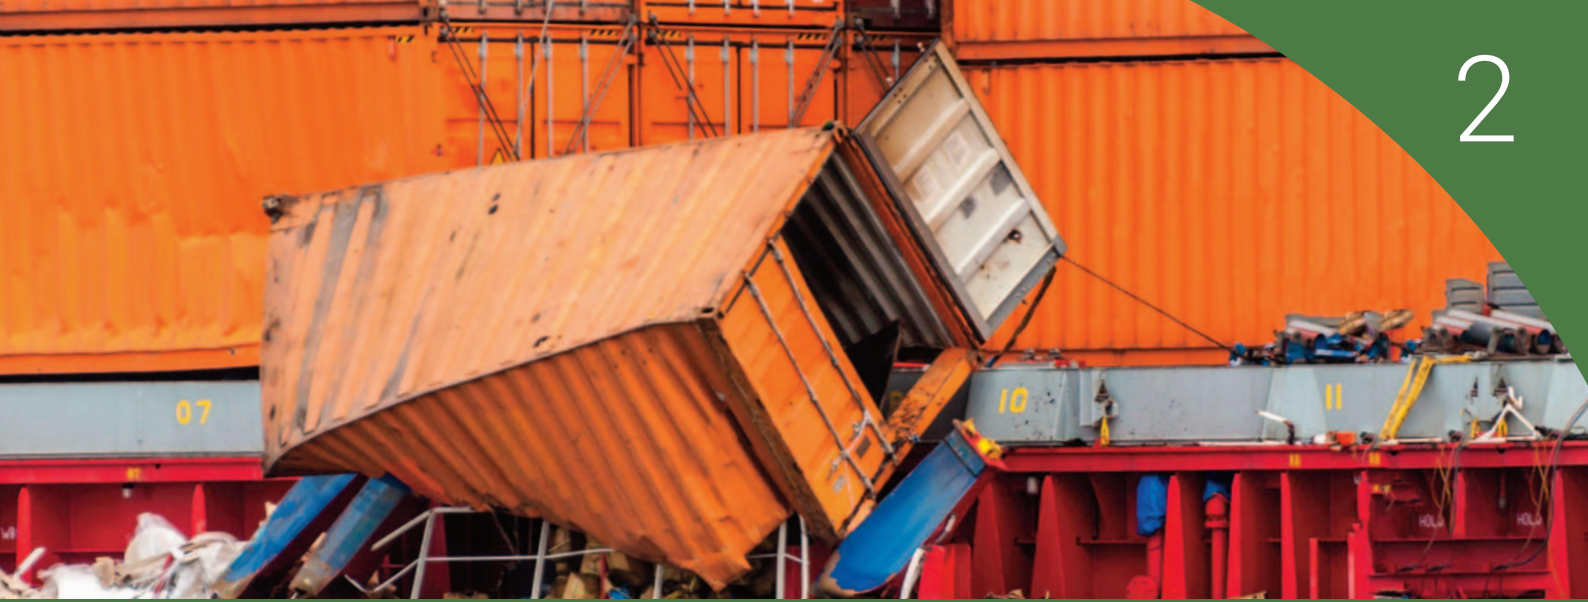
2.1

Containers were lost in heavy weather because of stiff vessel

The CSM required that the bottom containers on deck were secured by manual twistlocks. However, the twistlocks in the container shoes were unlocked. In accordance with the vessel's procedures, the lashings were to be checked prior to every departure, which the Chief Officer stated he had done. At the loading port the Chief Officer had signed the lashing report without noting any deficiencies.

- The base twistlocks had not been locked as they were found undamaged and still located in the shoe fittings. The combination of unlocked twistlocks and a very stiff vessel sailing through heavy weather led to the collapse of the container stacks.

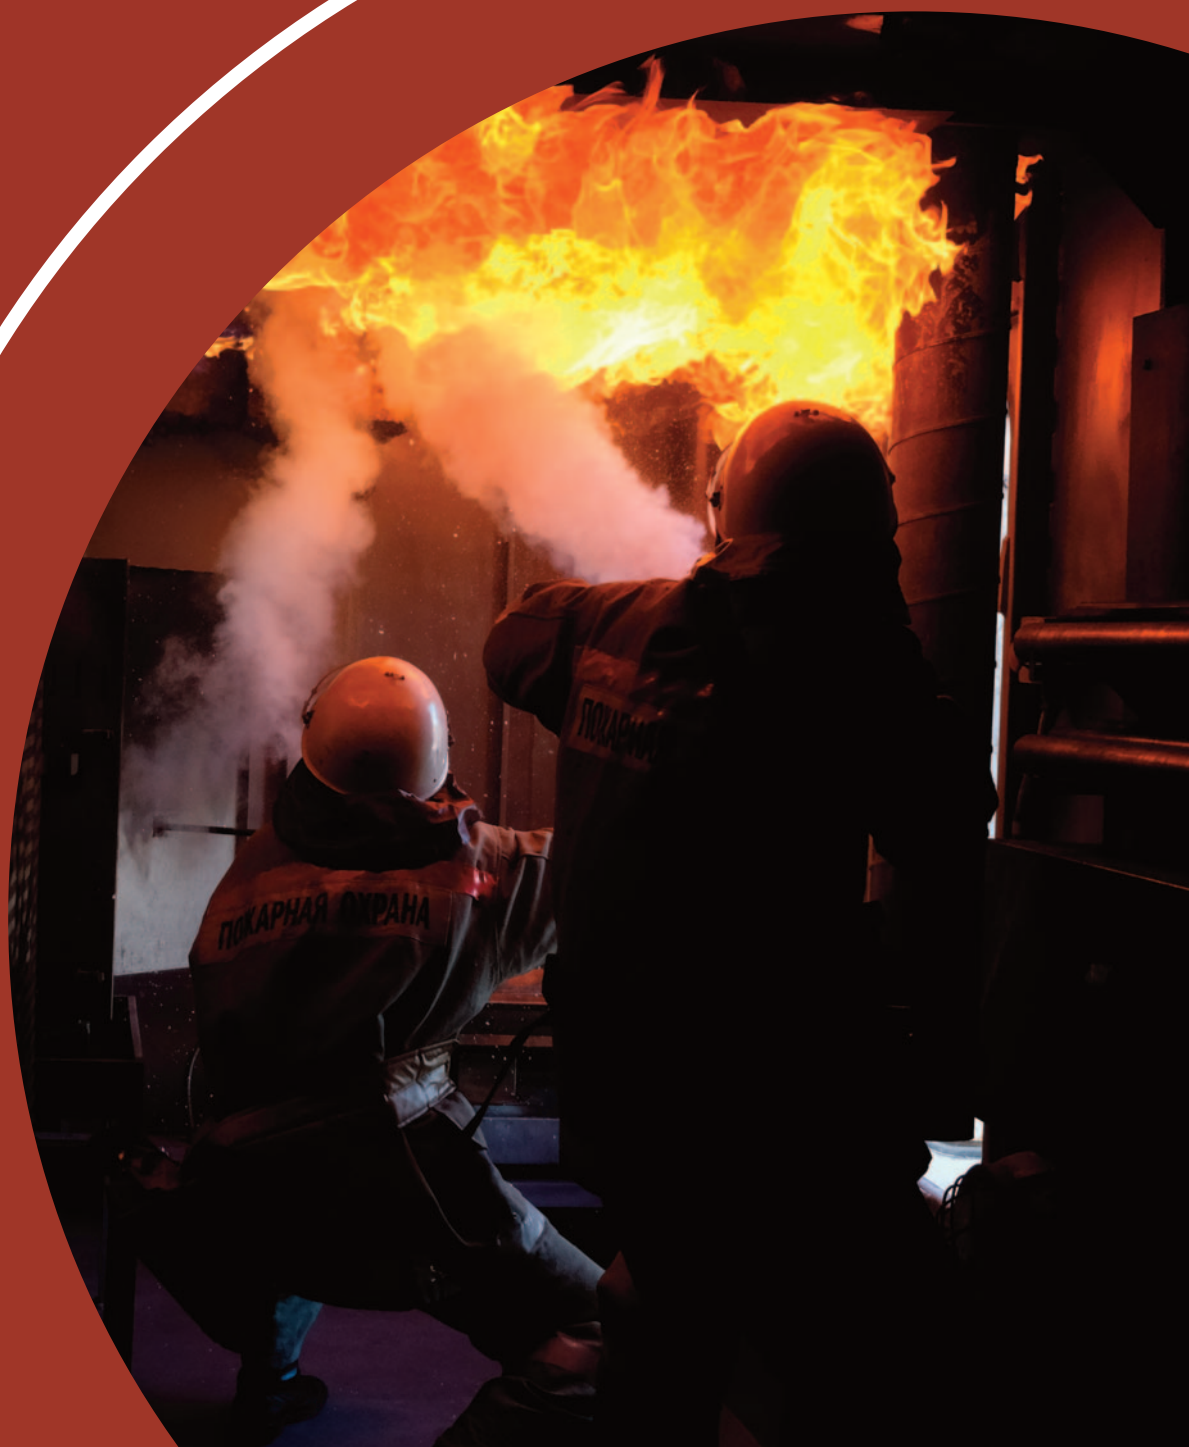
3.1 Explosion caused by fumigation

A couple of hours later an explosion occurred in one of the holds. The crew noted that the hatch covers had moved slightly and blue gray smoke was seen coming from under the edges. About an hour later another explosion occurred in a second hold, and a couple of minutes later an explosion occurred in a third. There were explosions in the remaining holds shortly afterwards.

The fumigant pellets in each hold had not been distributed across the entire cargo surface, or applied to the subsurface, but had been applied by simply pouring the pellets on top of the cargo. This method of application had permitted the accumulation of the pellets in limited areas and promoted a relatively rapid reaction of the pellets with moisture, generating concentrations of phosphine gas above the lower flammable limit, which lead to the explosions.

- If there is an excessive amount of fumigant in one place, or if the fumigant is in contact with liquid water e.g. from sweating or condensation, then the fumigant can react too quickly. This can evolve excessive heat and lead to ignition of cargo and/or packaging such as bags or paper placed over the top of the cargo. Under certain conditions the fumigant gas itself may ignite, producing an explosion. It is important that fumigant is applied according to the correct instructions. As holds are always un-ventilated for a time after fumigation, there may be a risk of excessive condensation, which can produce sweating or dripping. This can lead to cargo damage as well as the fire and explosion risks mentioned above. The weather conditions and cargo conditions, such as moisture content, therefore need to be considered properly before fumigation, which is often carried out by specialist companies.

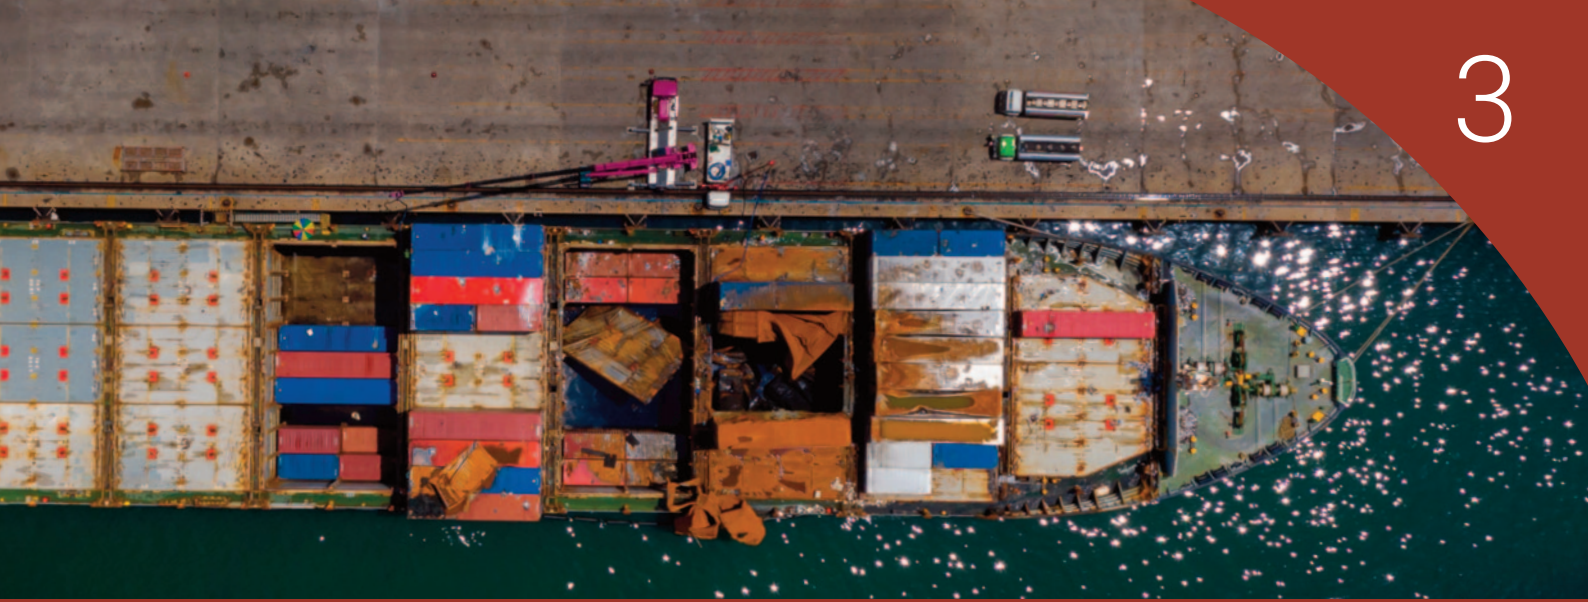
3.2 Misdeclared container caused fire

It was early morning and from the bridge the Master saw a large cloud of smoke issuing from the forward part of the vessel. At the same time the fire detection system for cargo hold 2 sounded on the bridge. The Master described the smoke as being white at first and then greyish. The Chief Officer, however, described the smoke as being "dark grey, almost black".

- Exposure to heat e.g. solar radiation (before or after loading), cargo lights and heated fuel tanks.
- Cargo formulation.
- Contamination of cargo at manufacture.
- Spillage and thus reaction between cargo and combustibles e.g. timber.
- Excess quantity of cargo in containers giving insufficient dissipation of heat Inadequate separation of packages in containers, also giving insufficient dissipation of heat.

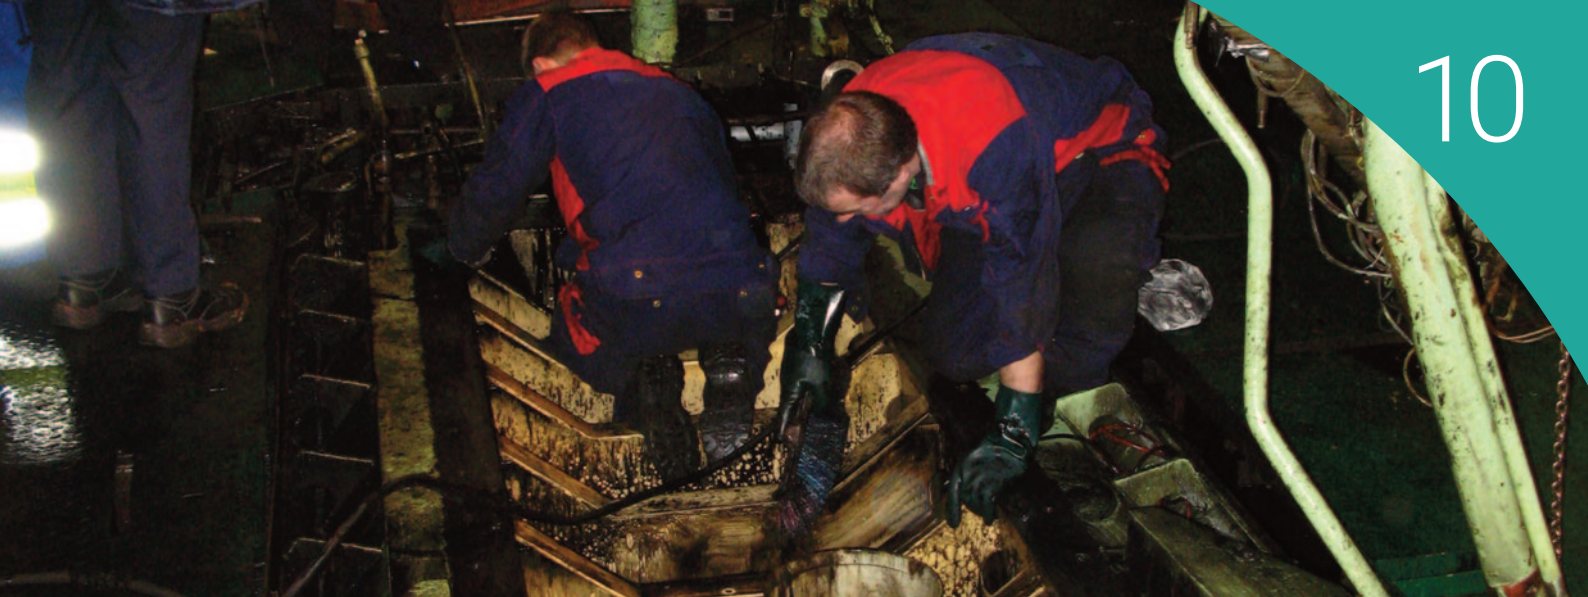
10.1 Machinery failure caused by contamination

A vessel was in ballast and at anchor, awaiting further instructions. After seven days the weather deteriorated and the vessel's anchor dragged. The anchor was heaved up and the vessel started to slow steam in the area. After about 24 hours the differential pressure alarm of the main engine duplex lubrication oil filter sounded in the engine control room. The crew found aluminium and other metal inside the lubrication filter, and in the crankcase of the main engine, metal particles were found.

- It is recommended that all diaphragms are replaced every five years in connection with the vessel's special survey.
- The exchange of rubber diaphragms should be included in the vessels PMS system.

- It is recommended to owners that spare diaphragms are kept on board at all times, in addition to enough system lubrication oil to completely replenish the system.

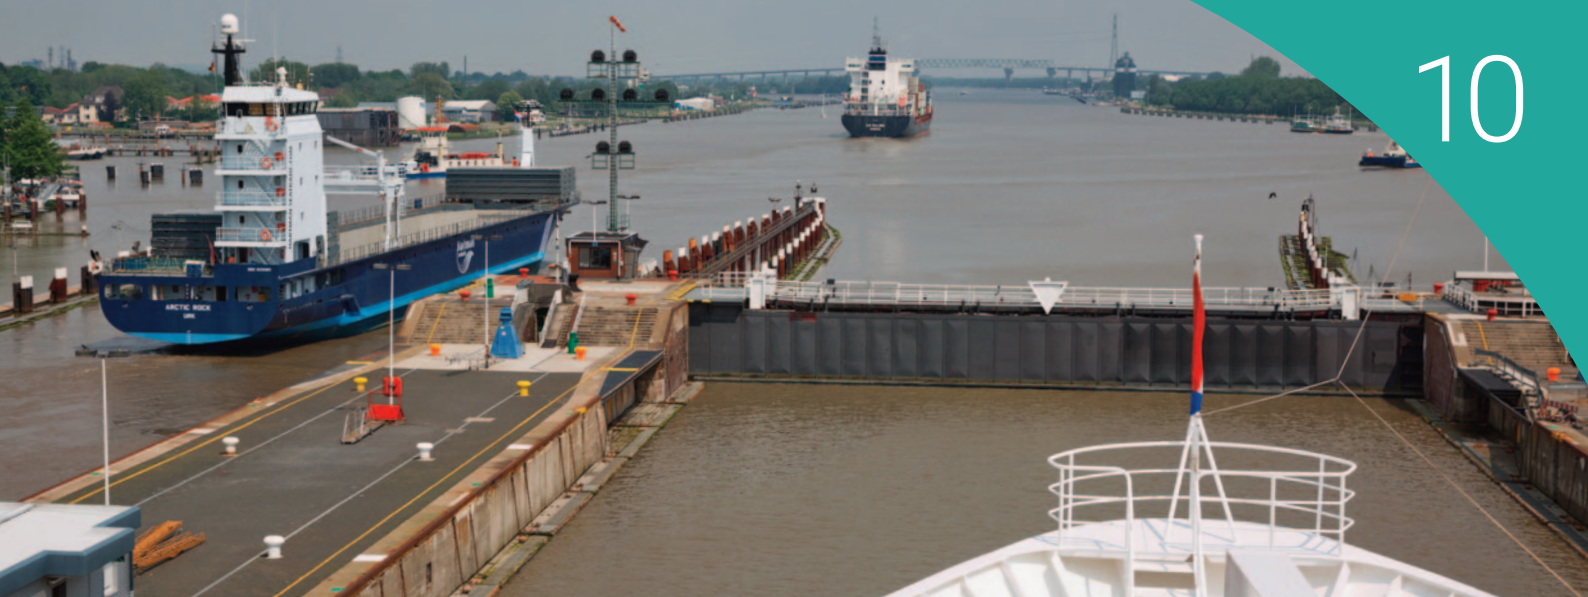
10.3 Machinery failure of the CPP caused heavy contact with lock gate

A vessel was berthed alongside the quay, waiting to proceed through a lock to another berth. The pilot called on the radio and asked the Master if it would be possible to depart in half an hour. Pre-departure checks were completed by the OOW, the radar was tuned and the ECDIS set up for departure. The OOW did not check the controllable pitch propeller (CPP) as the vessel had only been alongside for twelve hours and the OOW assumed everything should be OK. He also felt stressed about preparing everything for departure in such a short time. According to the company's SMS, the CPP should always be tested before departure.
