# MARINE TRANSPORTATION SAFETY INVESTIGATION REPORT M19C0403

## **ENGINE ROOM FIRE**

Bulk carrier *Tecumseh*  
Detroit River  
Windsor, Ontario  
15 December 2019

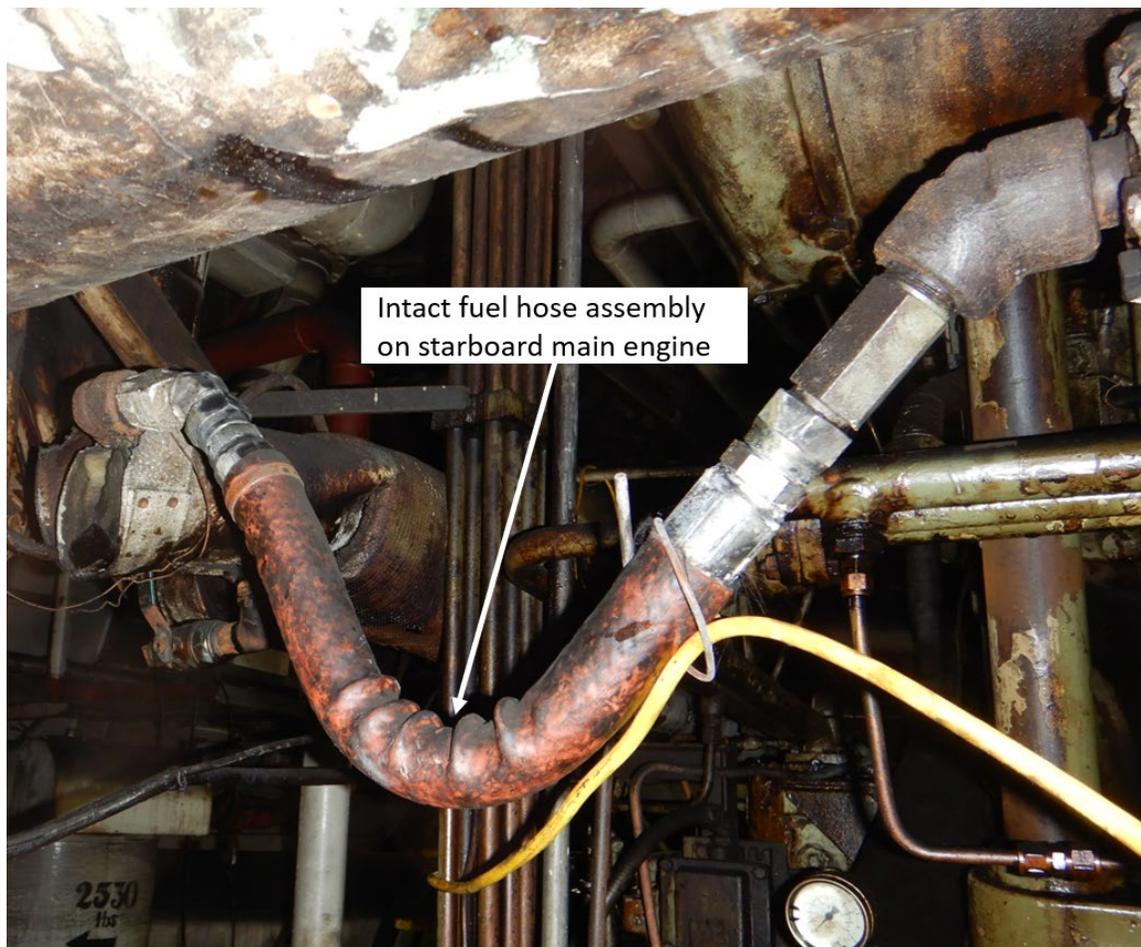
The main engines can be operated on either marine diesel oil or intermediate fuel oil.<sup>3</sup> The fuel supply system feeds both main engines and is fitted with an automatic back-pressure regulating valve that is designed to maintain a constant fuel oil pressure of 25 to 35 psi in the system. The fuel supply system (Figure 7) consists primarily of hard piping, except where it connects to the engines. At these locations, there are flexible fuel hose assemblies. Each assembly is made up of a short flexible fuel hose with threaded-crimp fittings at either end. The threaded-crimp fittings attach the flexible hose to the hard piping (Figure 8).

Figure 8. Flexible fuel hose assembly on the inboard side of the starboard main engine (Source: TSB)

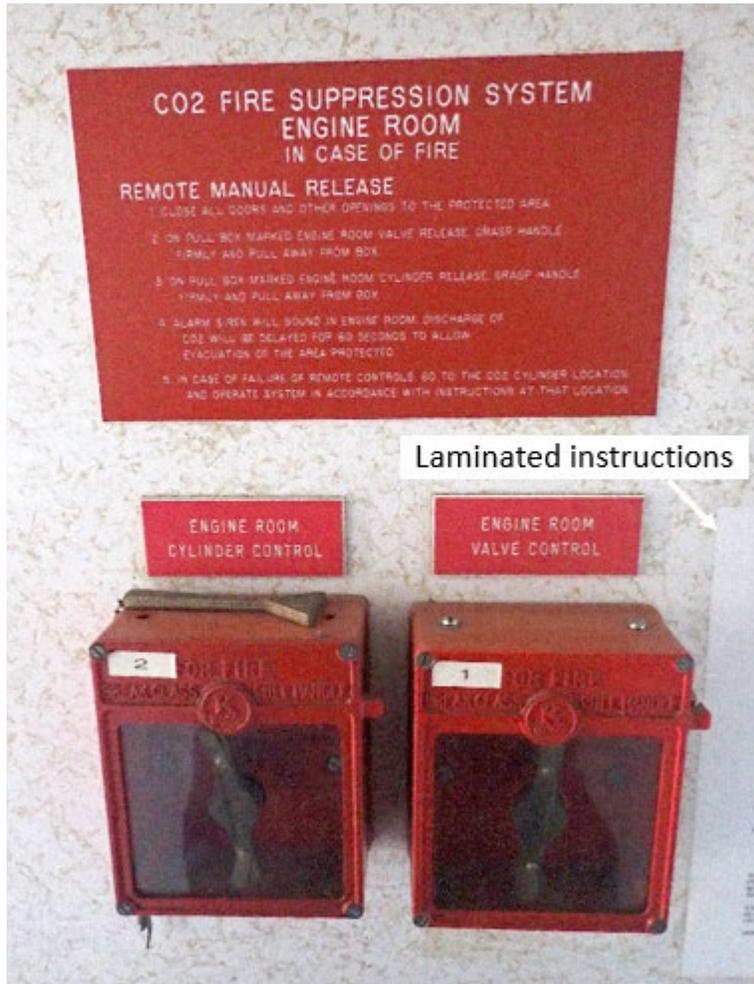
At all 3 release stations, there was a placard providing instructions about the release of CO<sub>2</sub>. At the remote release station on deck C, the placard instructions were supplemented with laminated instructions, which contained details about the process for the remote release of CO<sub>2</sub>. The laminated instructions (Appendix B) and the placard (Figure 13) showed different time delays between the activation of the remote release controls and the release of the CO<sub>2</sub> in the engine room (25 seconds versus 60 seconds).

In this occurrence, the CO<sub>2</sub> was released before the fuel supply was stopped and the steps to seal the engine room were completed.

Figure 13. Tecumseh's CO<sub>2</sub> remote release station on deck C (Source: TSB)

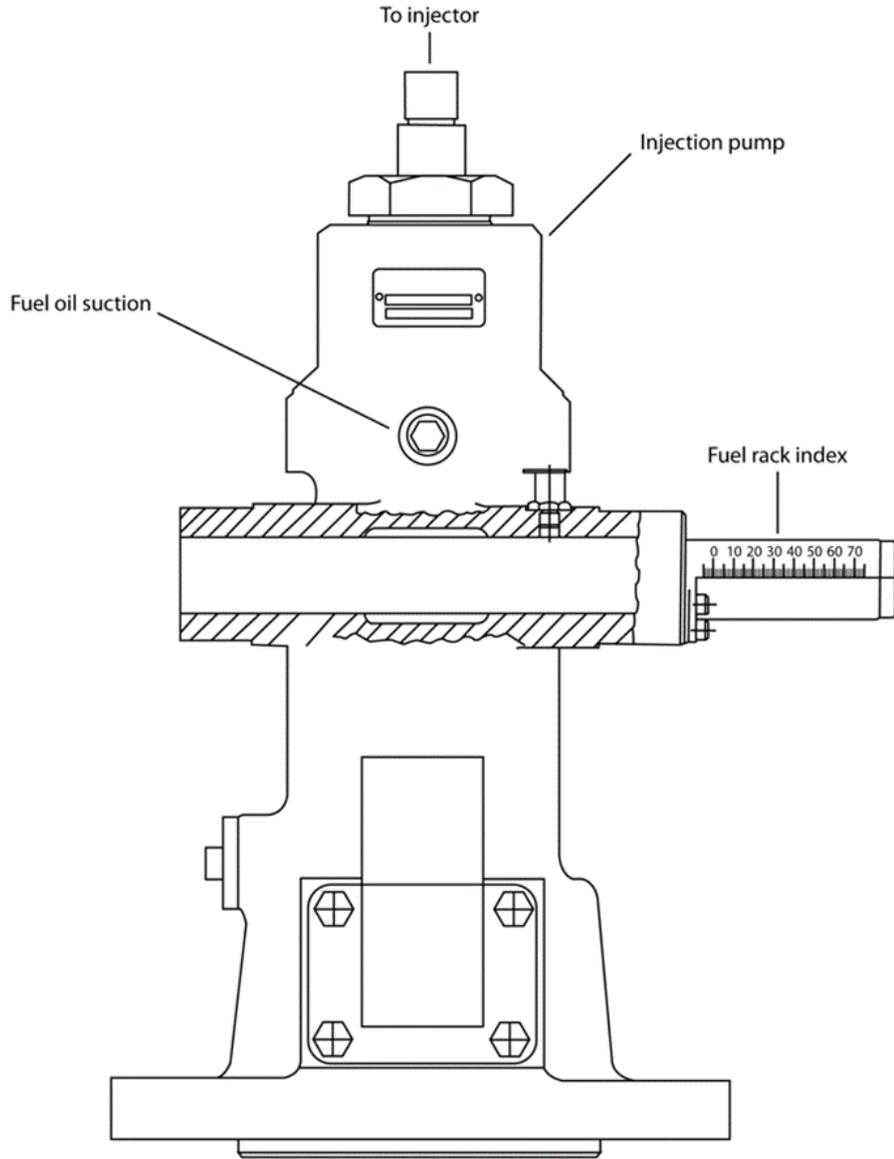
The fuel racks had indexes that indicated their positions in millimetres (Figure 14). With such indexes, the datum positions of individual fuel racks are adjusted by manually altering 2 nuts on each control linkage connected to the governor's control shafts (Figure 15). Manually altering the datum positions increases or decreases the quantity of fuel delivered, thus adjusting the load of each individual cylinder unit.

Figure 14. Diagram of fuel injection pump on the Tecumseh, showing the fuel rack index (Source: TSB, based on the engine manufacturer's diagram)

The datum positions of the fuel rack indexes varied in excess of the manufacturer-recommended 2 mm. The adjustment nuts for the fuel rack indexes were all properly secured, and there was no indication that they had come loose on their own over time. The datum positions of the fuel rack indexes had been manually adjusted in order to minimize the impact of differences in peak cylinder pressures and exhaust gas temperatures.
