**Bundesstelle für Seeunfalluntersuchung**  
**Federal Bureau of Maritime Casualty Investigation**  
Federal Higher Authority subordinated to the Federal Ministry  
for Digital and Transport

## **Investigation Report No. 261/20**

### **Less serious marine casualty**

**Fire in the engine room on board the ferry BERLIN in  
the access to the port of Rostock on 13 August 2020**

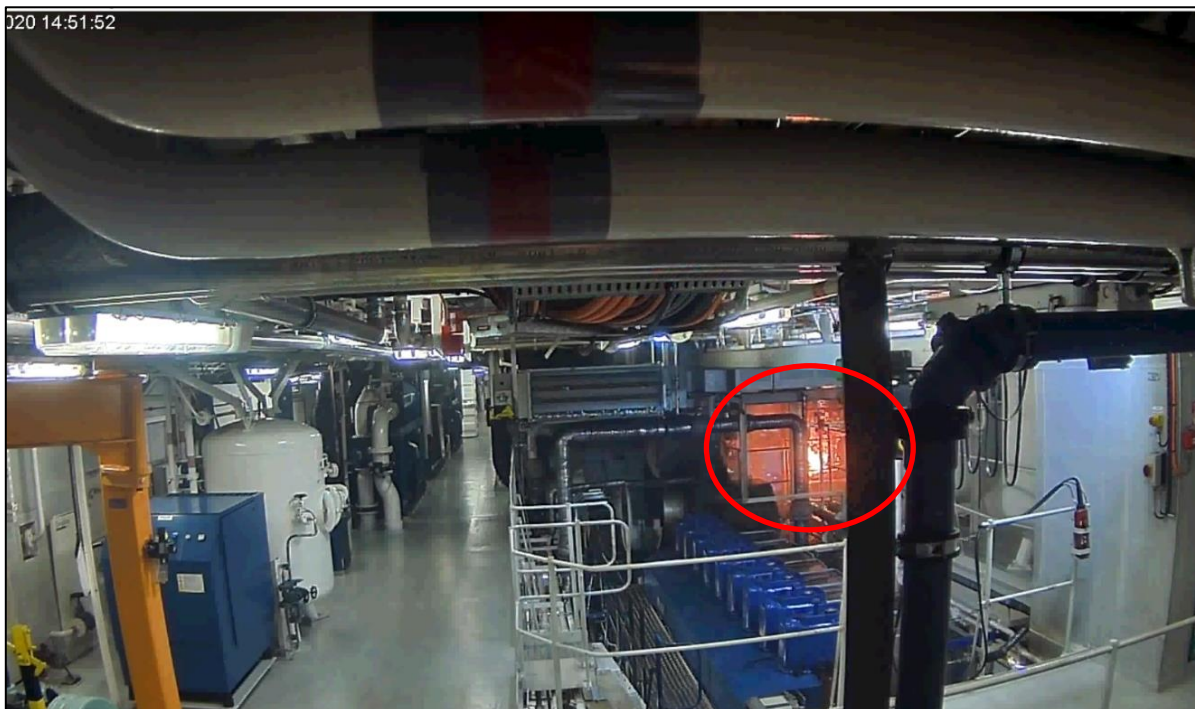
Ship mechanic 2 (SM 2) meanwhile reached the scene via Deck 1. He saw flames and smoke in the area of ME 2 turbocharger.

Figure 3: View of the fire from Deck 1<sup>8</sup>

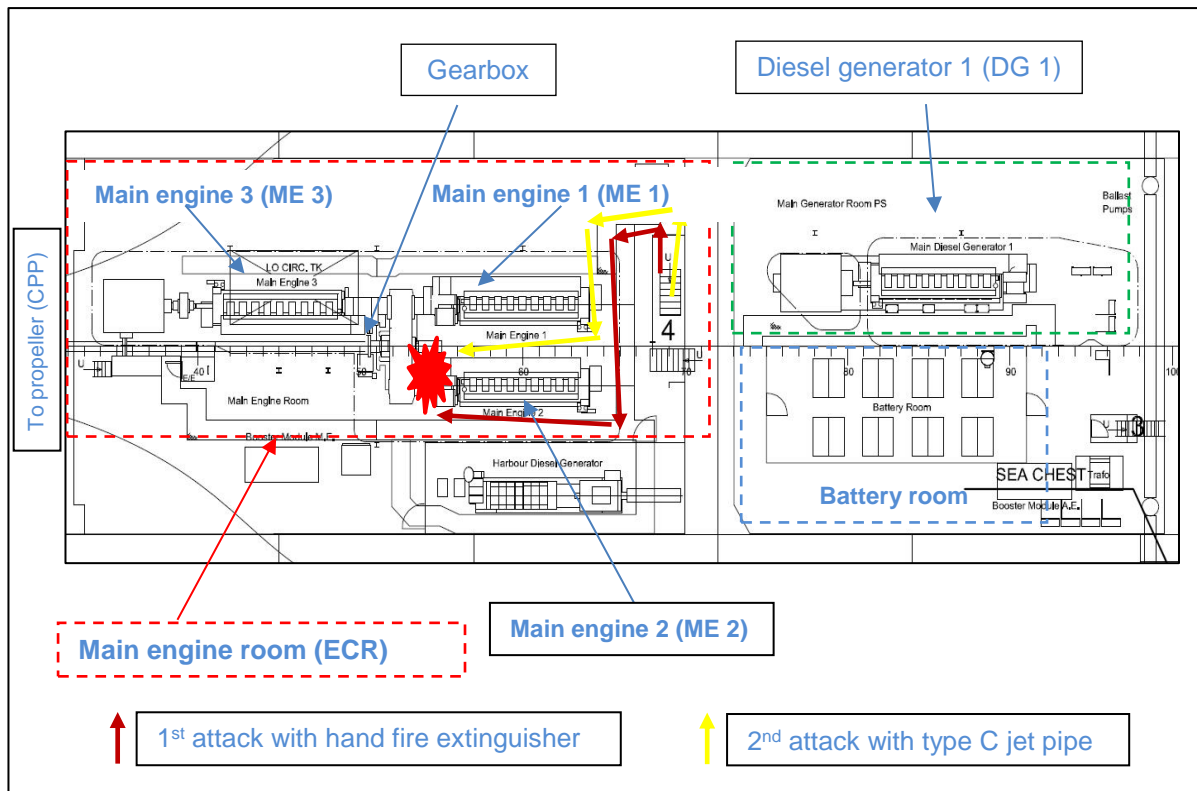
Figure 4: Floor plan of engine room with fire area on Deck 0

The engine room watch crew (TO, SM 1 and SM 2) now began manual firefighting using hand fire extinguishers (see Figure 4).

in the turbocharger area. The technical officer cooled the machinery space casing from Deck 1 until this was taken over by SM 1 (see Figure 4).

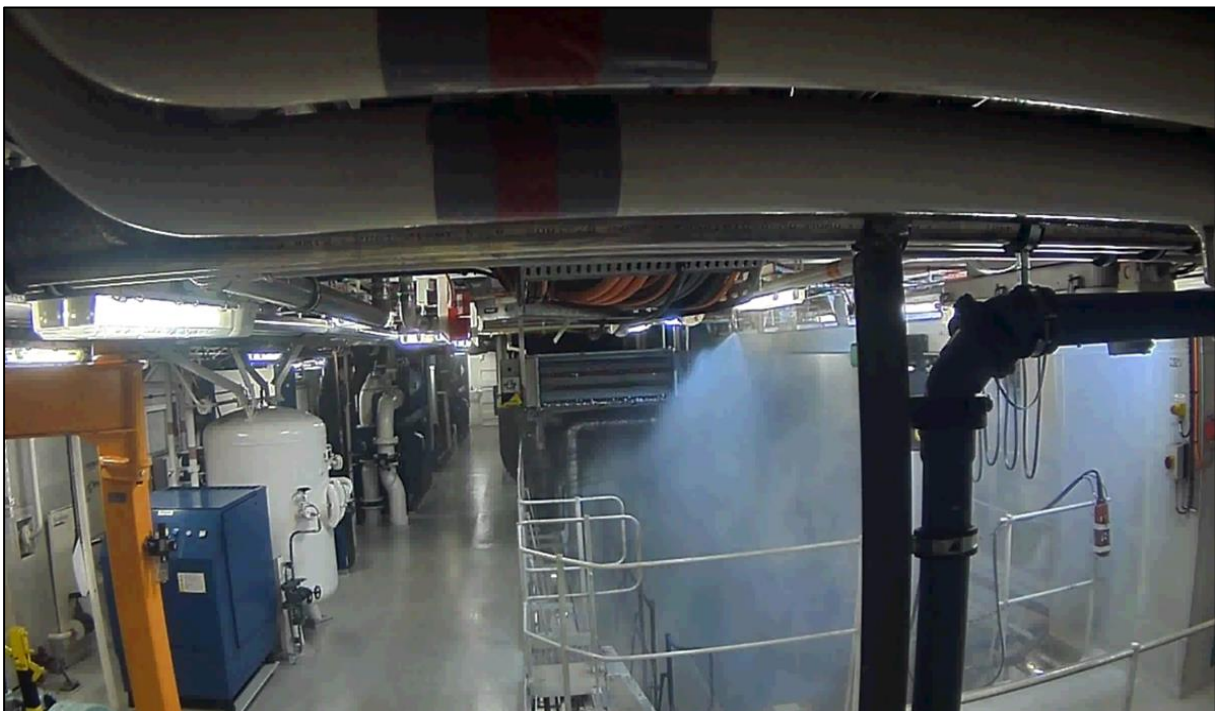
The hose squad prepared fire hoses. At this time, the Chief Engineer started the object protection system above ME 3.

Figure 5: Object protection system triggered above ME 3<sup>10</sup>

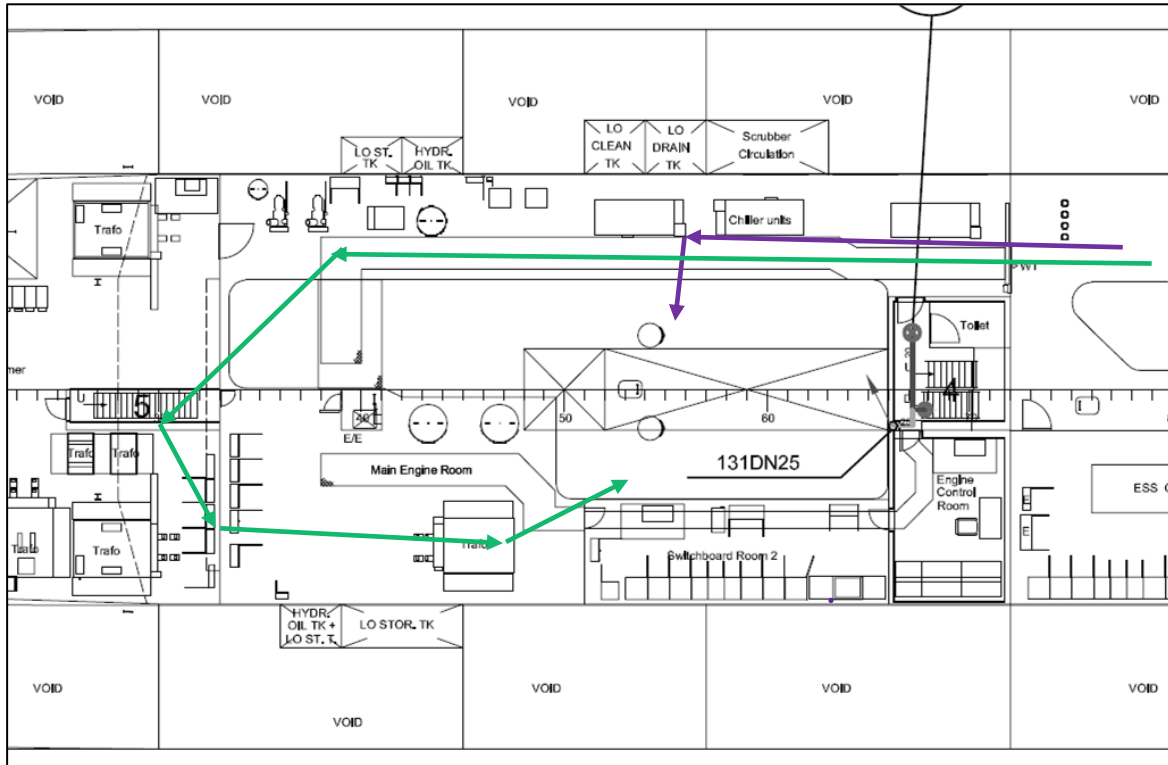
At 1504, the fire squad started local firefighting. They dispersed the extinguishing agent F-500<sup>11</sup> using a hose and a Venturi jet pipe<sup>12</sup>, and low-expansion foam using a second hose (see Figure 6). Due to the active ventilation and outflow of the gases via the exhaust duct, visibility remained good.

Figure 6: Floor plan of the engine room with the fire area on Deck 2

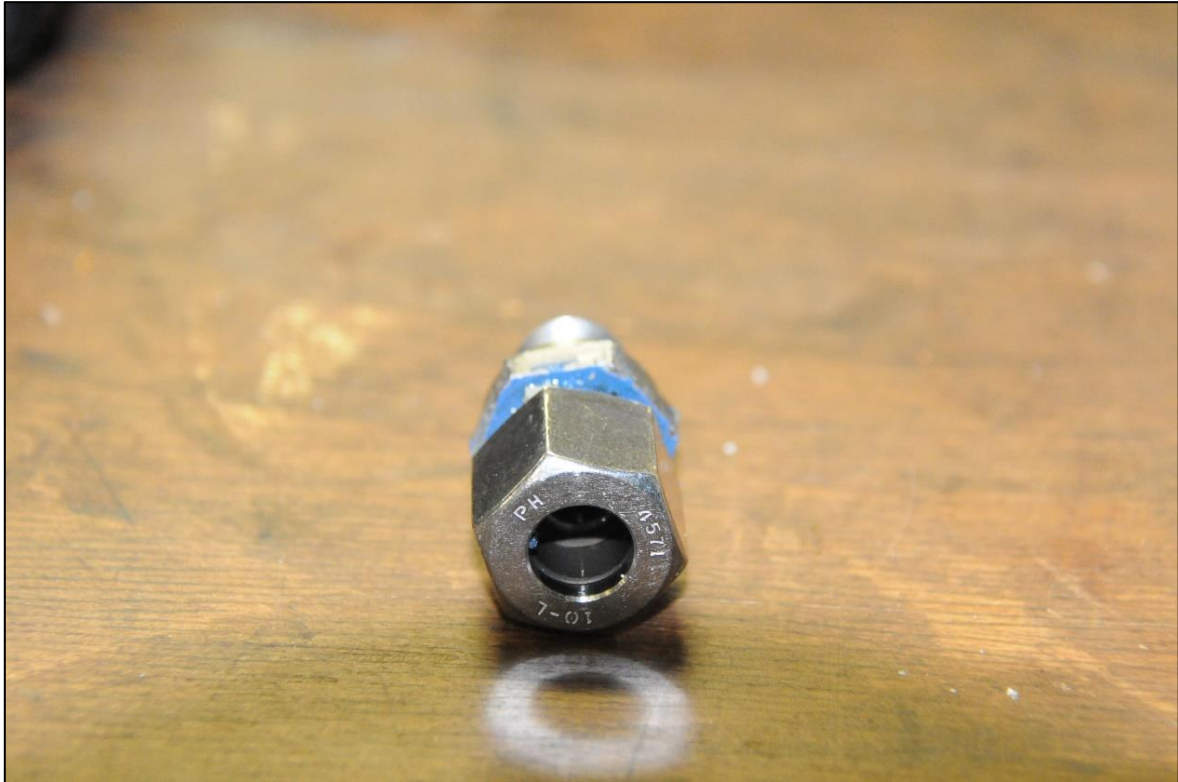
Figure 12: Detailed view from the front

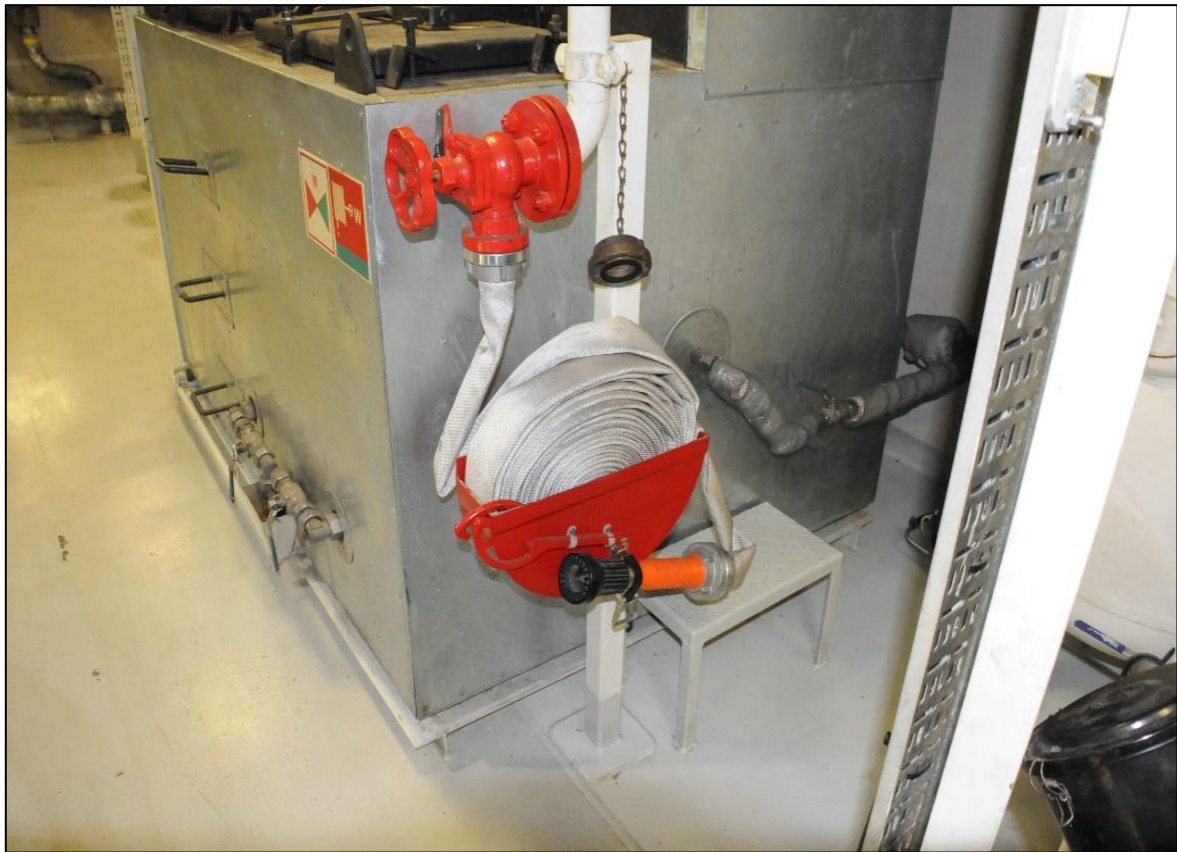
- Standard jet pipes of the simplest design with option of water curtain (see Figure 25)

Figure 25: Standard jet pipe / hydrant system

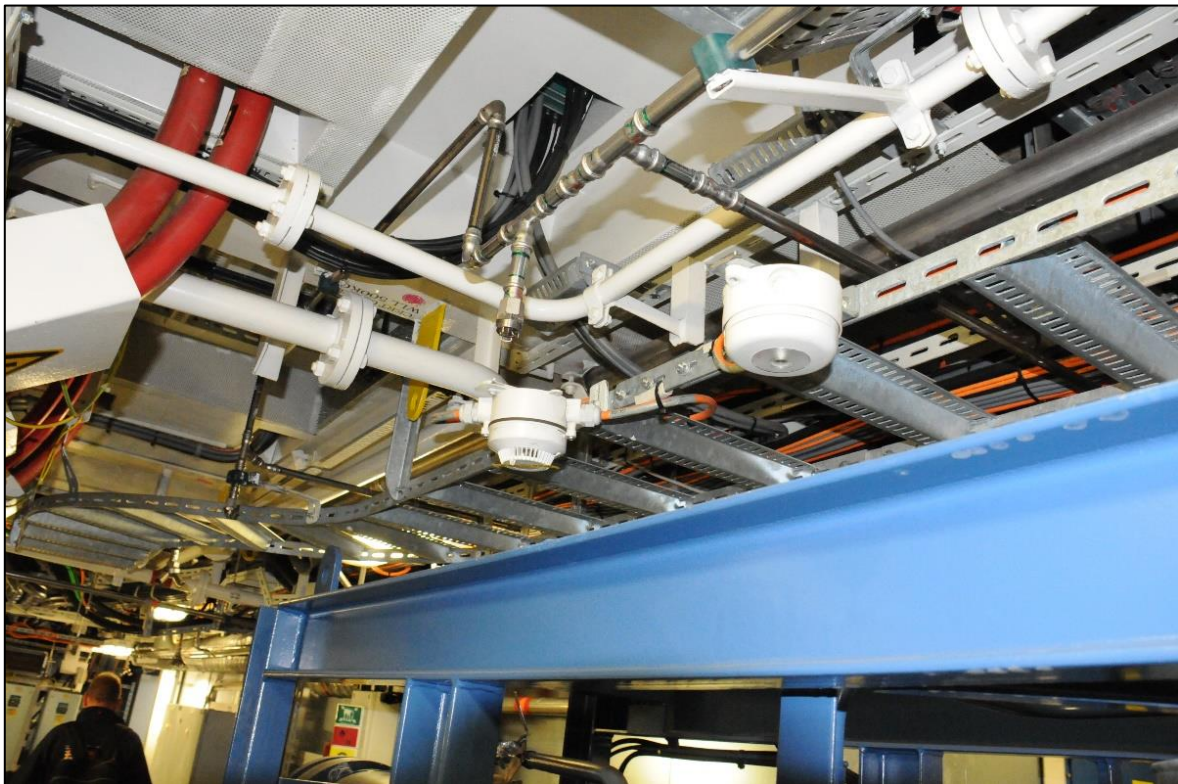
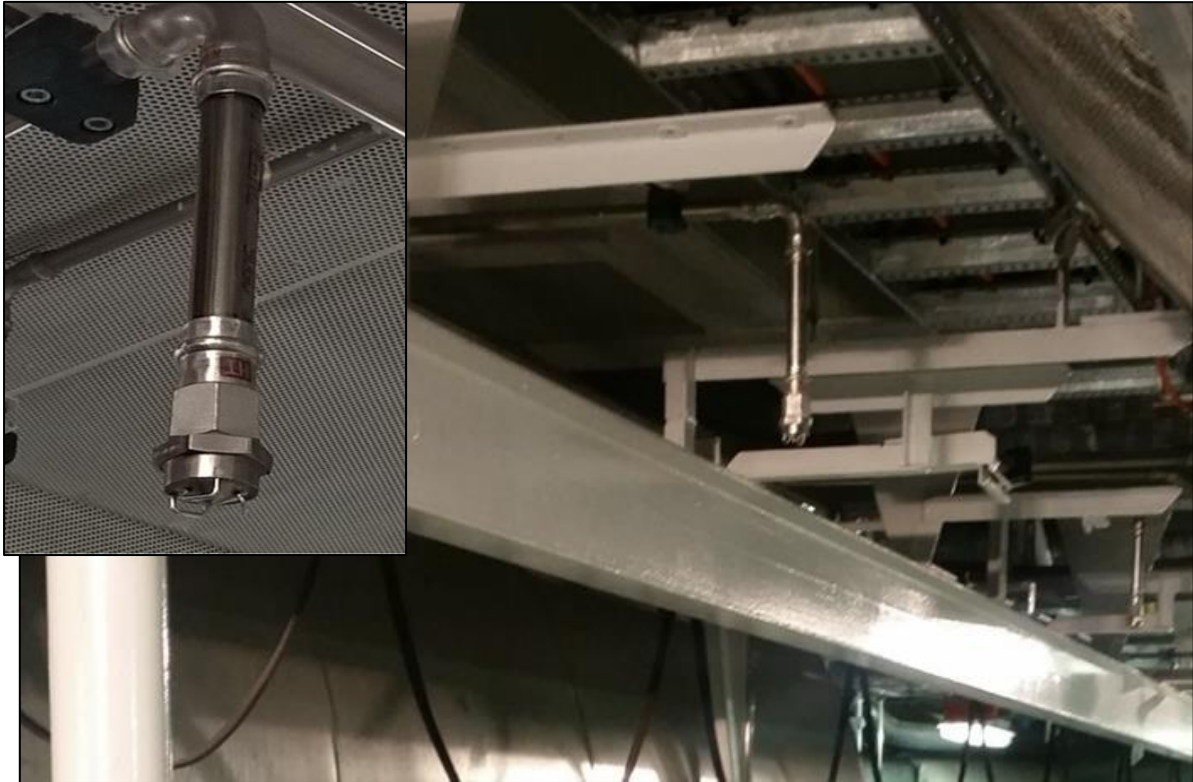
- Low-pressure system of the simplest design, spray cone formation via baffle hooks<sup>24</sup>
- System design: Ceiling system with six nozzles above the cylinder heads (ME 1 & 2), no extended object protection system for e.g. the pump area or the turbocharger area. (see Figures 28 and 29)
- Problem: Dependency on two detectors, in this case flame detector and combined smoke/heat detector (so-called "combination detector").  
Because the turbocharger covered the flames, the combination detector responded but the flame detector did not, so that the system did not trigger automatically. Additionally, the hot flue gases were expelled via the exhaust duct, so that the combination detector signal was not constant either.

Figure 28: Object protection system

Figure 29: Object protection assembly above engine

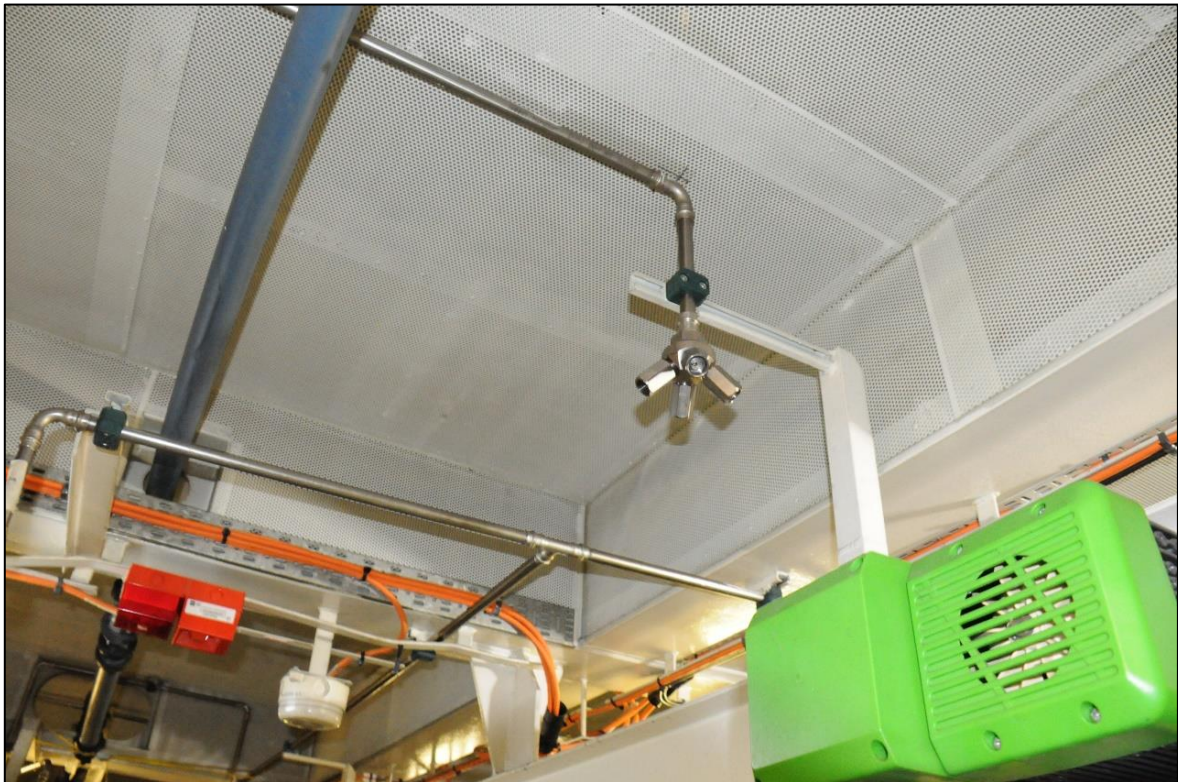
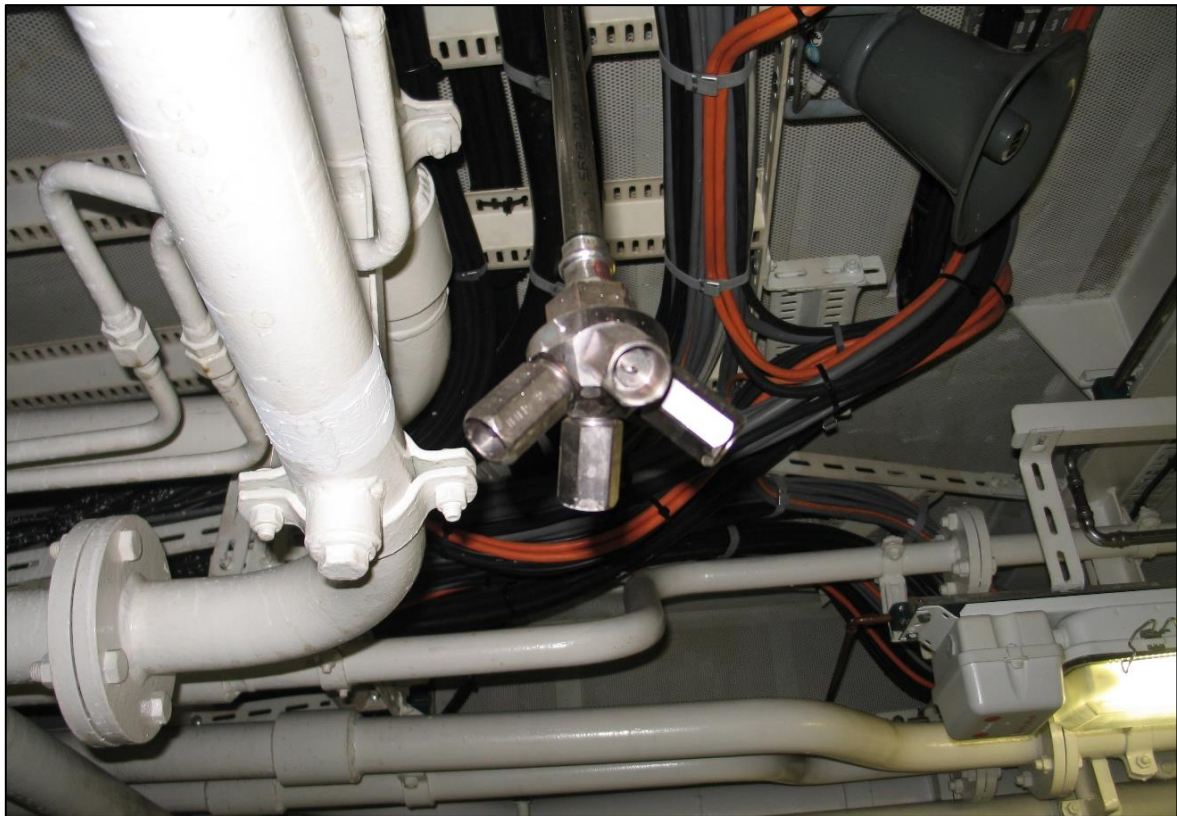
- Low-pressure system of the simplest design, nozzle head with four solid, X-shaped individual nozzles  
(X Flow 4x NHP2, 9.5 bar)
- The system for the aft and forward exhaust duct is directly connected to the system (section) of the adjacent main engine room. This means that the room protection system for the exhaust duct cannot be triggered separately. A separate object protection system for the exhaust ducts does not exist (see Figures 30 and 31).

Figure 30: Room protection system

Figure 31: Room protection nozzle – X-flow

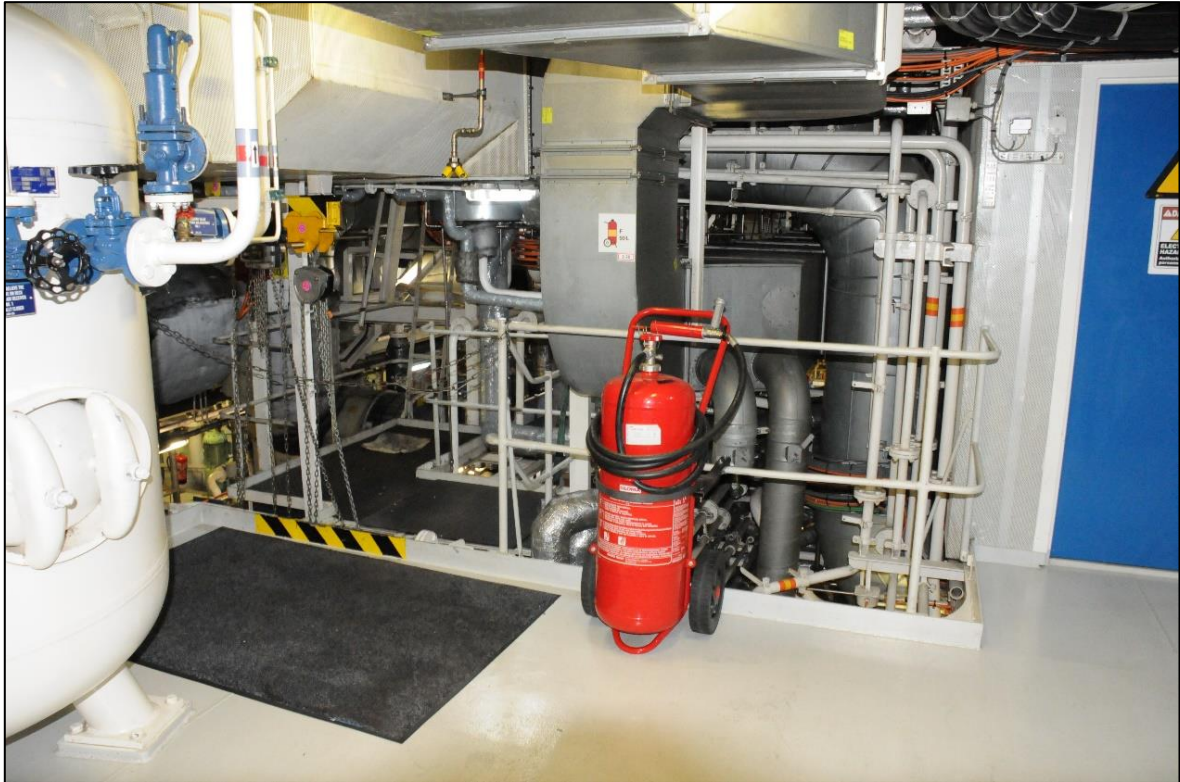
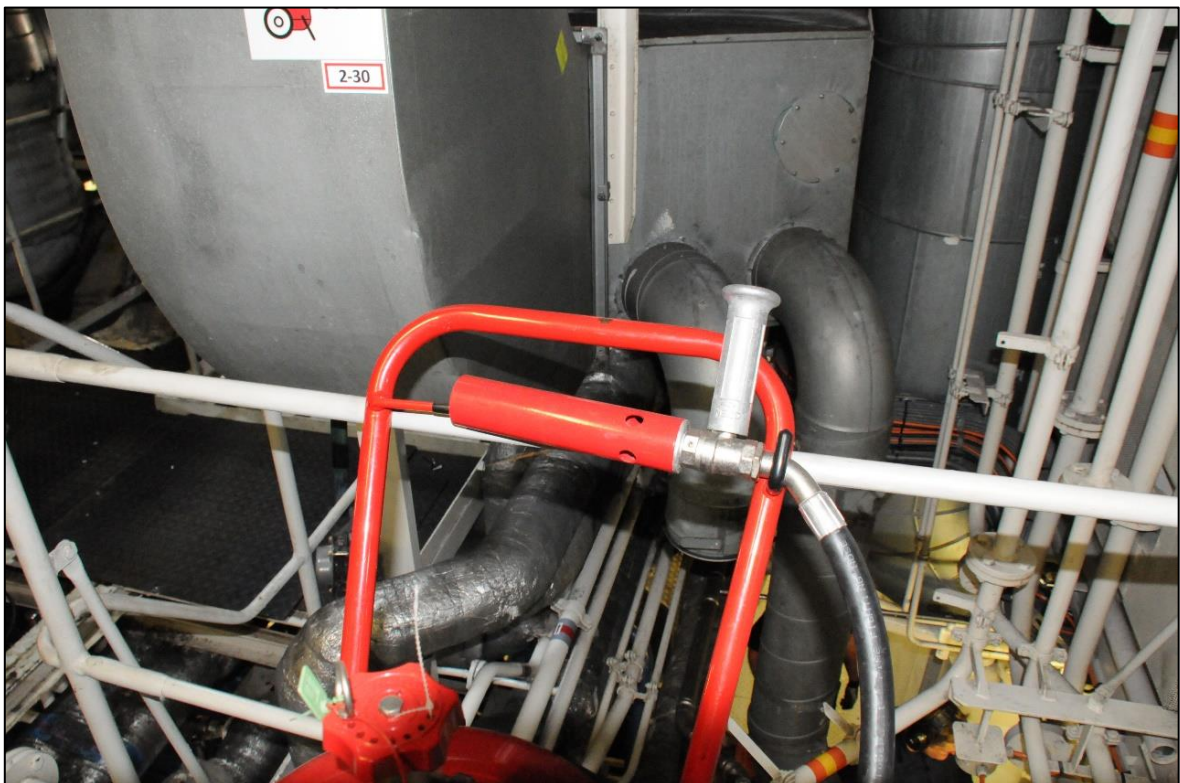
Figure 32: Foam trolley (in risk area)

Figure 33: Low-expansion foam pipe (trolley) for incipient firefighting

On the technical side, equipment weaknesses were identified, evaluated and rectified. Additional mobile extinguishing technology was purchased, such as foam trolleys and fog nozzles with wetting agent / foam / capsule agent admixture (see Figures 32 and 33). It is possible to apply a heavy foam of comparable quality to the more bulky low-expansion foam with these fog nozzles, if required. By controlling the flow rate directly at the nozzle, the firefighter can determine when to add foam concentrate or F-500 EA.

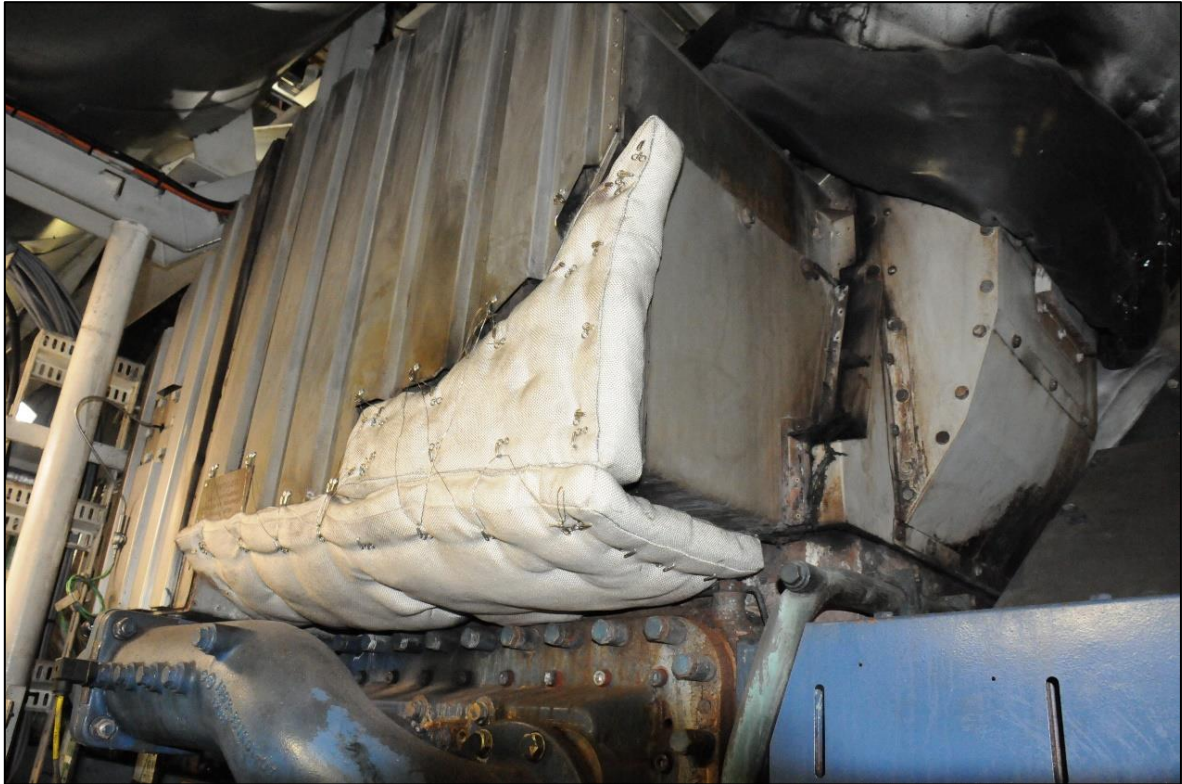
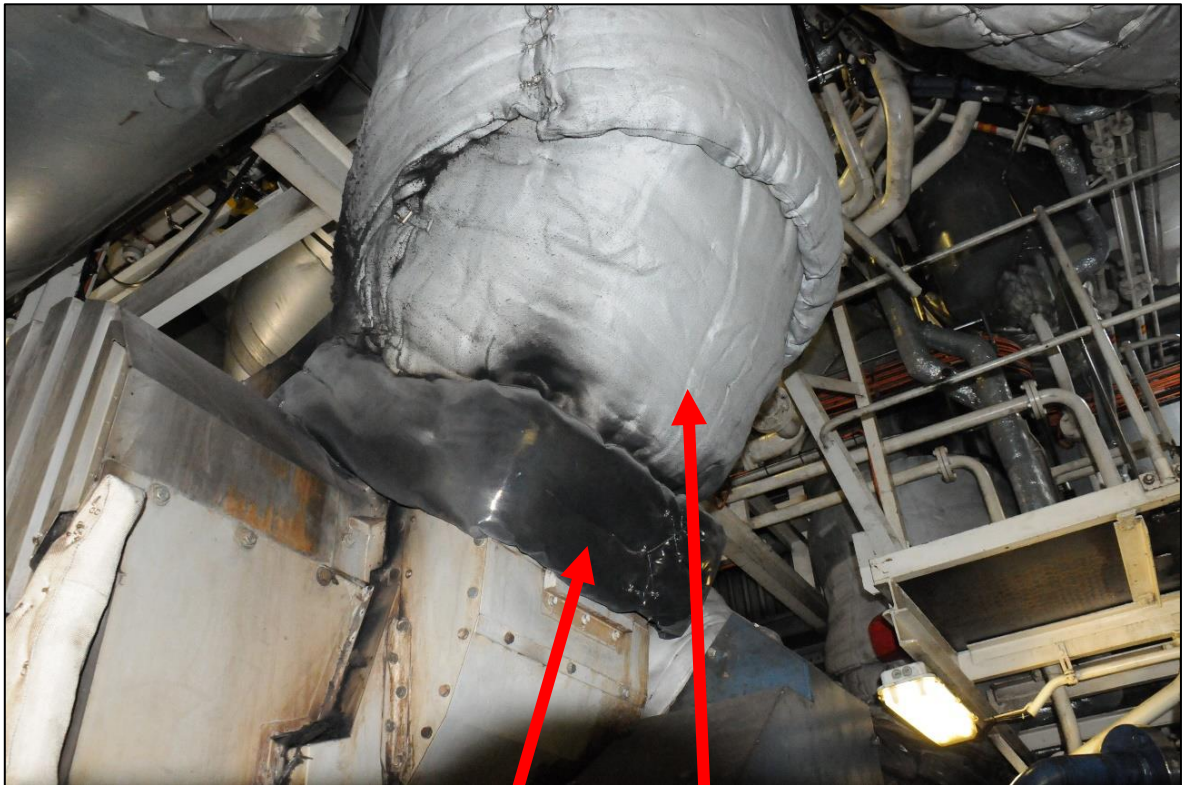
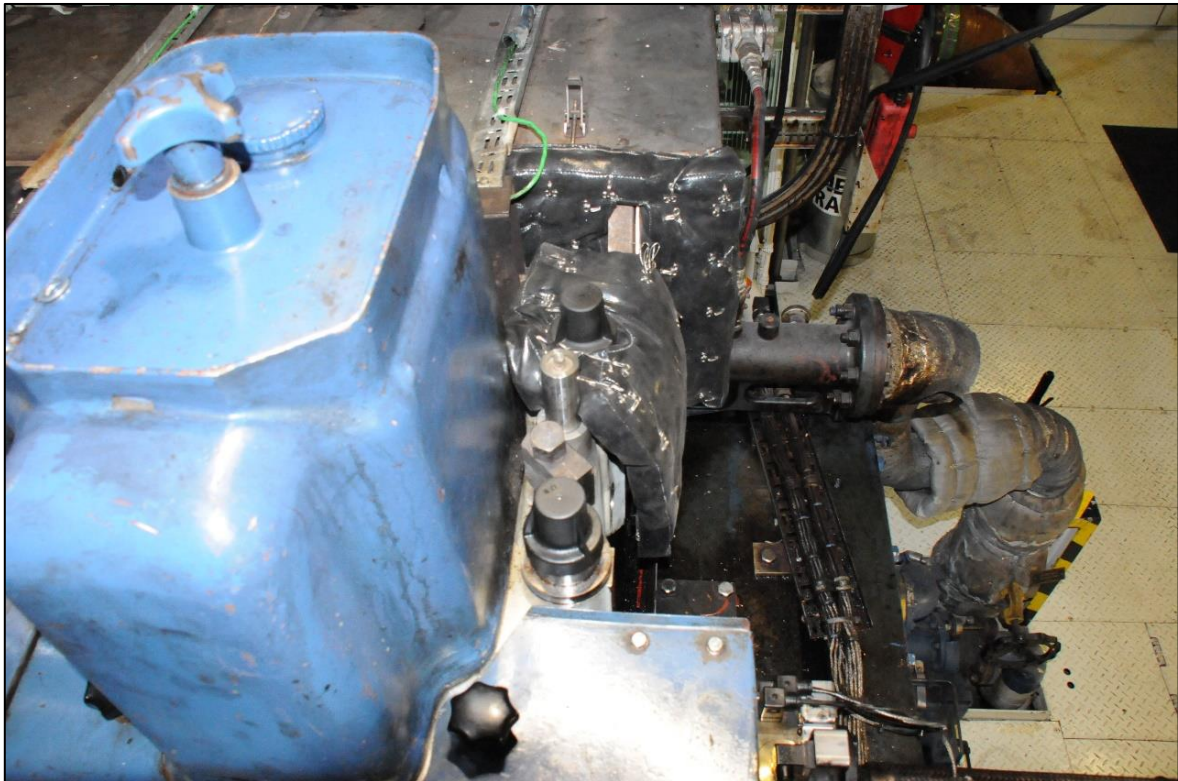
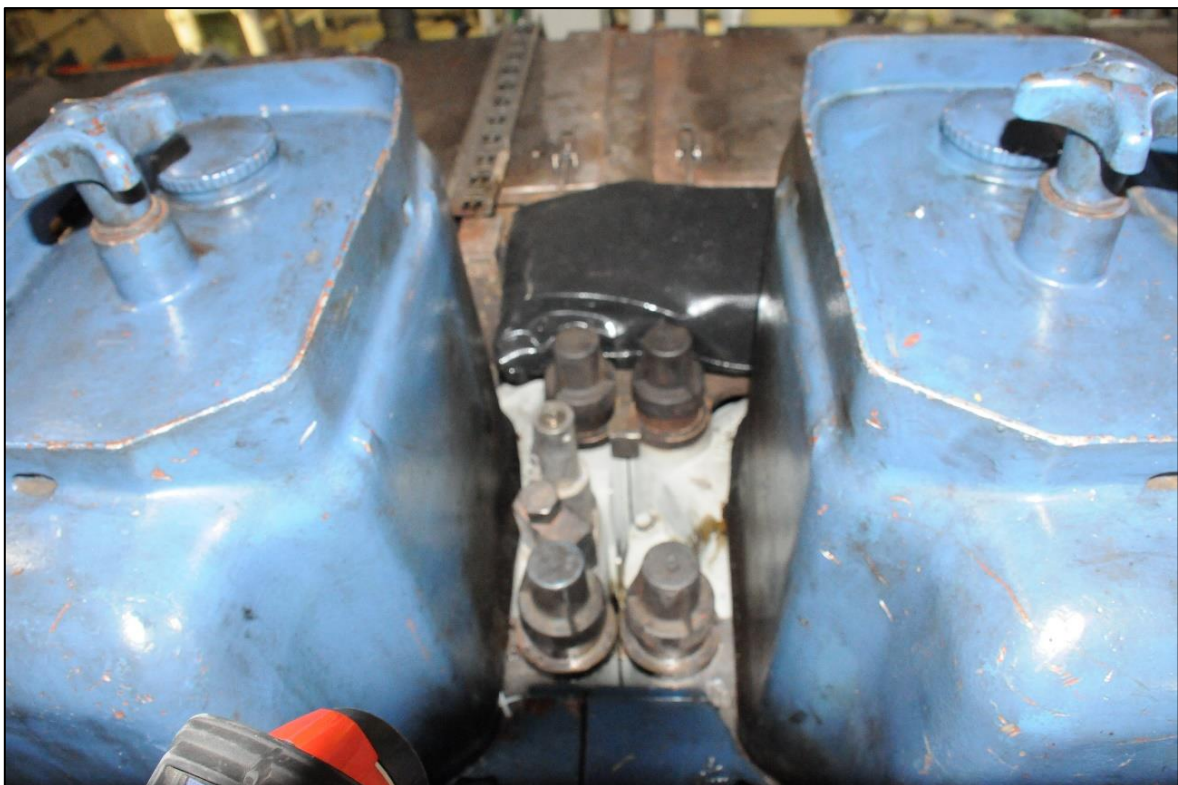
Figure 39: Additional insulating measures

Figure 40: Shield mats and insulating mats

Figure 41: Shield mats at cylinder station

Figure 42: Insulation between cylinder station and exhaust pipe

Moreover, a recent thermographic inspection was carried out in the engine rooms of all Scandlines Germany vessels. Detected hot spots were immediately shielded and re-insulated (see Figures 39 to 42)

Periodic thermographic checks have been incorporated into the maintenance management system. An inspection is now carried out every other year and/or after conversions or repair works. All detected hot spots are immediately shielded or insulated. If complete insulation is not possible or no fuel injection pipes are located in the vicinity, these areas are defined as risk areas and additional mobile extinguishing technology is stationed nearby.
