National Transportation Safety Board

Marine Accident Brief

Overtuning of the Liftboat *Kristin Faye*

Accident type	Other	No. DCA19FM050
Vessel name	<i>Kristin Faye</i>	
Location	Gulf of Mexico, Main Pass Block 64, about 18 miles east of Venice, Louisiana 29°18.10' N, 89°03.30 W	
Date	September 8, 2019	
Time	1015 central daylight time (coordinated universal time – 5 hours)	
Injuries	1 minor	
Property damage	\$750,000 est.	
Environmental damage	120 gallons of diesel fuel released (sheen 3 miles x 67 feet)	
Weather	Visibility 10 miles, cloudy, winds northwest at 6-7 knots, seas northwest 1-2 feet, air temperature 85°F, water temperature 82°F	
Waterway information	The Main Pass lease area of the Gulf of Mexico lies northeast of the Pass A Loutre entrance to the Mississippi River and abuts the Louisiana coastline.

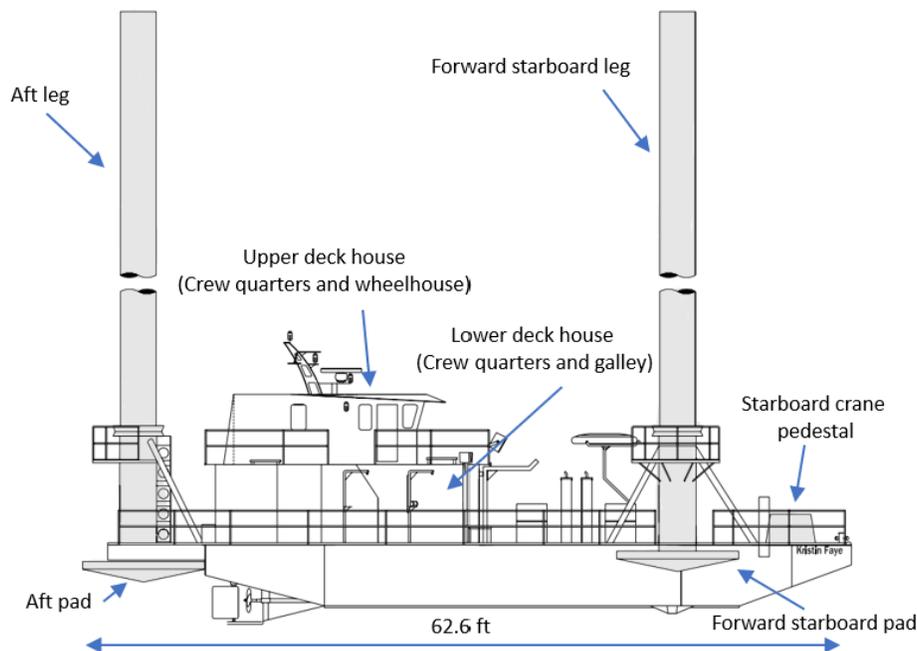
Outboard starboard profile of the liftboat *Kristin Faye*.
