SAFETY INVESTIGATION REPORT

REPORT NO.: 03/2023

MT PEARL LNG

Serious injury to three crew members during maintenance work on the fire jockey hydrophore tank in position 46° 53.9' N 006° 41.2' W 23 February 2022

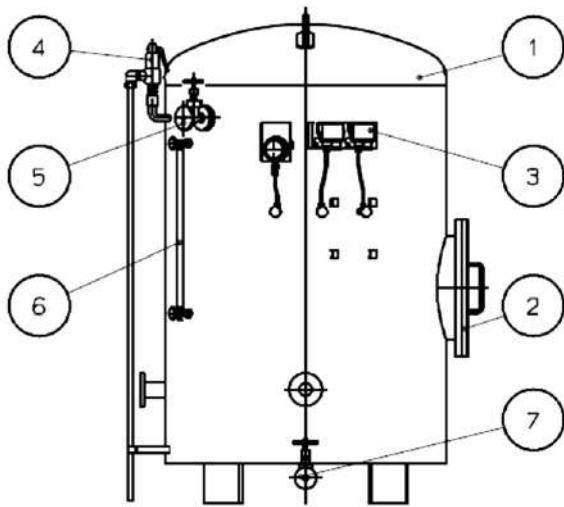
Figure 2: Hydrophore

The vessel's fire main was fitted with a hydrophore and a jockey pump. Jockey pumps are low flow, but high-head pumps, whose function is to maintain the system pressurised, if there is a small pressure drop in the system, thereby preventing the main fire pump from starting². The pump's capacity was 2.0 m³hr⁻¹ and designed for a maximum head of 90.0 m. The pump was driven by a 3-phase, 5.5 kW motor. The pressurised system was fitted with a conventional hydrophore (**Figure 2**).

The hydrophore tank had seven main design features:

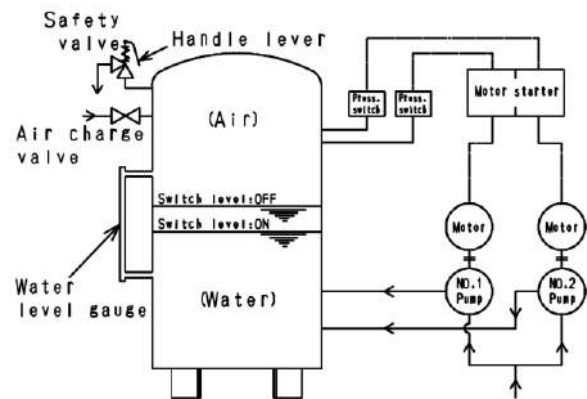
Figure 3: Hydrophore schematic

The operational principle of the hydrophore (**Figure 3**), is based on Boyle's law³. Changes in the volume of water inside the hydrophore will also affect the volume of the air above the water level, and hence its pressure. This fluctuation in the air pressure will operate the pressure switches (cut in and cut out), connected to the pumps.
