Report on the investigation of  
the capsize and full inversion of the self-righting keelboat

**RS Venture Connect sail number 307**

resulting in the death of a disabled sailor  
on Windermere, Cumbria

12 June 2019

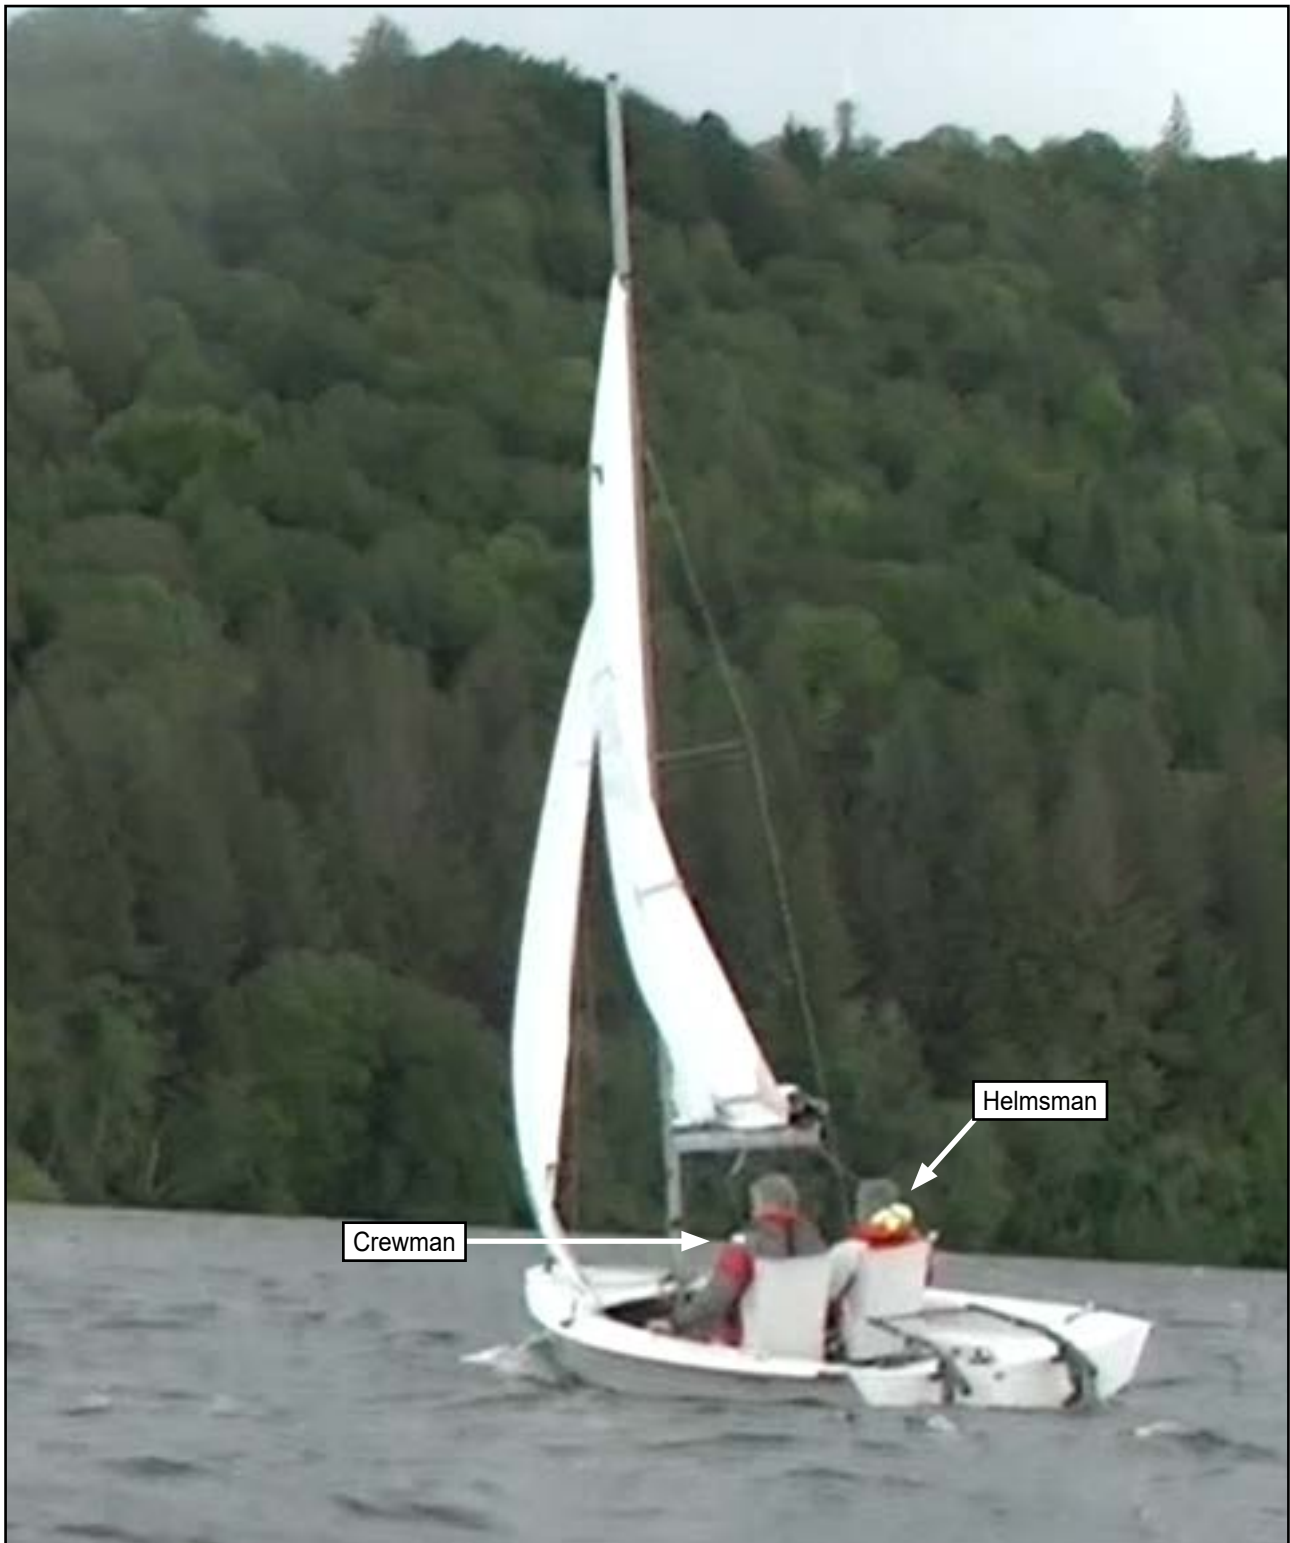
**Figure 2:** *RSVC 307* under sail – still from video footage

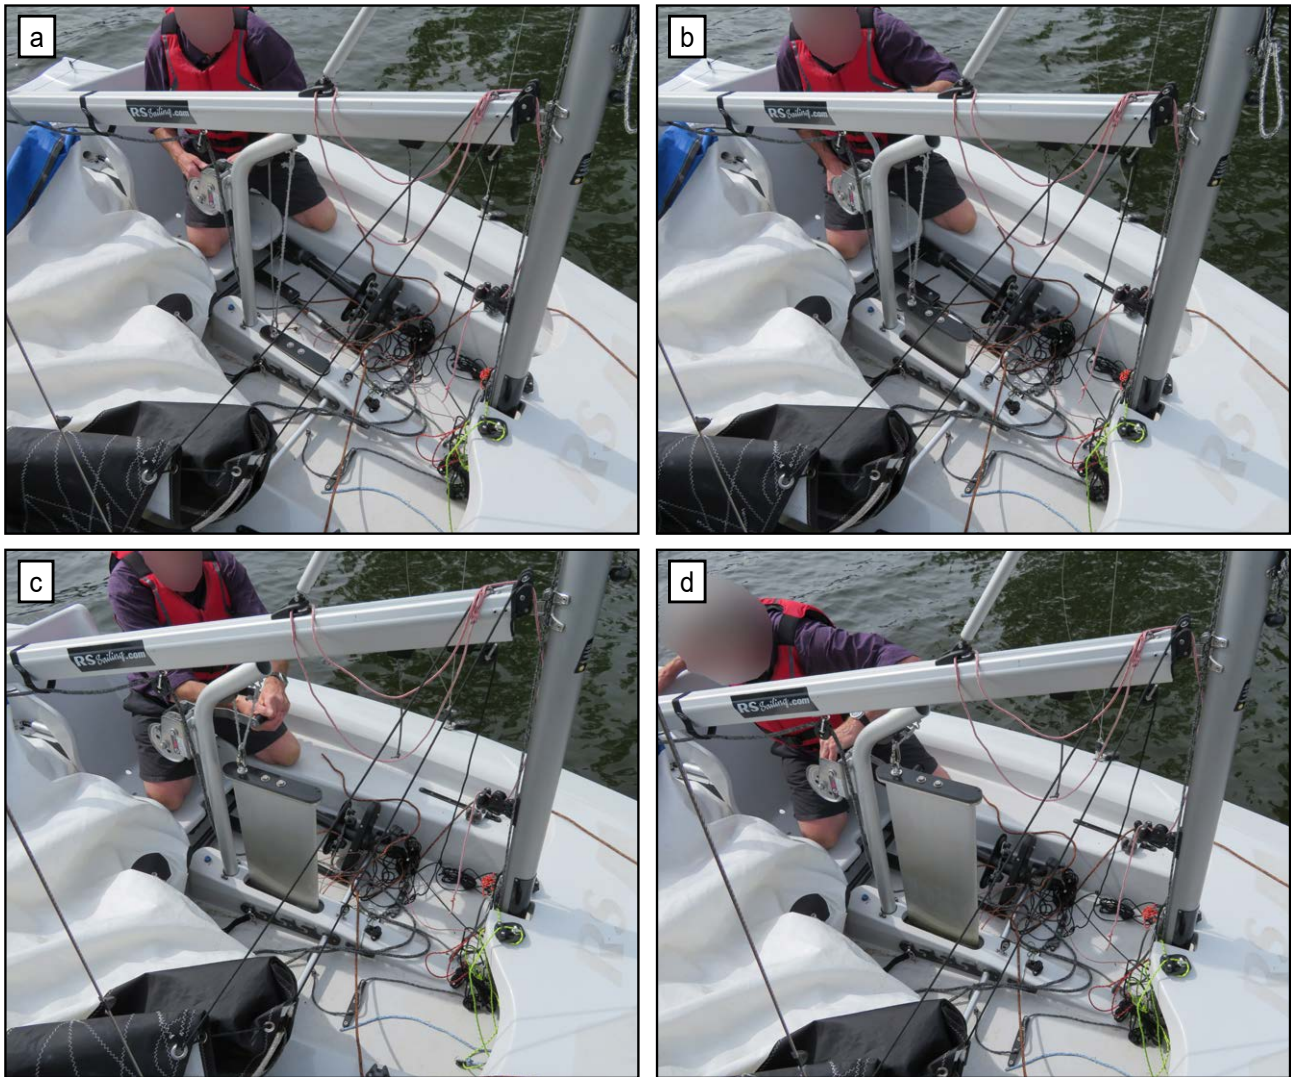
**Figure 12:** The liftable keel

After the success of the original RS Venture, RS Sailing went on to develop a choice of standard or ballasted centreboards along with a lifting keel version, the RS Venture Connect. The RS Venture Connect was very similar to the base model but had the weighted liftable keel (**Figure 12**) rather than a centreboard, making the boat a keelboat. The RS Sailing website<sup>11</sup> stated the following:

*RSVC 307*'s keel retracted when the boat was knocked down because the keel strap was not fitted in accordance with the manufacturer's Rigging Guide.

involved in the rigging or use of the boat on the day of the accident, were aware of the keel strap's function or of its importance. Therefore, it is very unlikely that this strap had ever been rigged to secure the keel.

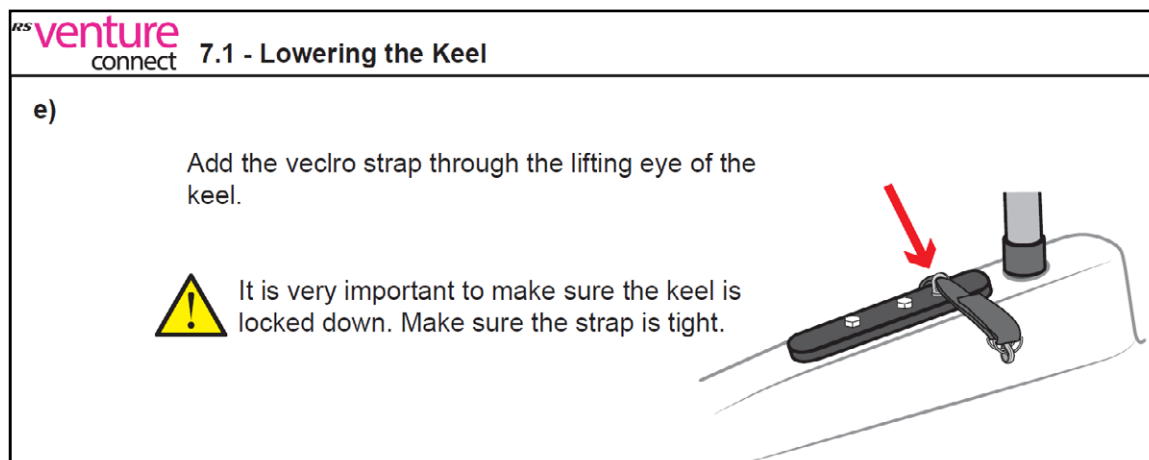
**Figure 16:** Extract from the RS Venture Connect Rigging Guide

This RS Venture Connect Rigging Guide included guidance on how to fit the keel strap, and warned of the importance of doing so (**Figure 16**). Blackwell Sailing did not have a downloaded copy of the Rigging Guide at the time of the accident.

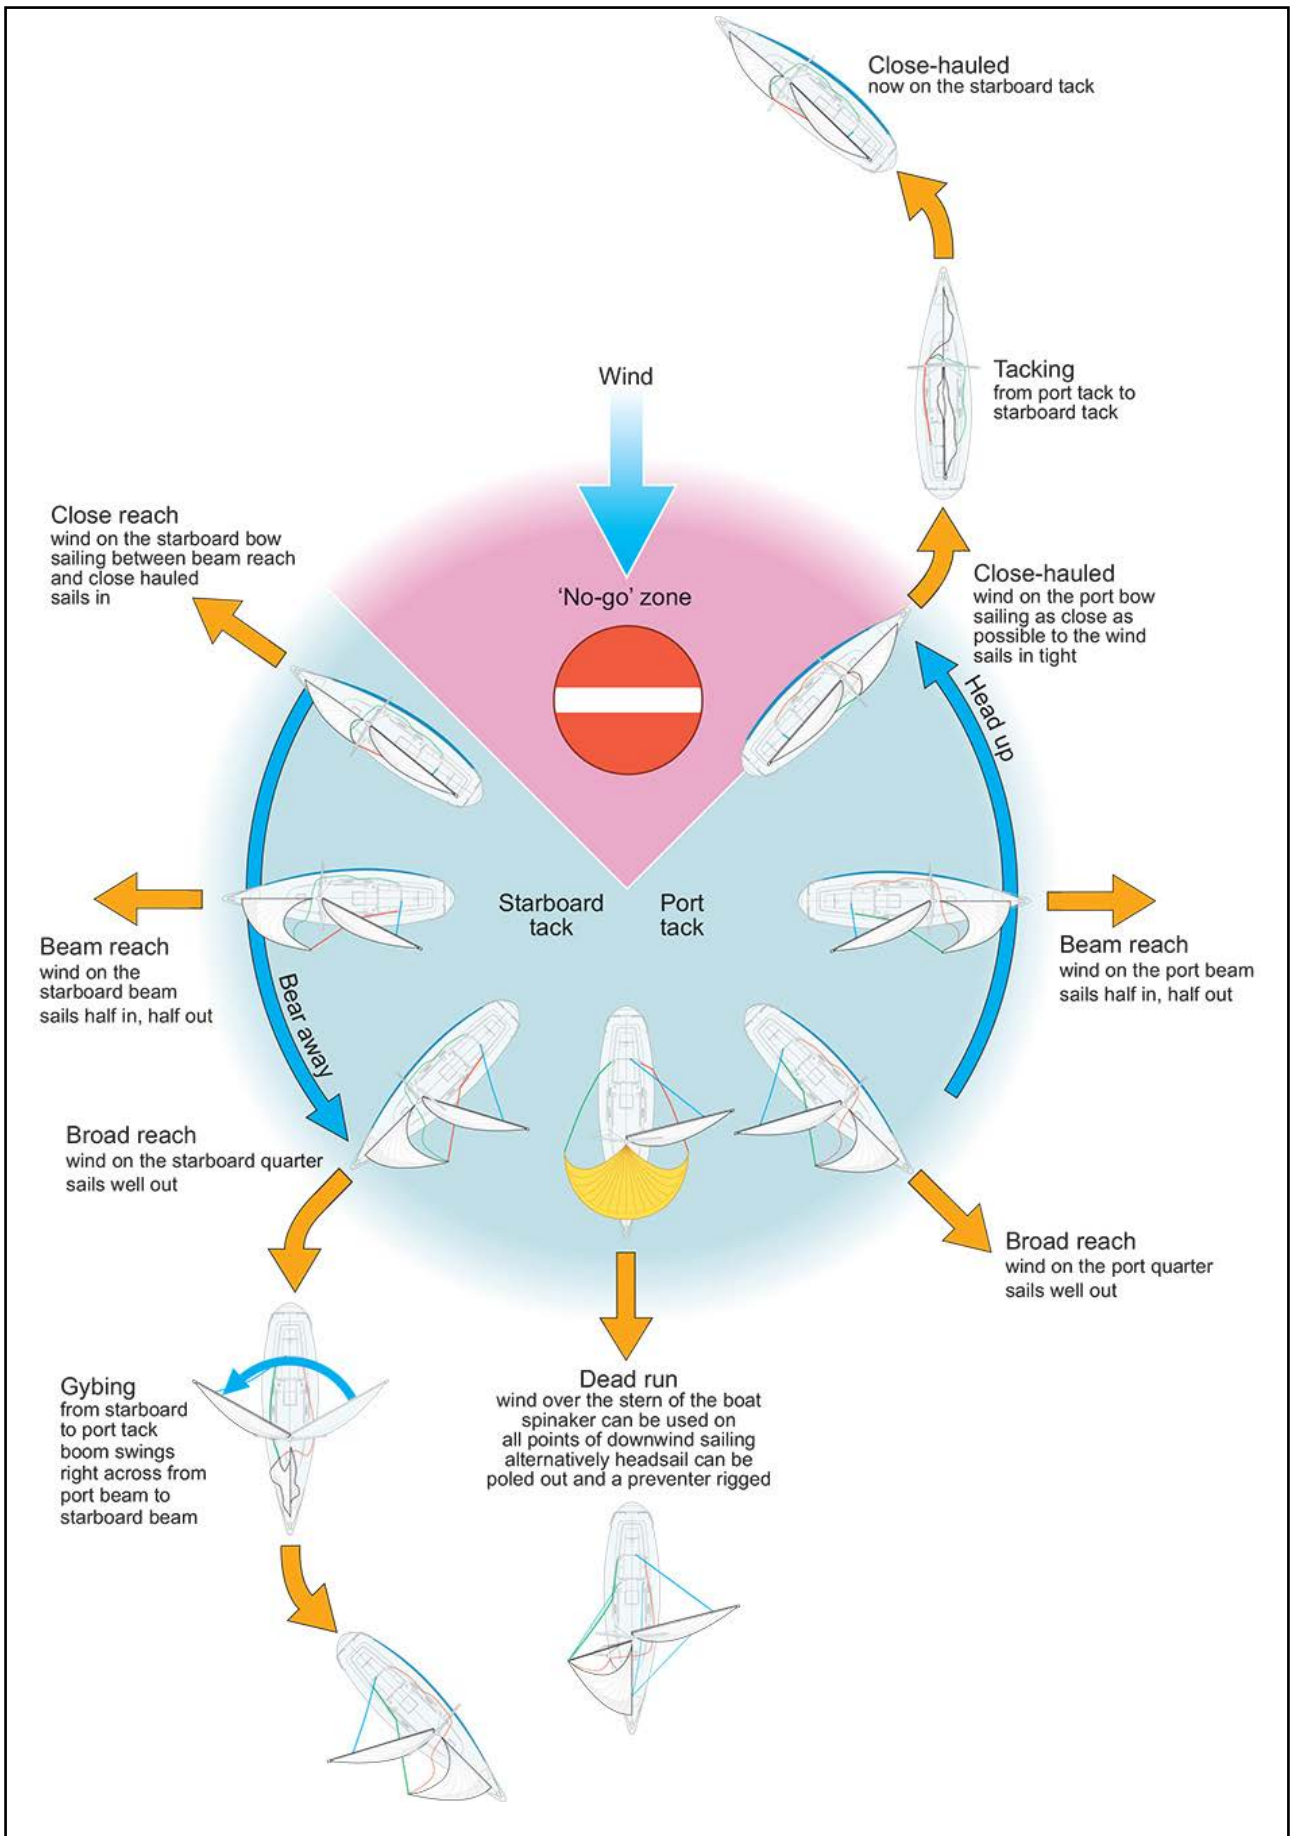
Figure 17: Points of sail

*RSVC 307* was sailing on a beam reach (**Figure 17**) with its sails out to starboard just before the accident. In the breezy wind conditions on the lake, the wind would shift and vary without warning. One such shift was coupled with a strong gust, causing the boat to heel suddenly to starboard despite its reefed sails. It is possible that, in his attempt to stay in his seat, Stephen inadvertently moved the joystick, causing the boat to turn to starboard, exacerbating this heel. In any event, the boat was knocked down due to the effects of gusting winds.
