An IIMS Self Help Guide

What A Marine Surveyor Needs To Know About

**BIOLOGICAL  
ATTACK ON  
IRON AND  
STEEL**

by **JEFFREY CASCIANI-WOOD**

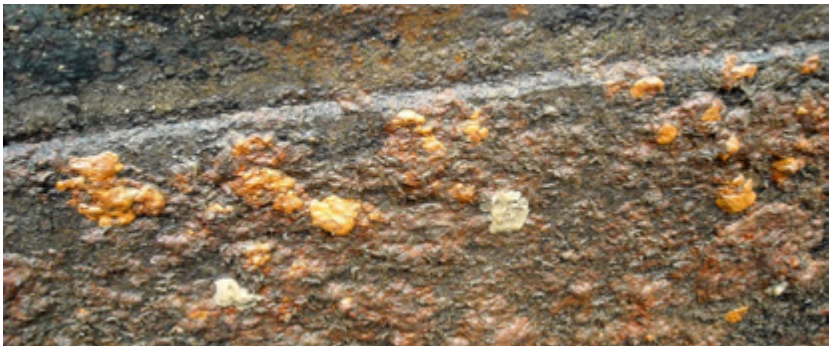
Photograph 2 - Extensive *Gallionella Ferruginea* attack on a Narrowboat

| <b>Bacterium</b> | <b>Type</b> | <b>Identifier</b> |
|---|---|--|
| <i>Gallionella ferruginea</i> | Iron oxidising bacterium<br>IOB | Yellow/brown crusted 'rusticles' of ferric and ferrous hydroxides. |

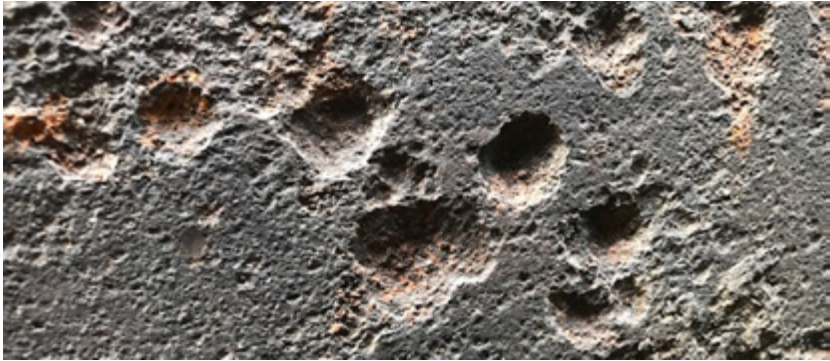
Photograph 3 – Contrast – Galvanic Pitting

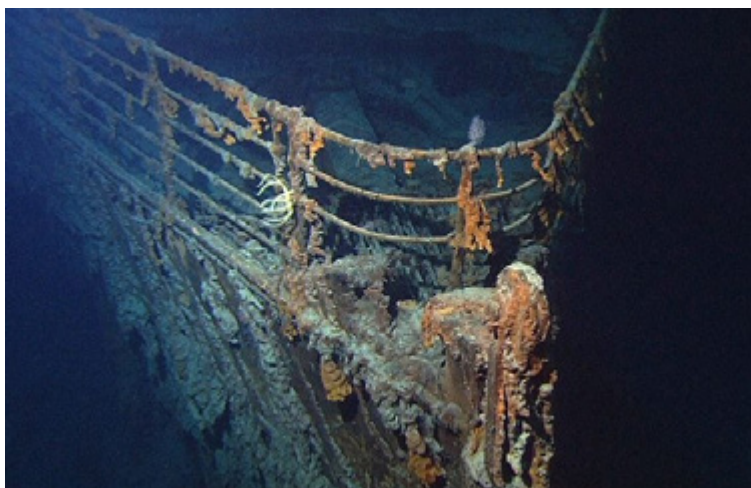
*Photograph 4 – Microbiological attack on the wreck of r.m.s. TITANIC*

In 2010, scientists also isolated *halomonas titanicae*, a Gram negative, heterotrophic, aerobic, non-endospore forming bacterial strain and motile by peritrichous flagella, designated strain BH1T, from a 'rusticle' sample collected from the wreck of the *r.m.s. TITANIC*. The pitting from microbiological sources has a high surface area/depth ratio the sides of the pits being stepped and the bottom of the pit flat. Sulphur reducing microbes leave the bottom of the pit coated with a soft black substance, easily cut with a penknife and giving off the characteristic bad eggs smell of hydrogen sulphide. Sulphur oxidising microbes leave the bottom of the pit coated with a bright silver coloured very hard substance. The 'rusticles' left behind by the gallionella microbes form a brown powder with a hard but brittle crust. They are a mixture of ferrous [Fe(OH)<sub>2</sub>] and ferric [Fe(OH)<sub>3</sub>] hydroxides which are insoluble in water and are also known as ferrous or ferric hydrate or iron hydroxide. The steel underneath often has the black lustrous characteristic of ferrosferric oxide (magnetite). If full identification is needed for, say, legal purposes then a full laboratory test is necessary. The vessel should also be fitted with an adequate number of properly electrically connected anodes whose material is suitable to the salinity of the water in which she lies. Anodes should not, of course, be painted but it is surprising how often that, even these days, one finds on surveys that that reasonably obvious rule is totally ignored particularly if the paint is applied by spray. A good practice when painting the boat is to clean the anodes all over right back to bright metal and then to coat them with soft soap or Vaseline before applying the paint to the hull. Any paint accidentally applied to the anode surface will then wash off with the soap when the boat is floated taking the unwanted paint with it. Experience has shown that, in the absence of sulphur reducing bacteria, adequate protection of mild steel is often achieved when there are sufficient anodes such that the electric potential is depressed by -0.85V with a silver/silver chloride reference anode. Where microbial activity is high or the risk is known to be present, however, the potential must be reduced to at least -1.00 V.
